## FISHING ACCIDENT FLYER

### *Meridian:* Catastrophic loss - 26 October 2006

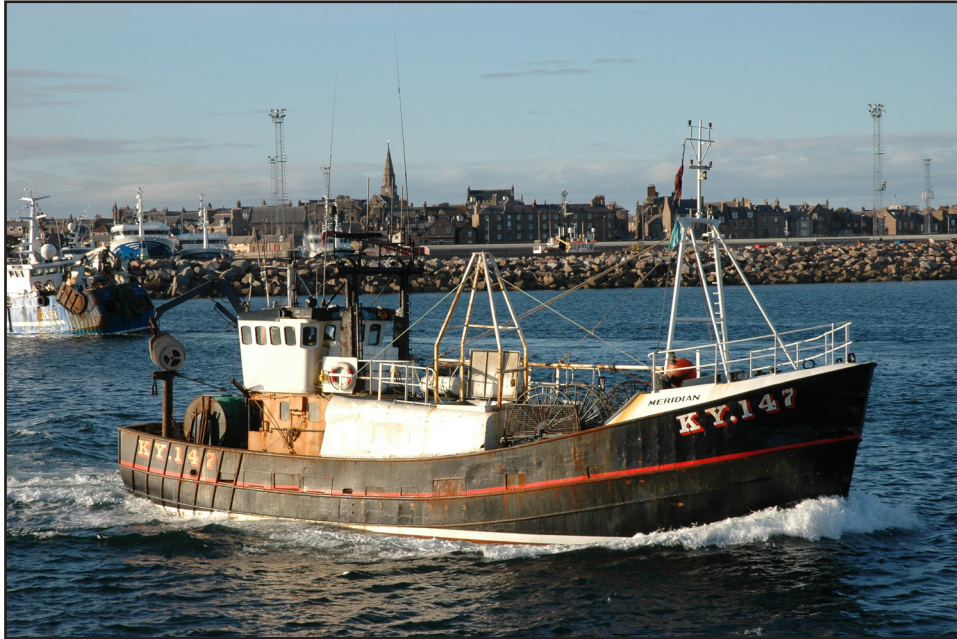
*Meridian* KY147, a 22.63m trawler, left Aberdeen on 11 October 2006 with four crew members onboard, and for the next 15 days she performed guard ship duties at the Blane Development Oilfield, 160 miles off the coast.
