Rail Accident Investigation Branch

Rail Accident Report

Class investigation into accidents and near misses involving trains and track workers outside possessions

Report 07/2017
April 2017

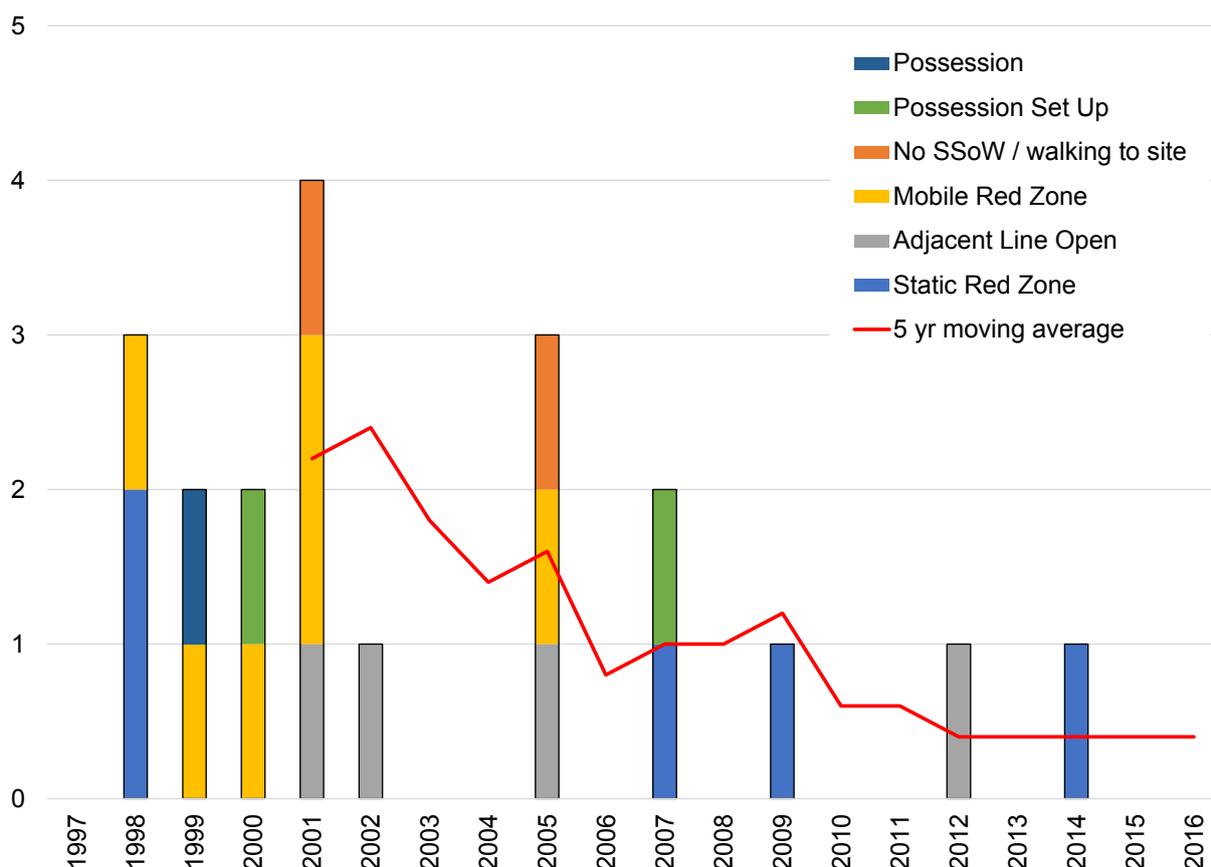
Figure 1: Track worker fatalities as a result of being struck by trains; twenty years 1997 to 2016

- 11 In order to provide some context for the investigation, the RAIB considered the incidence of fatalities and near misses with moving trains involving track workers. The numbers of fatalities has been generally declining over a twenty year period to 2016 (figure 1), although it should be noted that the numbers are very low so the trend may not be a reliable indicator of the risk. Details of the incidents are provided at appendix E.

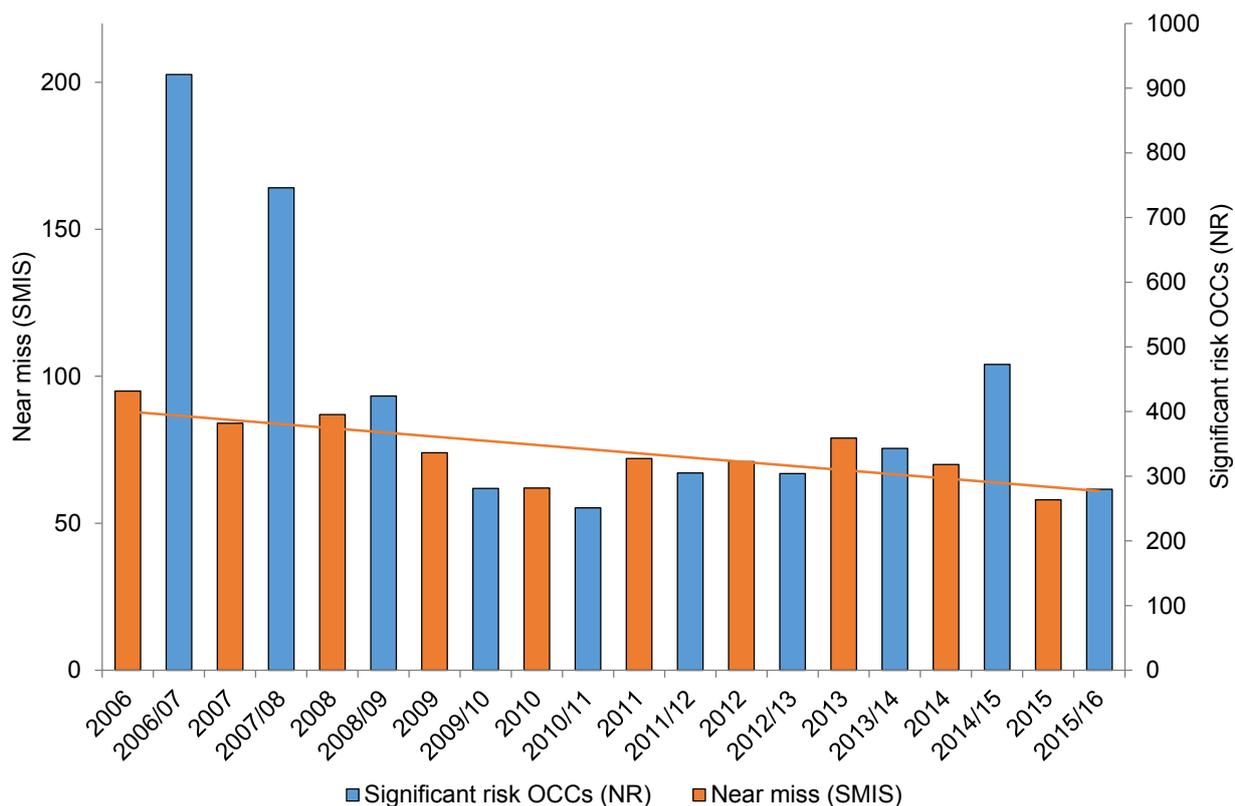
Figure 2: Comparison of SMIS data for workforce near miss incidents with Network Rail data for OCCs with significant risk; ten years 2006-2015⁴ (source: RSSB)

- 12 Data for incidents recorded as 'near miss - train with person (not at level crossing)' from the industry's safety management information system (SMIS) over a ten year period to 2015/16 is shown at figure 2. The data has been plotted alongside Network Rail's data for 'potentially significant' and 'potentially severe' OCC incidents³. Both sets of data indicate that there has been a reduction in the number of incidents over the period.

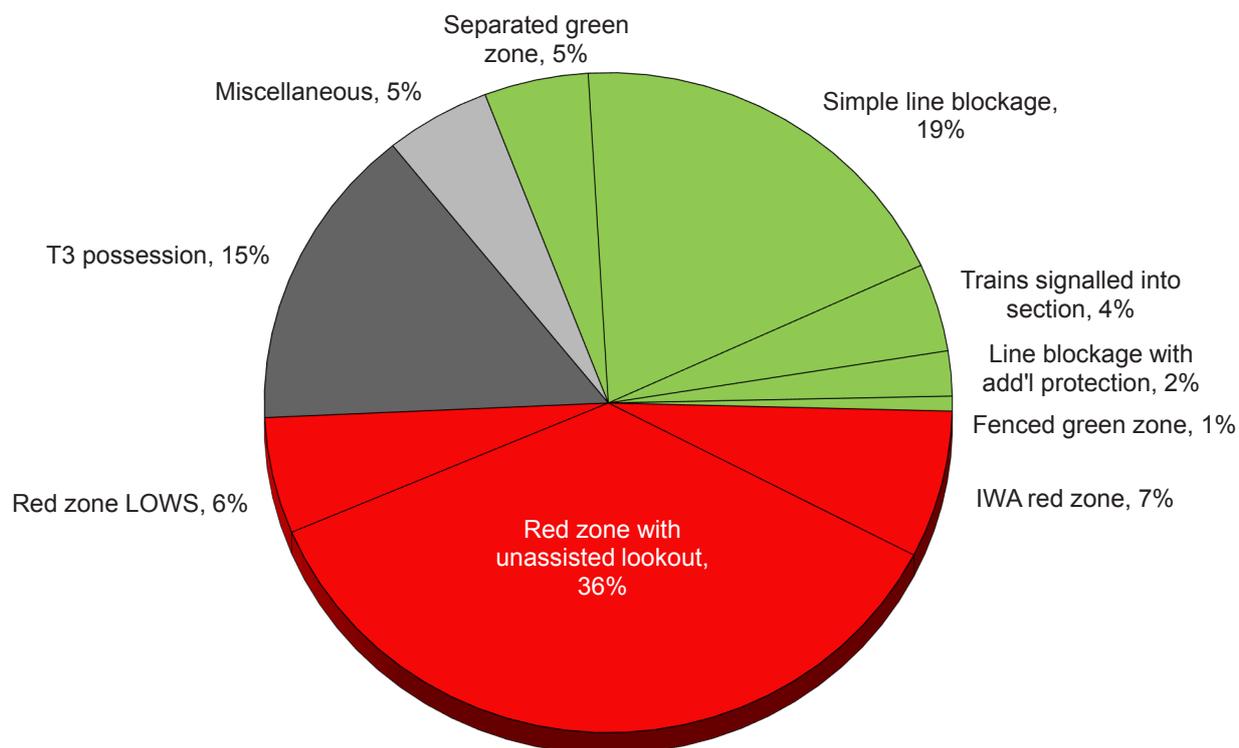
Figure 3: Near misses recorded for work planned using different types of SSOW; two years 2014/15-2015/16 (source: Network Rail)

- 16 Network Rail has identified that the highest number of near misses occur with red zone SSOWs using unassisted *lookouts* (RZUL)⁶ (figure 3). It has advised that, in order to reduce the volume of work being carried out using RZUL, the response of its regional management was to invest in *lookout operated warning systems* (LOWS)⁷. Such systems provide an extra degree of assurance through the incorporation of a vigilance device, requiring a regular response from the lookout. However, the RAIB's investigation into the near miss at Hest Bank in September 2014 ([RAIB report 08/2015](#)) found that LOWS is still vulnerable to a single point failure by one person. Since the data shown at figure 3 has not been normalised by the volume of work planned, it is not possible to determine whether the use of LOWS achieves a significant reduction in risk compared with RZUL (Recommendation 2 of [RAIB report 08/2015](#) refers).

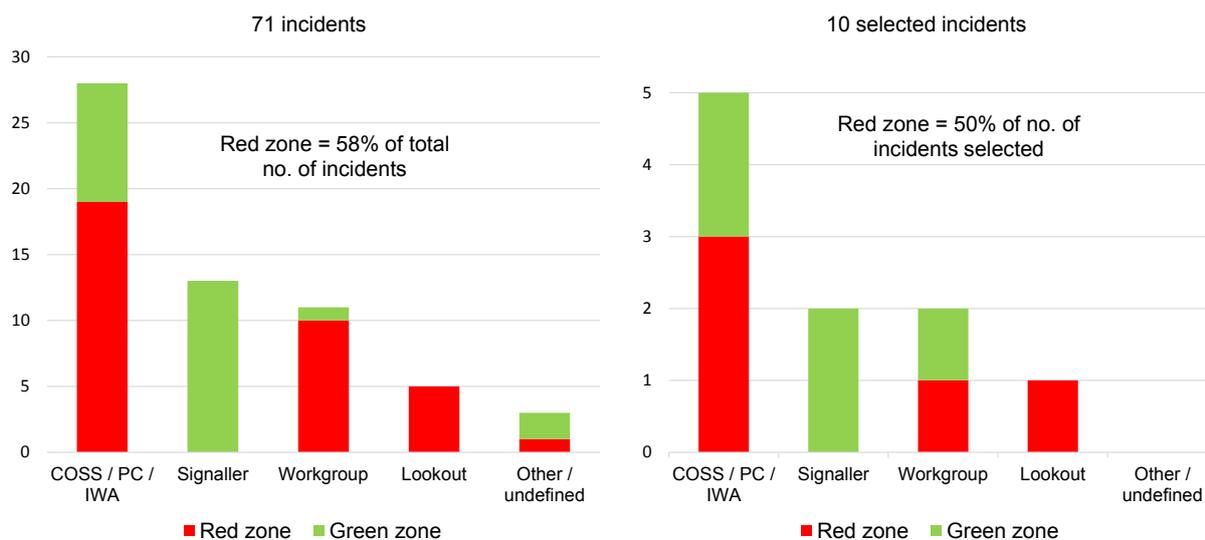
Figure 4: Categorisation of incidents occurring in 2015

- 18 The RAIB selected ten incidents that were representative of those occurring during 2015; the industry's investigation reports were then analysed to identify causal factors. It should be noted that the RAIB has not carried out independent investigations of these incidents. A breakdown of the incidents is shown at figure 4, showing the person most involved in the immediate cause of the incident⁸, with a comparison between the 71 incidents that were identified initially and the 10 that were selected for analysis. The figure includes incidents occurring under both red zone and green zone conditions (see appendix H).

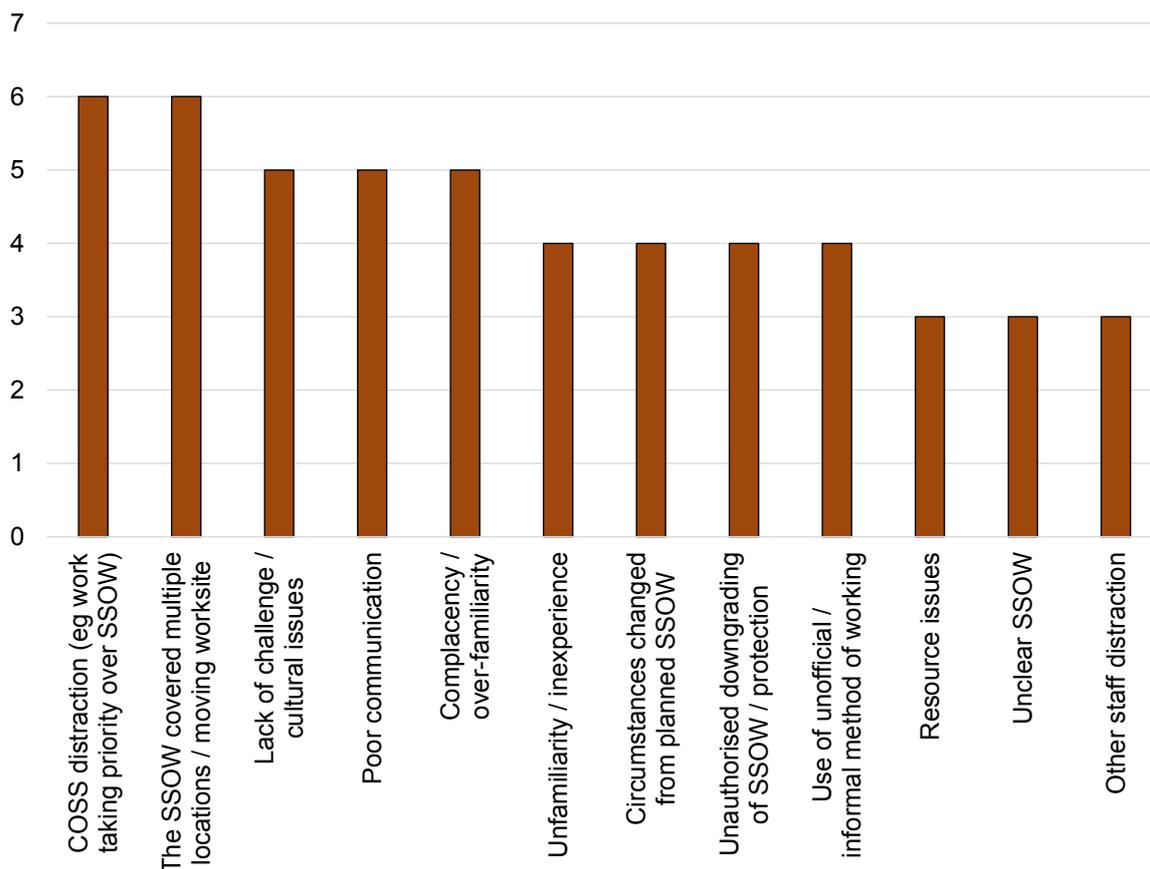
Figure 5: Occurrence of common factors in selected incidents occurring during 2015

- k. Unclear SSOW (paragraph 74).
 - l. Other staff distraction (paragraph 77).
- 42 A matrix showing the RAIB's assessment of the applicability of these common factors to the incidents occurring in 2015 is included at table G1 appendix G; figure 5 provides an overview. Each of these factors is now considered in turn.

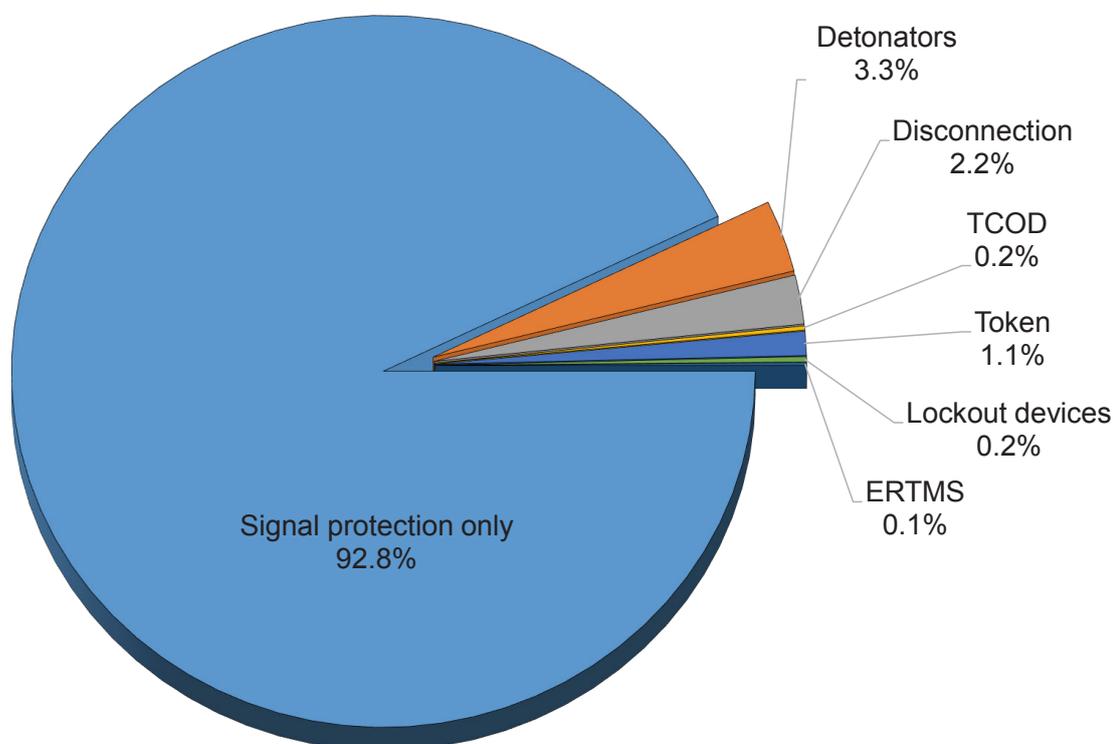
Figure 6: Protection arrangements for pre-planned line blockages²⁶; twelve months, 18/11/14-17/11/15 (source: Network Rail)

- 81 Most line blockages are taken without using any protection other than the signaller placing the protecting signal to danger (figure 6). Handbook 8 of the Rule Book states that *additional protection* such as the disconnection of signalling equipment or the use of a track circuit operating device must be arranged if the work will affect the safety of the line²⁵. Additional protection could be arranged for any line blockage, although the time taken to set up the arrangements may be disproportionate. NR/L2/OHS/019 states that such protection need not be used if it would increase the time taken to complete the work by more than 25%.

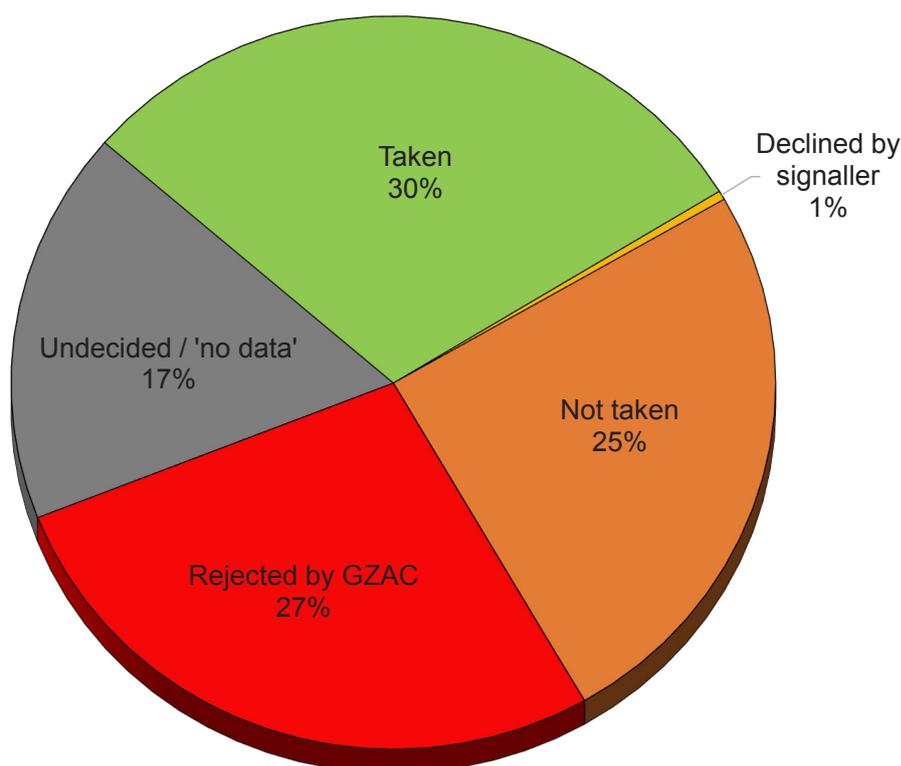
Figure 7: Implementation of pre-planned line blockages (Kent & Sussex)²⁹; twelve months, 03/05/15-02/05/16 (source: Network Rail)

- Witnesses report that planners often find themselves so busy that they do not have time to familiarise themselves with the infrastructure or to obtain first-hand experience of working on or about the line. Despite this high workload, the RAIB has been advised that a significant proportion of planned line blockages (possibly as high as 50%) are not actually implemented; data for Kent and Sussex is shown at figure 7.

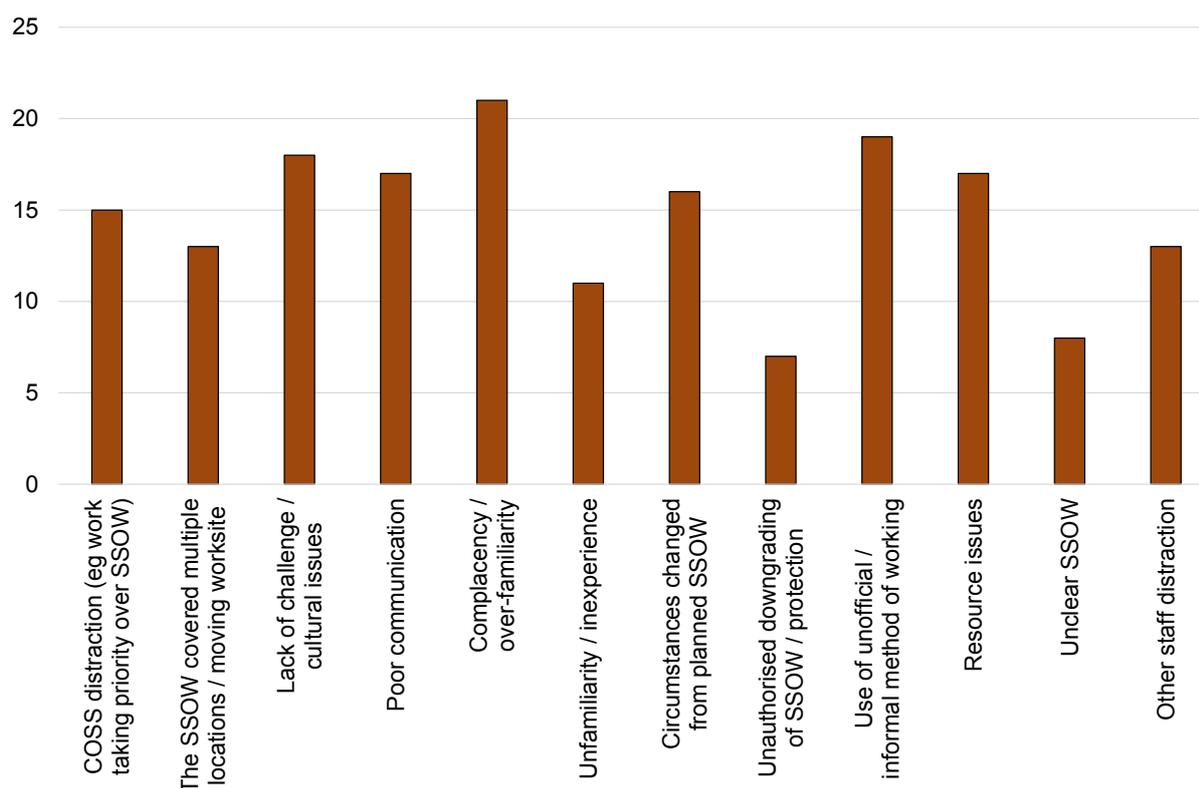
Figure 8: Occurrence of common factors in RAIB investigations and safety digests involving track worker safety

- 84 The RAIB has categorised its investigations and safety digests involving track worker safety (summarised at appendix M) using the same factors as those identified for the selected incidents that occurred during 2015 (table G2, appendix G). Figure 8 provides an overview and indicates that the RAIB's investigations and safety digests involve a similar range of factors to the 2015 incidents, although the relative importance of each is different.

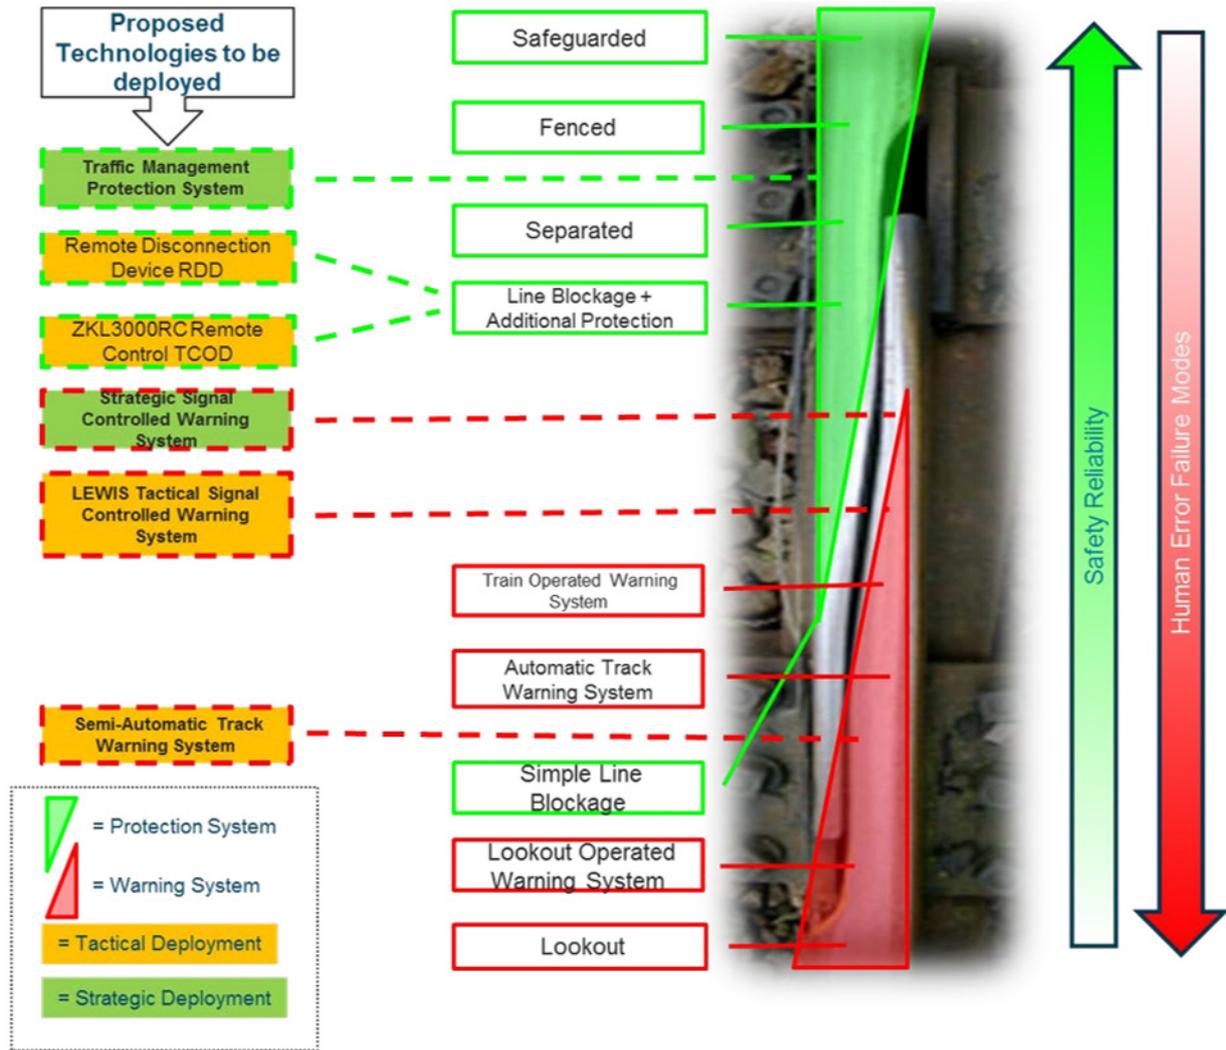
Figure D1: Risk-based hierarchy proposed as part of STW programme (courtesy Network Rail)
