Air Quality and Dust Monitoring Monthly Report – July 2018

London Borough of Camden

Department for Transport

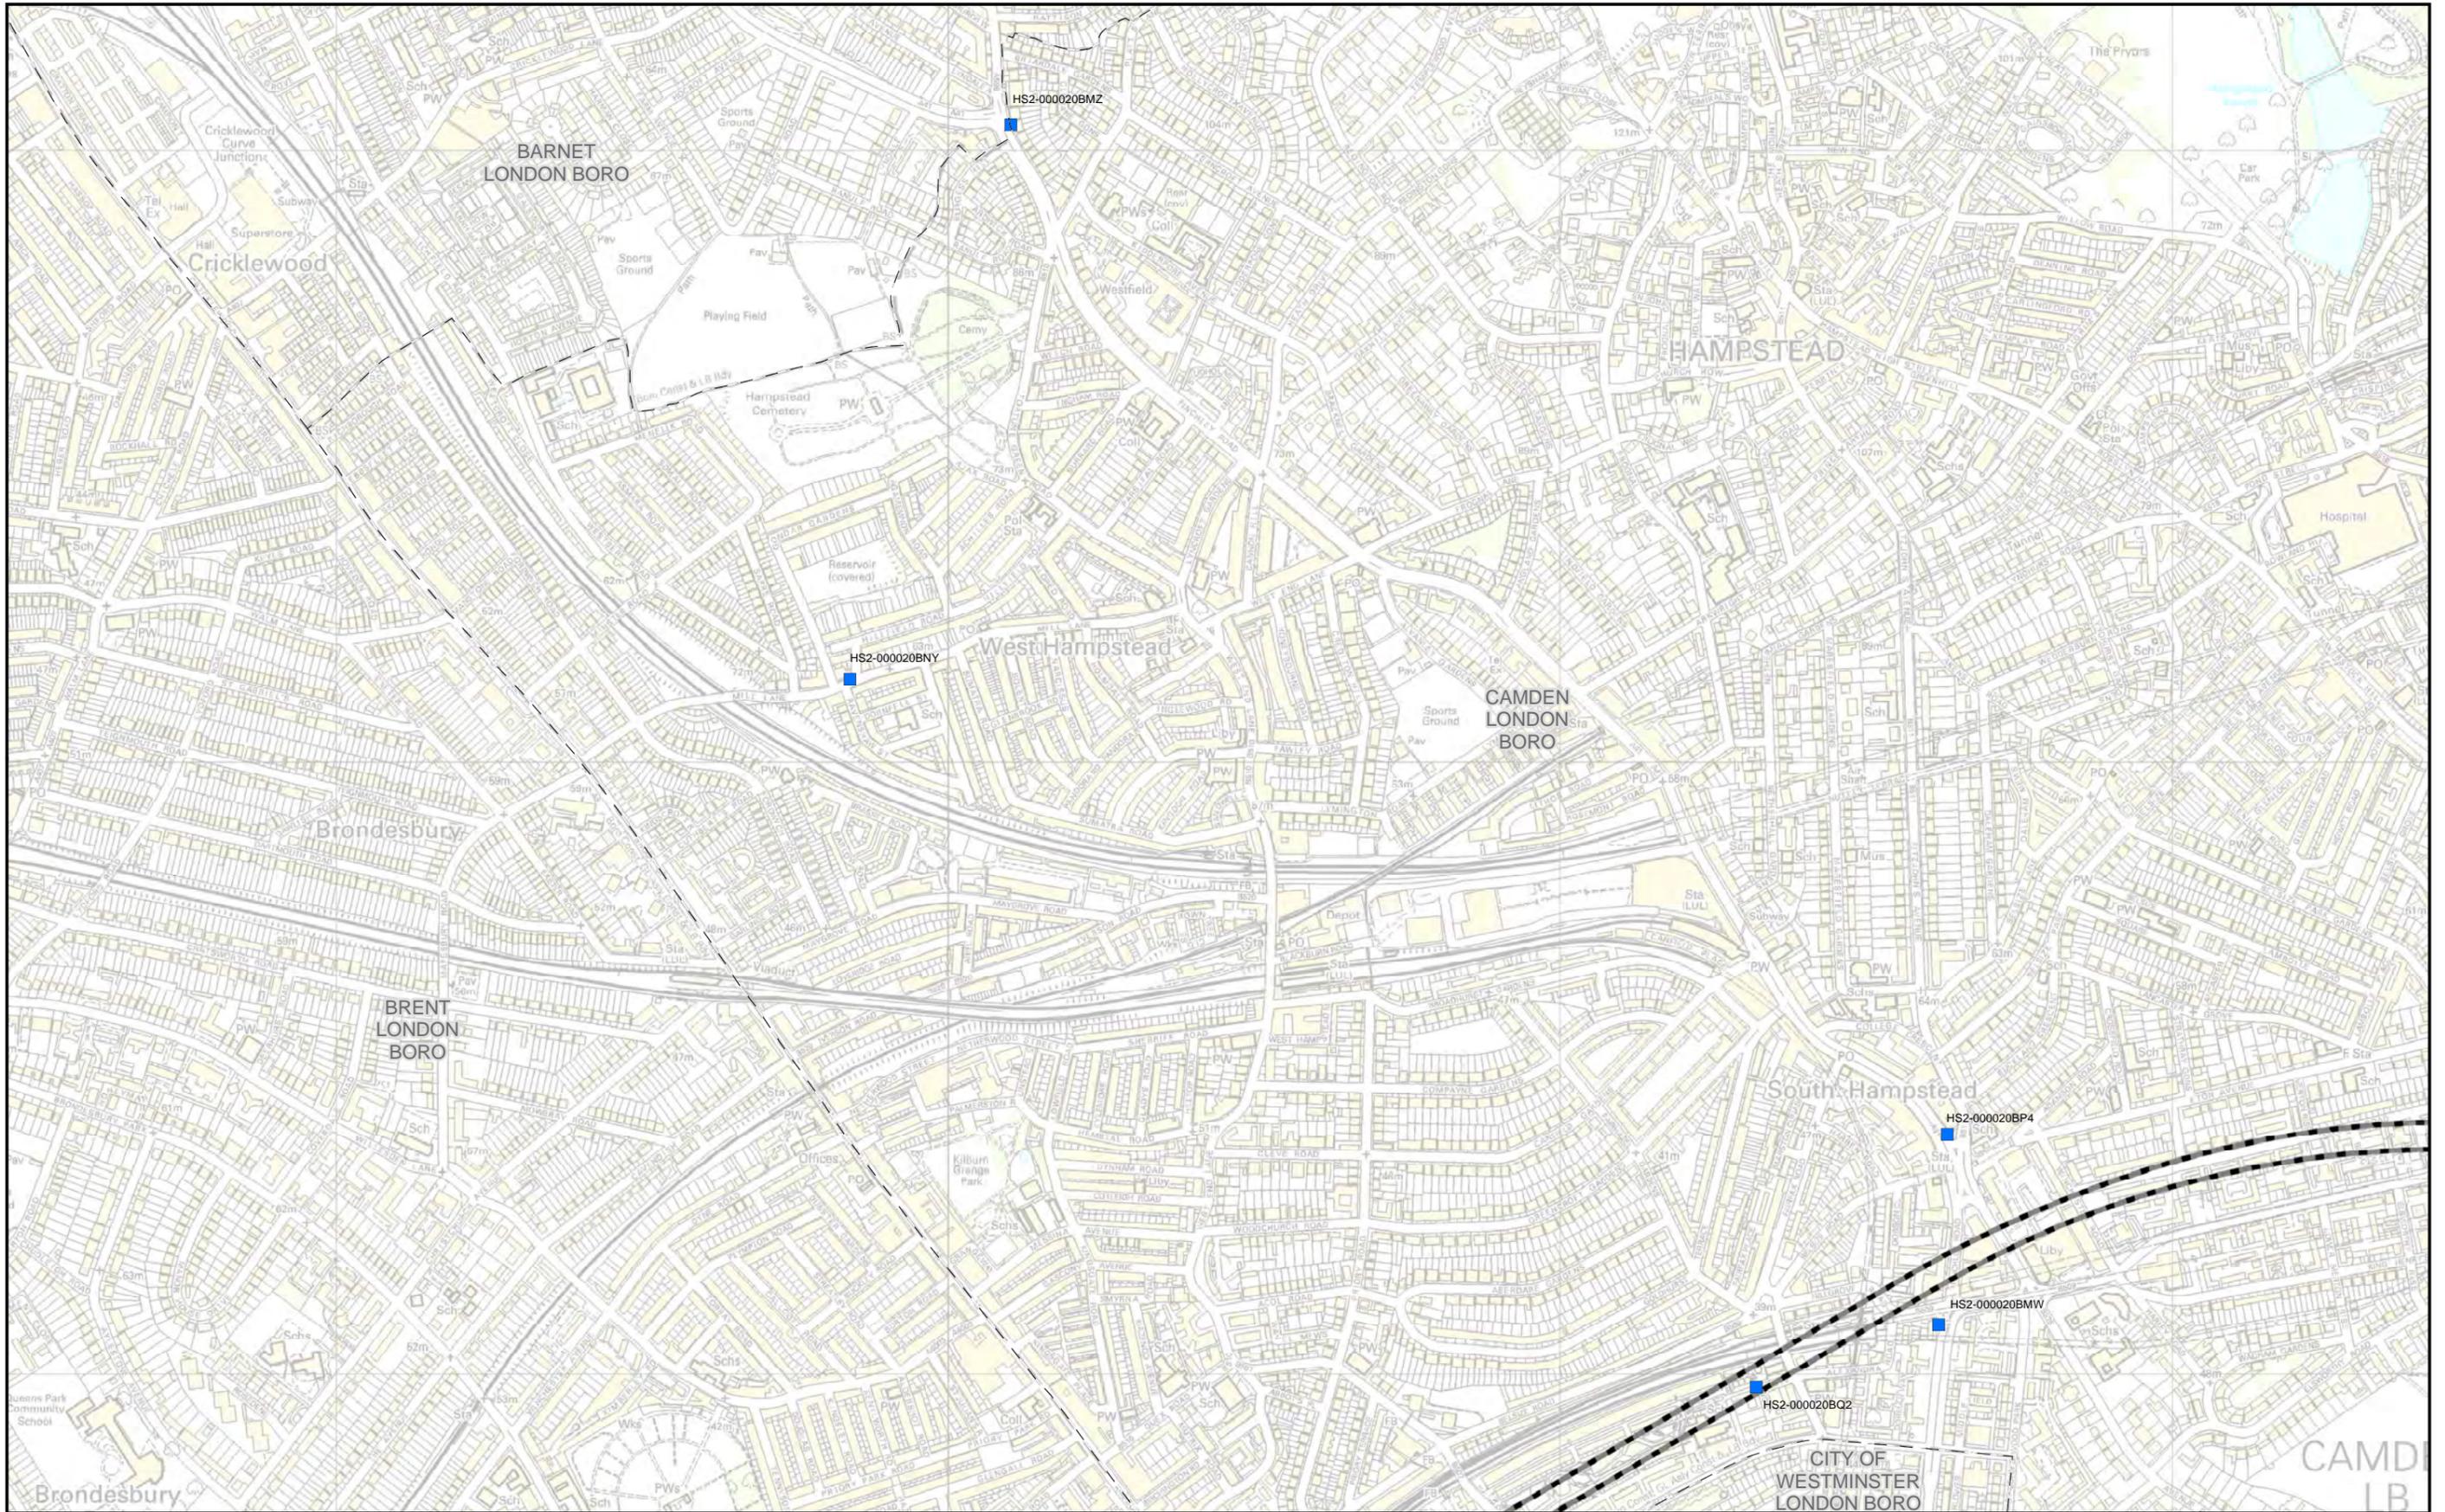
Diffusion tube monitoring location

Figure Number
Figure Name
Worksites and Monitoring locations in LBC
London Borough of Camden

- 1.1.2 Figure 1 to Figure 3 in Appendix A indicate the current work sites together with air quality and dust monitoring locations.
- 1.1.3 This summary should be read in conjunction with the overview monitoring report available from www.gov.uk/government/collections/monitoring-the-environmental-effects-of-hs2, which highlights: the applicable standards and guidance, as well as the air quality and dust monitoring methodologies to be implemented by nominated undertakers throughout construction.

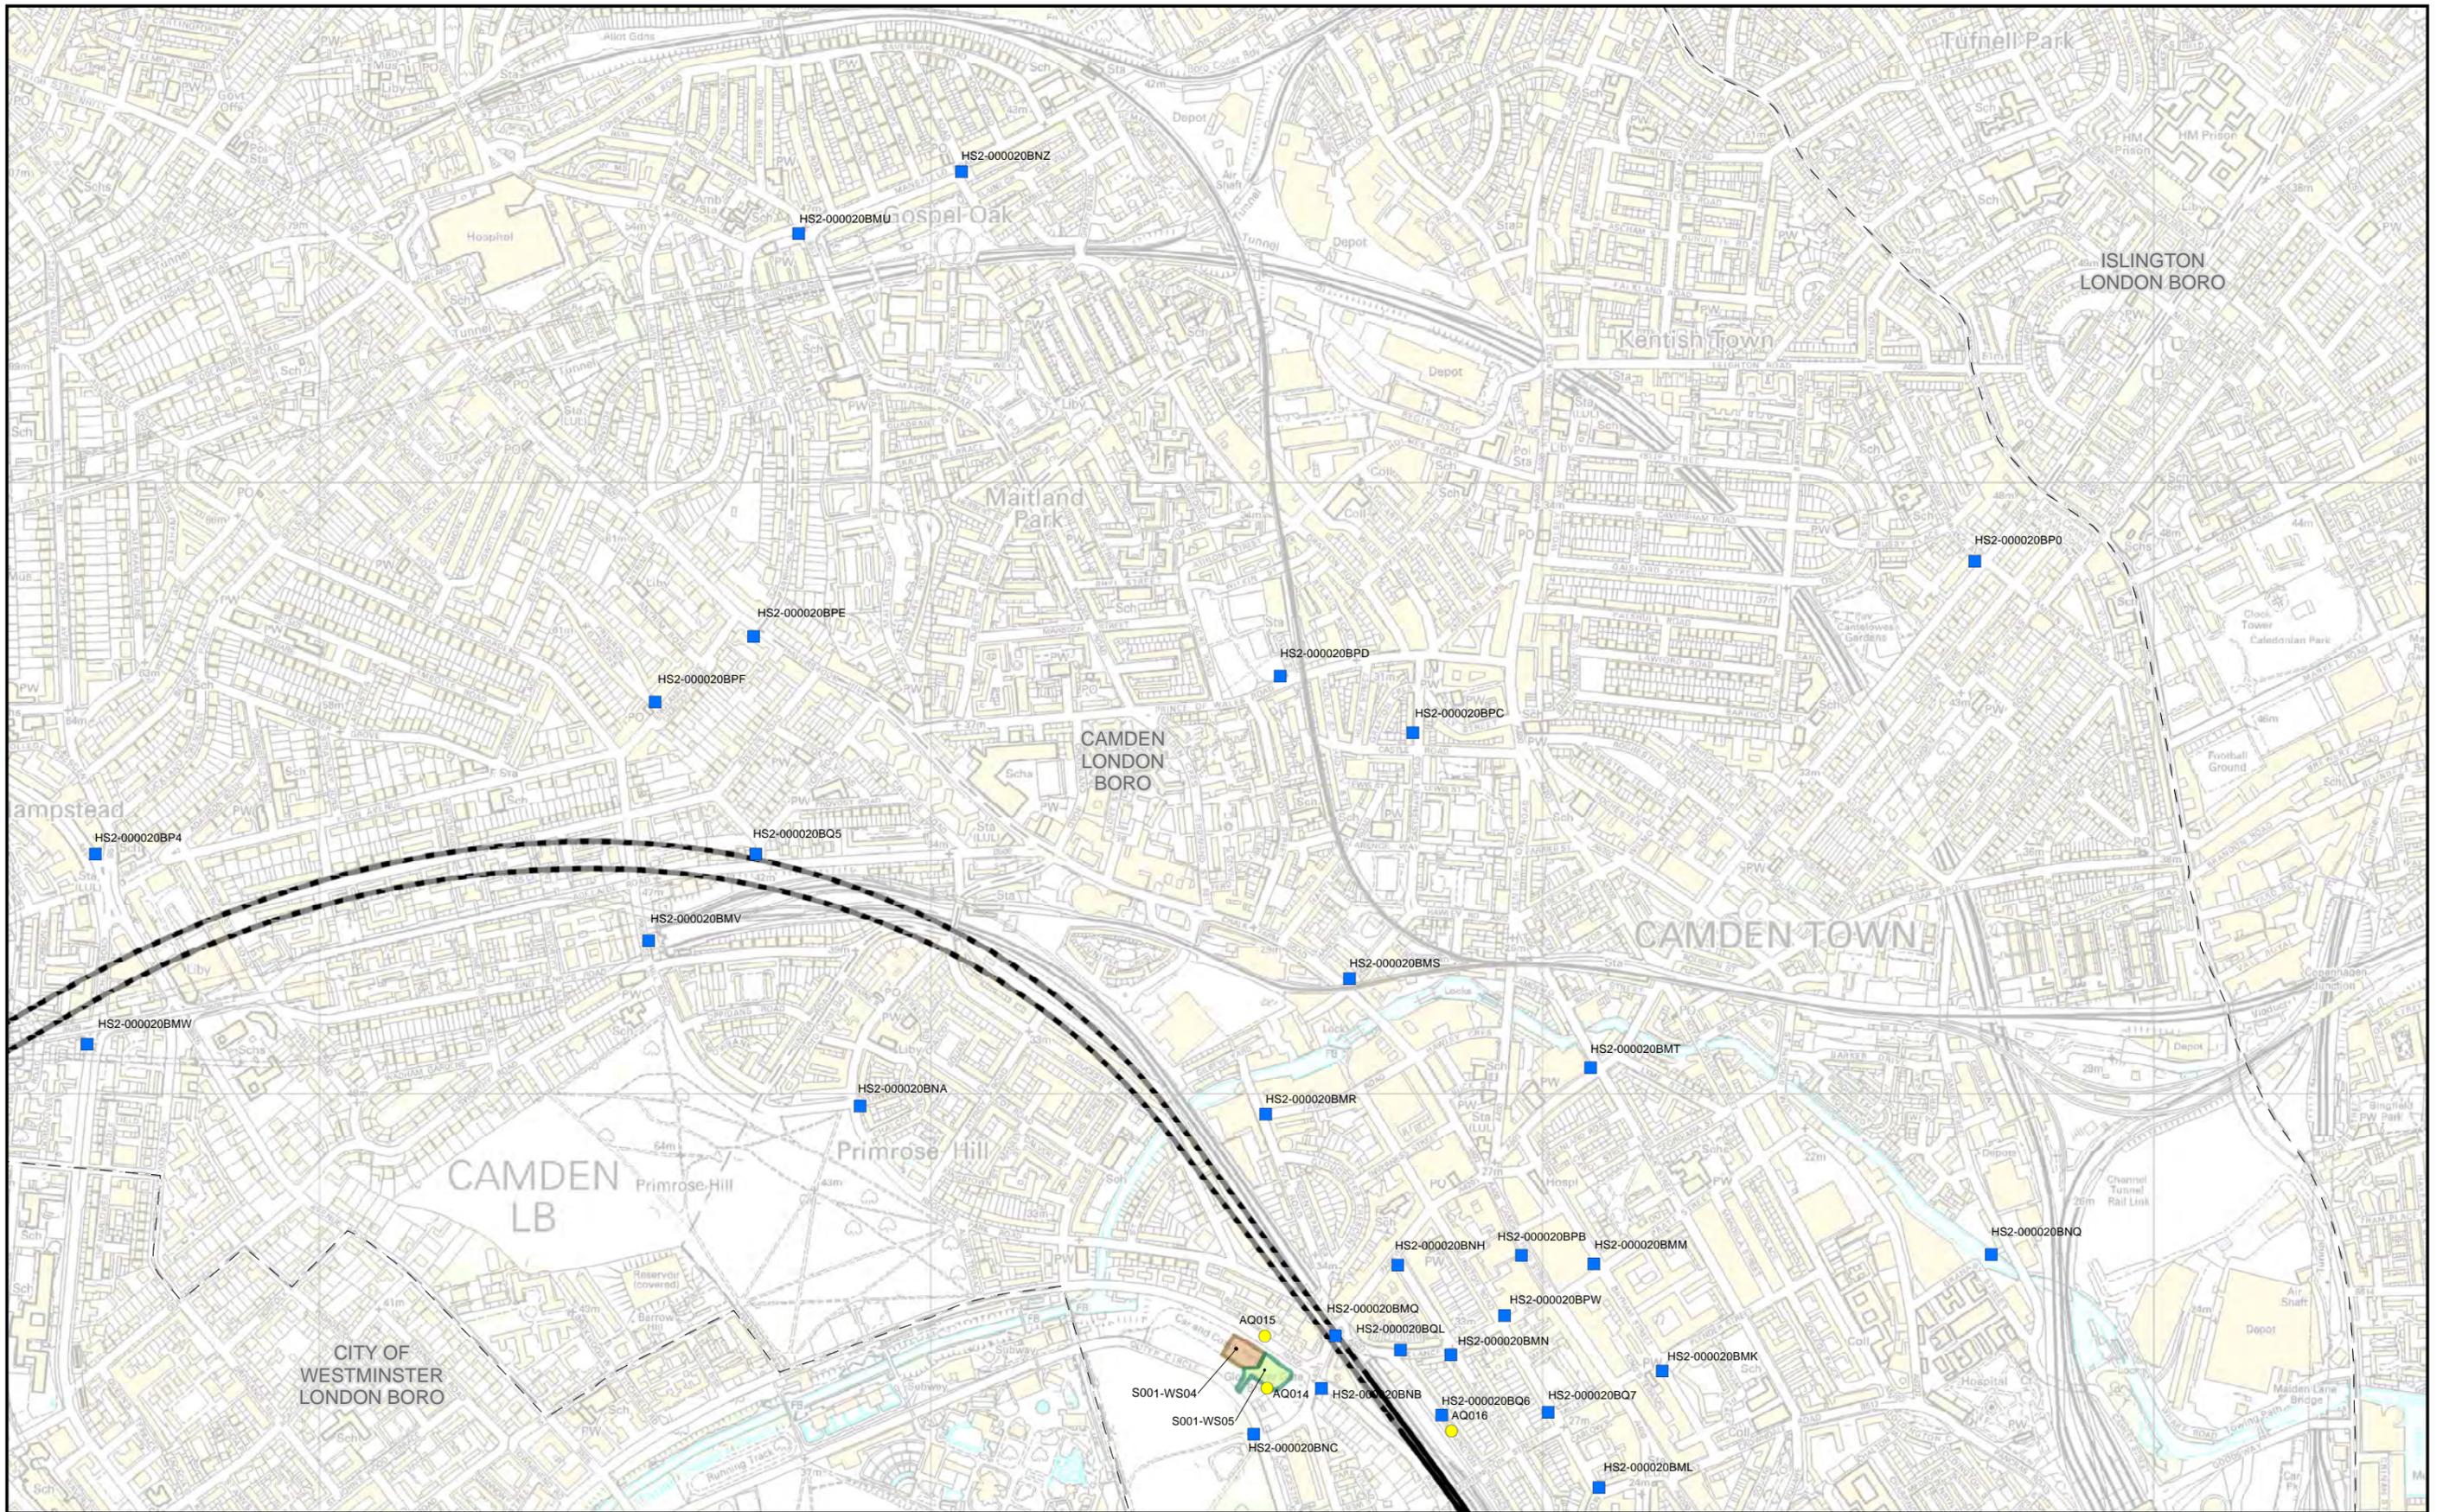
Figure Number

- Legend**
- Route in tunnel
 - Route on surface
 - Diffusion tube monitoring location
 - Dust monitoring location
 - Vehicle Holding Area
 - Thames Water Compound

Figure Name
Worksites and Monitoring locations in LBC
 (sheet 2)

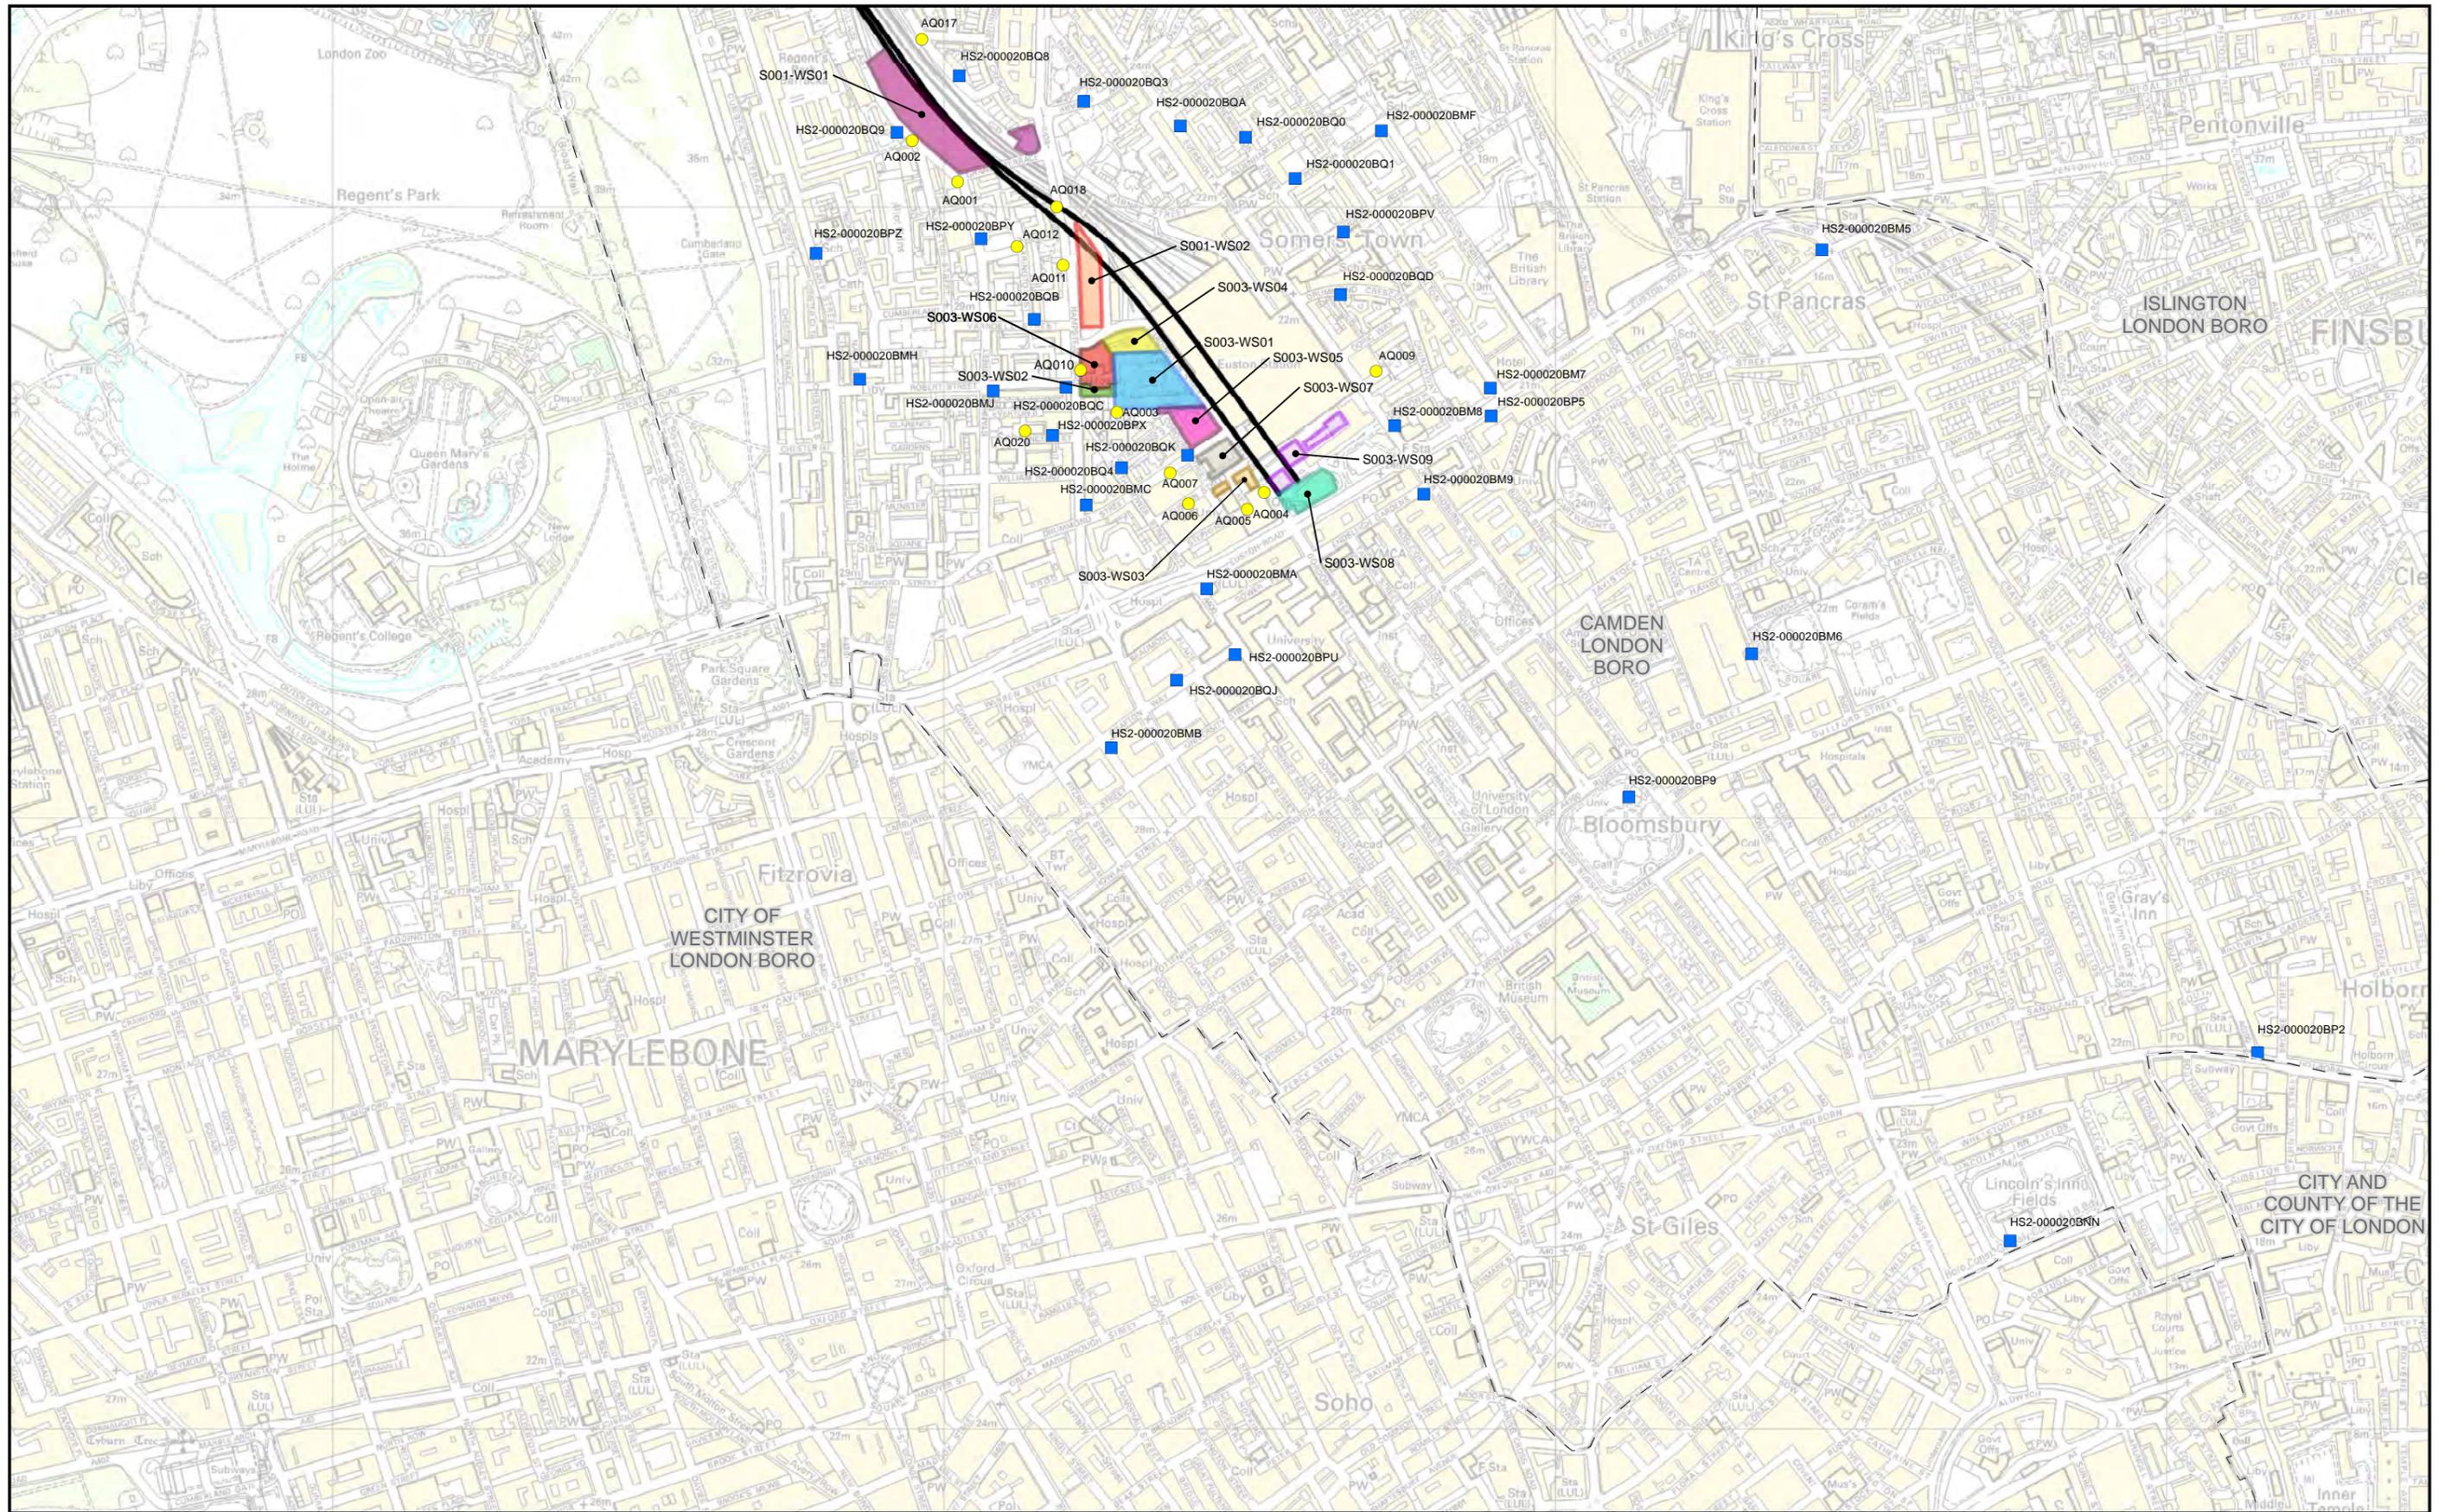
Legend			
	Route in tunnel		National Temperance Hospital worksite
	Route on surface		Ibis Hotel, 3 Cardington Street & 1-3 Cobourg Street
	Diffusion tube monitoring location		National Temperance Hospital, Insull Wing
	Dust monitoring location		Walkden House, 65-75 & 77-79 Euston Street
	DB Cargo Shed and Compound worksite		Thistle Hotel, Cardington Street
	St. James' Gardens worksite		Euston Street, Melton Street, Drummond Street block
			One Euston Square, 40 Melston Street and Gran Thortorn House, 22 Melston Street
			132 and 140 Hampstead Road and Petrol Station

Figure Number	
Figure Name	Worksites and Monitoring locations in LBC (sheet 3)
London Borough of Camden

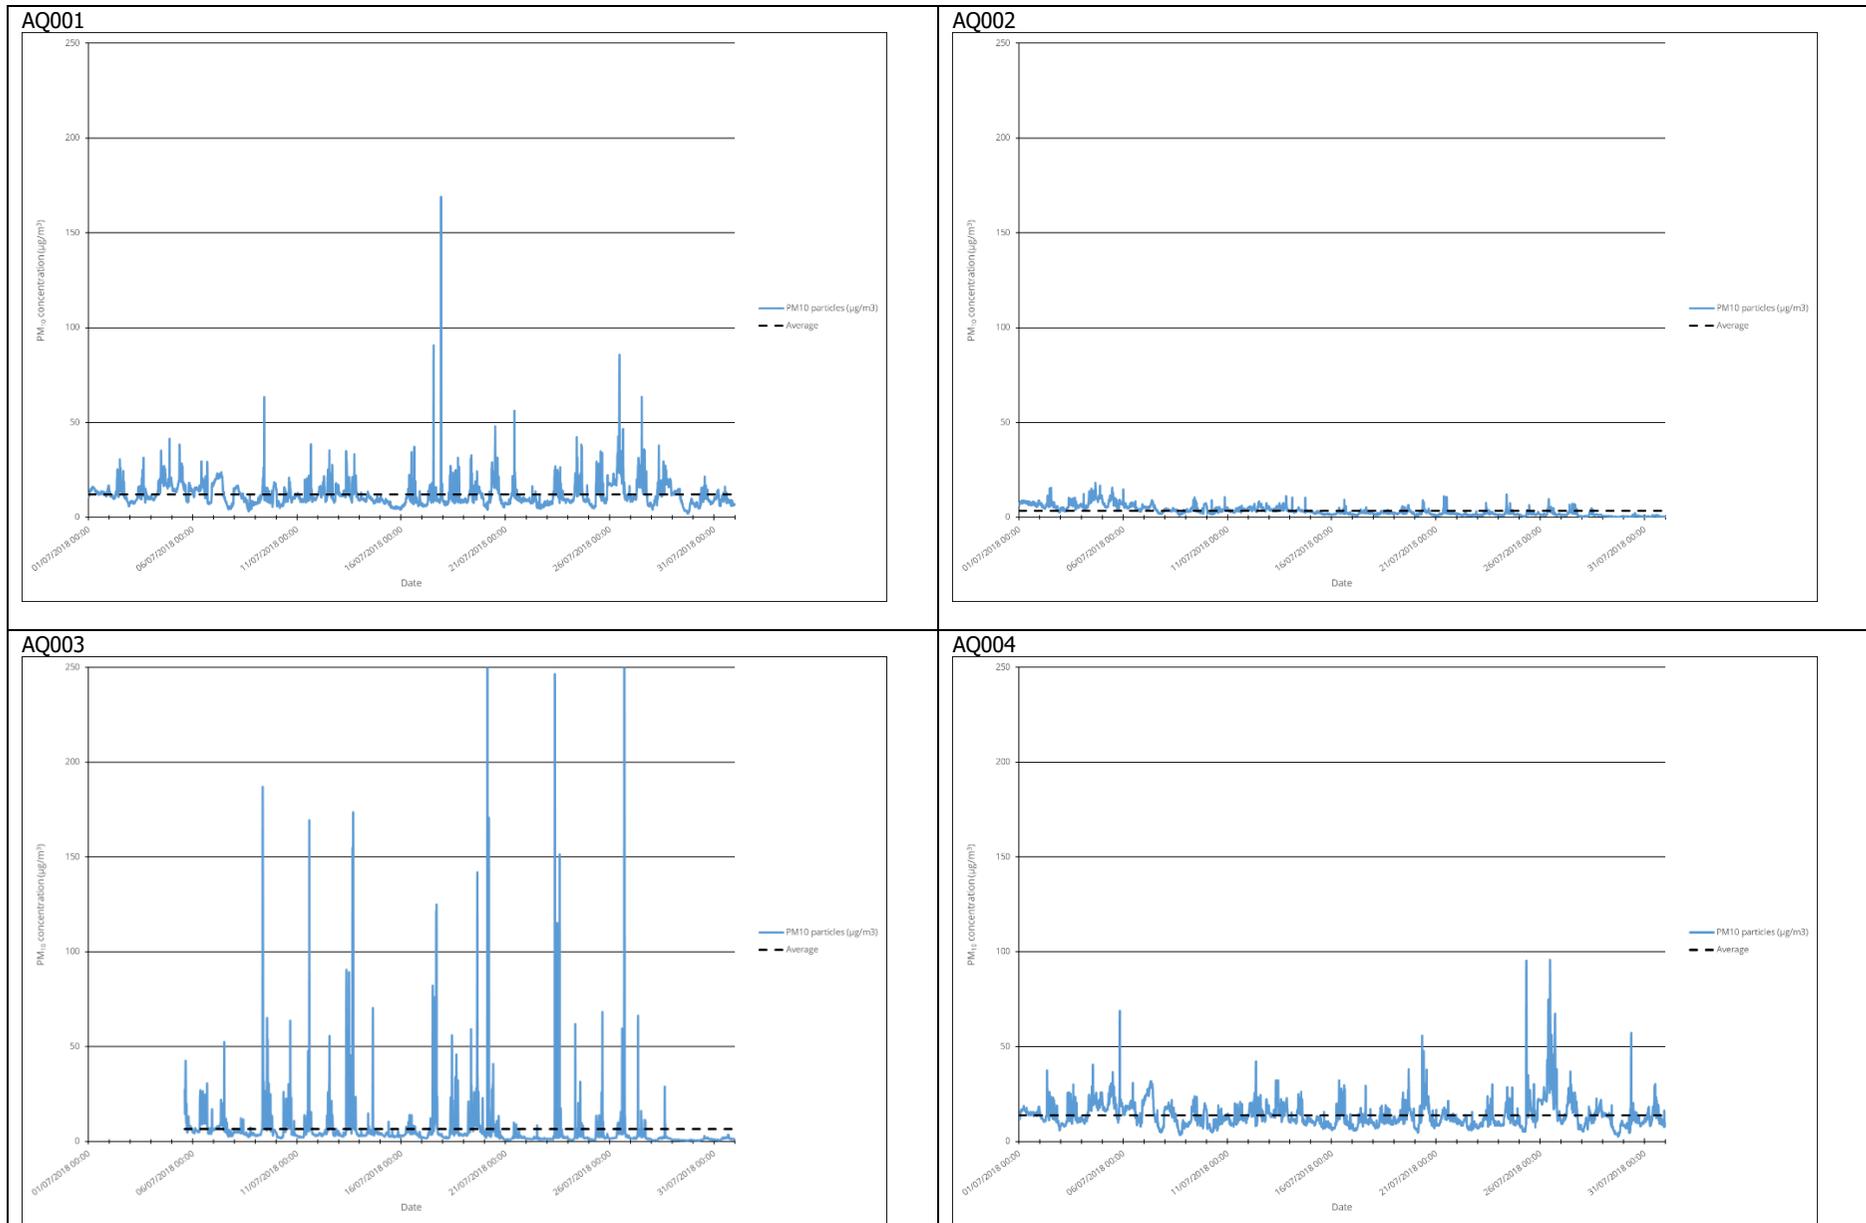
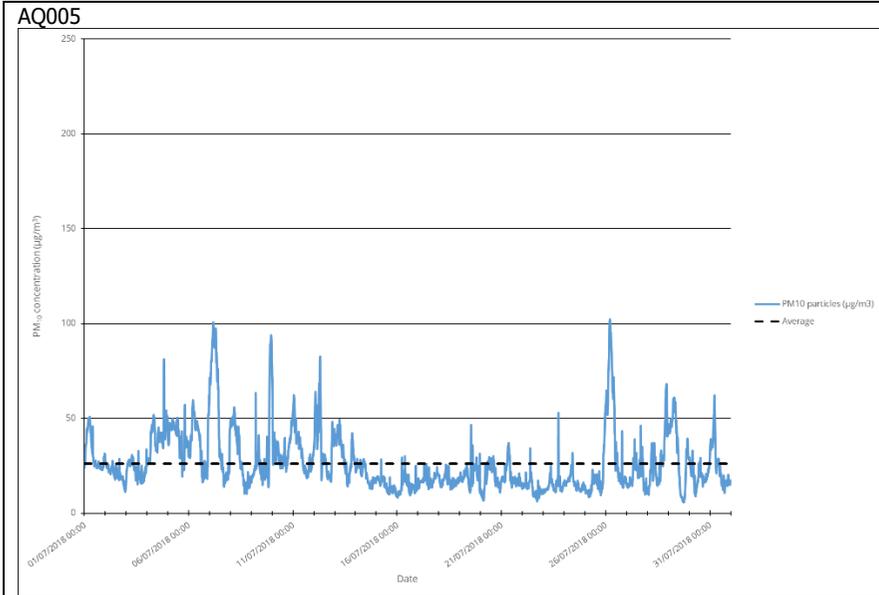
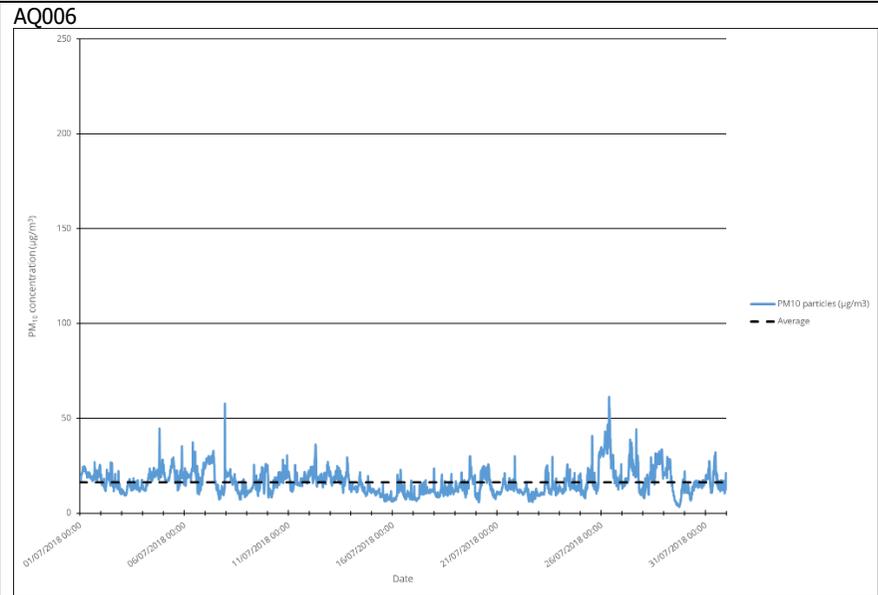
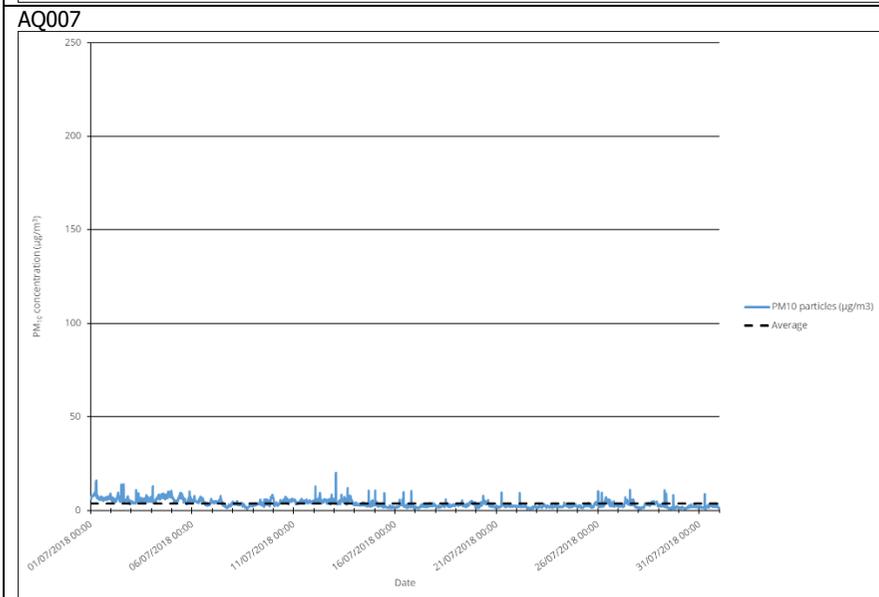
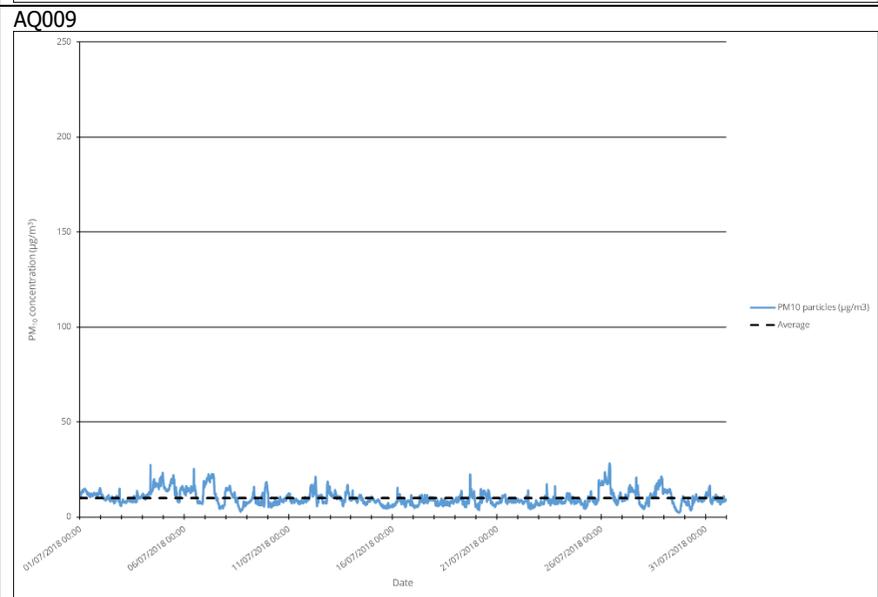
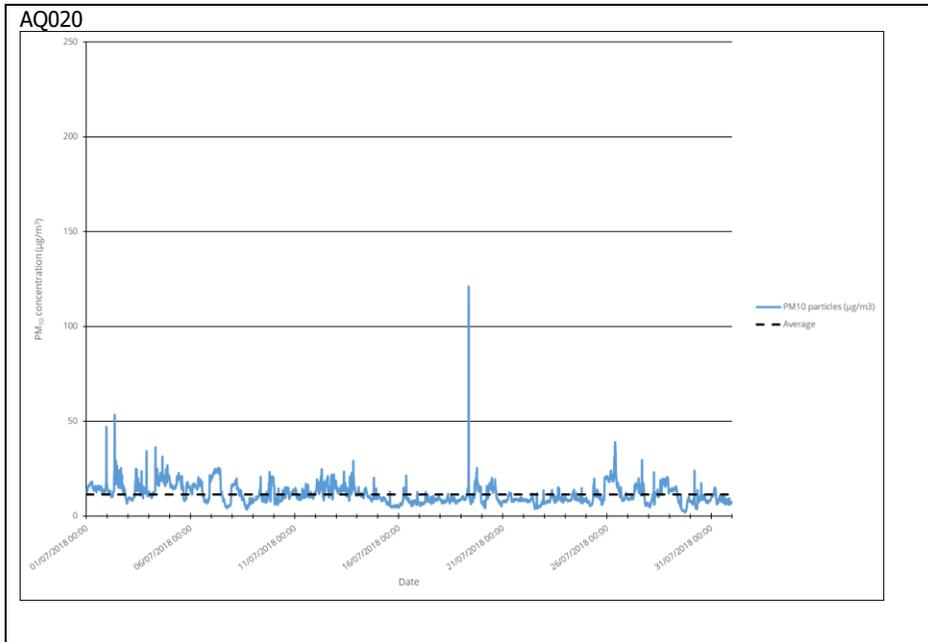
Figure 4: Construction dust 15-minute mean indicative PM₁₀ concentration for dust monitors

Period exceeding trigger level	Worksite reference	Monitoring site ID	Complaint reference number (if applicable)	Reason	Resolution
20/07/2018 03:01 – 20/07/2018 03:15	S003-WS01	AQ003	n/a	No site activities were being undertaken during this trigger. It is assumed to have resulted from a short episode of wind-blown dust from the site or moisture in the air during the early hours.	Active dust suppression and damping down is implemented on site every day, throughout the day. Areas of site around perimeter of the site are double-checked in the morning to determine if they are dry. Damping down carried at the end of the day to reduce the risk of windblown dust during hours when the site is closed.
26/07/2018 16:46 – 26/07/2018 17:00	S003-WS01	AQ003	n/a	Trigger attributed to the lifting / movement of a monument in the corner of the gardens in close proximity to the monitor.	Given the deep excavation in the south-east area of the site it is not possible to get a vehicle pulled mobile bowser to dampen down the area. Therefore a

01/07/2018 19:31 – 01/07/2018 19:45	n/a	AQ016	n/a	Attributable to ballast unloading in the railway cutting.
