March 2021

Construction noise and vibration Monthly Report – January 2021

London Borough of Ealing

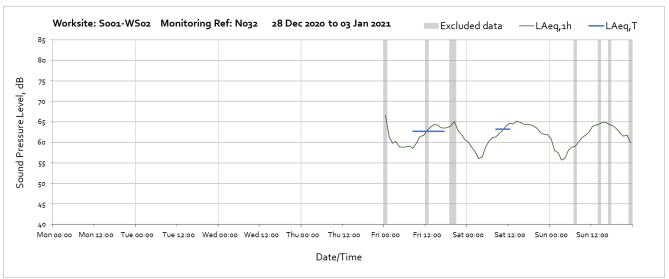
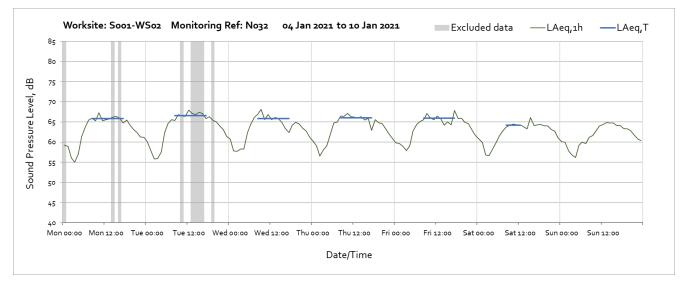
Worksite: S001-WS02 – Monitoring Ref: N032

The following graphs show the hourly measured ambient noise level $L_{Aeq,1h}$ and, where relevant, the averaged noise level $L_{Aeq,T}$ values, where the time period T is as specified in Table 1 of HS2 Information Paper E23. Periods with adversely weather affected noise levels are greyed out and have been excluded from the calculation of the $L_{Aeq,T}$ values in Table 3 of the main report.

Note: High noise levels on the early hours of the 1st January were due to New Year's Eve celebrations and have been excluded to calculate values in Table 3.

2.1.3 Appendix C presents graphs of the noise and vibration monitoring data over the month for each of the measurement locations. Noise data presented consists of the hourly L_{Aeq} values and, where relevant, the L_{Aeq,T} values (where the time period T has been taken to be the averaging period as specified in Table 1 of HS2 Information Paper E23). Vibration data presented consist of hourly PPV values. The full data set for the monitoring equipment can be found at the following location: <u>https://data.gov.uk/dataset/24542ae7-dd44-444f-b259-871c4cc43b5e/environmental-monitoring-data</u>.

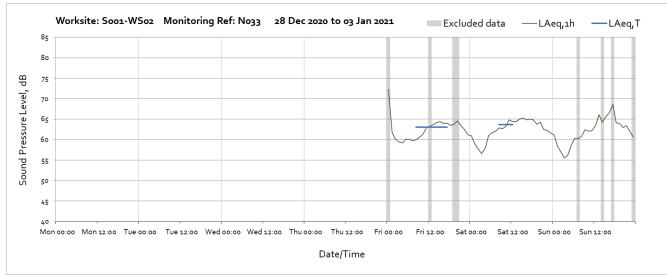
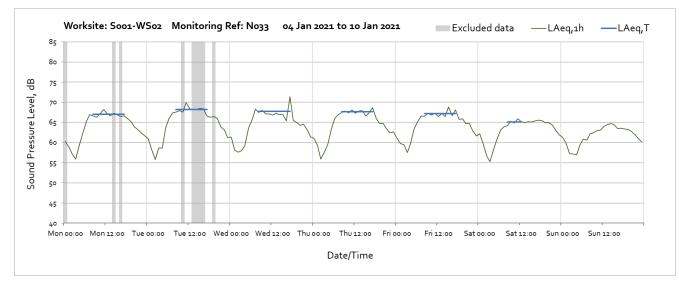
Worksite: S001-WS02 – Monitoring Ref: N033

Note: High noise levels on the early hours of the 1st January were due to New Year's Eve celebrations and have been excluded to calculate values in Table 3.

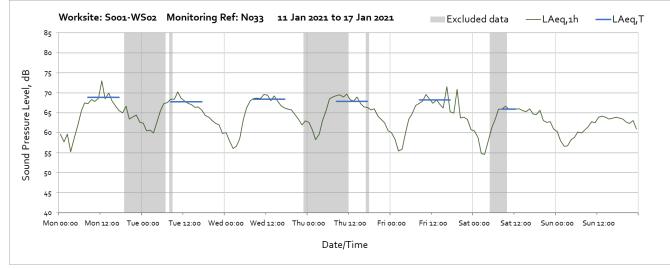
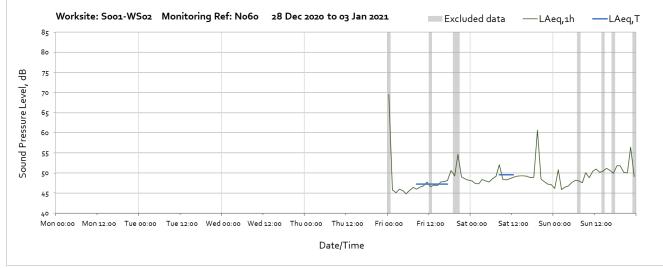
Worksite: S001-WS02 – Monitoring Ref: N060

Note: High noise levels on the early hours of the 1st January were due to New Year's Eve celebrations and have been excluded to calculate values in Table 3.

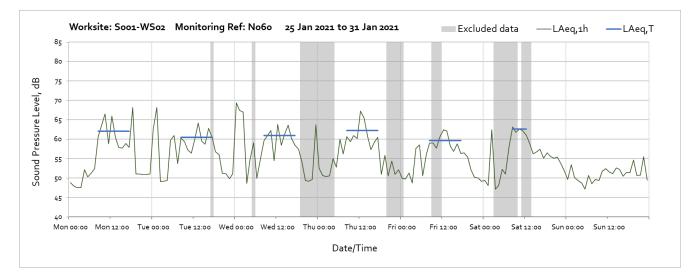
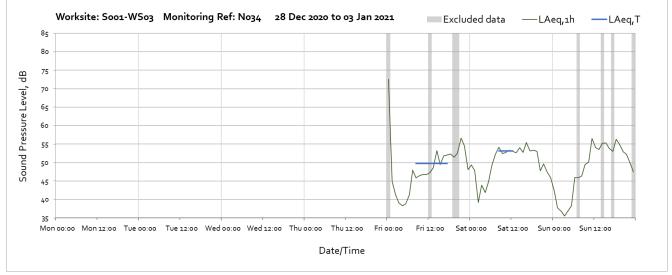
Worksite: S001-WS03 – Monitoring Ref: N034

Note: High noise levels on the early hours of the 1st January were due to New Year's Eve celebrations and have been excluded to calculate values in Table 3.

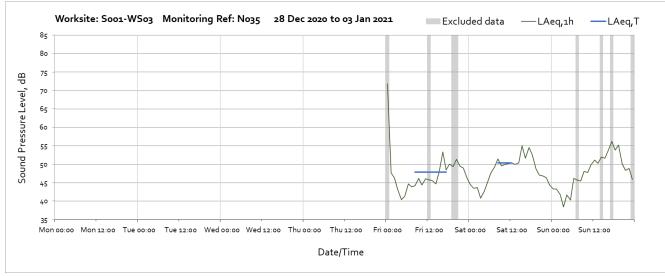
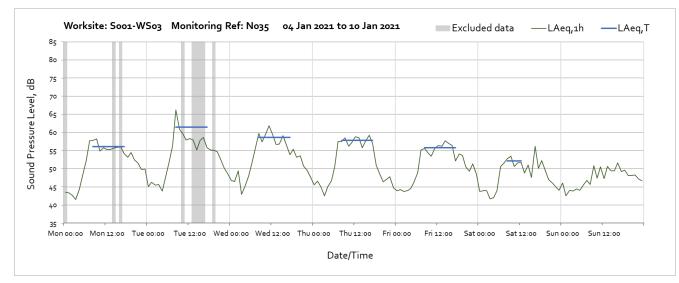
Worksite: S001-WS03 – Monitoring Ref: N035

Note: High noise levels on the early hours of the 1st January were due to New Year's Eve celebrations and have been excluded to calculate values in Table 3.

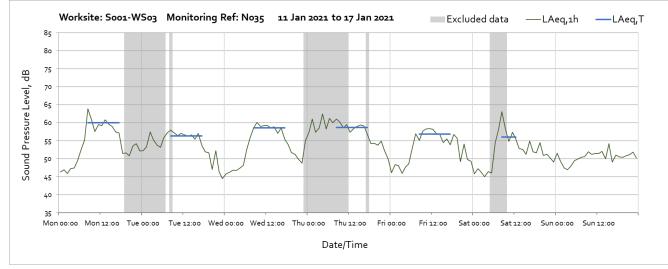
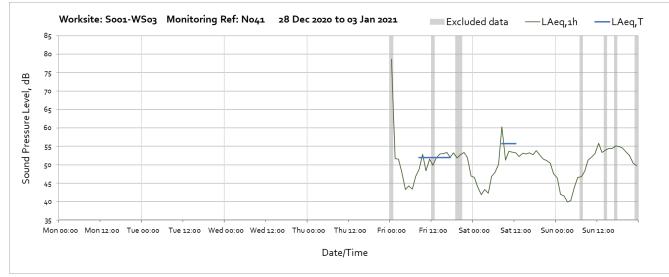
Worksite: S001-WS03 - Monitoring Ref: N041

Note: High noise levels on the early hours of the 1st January were due to New Year's Eve celebrations and have been excluded to calculate values in Table 3.

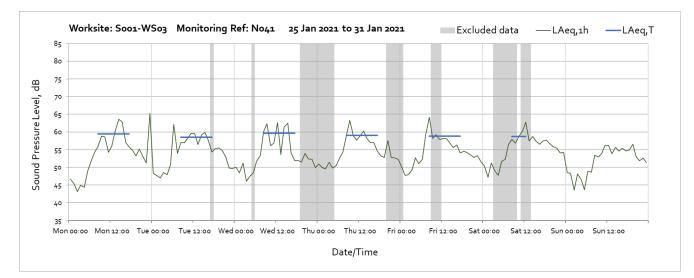
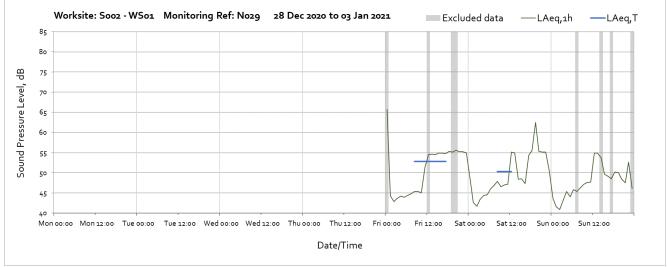
Worksite: S002-WS01 – Monitoring Ref: N029

Note: High noise levels on the early hours of the 1st January were due to New Year's Eve celebrations and have been excluded to calculate values in Table 3.

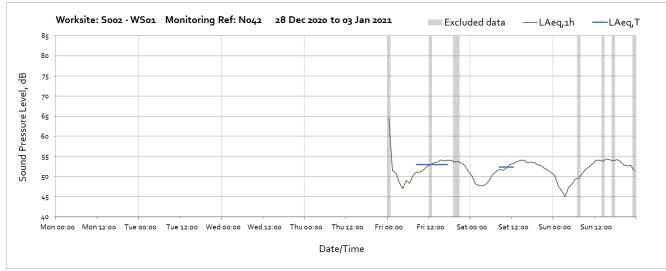
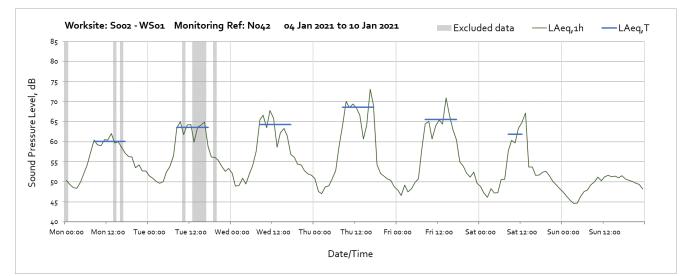
Worksite: S002-WS01 – Monitoring Ref: N042

Note: High noise levels on the early hours of the 1st January were due to New Year's Eve celebrations and have been excluded to calculate values in Table 3.

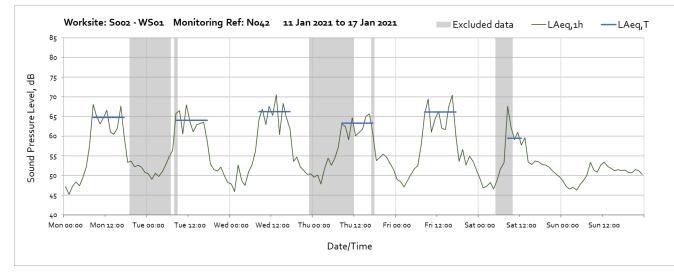
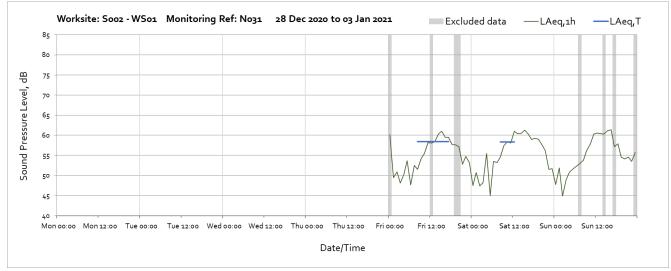
Worksite: S002-WS01 - Monitoring Ref: N031

Note: High noise levels on the early hours of the 1st January were due to New Year's Eve celebrations and have been excluded to calculate values in Table 3.

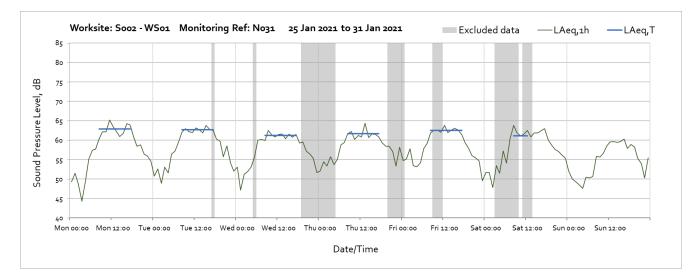
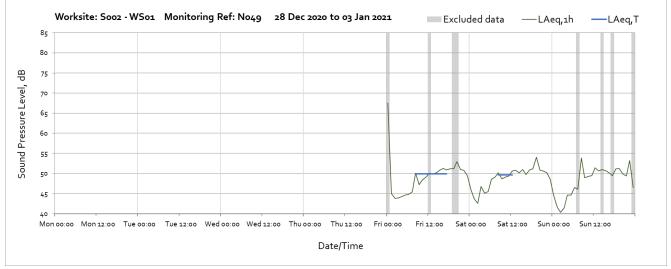
Worksite: S002-WS01 – Monitoring Ref: N049

Note: High noise levels on the early hours of the 1st January were due to New Year's Eve celebrations and have been excluded to calculate values in Table 3.

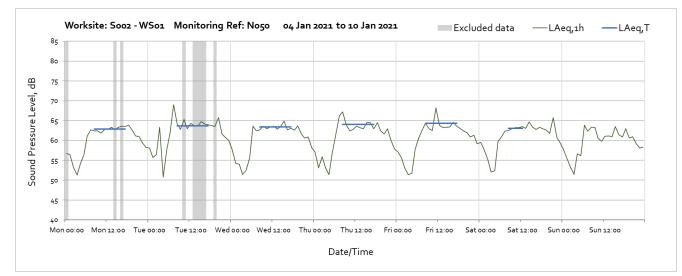
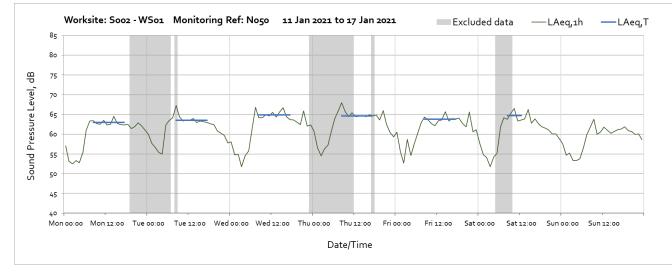
Worksite: S002-WS01 – Monitoring Ref: N050

Note: High noise levels on the early hours of the 1st January were due to New Year's Eve celebrations and have been excluded to calculate values in Table 3.

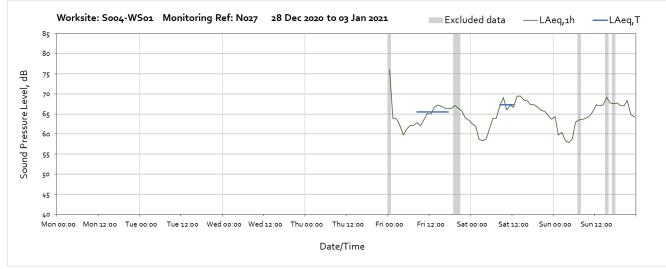
Worksite: S004-WS01 – Monitoring Ref: N027

Note: High noise levels on the early hours of the 1st January were due to New Year's Eve celebrations and have been excluded to calculate values in Table 3.

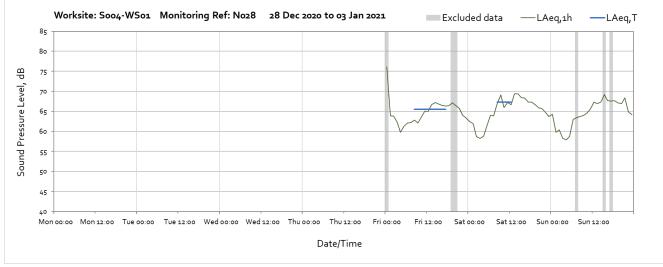
Worksite: S004-WS01 – Monitoring Ref: N028

Note: High noise levels on the early hours of the 1st January were due to New Year's Eve celebrations and have been excluded to calculate values in Table 3.

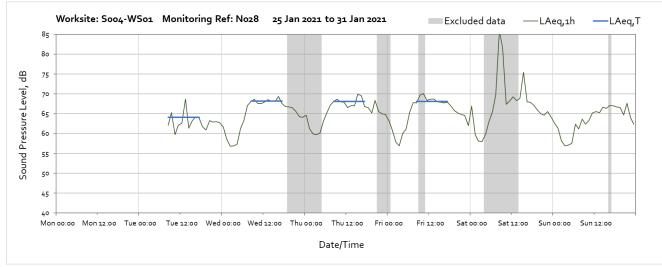
Note: Missing data between 09:00 on Thursday 21st and 08:00 on Tuesday 26th January 2021 was due to a fault with the system log in configuration of the noise monitor.

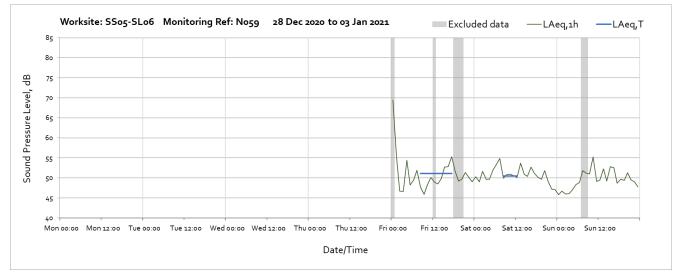
Worksite: SS05-SL06 – Monitoring Ref: N059

Note: High noise levels on the early hours of the 1st January were due to New Year's Eve celebrations and have been excluded to calculate values in Table 3.

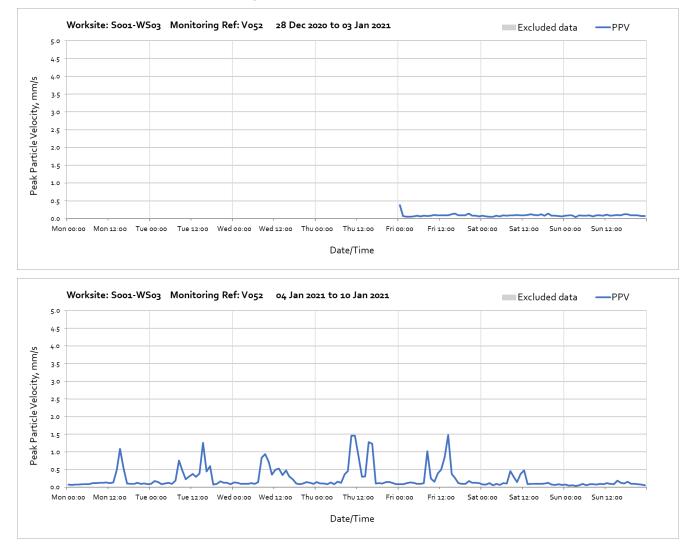
The following graphs show the hourly measured peak particle velocity PPV recorded during the monitoring period. The graphs show the resultant PPV due to vibration components on three orthogonal axis x, y and z. Where high values of PPV were caused by local interference with the vibration monitor, which are not representative of HS2 construction works, these values have been greyed out in the following charts and have been excluded to calculate values in Table 4 of the main report.

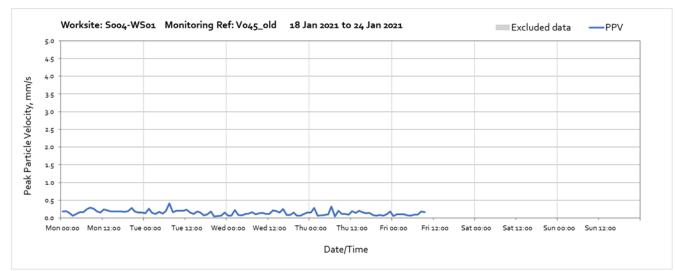
Worksite: S004-WS01 - Monitoring Ref: V045_old

Note: High vibration levels and missing data between 11:00 on Friday 22nd and 00:00 on Saturday 23rd January 2021 was due to change of monitor location. The vibration monitor was moved from the worksite boundary to 25 Wells House Road.

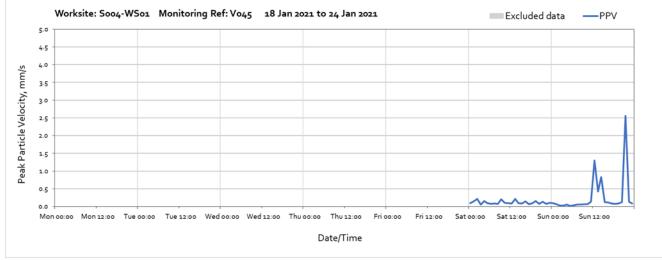
Worksite: S004-WS01 – Monitoring Ref: V045

Note: High vibration levels and missing data between 11:00 on Friday 22nd and 00:00 on Saturday 23rd January 2021 was due to change of monitor location. The vibration monitor was moved from the worksite boundary to 25 Wells House Road.

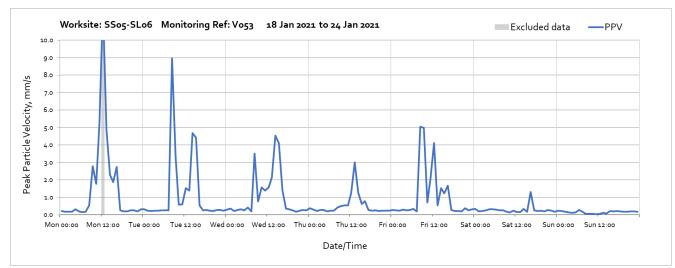
Worksite: SS05-SL06 – Monitoring Ref: V053

Note: High vibration levels measured at 12:00 on Monday 18th January 2021 was due works undertaken close to the monitor and are not representative of HS2 construction vibration.

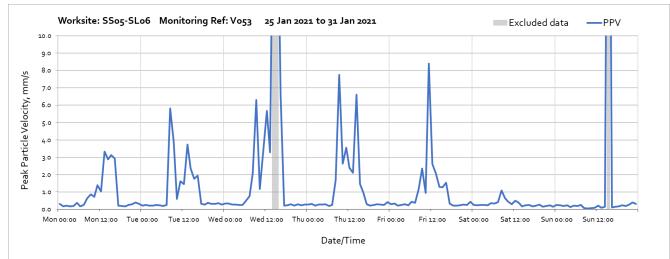
Note: High vibration levels measured between 14:00 and 16:00 on Wednesday 27th January 2021 was due works undertaken close to the monitor and are not representative of HS2 construction vibration. High vibration levels measured at 15:00 on Sunday 31st January 2021 was due to local disturbance to the monitor and not representative of HS2 construction vibration.
