AAIB Bulletin No: 1/96

Aircraft Type and Registration: Cessna 336 Skymaster, G-ASKS

Date & Time (UTC): 13 October 1995 at 0835 hrs

Location: Slieau Ruy, Isle of Man
(8 nm north east of Ronaldsway Airport)

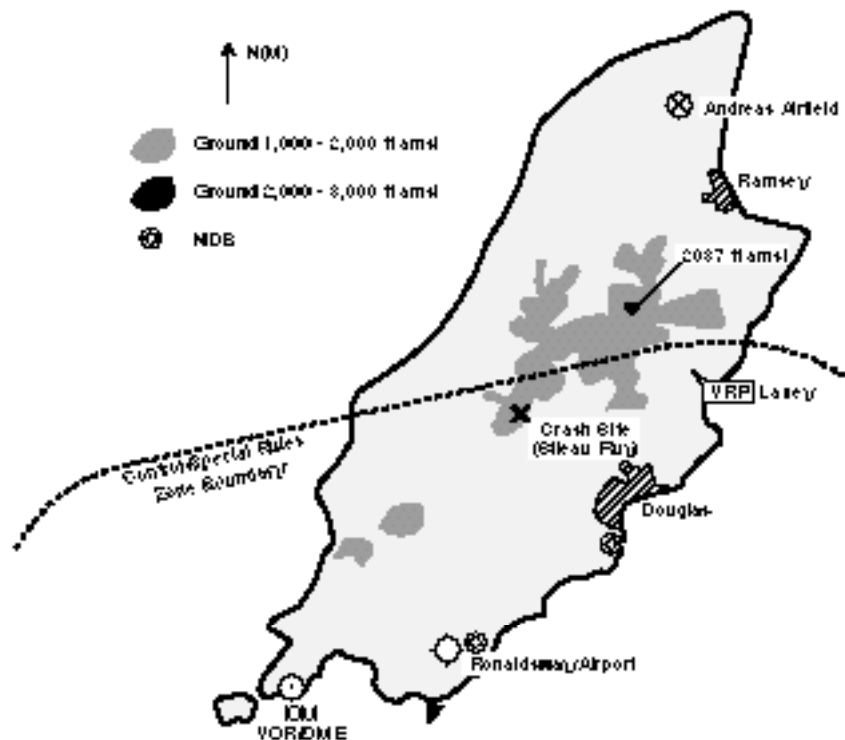
he booked out in the movement's book at 0815 hrs indicating his declared destination as Ronaldsway Airport; the Prevention of Terrorism Act 1990 requires all aircraft leaving or arriving in the Isle of Man to report to a Police Examining Officer at Ronaldsway. Shortly after the pilot booked out, a local farmer, who was working in a field adjacent to Andreas Airstrip, heard the sound of power being applied to an aircraft. He looked up and recognised the aircraft as being G-ASKS. He saw it take off from Runway 11 and climb out to the east towards Ramsey. The farmer was the son of the owner of Andreas and was familiar with both the aircraft and the pilot. He considered that G-ASKS sounded normal and heard the engines for quite a while as the aircraft flew away. At the time it was a still, clear day with good visibility, although there were clouds covering the hills to the south. Over the next few minutes, various eyewitnesses reported seeing an aircraft flying over Ramsey and then following the eastern coastline down towards Laxey. The witnesses all confirmed that the

weather was clear to the north but that there were clouds covering the hills. At Ronaldsway Airport, the weather recorded at 0820 hrs showed a surface wind of 190°/09 kt, visibility of 9 km and scattered cloud at 500 feet and 1,000 feet agl.
