RAF 2000 GTX-SE, G-REBA

AAIB Bulletin No: 6/2004	Ref: EW/G2004/04/19	Category: 2.3
Aircraft Type and Registration:	RAF 2000 GTX-SE, G-REBA	
No & Type of Engines:	1 Subaru EJ22 piston engine	
Year of Manufacture:	2001	
Date & Time (UTC):	24 April 2004 at 1530 hrs	
Location:	Field near Stoke Gabriel, Devon	
Type of Flight:	Private	
Persons on Board:	Crew - 1	Passengers - None
Injuries:	Crew - None	Passengers - N/A
Nature of Damage:	Damage to rotor, propeller, right door, wheel axle and rotor mast	
Commander's Licence:	Private Pilot's Licence	
Commander's Age:	67 years	
Commander's Flying Experience:	3,271 hours (of which 141 were on type)	
	Last 90 days - 6 hours	
	Last 28 days - 2 hours	
Information Source:	Aircraft Accident Report Form submitted by the pilot

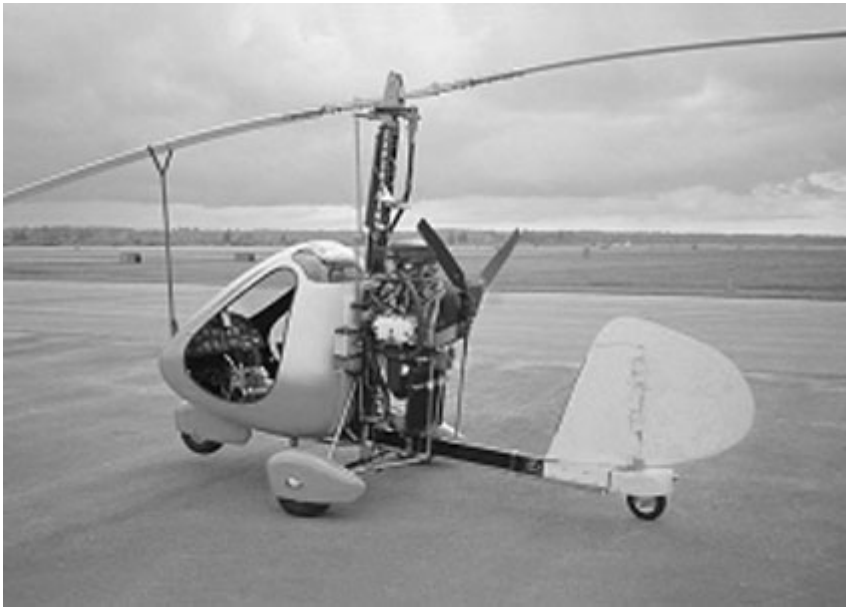
RAF 2000 GTX-SE

The RAF 2000 is a Canadian designed kit-built two-seat gyroplane of conventional layout with a pusher engine configuration.
