ACCIDENT

Aircraft Type and Registration:	Pioneer 400, G-TLOY	
No & Type of Engines:	1 Rotax 914F piston engine	
Year of Manufacture:	2012 (Serial no: LAA 364-15112)	
Date & Time (UTC):	26 August 2012 at 1534 hrs	
Location:	Ledbury Airstrip, Herefordshire	
Type of Flight:	Private	
Persons on Board:	Crew - 1	Passengers - 1
Injuries:	Crew - None	Passengers - None
Nature of Damage:	Propeller, underside of aircraft and landing gear jackscrews	
Commander's Licence:	Commercial Pilot's Licence	
Commander's Age:	56 years	
Commander's Flying Experience:	6,500 hours (of which 40 were on type) Last 90 days - 28 hours Last 28 days - 19 hours	
Information Source:	Aircraft Accident Report Form submitted by the pilot and subsequent AAIB enquiries

Synopsis

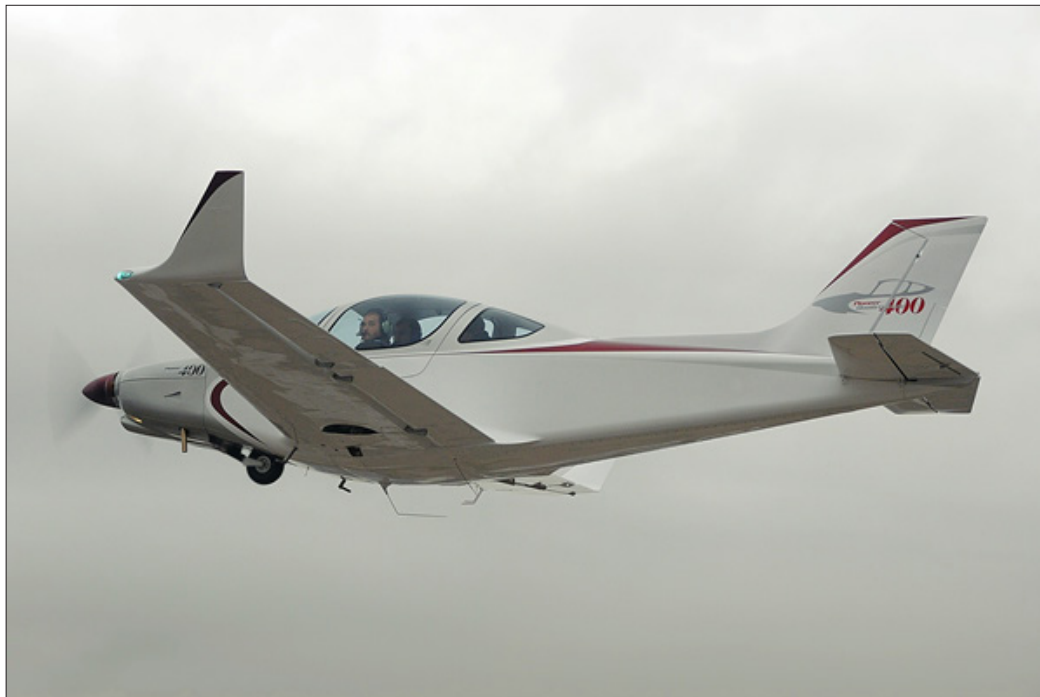
Figure 1

General view of a similar aircraft

The aircraft is a four-seat design featuring a wooden primary structure (Figure 1). The design was approved by the LAA and two other examples are on the UK register. Power is provided by a Rotax 914F piston engine and the landing gear is retractable via an electric motor driving three screwjacks, one for each landing gear leg. Pitch control is provided by a fixed tailplane with an elevator connected to the control stick by cables. Pitch trim is provided by an electrically-driven trim tab on the left elevator, operated by a rocker switch in the cockpit. A fixed Gurney flap¹ is installed on the lower trailing edge of the trim tab to provide the optimum trim range throughout the wide speed and loading range of this aircraft type.
