INCIDENT

Aircraft Type and Registration:	Boeing 737-800, EI-DHD	
No & Type of Engines:	2 CFM 56-7B26 turbofan engines	
Year of Manufacture:	2005	
Date & Time (UTC):	23 December 2009 at 0847 hrs	
Location:	Glasgow Prestwick Airport	
Type of Flight:	Commercial Air Transport (Passenger)	
Persons on Board:	Crew - 6	Passengers - 129
Injuries:	Crew - None	Passengers - None
Nature of Damage:	None	
Commander's Licence:	Airline Transport Pilot's Licence	
Commander's Age:	33 years	
Commander's Flying Experience:	5,557 hours (of which 1,832 were on type) Last 90 days - 113 hours Last 28 days - 78 hours	
Information Source:	Airfield operator's investigation report and further enquiries by the AAIB

Synopsis

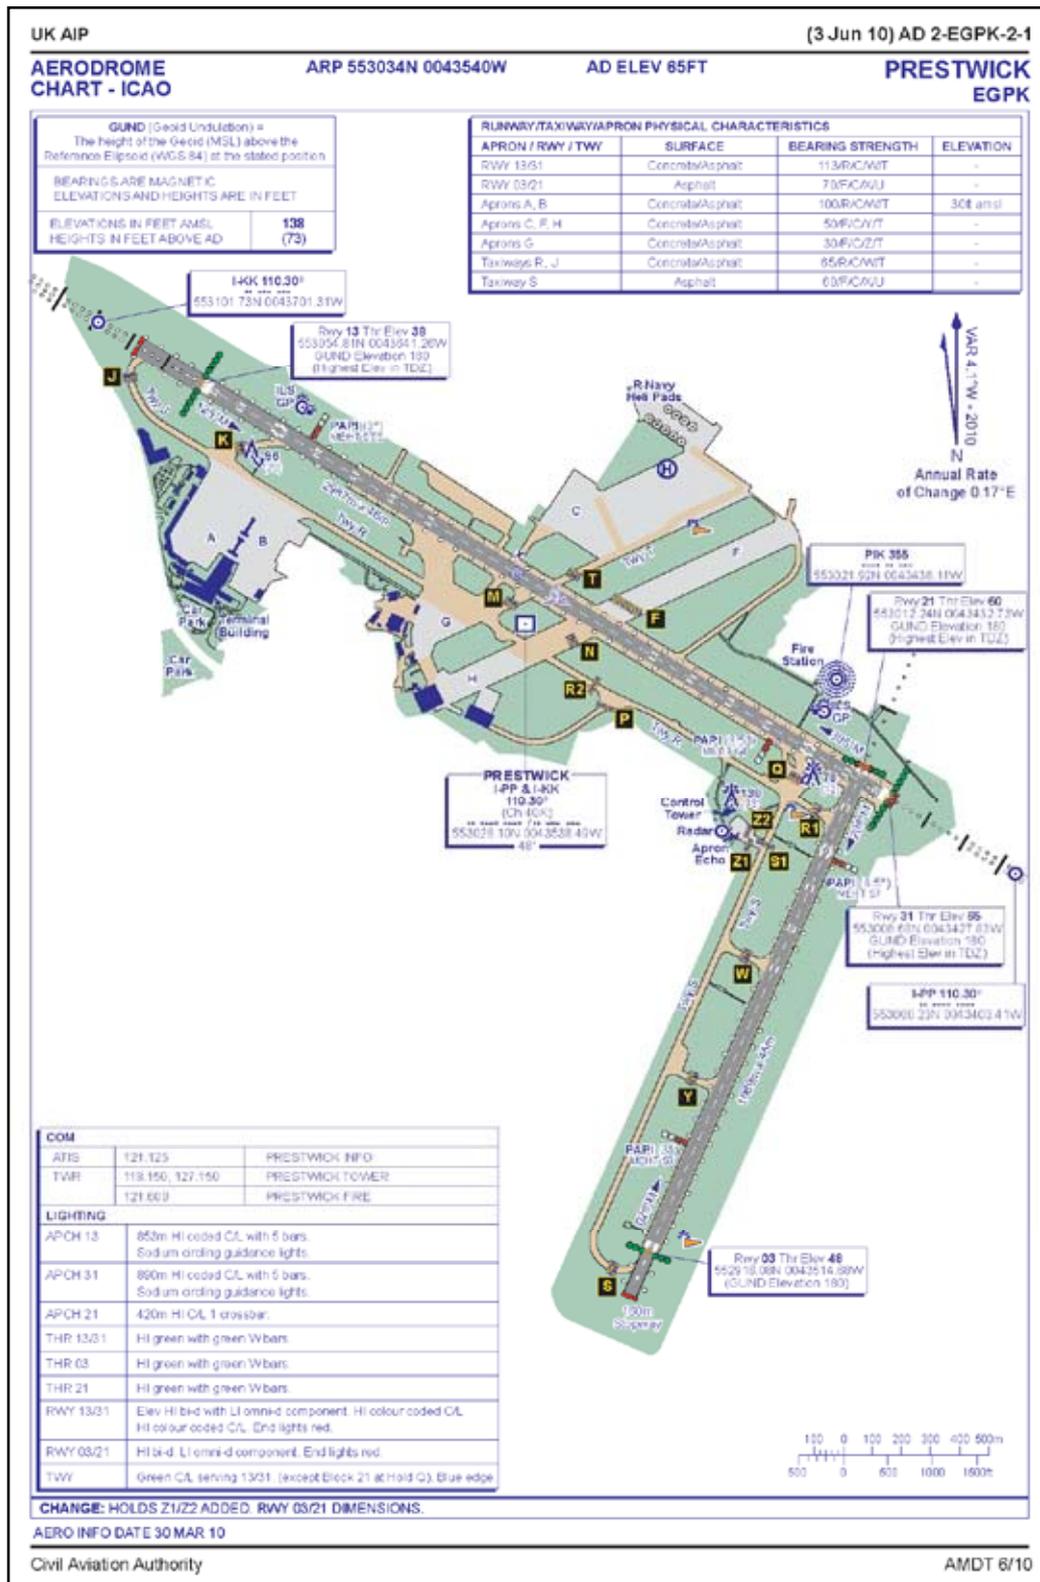
Figure 1

Airport information

At 0835 hrs, the crew made contact with Prestwick Radar. They were advised that ATIS information B was current and that they were number two behind a company aircraft positioning to land on Runway 31. ATC asked which runway they would prefer and the crew opted for Runway 31. ATC also advised that Taxiway K was closed and that the aircraft would have to vacate the runway at J. A copy of the aerodrome chart is included at Figure 1.
