Zlin Z.37 A-2 Bumble Bee, G-KDLN

| AAIB Bulletin No: 9/2004 | Ref: EW/G2004/05/06 | Category: 1.3 |
| Aircraft Type and Registration: | Zlin Z.37 A-2 Bumble Bee, G-KDLN | |

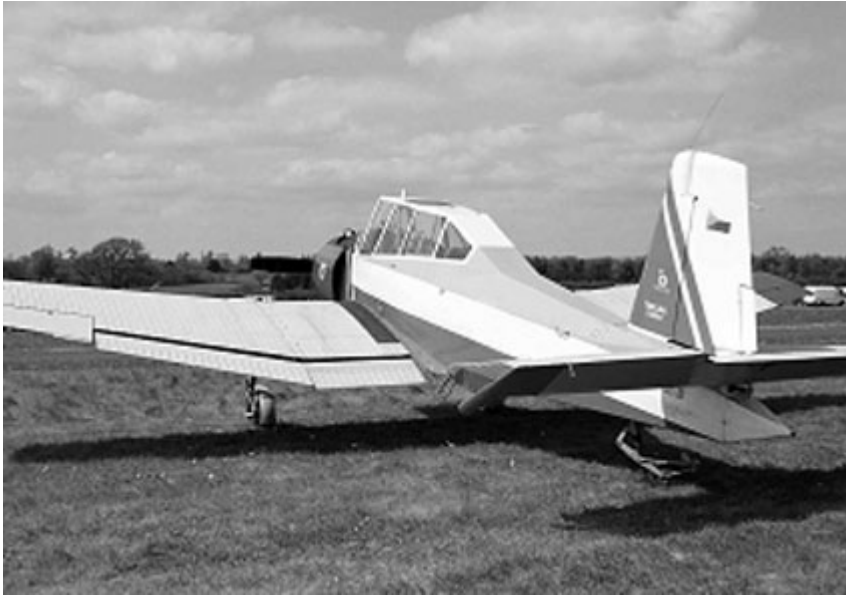
Figure 1 Zlin Z.37 A-2 Bumble Bee

The Zlin Z.37 is a large single engine tail wheel type aircraft, originally designed for crop spraying. Attached to the fixed tailplane is a fabric covered elevator that can be held with full up deflection by a mechanical control lock operated from the cockpit. There is a mass balance horn at each tip of the elevator, protruding ahead of the hinge line.
