INCIDENT

Aircraft Type and Registration: Boeing 747-200, LV-MLP

Location: Gate M28A, London Heathrow Airport

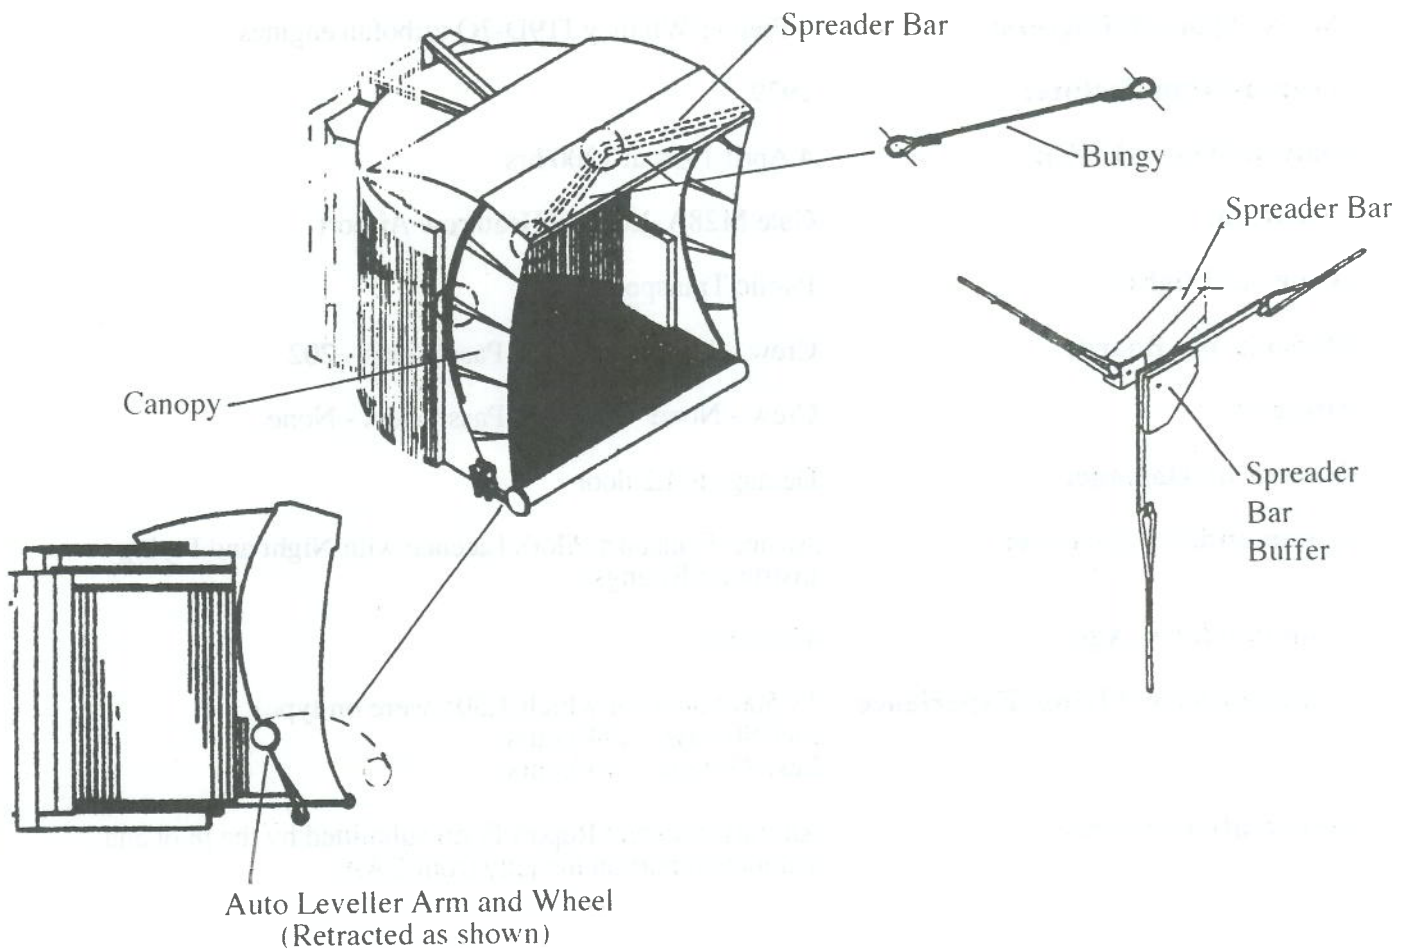
When an engineer arrived to investigate the mishap he found that the main circuit breaker had tripped, the canopy was retracted and the auto-leveller wheel was in contact with the aircraft about four inches above floor level. The jetty was moved clear of the aircraft and a functional check was carried out. When the jetty was put into 'AUTO' mode it started rising until the auto-leveller was fully extended. It was found that this was caused by the canopy, which was very loose and blowing in the wind, catching the auto-leveller arm and wheel assembly. The canopy had become loose because the

spreader bar buffer had detached from the bar, relieving load in the tensioning bungy cord. The buffer is connected to the bar by one bolt which was missing and could not be found. The last maintenance and inspection had been carried out in December 1993.
