AAIB Bulletin No: 9/93

Ref: EW/G93/05/21

Aircraft Type and Registration: Avions Pierre Robin DR400/2+2, G-RBIN

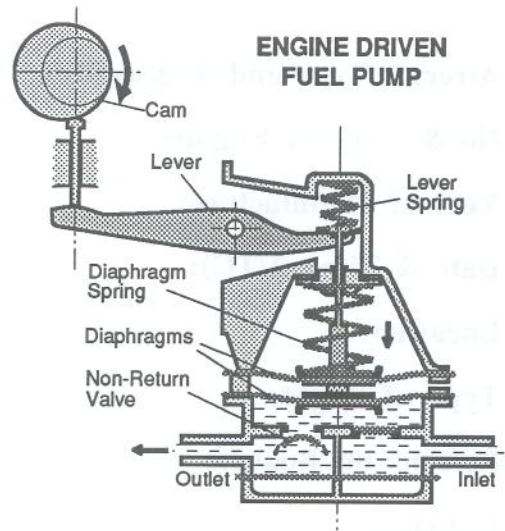
Engine strip examination showed no evidence of pre-accident malfunction or failure, except in the case of the engine driven fuel pump. This pumps fuel to the carburettor by means of a reciprocating diaphragm operated by an engine driven lever and by springs. A cam in the engine accessory gearbox acts on the lever to drive the diaphragm up and suck fuel into the pumping chamber via a non-return valve; further rotation of the cam allows the diaphragm to be driven downwards under the influence of

a helical compression spring and thus expel fuel from the chamber to the outlet via a second non-return valve. A second helical compression spring acts on the diaphragm end of the lever to preload it downwards. The springs are located in an upper chamber that is open to the interior of the gearbox. Strip examination found that the lever spring had fractured into three parts, and markings suggested that the pump had operated in this condition for a limited period. Specialist inspection confirmed that both spring fractures had resulted from fatigue cracking under the effects of torsional loading. The spring surface had extensive patches of rust, with corrosion pitting in some areas, but it was probable that at least some of this corrosion had occurred

after the accident. Operation of the pump, reassembled with the lever spring absent, on a similar engine on a test bed found no significant difference in fuel pressures and flows compared with operation with a normal pump, throughout the engine operating envelope, with and without backing pump pressure. However, the possibility that the lever or diaphragm had been jammed by parts of the broken spring could not be dismissed, but an operating electric pump should have been capable of supplying the engine in this circumstance.
