**ACCIDENT**

<b>Aircraft Type and Registration:</b>	EV-97 TeamEurostar UK, G-IHOT	
<b>No &amp; type of Engines:</b>	1 Rotax 912-UL piston engine	
<b>Year of Manufacture:</b>	2004	
<b>Date &amp; Time (UTC):</b>	16 June 2006 at 1800 hrs	
<b>Location:</b>	Barling farmers strip, Essex	
<b>Type of Flight:</b>	Private	
<b>Persons on Board:</b>	Crew - 1	Passengers - 1
<b>Injuries:</b>	Crew - None	Passengers - None
<b>Nature of Damage:</b>	Right main gear leg separated, nose gear leg collapsed, damage to fuselage and right wing, propeller tip damage and engine shockloaded	
<b>Commander's Licence:</b>	Private Pilot's Licence (Microlights)	
<b>Commander's Age:</b>	47 years	
<b>Commander's Flying Experience:</b>	454 hours (of which 82 were on type) Last 90 days - 47 hours Last 28 days - 5 hours	
<b>Information Source:</b>	Aircraft Accident Report Form submitted by the pilot and further enquiries by the AAIB

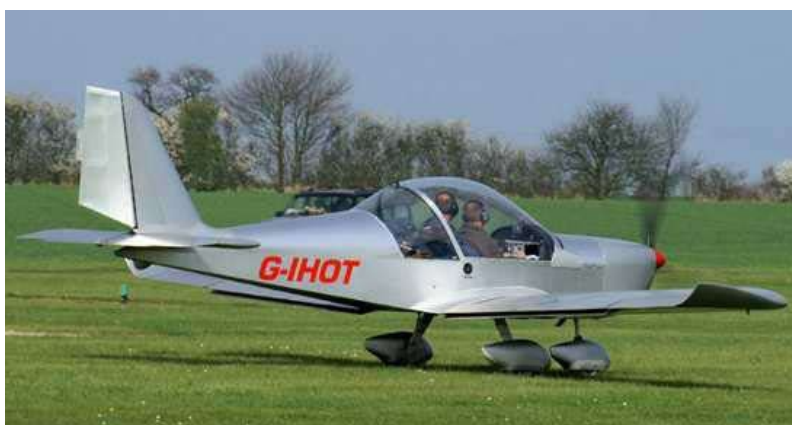
**Figure 1**

G-IHOT before the accident

The EV-97 TeamEurostar is a kit-built aircraft manufactured by Evezektor-Aerotechnik. G-IHOT had been assembled by Cosmik Aviation Ltd in the UK and sold as a Ready-to-fly aircraft in the microlight category with a Permit to Fly. The EV-97 is an all-metal fixed-wing aircraft with tricycle landing gear, as depicted in Figure 1. It has a steerable nosewheel that is controlled by the rudder pedals: left pedal results in a left turn and vice versa. The aircraft is also fitted with toe-operated hydraulic brakes that permit differential braking to assist with steering.
