No: 11/92

Aircraft Type and Registration: Replica SE5A, G-BMDB

Information Source: Aircraft Accident Report Form submitted by the pilot and examinations by AAIB Inspector

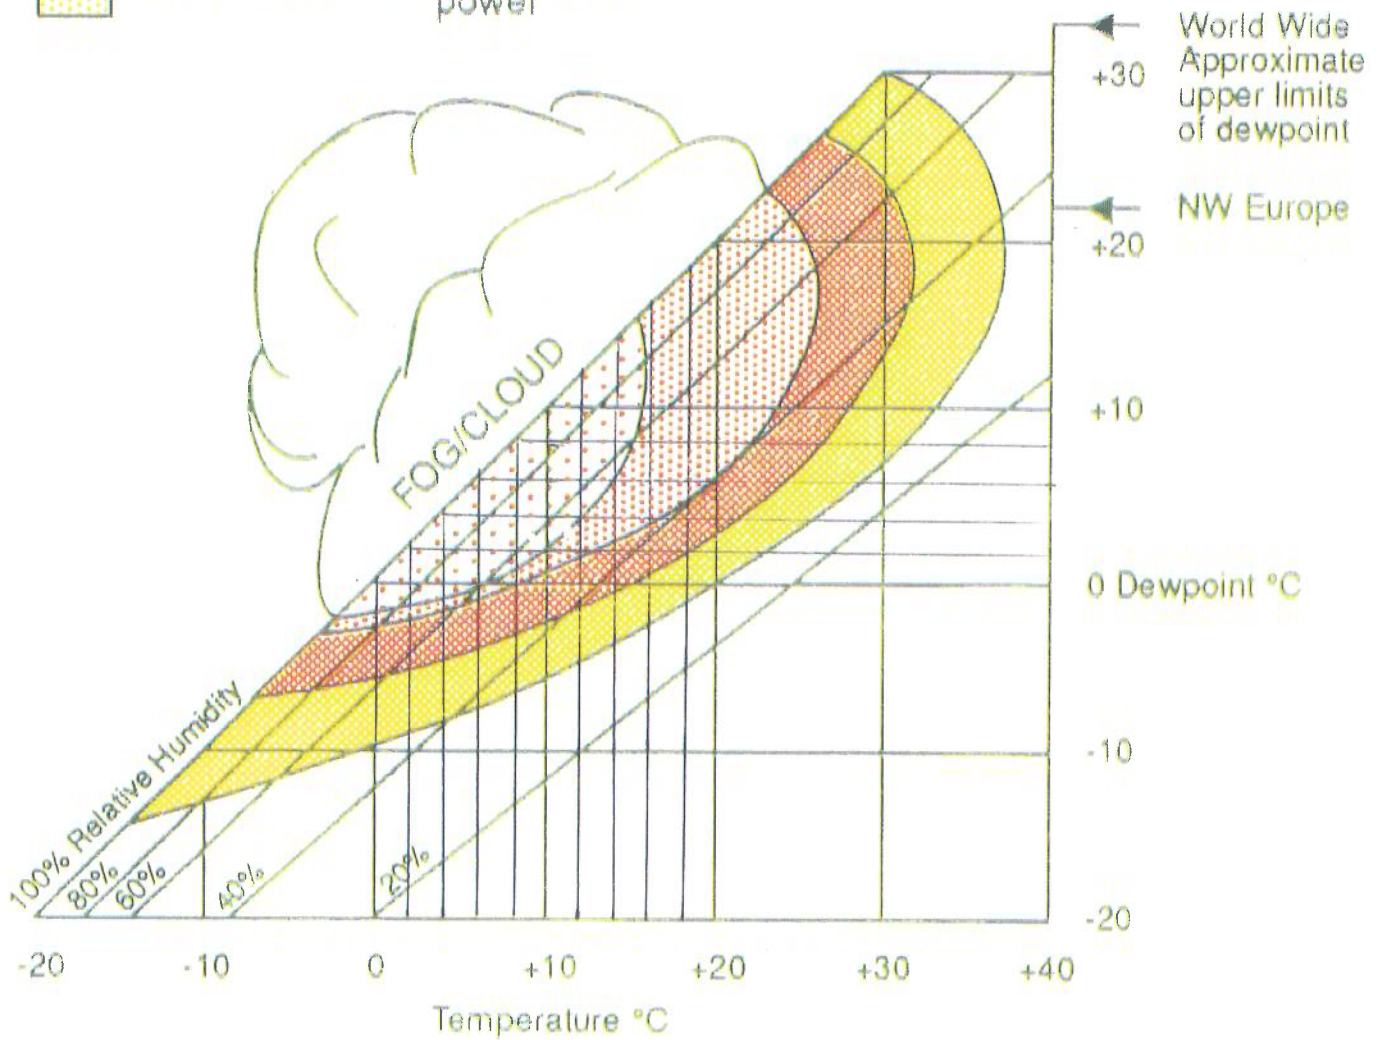
The rapidity and lack of warning associated with the engine rundown supported this possibility, in the view of the pilot, and tended to exclude carburettor icing as the cause. The AAIB obtained a meteorological aftercast which indicated that the surface temperature was 18°C and the dew point 13°C, giving a relative humidity (RH) of 72%. At 1000 feet agl the temperature was 14.5°C, dew point 10.5°C and the RH 74%. The meteorological office commented: "These are some fairly high relative humidities and those above 500 feet fall into the 'serious any power band' on the carburettor icing diagram". In addition, the aircraft was operating on Mogas, which is widely acknowledged to increase the susceptibility to icing. Although it seems unlikely that this accident was initiated by carburettor icing, the following diagram is provided to highlight this issue for all pilots.

**Light icing – cruise or descent power**
