Air Accidents Investigation Branch

**Report on the serious incident to
Boeing 737-86N
registration G-XLAG
at Manchester Airport
on 16 July 2003**

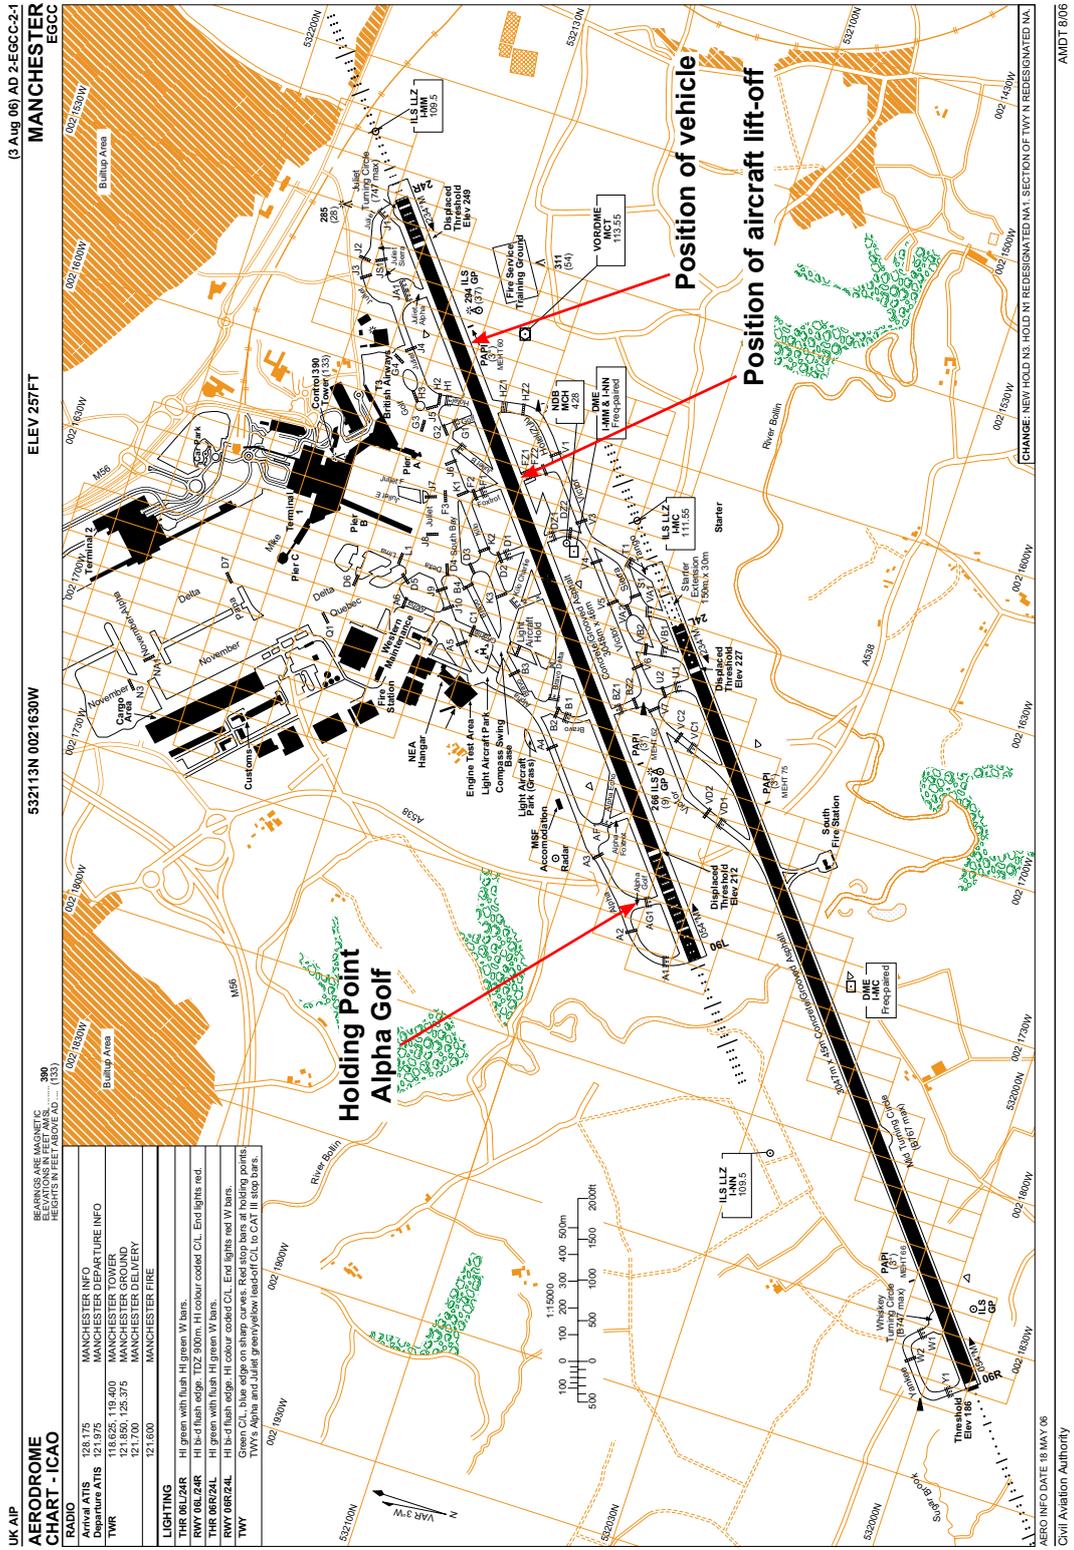
Appendix B

Manchester International Airport - Aerodrome Chart

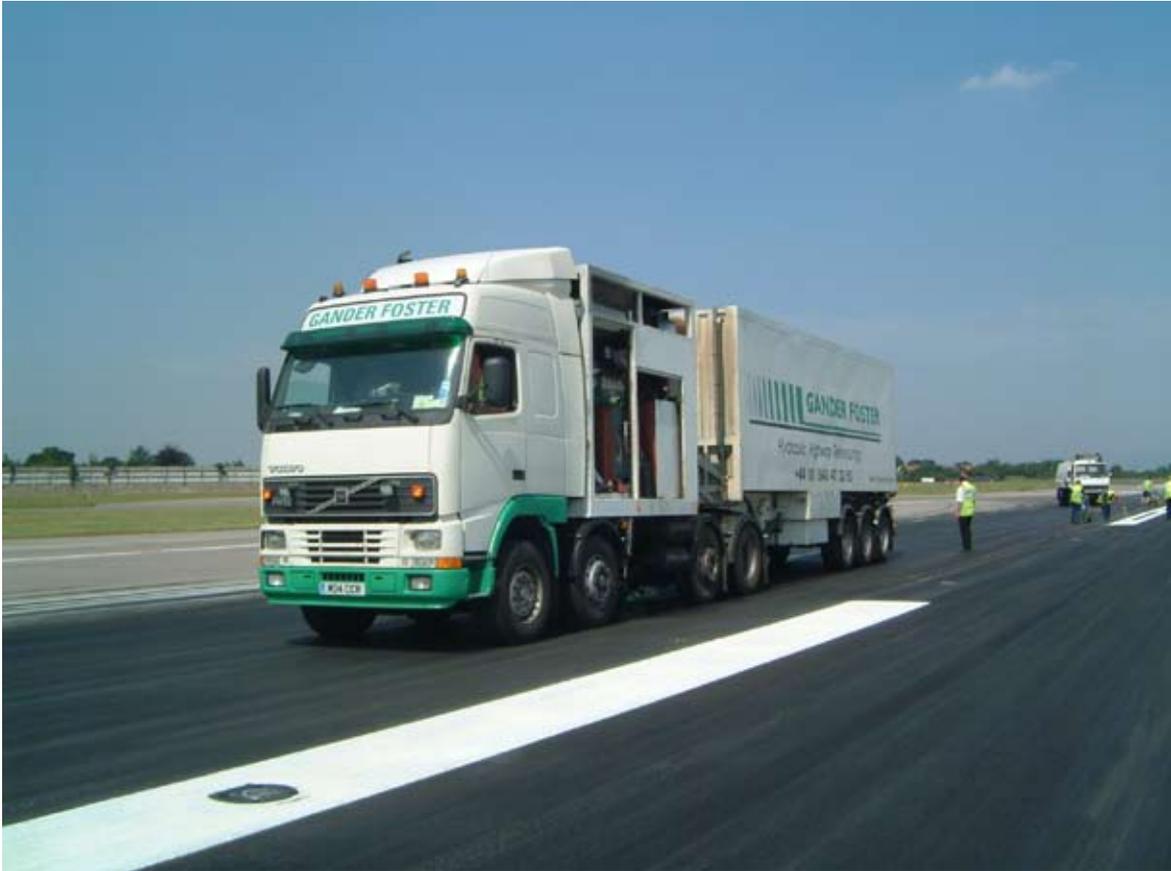
Rubber Deposits Removal Vehicle

A programme of works in order to remove rubber deposits on the touchdown zone of Runway 24R is scheduled to commence on Monday 14th – Sunday 20th July 2003. In order to facilitate this process, Runway 06L / 24R will be shortened (see Table 1) and the procedure for rubber removal will take place on the closed portion of the runway. It should be noted that Runway 06R / 24L will remain operational throughout the works and will be available at all times whilst the rubber removal is taking place. The works are scheduled to be undertaken at times which will create the least operational impact as follows:
