EMU Marine Circular 22 April 2010 - Safety Measures on Elevator Maintenance

# MARINE CIRCULAR

## EVERGREEN MARINE (UK) LIMITED

### Safety Measures on Elevator Maintenance

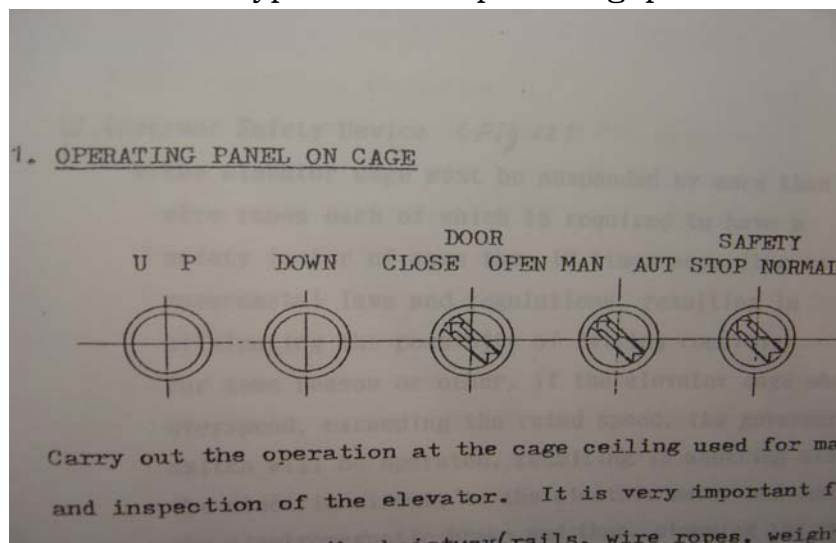
以下為E-Type 在Cage 上的 Operating Panel 簡圖。

Below the sketch of E-type manual operating panel on the cage

Safety selection switch on control panel

At NORMAL, means safety device in working.

2. Limit switch cam	Inspection	<p>3. Control the cage up and down by use of the "UP" and "DOWN" buttons.</p> <p>4. Switch over the "SAFETY" switch from the "NORMAL" to "STOP" position and perform appropriate maintenance work on switches inside the operating panel. Then, check if wiring and contacts conditions are normal. Also check if all bolts are securely tightened.</p> <p>✓ The "SAFETY" switch is provided to avoid the automatic operation during the maintenance. The function of this switch protects the person on the cage ceiling if he/she forgets to switch over the "AUT-MAN" switch to the "MAN".</p> <p>✓ The "BS" switch is provided such that it prevents the cage operation in the case which someone in any floors presses a call button. This function protects worker(s) on the cage ceiling to exit safely after he returns all switches to their initial positions to complete his work.</p> <p>✓ The "RESET" switch attached on the controller door is provided to prevent the cage operation by pressing "CALL" buttons in any floors. This function protects passengers in emergency case which they try to escape through the hoistway.</p>

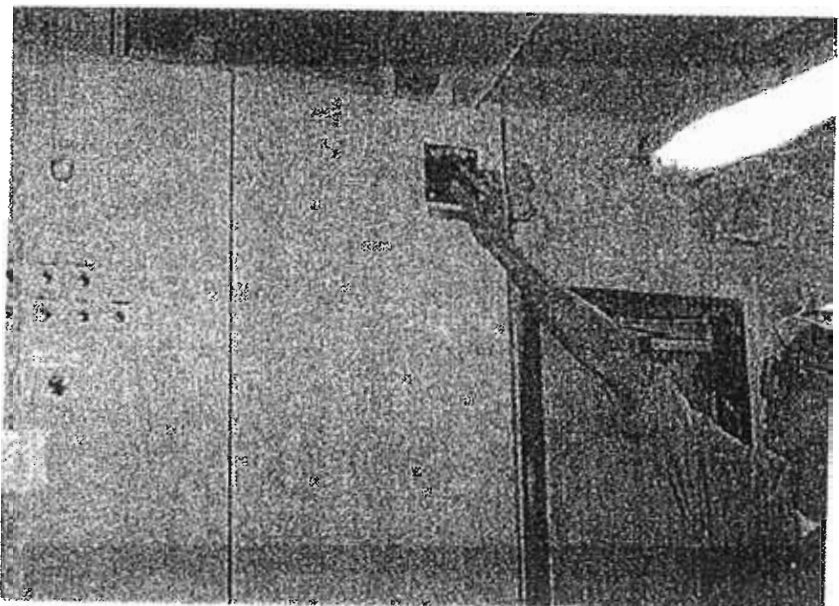
- (1) The staff-member in charge who has come in contact with the passenger in the case by emergency bell goes to the elevator machine room immediately.
- (2) The number of staff-members in charge who go to the elevator machine room must be more than 2 and they must carry an electric torch.
- (3) Turn off the main power switch for control panel installed at machine room. (PHOTO 1)

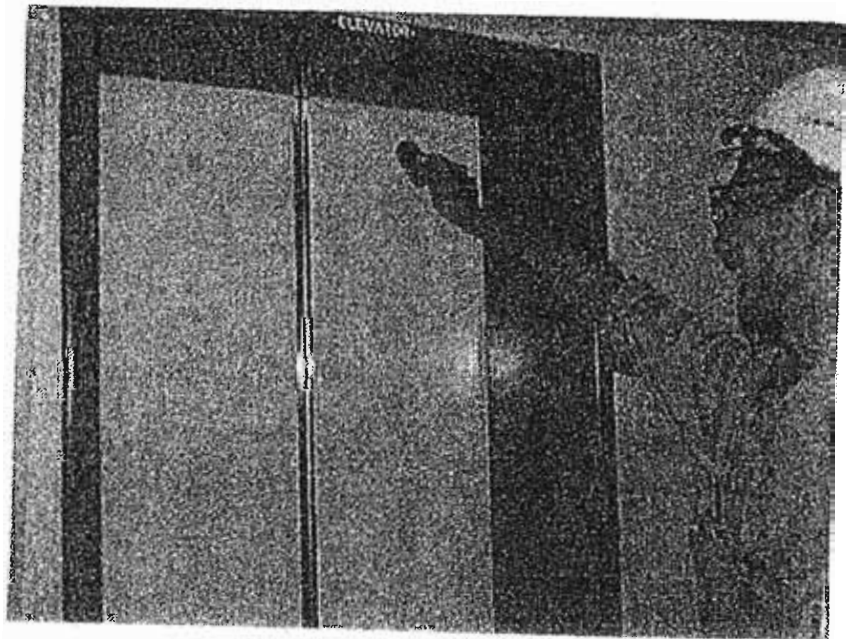
Photo2

- (4) Open the hatch for rescue and confirm the position where the cage is stopped.
- (5) Open the door at the floor above the position where the cage has stopped. In this case, be sure to use the key for emergency use provided at machine room.
- (6) The Emergency Key Hole is located on upper side of floor door panel. To open the door, insert the key horizontally into the hole, move your key-holding hand toward the center of door, and then push the door in opening direction.  
(See Photo2)

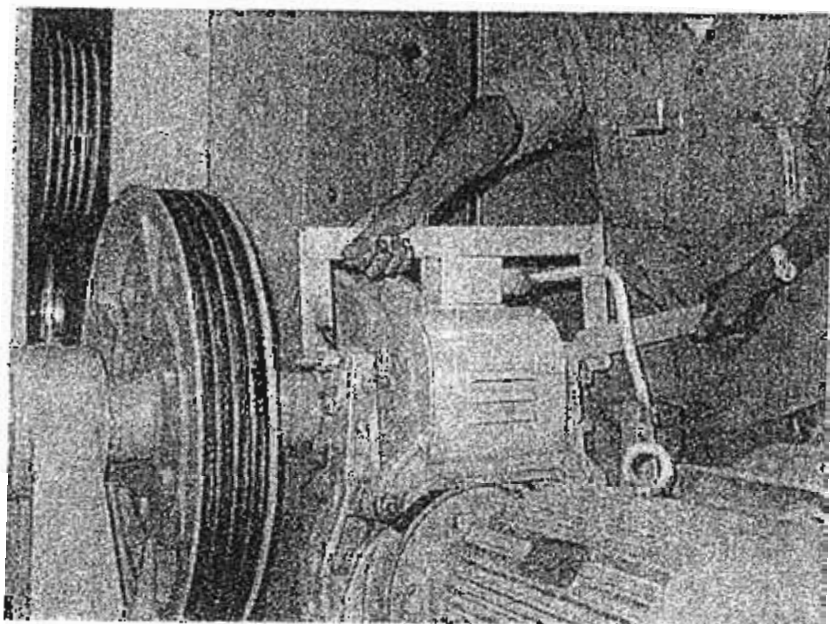
(PHOTO 4)

(9) Release the brake mechanism by means of the handle for releasing of the brake provided at the machine room. (PHOTOS 3 and 4)

In this case, simultaneously with releasing of brake, the cage shaft will be turned some times due to the unbalancing of the cage and counterweight. Accordingly, one or 2 staff-members in charge must hold the turning handle which has been inserted in the electric motor. (PHOTO 5)

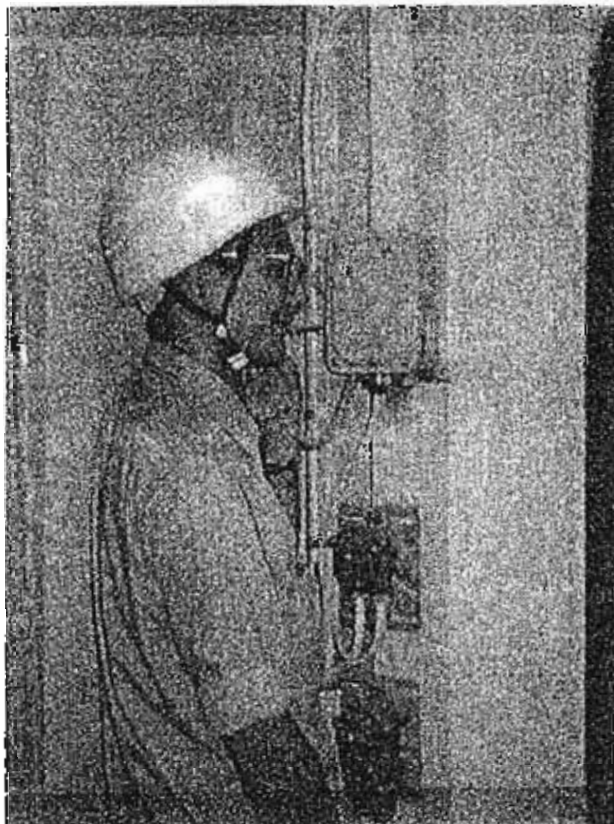
(16) When there is a telephone between cage and elevator machine room, make the best use of the telephone.

You can get a grip on the situation inside the cage by exchanging conversation with passengers inside the cage by telephone. Thus, you can control the ascending quantity of the cage according to the instruction of passengers inside the cage . (PHOTO 5)
