Report on the investigation of

Lord Nelson

contact with Tower Bridge London

**Report No 14/2004
October 2004**

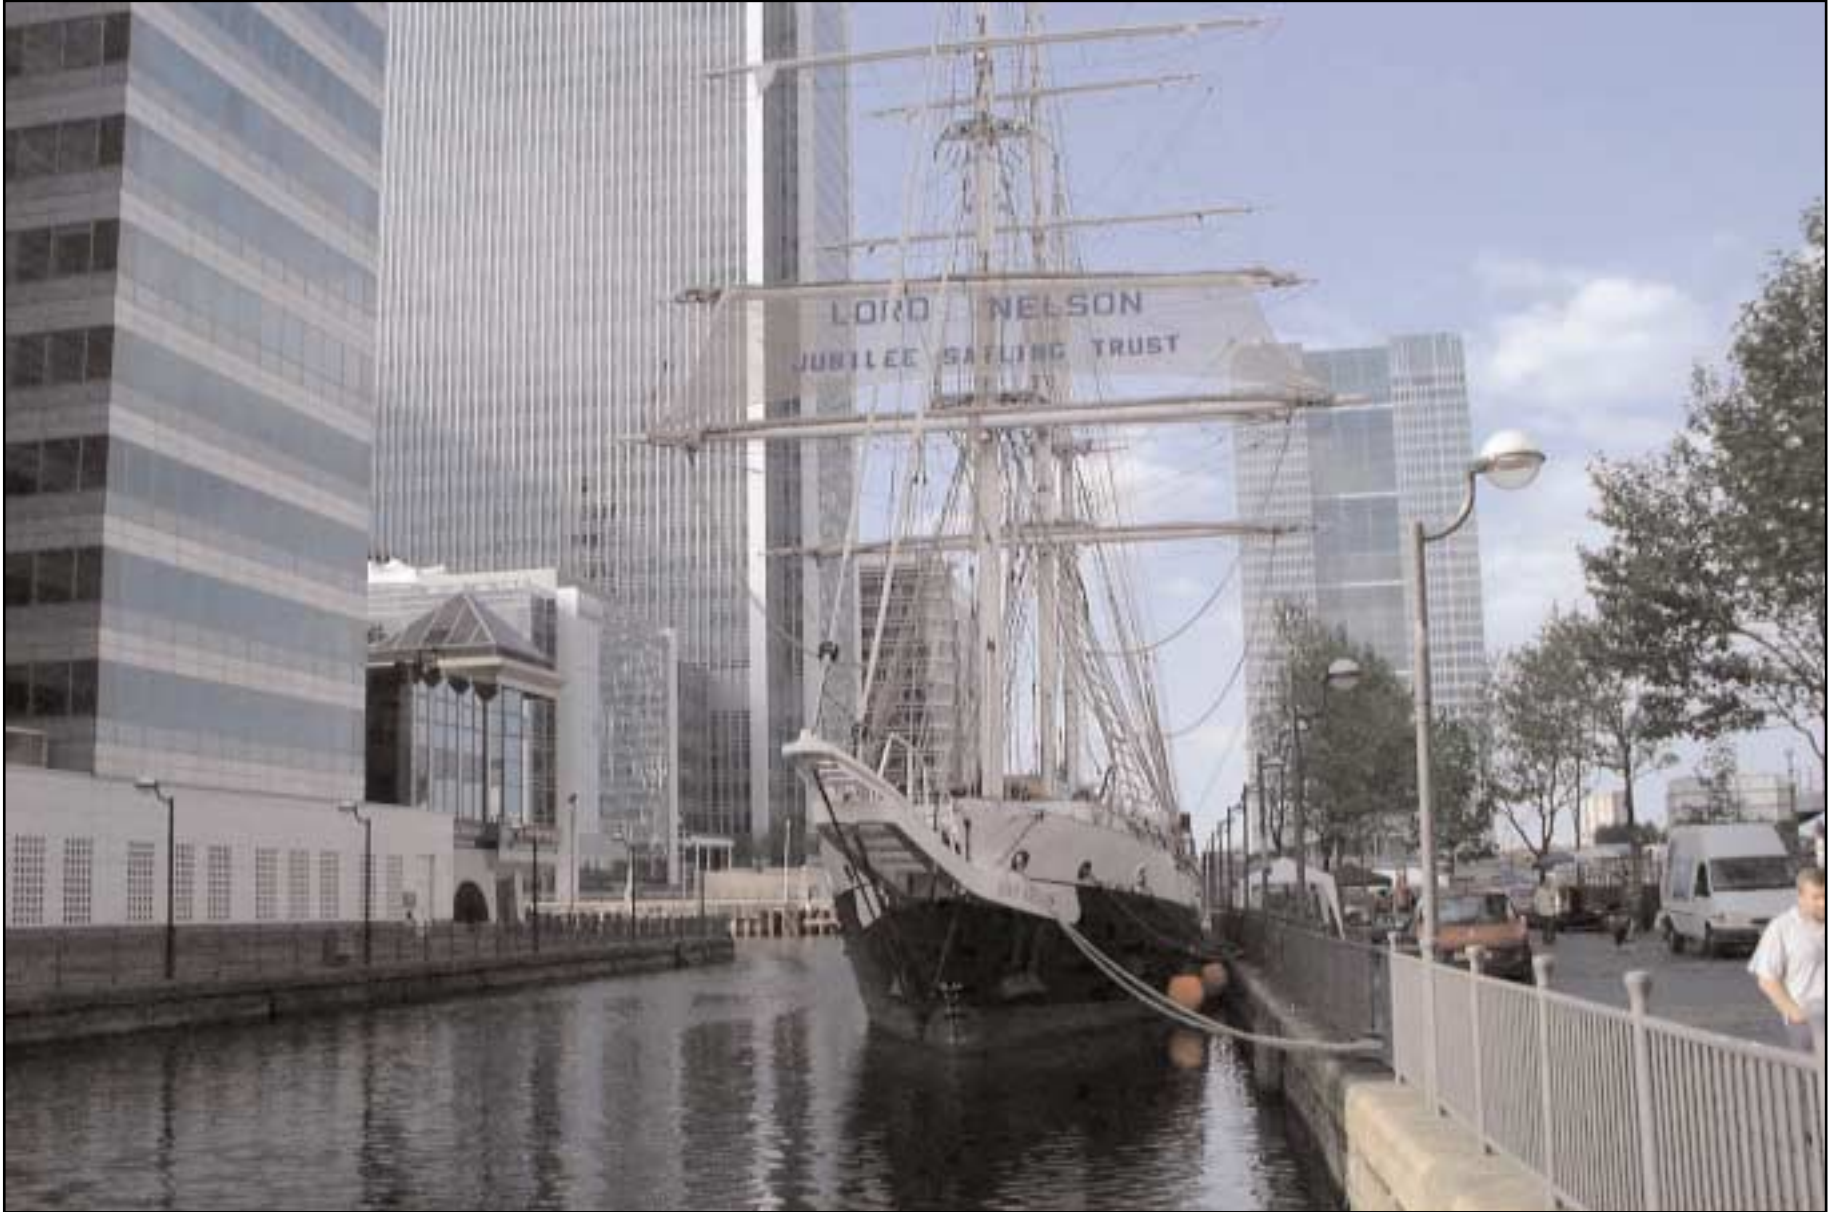
Figure 1

Lord Nelson

The trust is a unique charity in that it owns two specially designed tall ships, *Lord Nelson* (**Figure 1**) and *Tenacious*, both square rigged barques. The ships are purpose-built to enable physically disabled and able-bodied people to work and live alongside one another onboard. No-one onboard is a passenger, everyone works to his or her best ability. The ships spend the winter months island-hopping in the Canaries, and then return to the UK in the spring for voyages around the UK and Northern Europe.

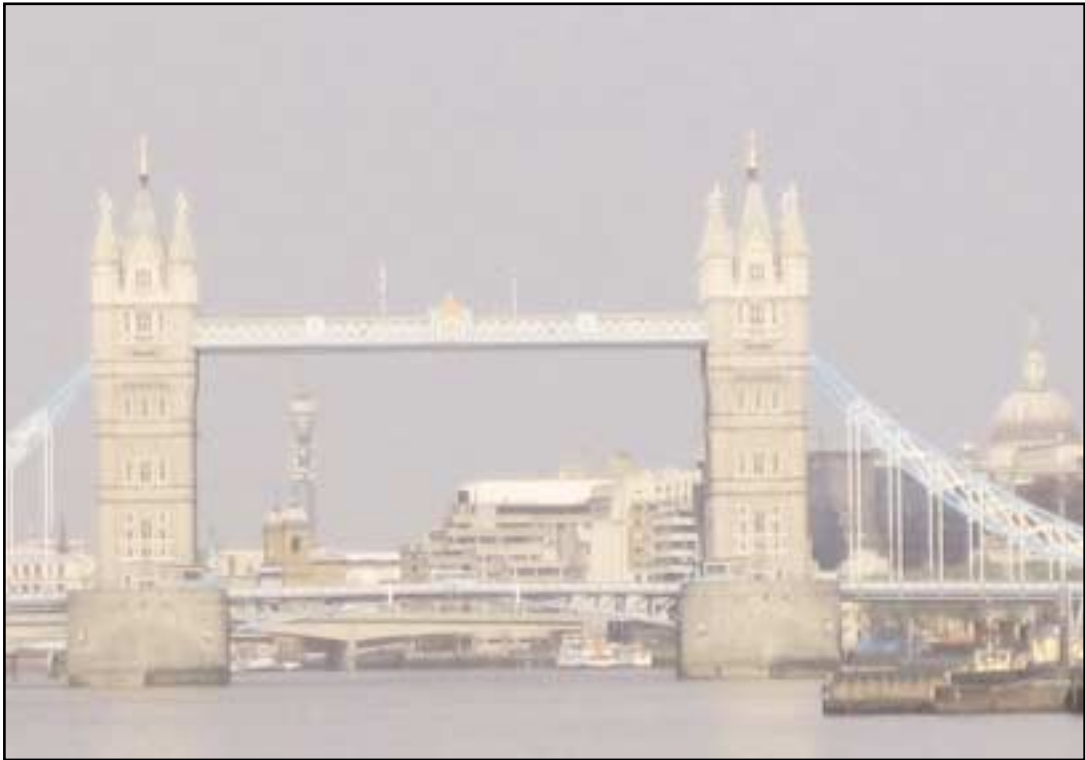
Figure 3

Tower Bridge

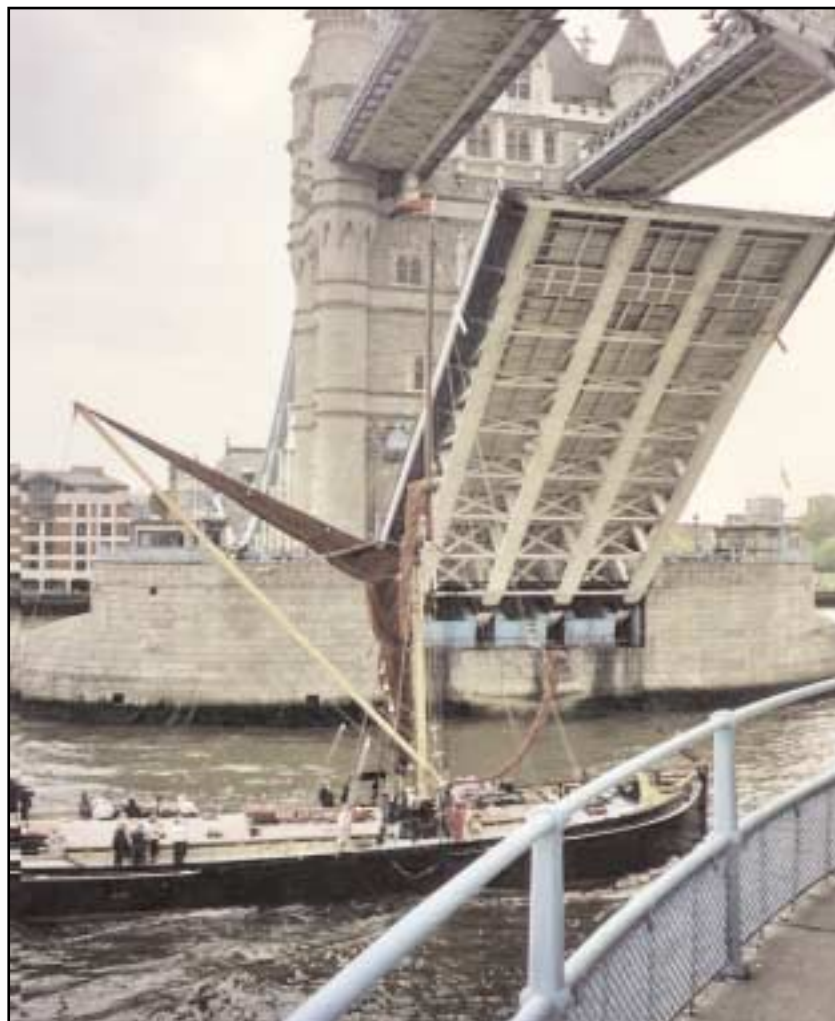
The bascules

The bascules (**Figure 3**) are capable of being lifted to a maximum angle of 86° which can be completed in approximately 1 minute. On average, the bascules are lifted 800-1000 times per annum.
