Report on the investigation of

Lord Nelson

contact with Tower Bridge London

**Report No 14/2004
October 2004**

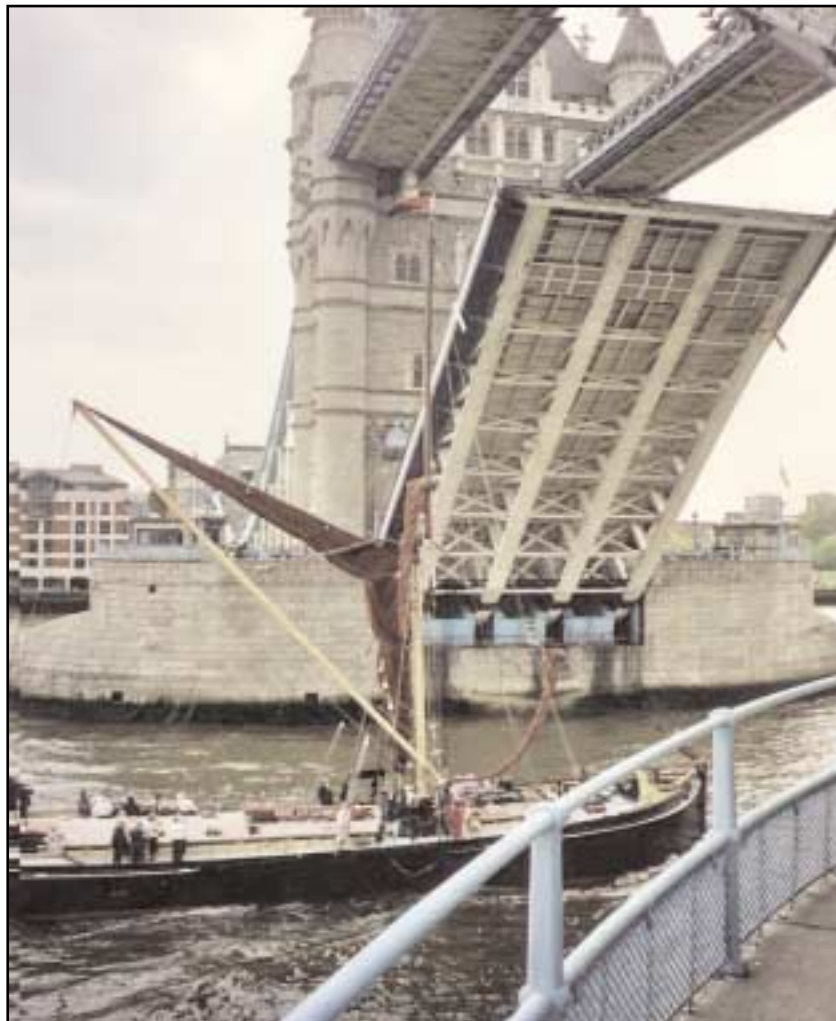
Figure 3

The bascules

The bascules (**Figure 3**) are capable of being lifted to a maximum angle of 86° which can be completed in approximately 1 minute. On average, the bascules are lifted 800-1000 times per annum.
