Report on the investigation of
the flooding and foundering of
CHRISTINE NIELSEN (GY 298)
120 miles north-east of River Tyne
on
18 March 2001

Marine Accident Investigation Branch
First Floor
Carlton House
Carlton Place
Southampton
United Kingdom
SO15 2DZ

**Report No 38/2001
November 2001**

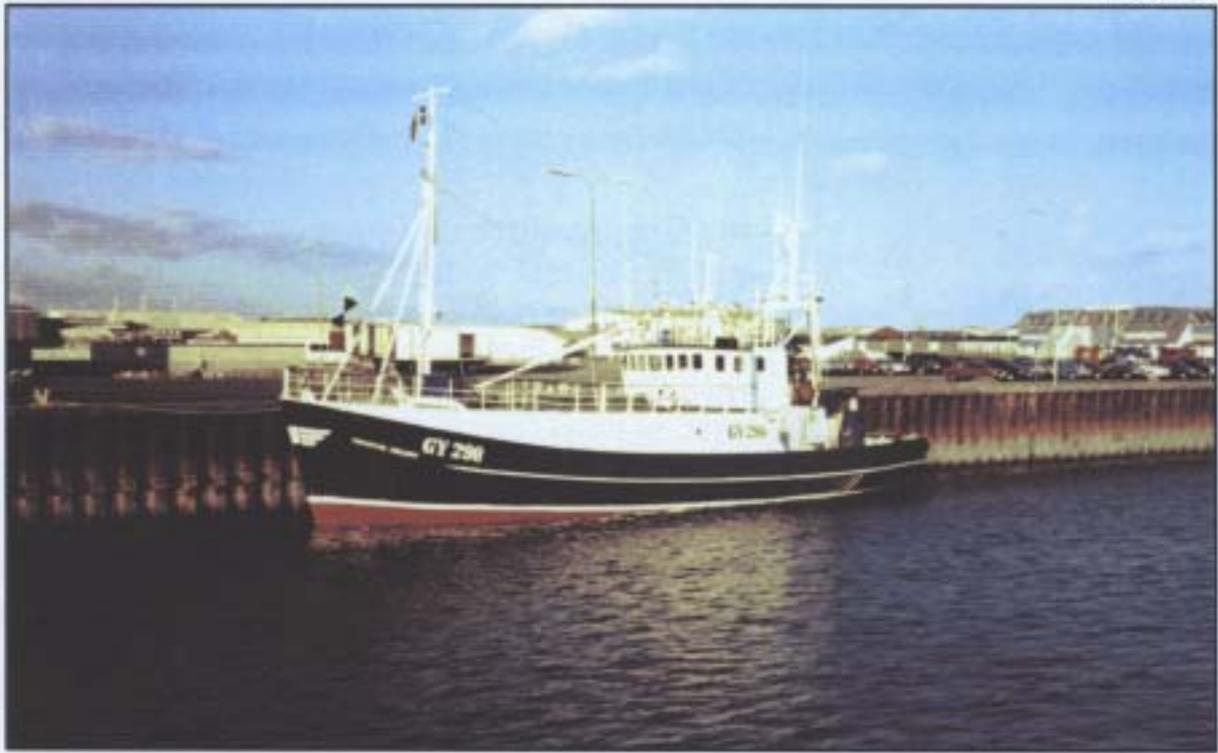
Figure 1

Christine Nielsen
