*Maersk Newport's* Heavy Weather Casualty Report dated 11 November 2008

## Casualty Report

Vessel: Maersk Newport

Time/Place of accident (or en-route from/to): <b>En route Le Harve to Algeciras</b>					
Nature of Casualty: <b>Hull damage to port side for'd</b>				Name of Pilot:	
Tugs(s) (Name(s)):				Draft: Fore: <b>9.70</b> Aft: <b>10.70</b>	
Course: <b>240</b>	Speed: <b>15</b>	Current:	Sea: <b>Rough</b>	Wind: <b>WSW8/9</b>

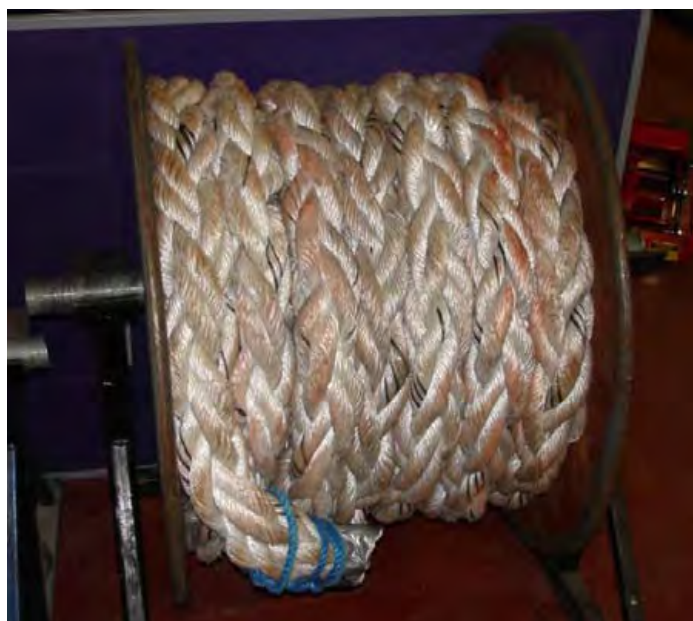
Figure 1 – Rope sample wound on to steel flanged core.

Description of sample(s): 8 strand braided polypropylene mooring rope, 80 mm Ø  
a) Wound 3 layers deep by 6/7 coils wide onto a steel flanged core  
(Figure 1)  
b) 80 cm length sample of rope taken from ~2 m back from failed  
end of line (herein after "Burn End")  
c) 80 cm length sample of rope taken from ~2 m back from eye end  
of line (herein after "Eye End")

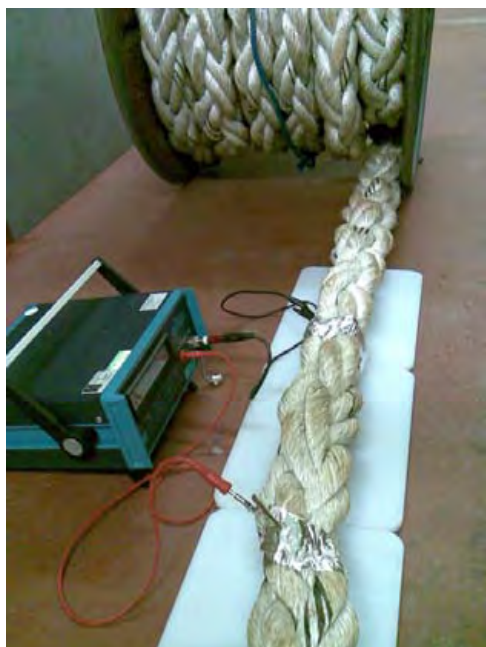
Figure 3 – Arrangement for measuring point-to-point resistance along the rope.

A length of rope, approximately 1.5 m long is unwound from the core and is placed on four insulating plastic plates (278 mm × 208 mm × 8 mm) of volume resistivity greater than  $10^{13}$  Ω.cm. A pair of electrodes is formed around the rope using 50 mm wide self-adhesive aluminium tape (Figures 2 & 3). The electrical resistance between the electrodes is measured using an Eltex Type 6206 Tera-ohm-meter under an applied potential of 250 V d.c. Measurements are made with electrodes positioned in two ways: a) electrodes formed around entire circumference of the rope, and b) electrodes formed around the circumference of a single rope strand. In the latter case, the electrodes are placed on the same strand as it appears at the rope surface at an adjacent braiding pattern repeat.

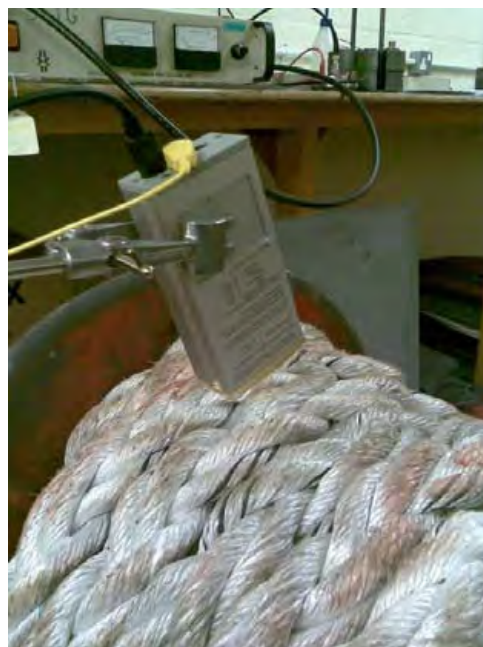
Figure 4 – Arrangement for measuring charge decay time from the rope.

The steel flanged core is connected directly to earth and a JCI 140F electrostatic fieldmeter positioned at a distance of 10 cm from the surface of the rope in place on the core. The centre of the fieldmeter measuring aperture is in line with the centre of the third coil in from the right hand side (Figure 4). The JCI 140F fieldmeter is calibrated to produce a reading of the surface voltage when the fieldmeter aperture is 10 cm from the surface being measured. The fieldmeter is connected to a National Instruments USB-6009 data acquisition system and personal computer. The rope is charged using corona produced by a carbon fibre brush connected to a Glassman EL Series high voltage power supply. The charging procedure is to energise the power supply to -10 kV and pass the carbon fibre brush several times over the area of rope immediately beneath the fieldmeter, without the carbon fibre brush touching the rope. The carbon fibre brush is then removed to some distance from the measuring area and the power supply switched off.

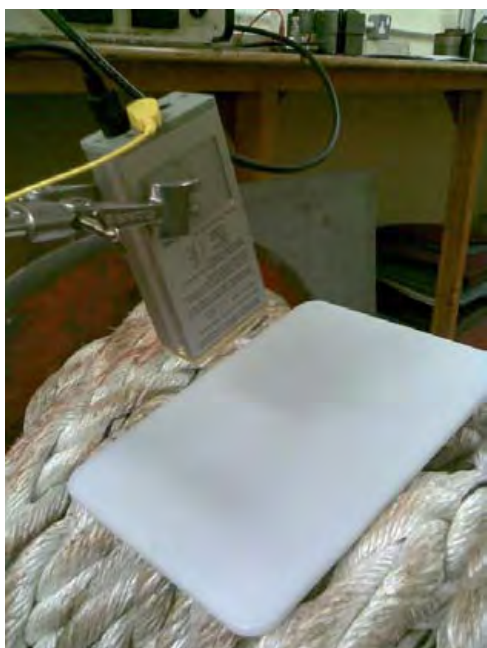
Figure 5 – Arrangement for measuring charge decay time from an insulating plastic plate.

For reference purposes and to demonstrate that charging can be achieved on insulating surfaces by the procedure described above, an insulating plastic plate (278 mm × 208 mm × 8 mm) is placed on the rope (Figure 5) and the charging procedure is repeated. The position of the fieldmeter is adjusted so that it remains 10 cm from the surface being measured.

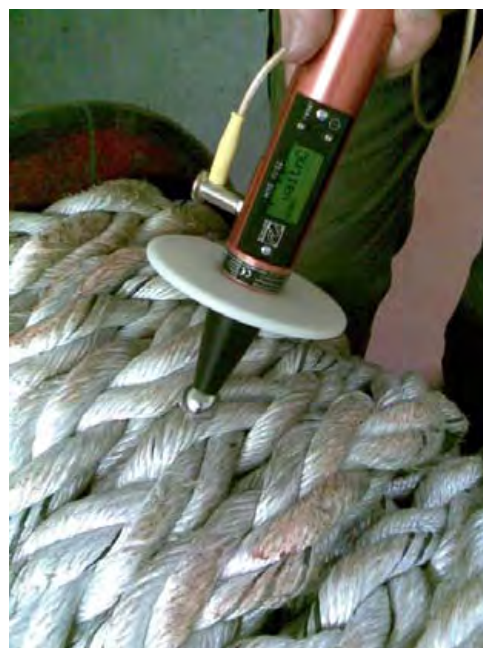
Figure 6 – Arrangement for measuring charge transfer in any discharges from the rope.

The steel flanged core is connected directly to earth and the rope is charged in the same way as described above for charge decay time testing. Immediately after charging, a Schnier HMG 11/02 Hand Coulombmeter is brought up to the surface of the rope in an attempt to provoke an electrostatic discharge (Figure 6). The HMG 11/02 is an instrument designed to record the charge transferred during any electrostatic discharge. It comprises a 25 mm diameter steel ball connected to a capacitor. An internal voltage measuring circuit is calibrated such that the display readout gives the charge transfer in nanocoulomb.

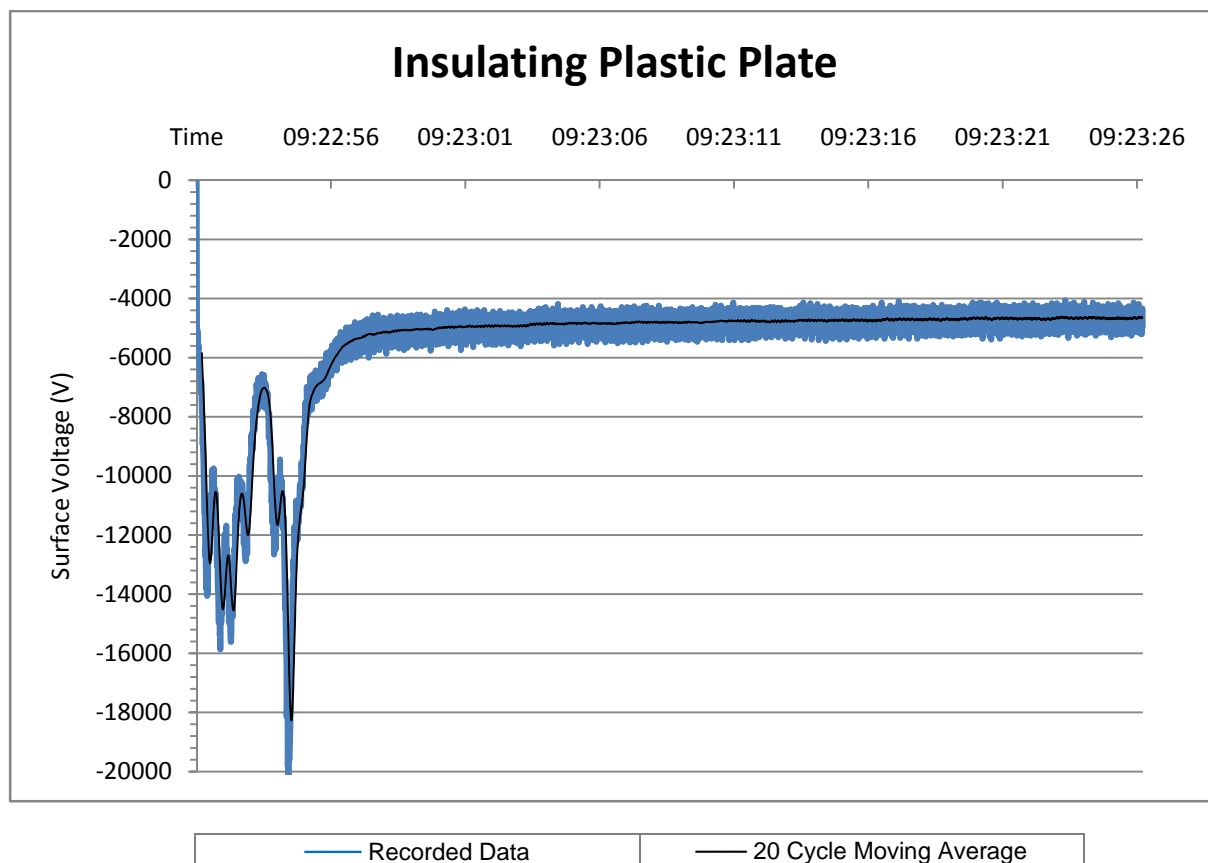
Figure 10 – Charge Decay for Insulating Plastic Plate at 25 % RH.

The following charts show the data recorded during charge decay time measurements. As fieldmeters invariably suffer some degree of noise, recorded data is overlaid with a moving average to aid analysis and interpretation of results. The large amplitude oscillations represent the response to the fieldmeter caused by the carbon fibre brush, which is charged to -10 kV. The charge decay time analysis is taken from the data recorded immediately after these oscillations have ceased, i.e. when the carbon fibre brush has been removed from the measuring area.
