TAN008

Design, Construction and Monitoring of Demonstration Sites for District Road Improvement in Tanzania to the Prime Minister's Office – Regional Administration and Local Government (PMO-RALG) under the African Community Access Programme (AFCAP)

Bagamoyo Final Monitoring Report

June 2013

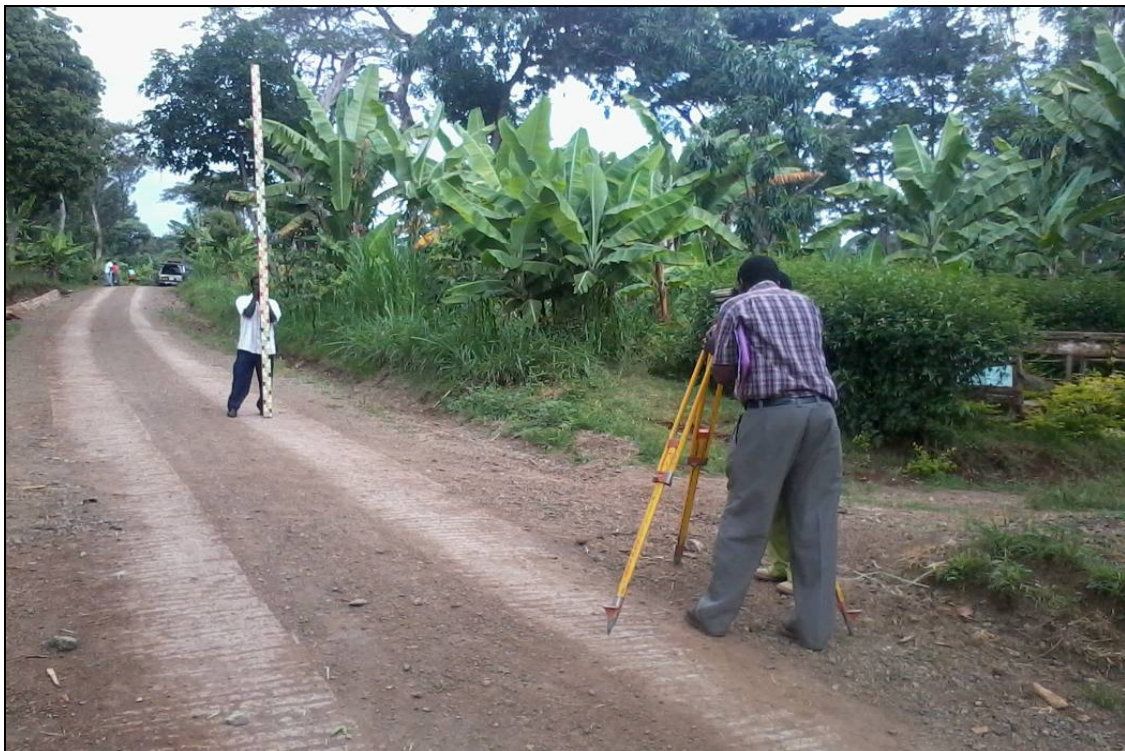
Figure 2: Surface Profile Measurement

A staff and dumpy level are used to take surface profile measurements at each beacon location, so that any changes in the surface profile between each monitoring phase can be measured. Levels are taken at regular intervals across the cross-section, so that the surface profile levels can be determined. This method of measuring the surface profile is shown in Figure 2.

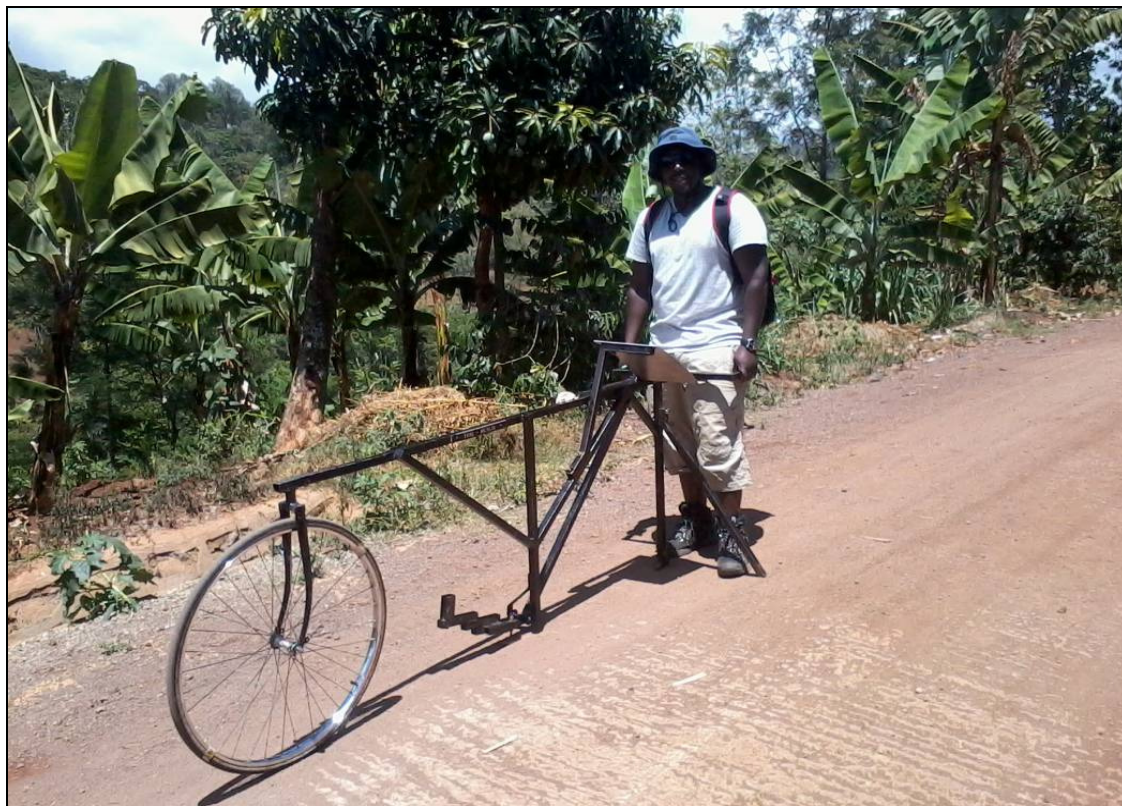
Figure 4: MERLIN Apparatus

Surface roughness measurement should be carried out using MERLIN apparatus, which records the longitudinal unevenness of a road surface by taking numerous readings along the wheel path. Taking two hundred readings along the wheel path of a road section will produce a histogram, from which a value of the International Roughness Index (IRI) can be calculated. A full, detailed user guide on the MERLIN roughness machine is given in TRL Report 229¹. It is to be noted that there is an inherent standard error in the IRI value calculated using the MERLIN apparatus. This error is given to be up to 10%. The MERLIN apparatus is shown in Figure 4.

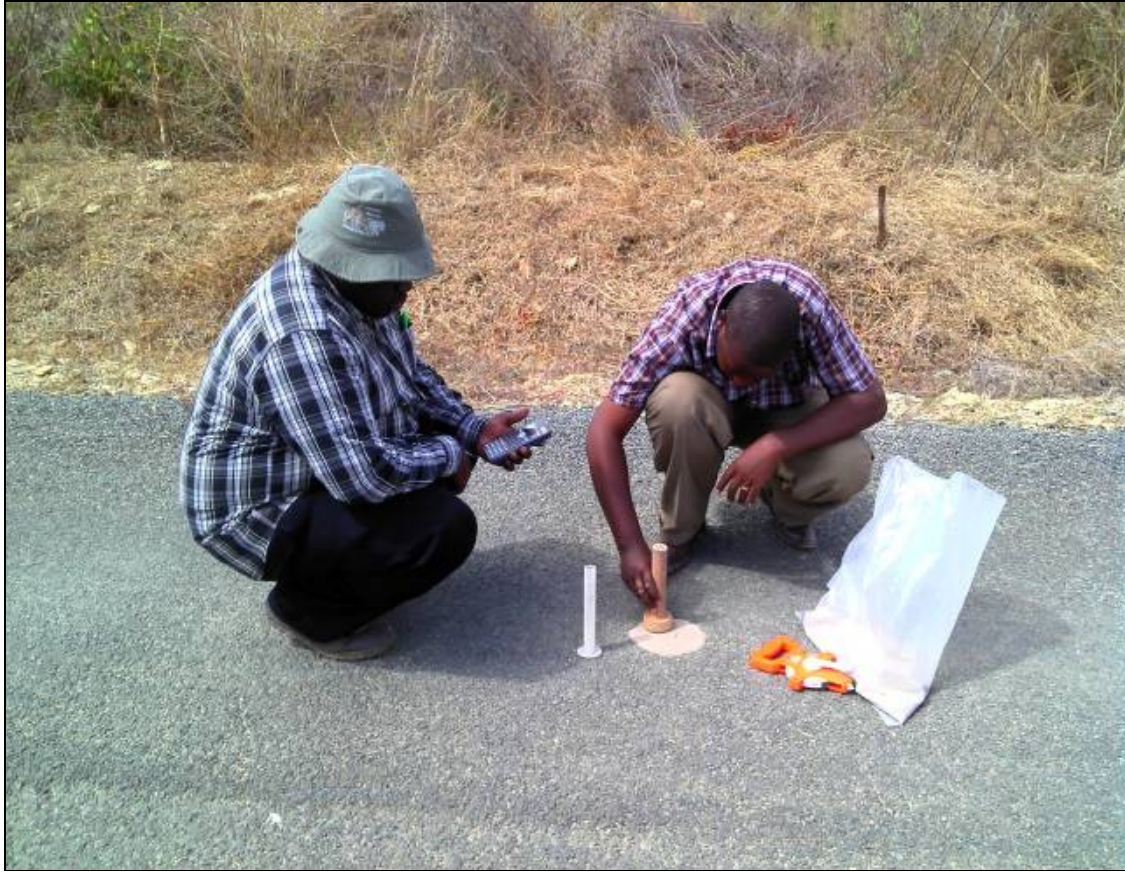
Figure 5: Sand Patch Testing

The sand patch method is used on bituminous sections to measure surface texture, and takes place at each set of monitoring beacons in order to provide consistency in future monitoring phases. During the test procedure a measuring cylinder is filled with a measured quantity of sand, which is then poured onto the surface and spread into a circular patch. The diameter of the sand patch is measured at four diameters and the mean diameter is calculated; the mean diameter is then used to calculate surface texture. This method is illustrated in Figure 5.

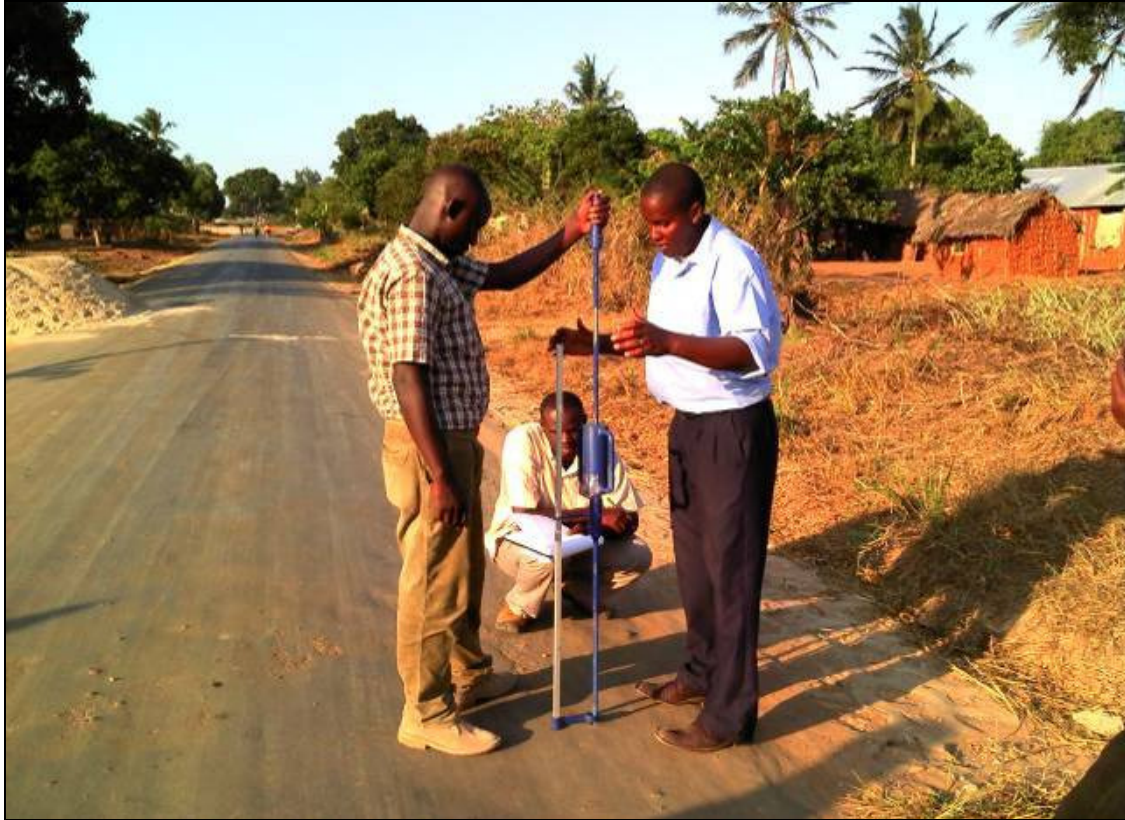
Figure 6: DCP Testing

The Dynamic Cone Penetrometer (DCP) is an instrument designed for the rapid in-situ measurement of the structural properties of existing road pavements or existing subgrade. Where pavement layers have different strengths the boundaries can be identified and the thickness of the layers determined. With a team of three operators, the instrument provides a quick and efficient method of obtaining information and tests are carried out at each set of monitoring beacons on all bituminous and gravel demonstration sections. The DCP device consists of an 8 kg weight dropping through a height of 575 mm, delivering a blow onto a penetration cone. The depth of penetration below the road surface is recorded every five blows; continuous measurements are taken until the penetration reaches a depth of 800 mm. The DCP method is shown in Figure 6.
