Design, Construction and Monitoring of Demonstration Sites for District Road Improvement in Tanzania to the Prime Minister's Office – Regional Administration and Local Government (PMO-RALG) under the African Community Access Programme (AFCAP)

Siha Final Monitoring Report

June 2013

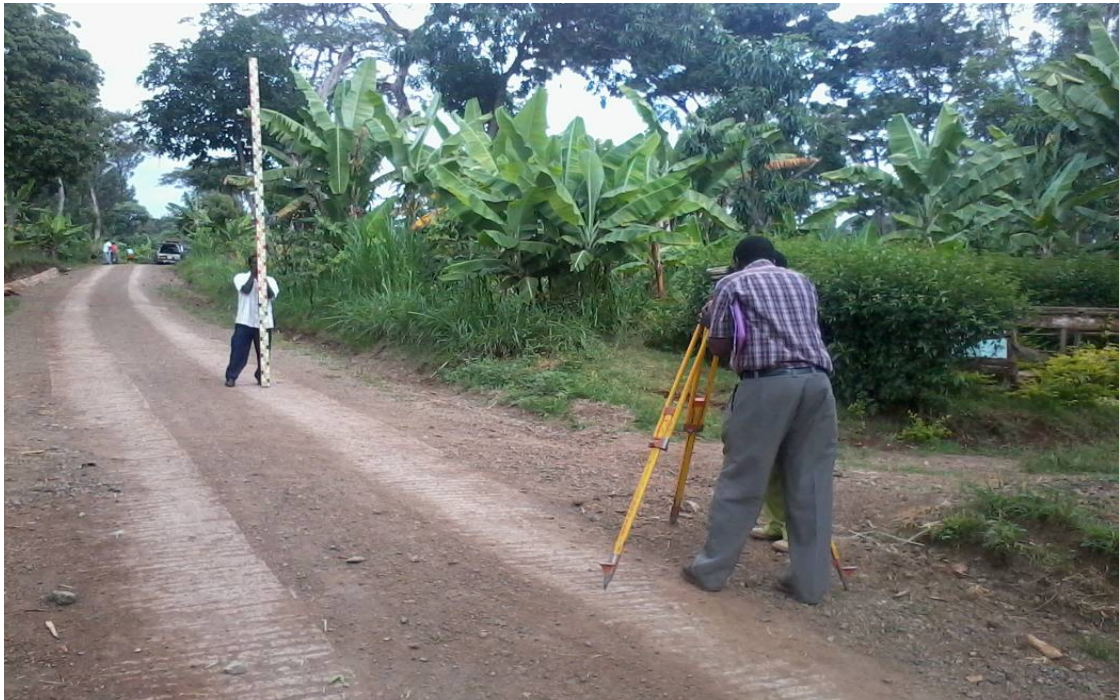
Figure 2: Surface Profile Measurement

A staff and dumpy level are used to take surface profile measurements at each beacon location, so that any changes in the surface profile between each monitoring phase can be measured. Levels are taken at regular intervals across the cross-section, so that the surface profile levels can be determined. This method of measuring the surface profile is shown in Figure 2.

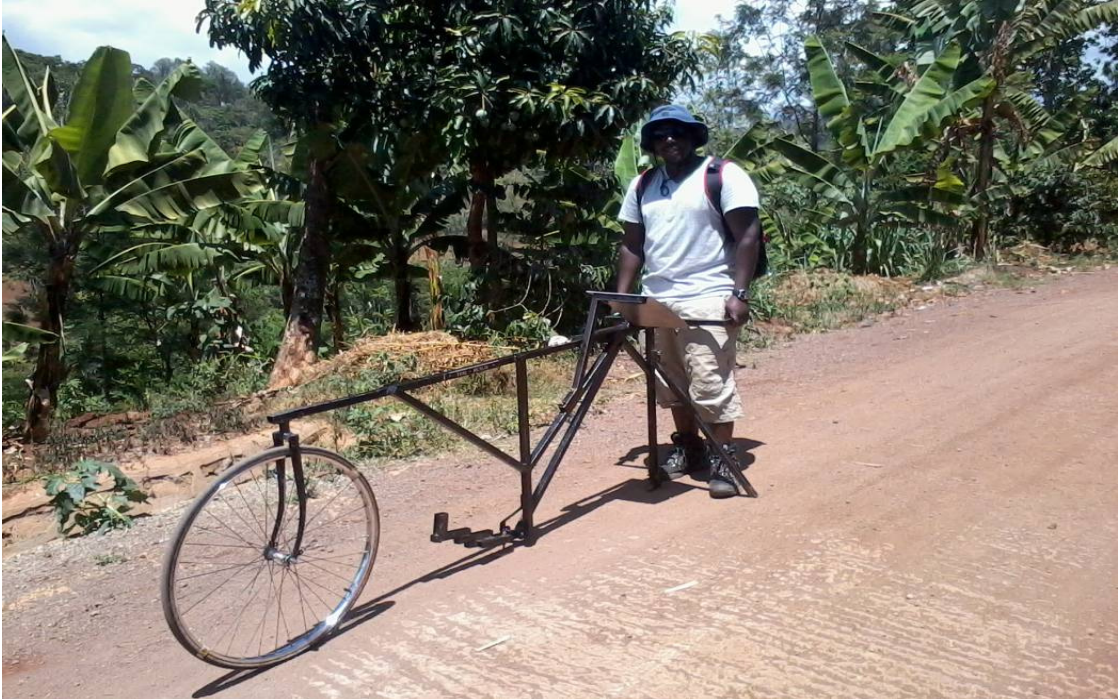
Figure 4 MERLIN Apparatus

Surface roughness measurement should be carried out using MERLIN apparatus, which records the longitudinal unevenness of a road surface by taking numerous readings along the wheel path. Taking two hundred readings along the wheel path of a road section will produce a histogram, from which a value of the International Roughness Index (IRI) can be calculated. A full, detailed user guide on the MERLIN roughness machine is given in TRL Report 229¹. It is to be noted that there is an inherent standard error in the IRI value calculated using the MERLIN apparatus. This error is given to be up to 10%. The MERLIN apparatus is shown in Figure 4.

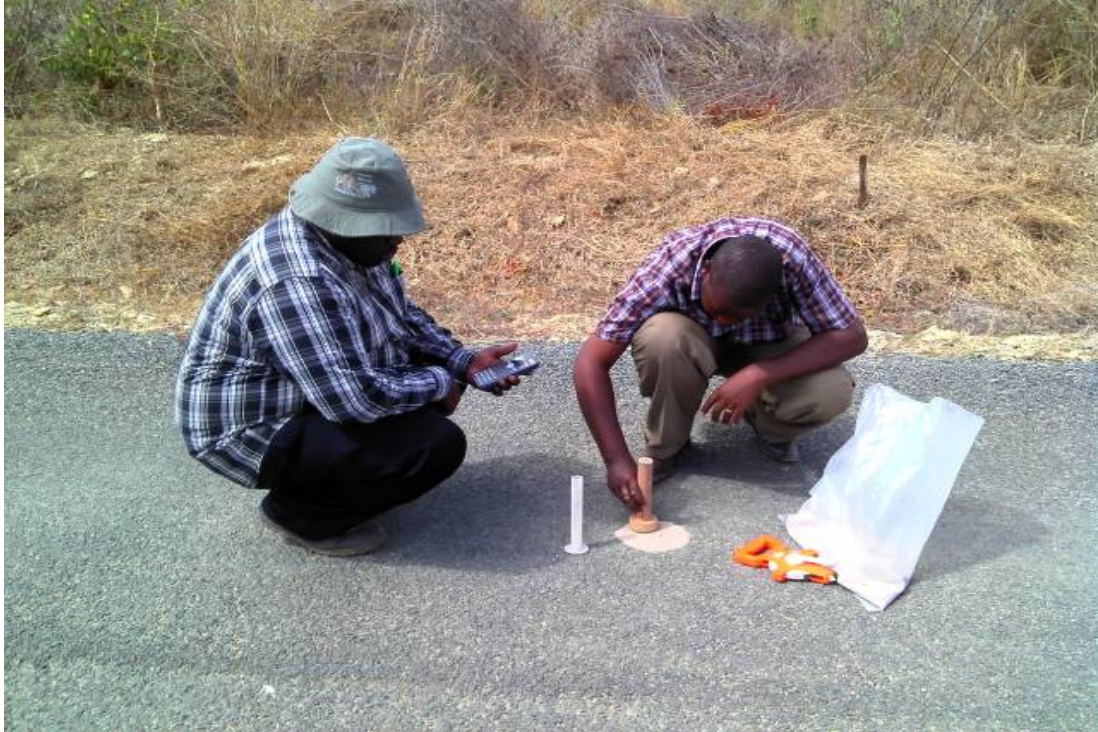
Figure 5: Sand Patch Testing

The sand patch method is used on bituminous sections to measure surface texture, and takes place at each set of monitoring beacons in order to provide consistency in future monitoring phases. During the test procedure a measuring cylinder is filled with a measured quantity of sand, which is then poured onto the surface and spread into a circular patch. The diameter of the sand patch is measured at four diameters and the mean diameter is calculated; the mean diameter is then used to calculate surface texture. This method is illustrated in Figure 5.

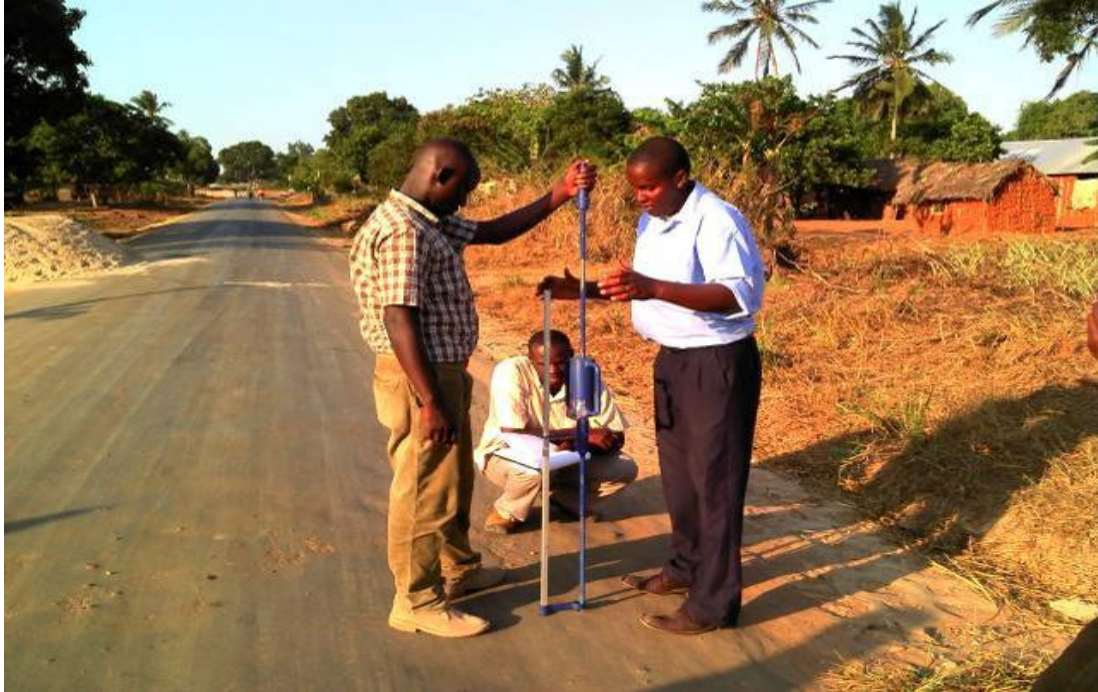
Figure 6 DCP Testing

The Dynamic Cone Penetrometer (DCP) is an instrument designed for the rapid in-situ measurement of the structural properties of existing road pavements or existing subgrade. Where pavement layers have different strengths the boundaries can be identified and the thickness of the layers determined. With a team of three operators, the instrument provides a quick and efficient method of obtaining information and tests are carried out at each set of monitoring beacons on all bituminous and gravel demonstration sections. The DCP device consists of an 8 kg weight dropping through a height of 575 mm, delivering a blow onto a penetration cone. The depth of penetration below the road surface is recorded every five blows; continuous measurements are taken until the penetration reaches a depth of 800 mm. The DCP method is shown in Figure 6.
