SEACAP 21/004 Practitioner Training

Theme 4 Slope and Roadside Inspections and Assessments

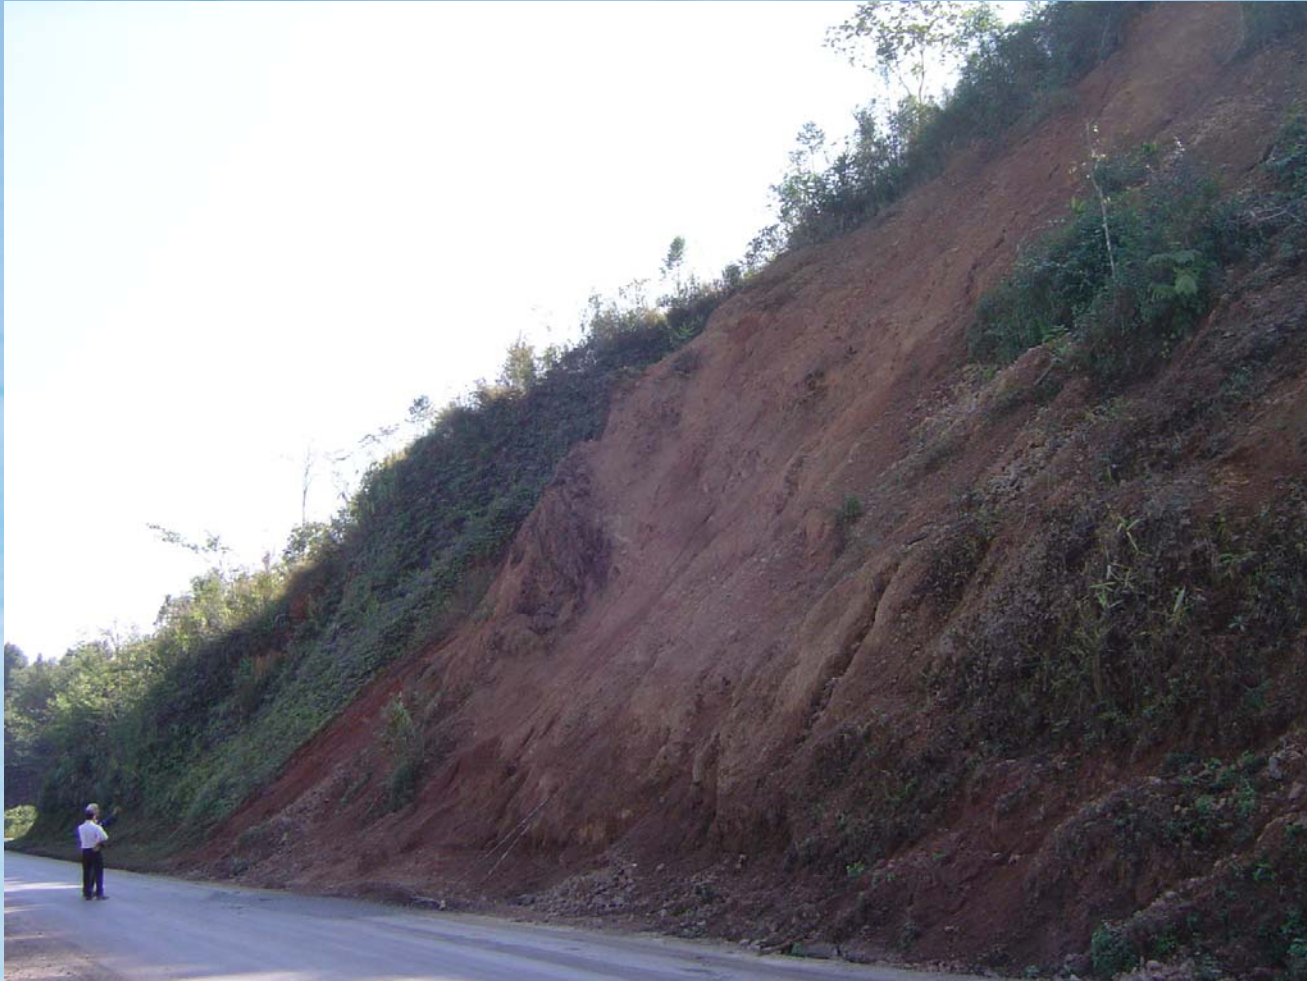
Erosion of cut slope surface

Problem	Common evidence	Likely consequences
Above the road		
Erosion of the cut slope surface	<ul style="list-style-type: none"> • Debris present in roadside drains. • Gullies have formed in the cut slope. • Signs of damage to the vegetation. 	<ul style="list-style-type: none"> • Debris <i>will</i> block drains and adjacent carriageway and <i>may</i> damage the road surface. • Loss of mass on the cut slope <i>may</i> undermine the hill slope above and cause a failure.
Failure in cut slope only	<ul style="list-style-type: none"> • A cone of debris blocking the drain and extending on to the carriageway. • A landslide scar on the cut slope. 	<ul style="list-style-type: none"> • Debris <i>will</i> block drains and <i>may</i> damage the road surface. • Water from the blocked drains <i>may</i> flow across the road and cause erosion down slope. • Traffic <i>will</i> be disrupted on at least one side of the road. • Loss of mass on the cut slope <i>may</i> undermine the hill slope above and cause a larger failure.

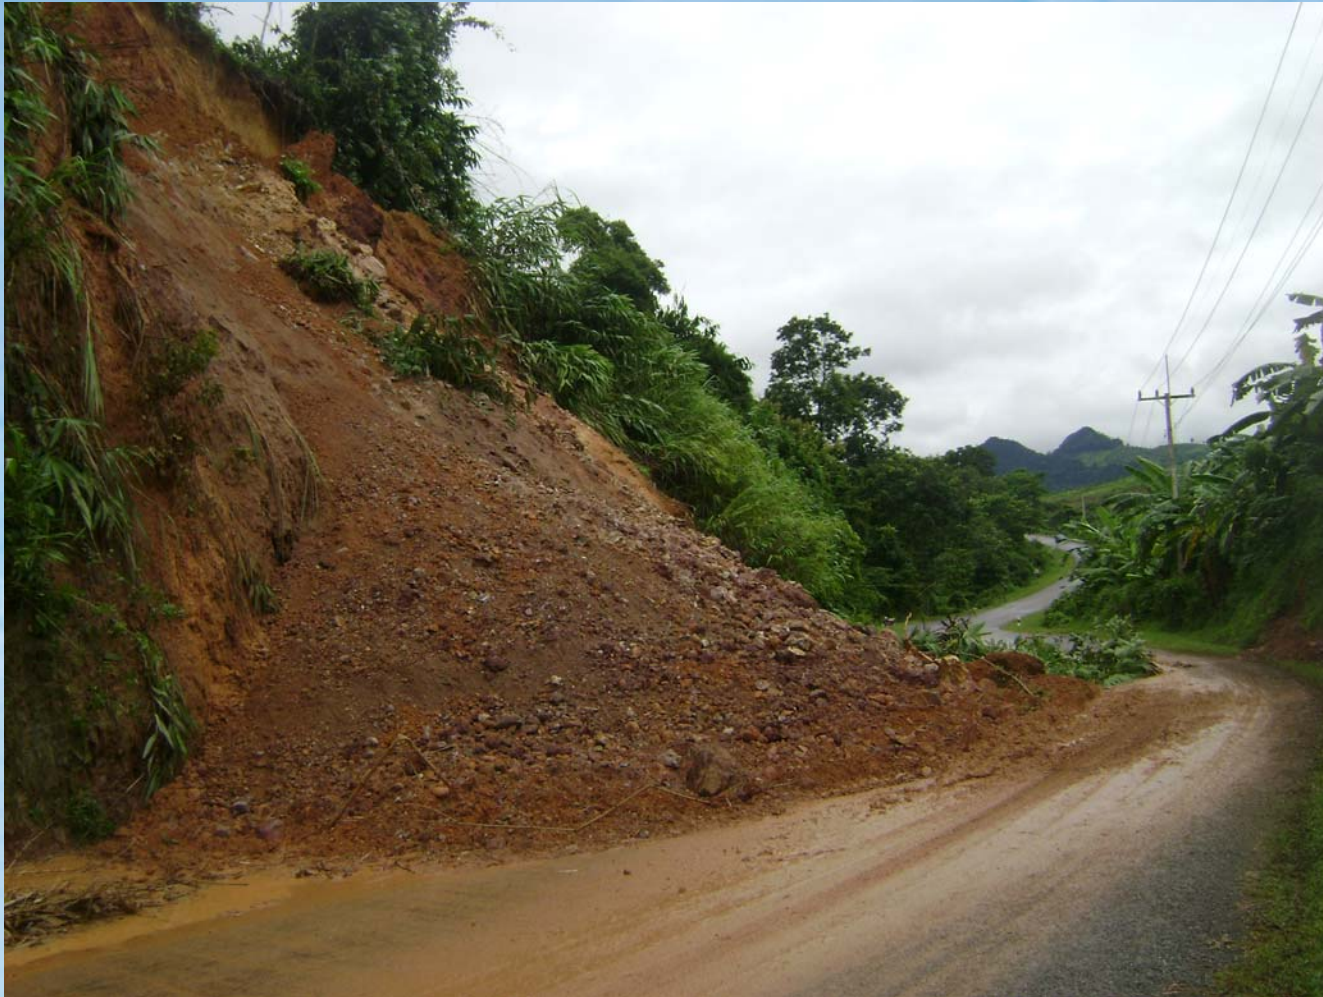
Failure in cut slope only

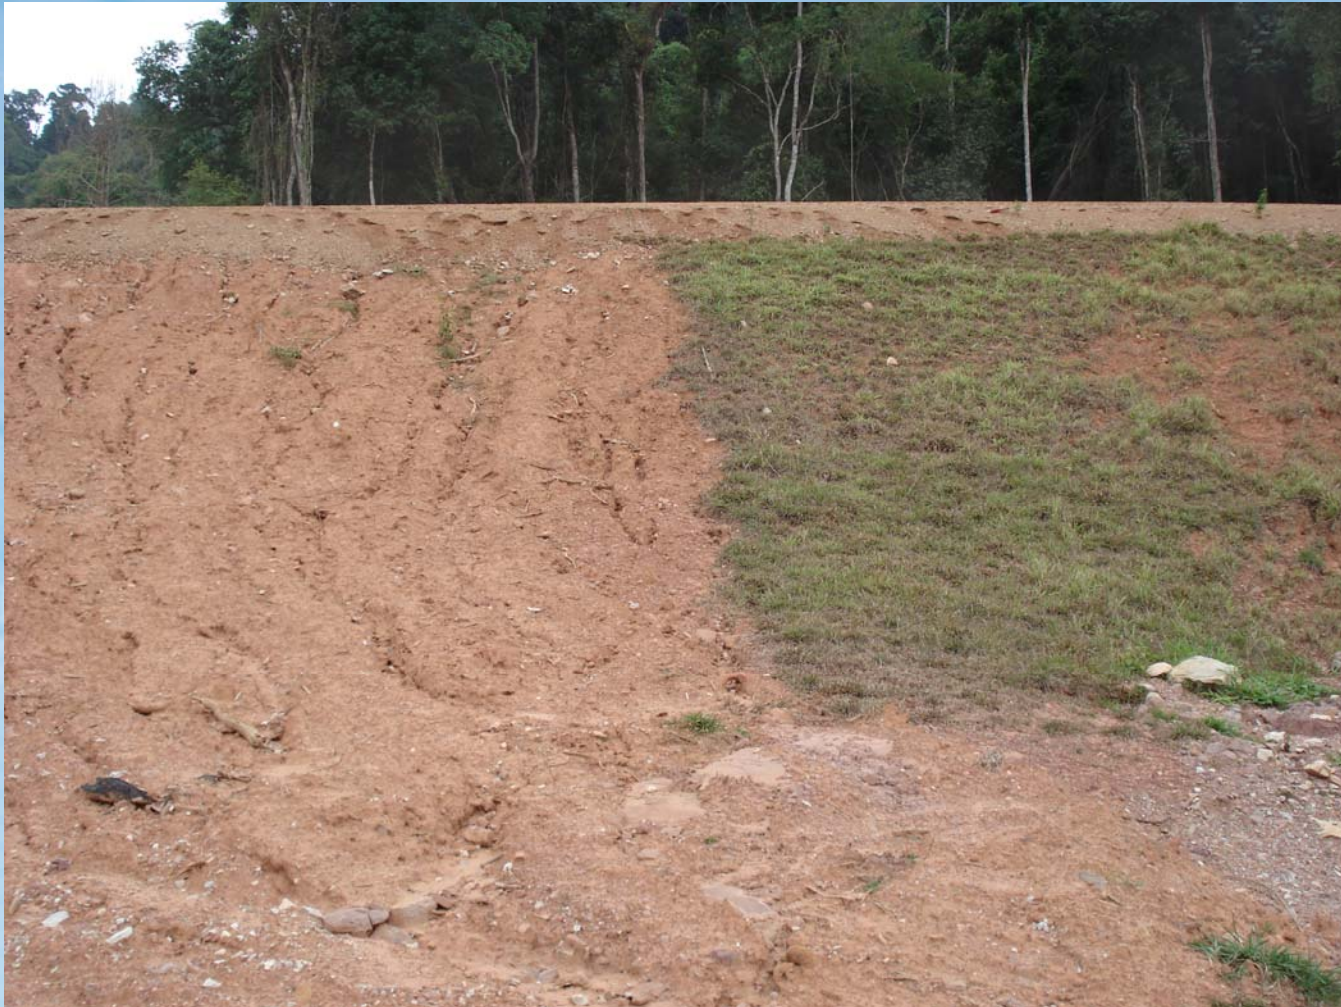
Erosion of the fill slope surface

Problem	Common evidence	Likely consequences
Below the road		
Erosion of the fill slope surface	<ul style="list-style-type: none"> Gullies have formed in the fill slope. Signs of damage to the vegetation. 	<ul style="list-style-type: none"> If untreated, the erosion <i>may</i> cause a failure of the fill slope
Failure in fill slope only	<ul style="list-style-type: none"> Tension cracks on the valley side of the road. A landslide scar in the fill slope. 	<ul style="list-style-type: none"> The road <i>may</i> be partly or wholly cut off. Traffic <i>may</i> be disrupted on at least one side of the road.
Failure in fill slope and original valley slope	<ul style="list-style-type: none"> Tension cracks on the valley side of the road. A landslide scar in the fill slope extending into the original ground beneath. Evidence that the slope below and either side of the fill slope is moving (e.g. scars, tension cracks) 	<ul style="list-style-type: none"> Loss of mass on the slope <i>will</i> undermine the fill slope above and <i>may</i> cause a larger failure.

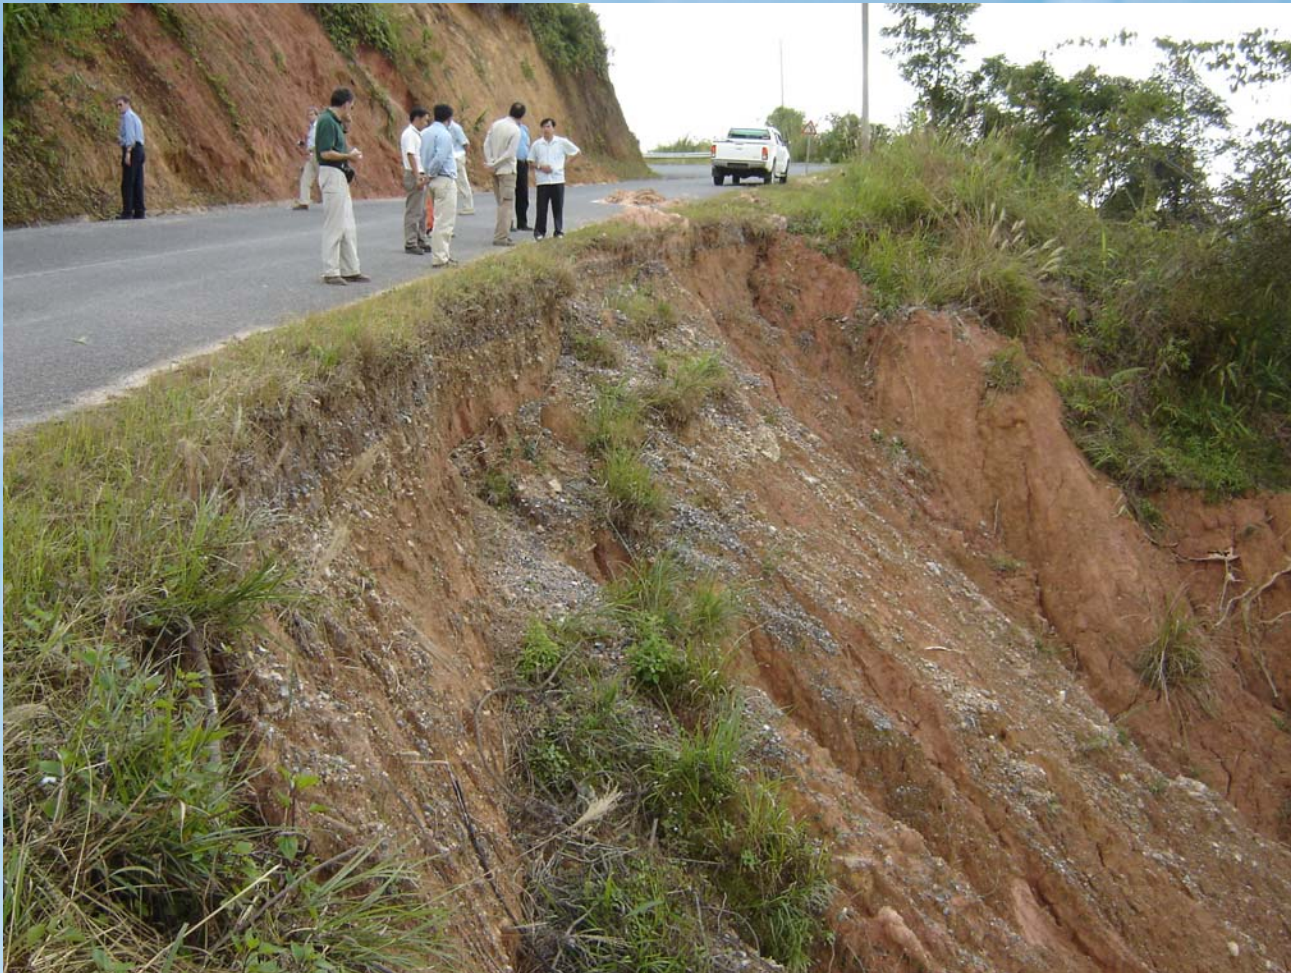
Failure in the fill slope only

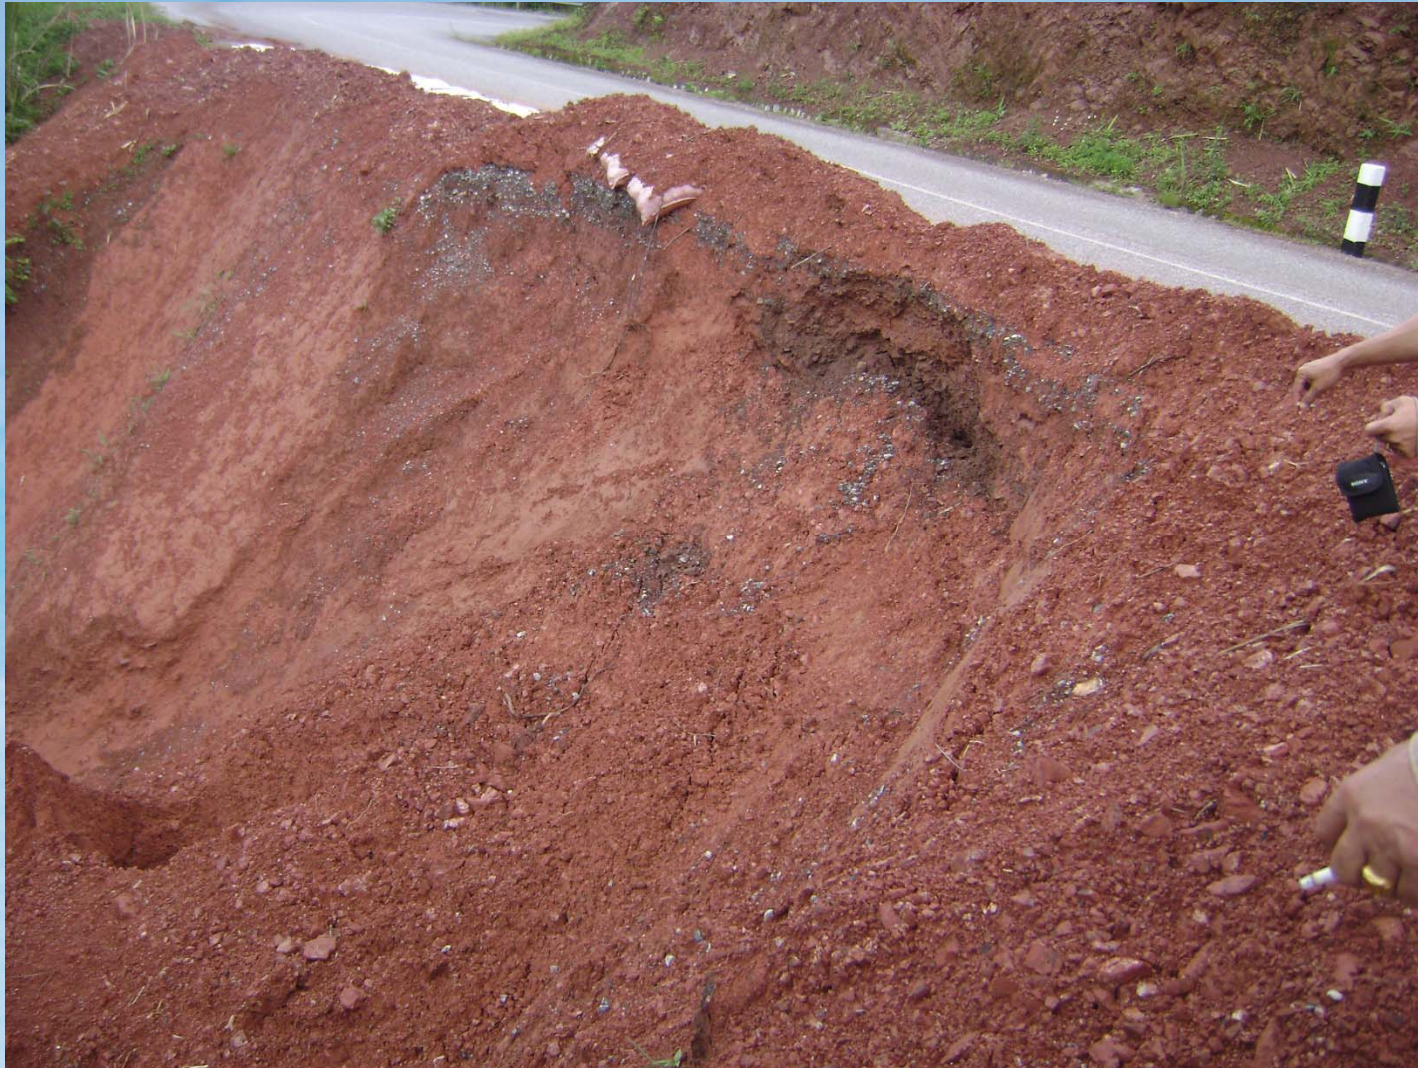
Failure in the fill slope and original valley slope
