South-East Asia Community Access Programme

SEACAP 21/002: Feasibility Study for a National Programme to Manage Slope Stability

Final Report: Background Paper 12 September 2008

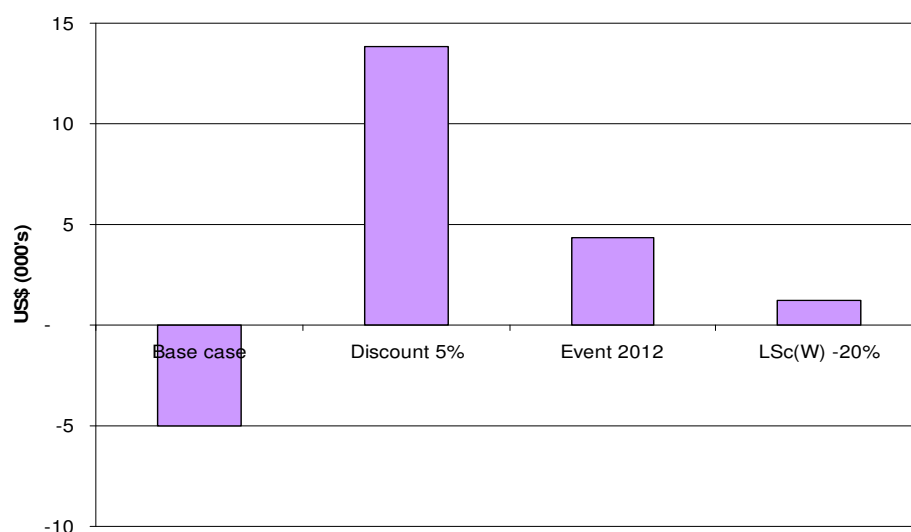
Figure 8.1. Sensitivity analysis on results of example.

A series of sensitivity analyses were carried out on the hypothetical example presented to illustrate how vulnerable the results are to the inputs for the model. These are shown graphically in Figure 8.1.

The base case result is the net present value presented in Table 8.1. A decrease in the discount factor to 5% leads to an NPV change of approximately US\$19,000 (from a negative US\$5,000 to a positive NPV of nearly US\$14,000). If the anticipated landslide takes place in 2012 instead of 2013, the NPV result again swings from negative to positive. The NPV also becomes positive if the economic impact of the preventative measures is changed by 20% (i.e. the landslide costs US\$40,000 instead of US\$50,000 to stabilise), although the change is smaller.
