**Report IV**  
**Field Trials using the Modified DCP**  
**Apparatus**

# Appropriate and Efficient Maintenance of Low Cost Rural Roads

**Project Title:** Appropriate and Efficient Maintenance of Low Cost Rural Roads

**Element C:** Assessing Materials for Low Cost Roads

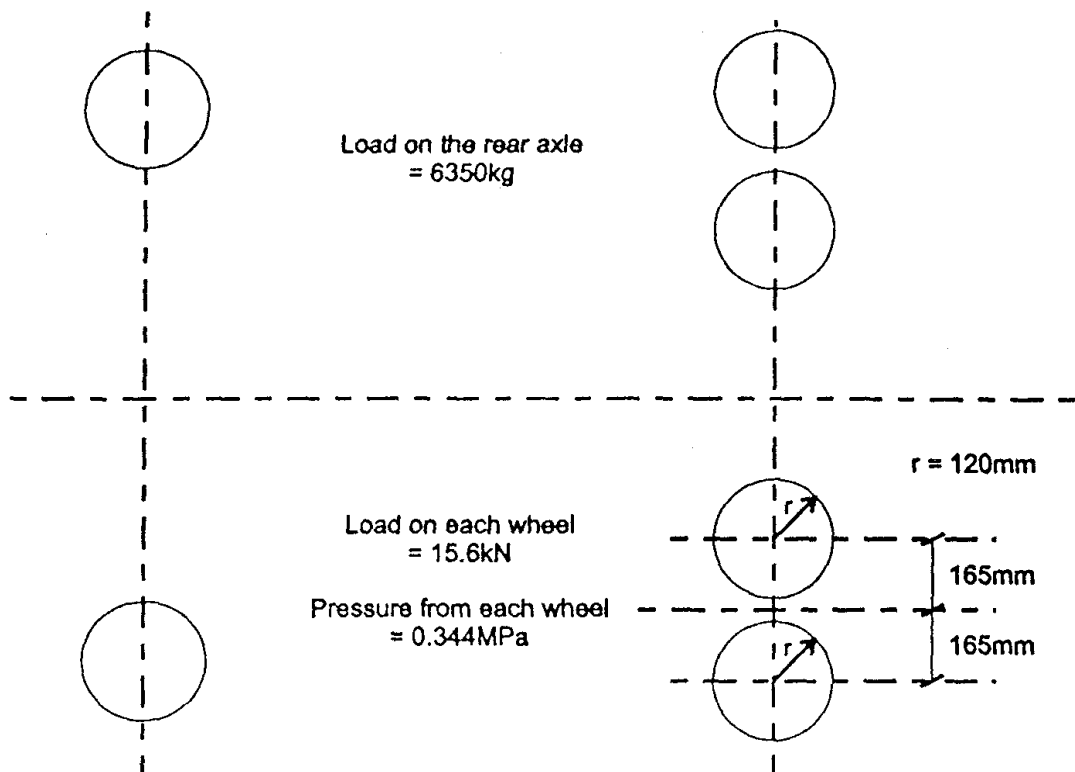
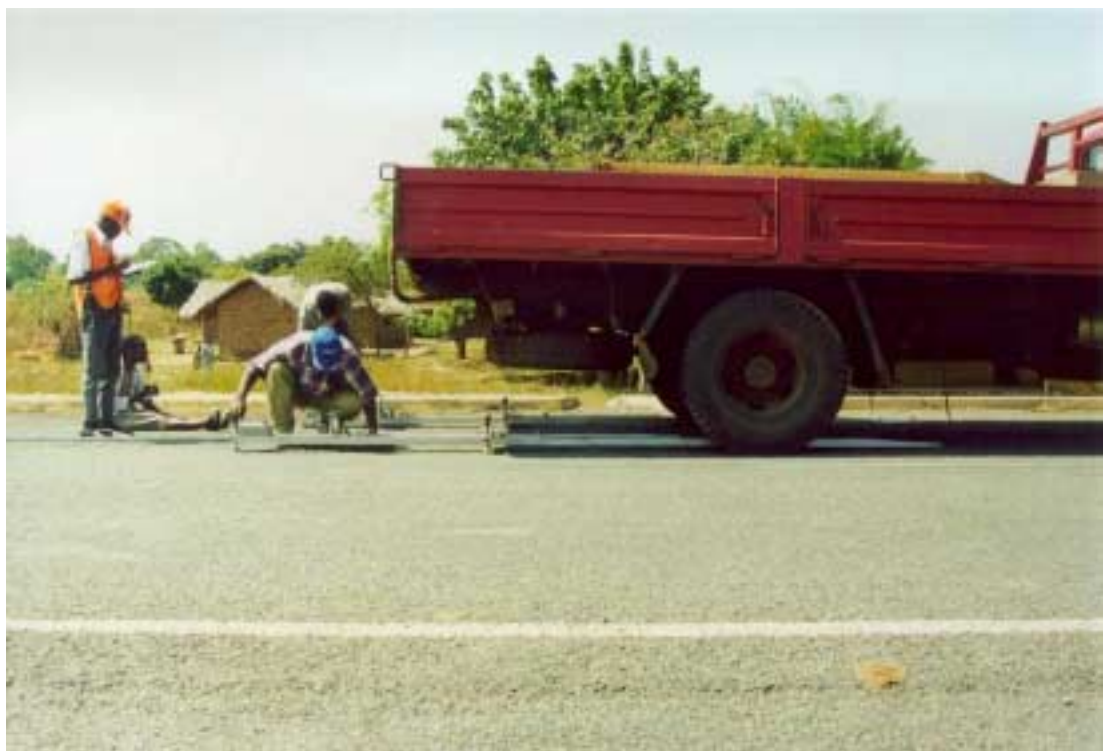
**Figure 3-1 - Configuration of the Axle Loading as applied by the Deflection Truck**

All structural response tests were conducted using a truck that was loaded to achieve 15.6 kN on each of the four rear wheels. For analytical purposes the application area of each tyre was taken to be circular, with a radius of 120 mm, applying a pressure to the road surface of 0.344 MPa. The centre of the tyres is taken as 165 mm from the origin as shown in Figure 3-1 together with a photograph showing the deflection testing.

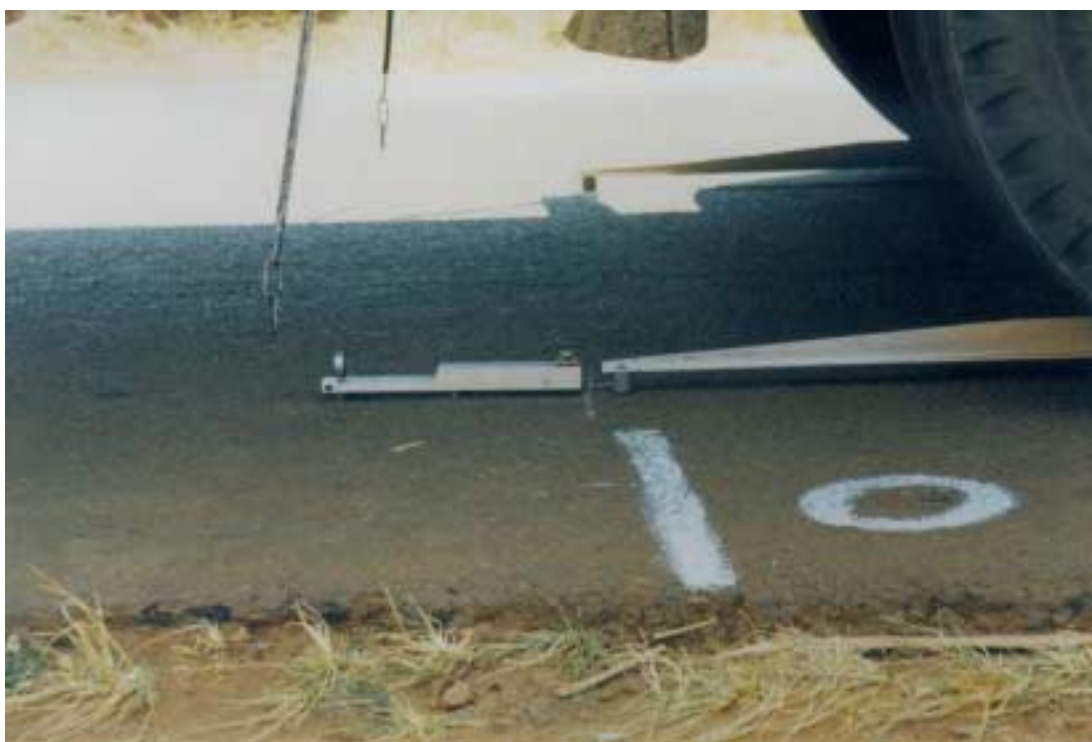
Figure 3-2- The Radius of Curvature Meter

Where possible, at each deflection point in the outer wheel-path, the radius of curvature was measured. This was conducted using a Dehlen curvature meter {Dehlen, 1962} to determine the minimum radius of curvature of the deflection bowl as shown in Figure 3-3. The tests were used to give information about the quality of the base as well as approximate values of the resilient, or elastic, modulus of the base and the subgrade. The radius of curvature meter can be seen in operation in Figure 3-2.

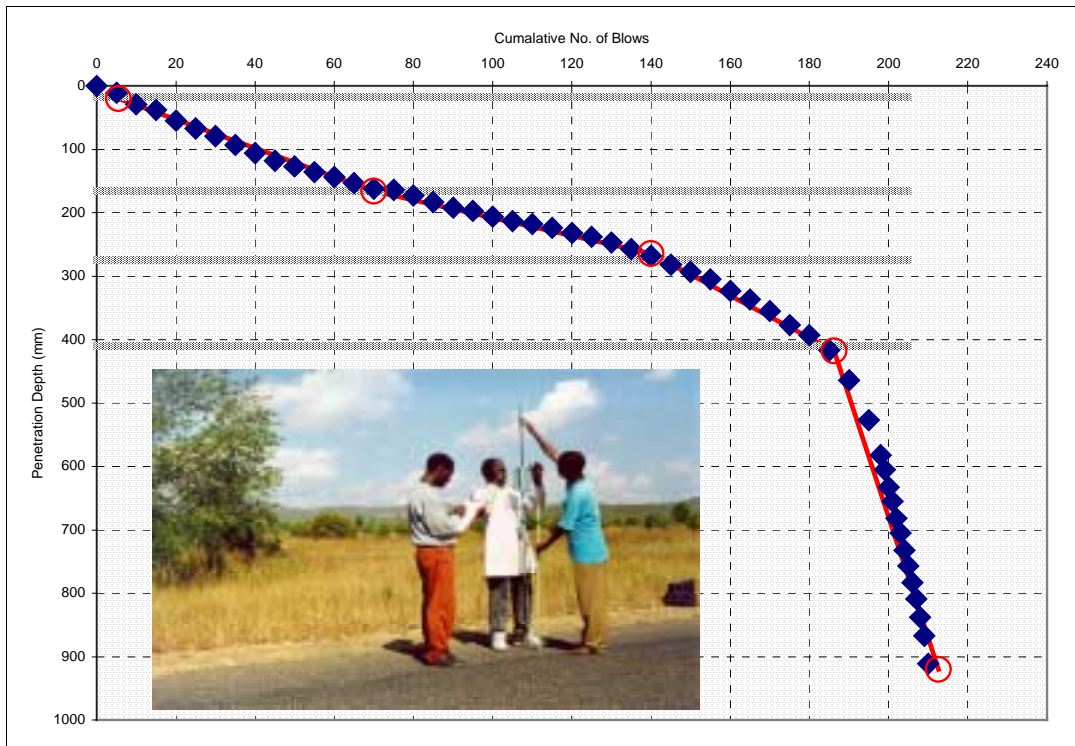
Road Name: **Mzuzu to Nkhata Bay**  
 Road Code: **4** Operator: **FOSTINO**  
 Section No.: **1** Chainage: **0.500 km** Date: **24/7/98**  
 Depth below Surface at test start: **0 mm** Side: **LHS**  
 Layer Description at test start: **Surface Dressing - Cracked, Old and Brittle**  
 Description of Area: **Small Cutting**

Strength CBR Relationship  $\log_{10} (CBR) = 2.48 - 1.057 \log_{10} (mm/blow)$

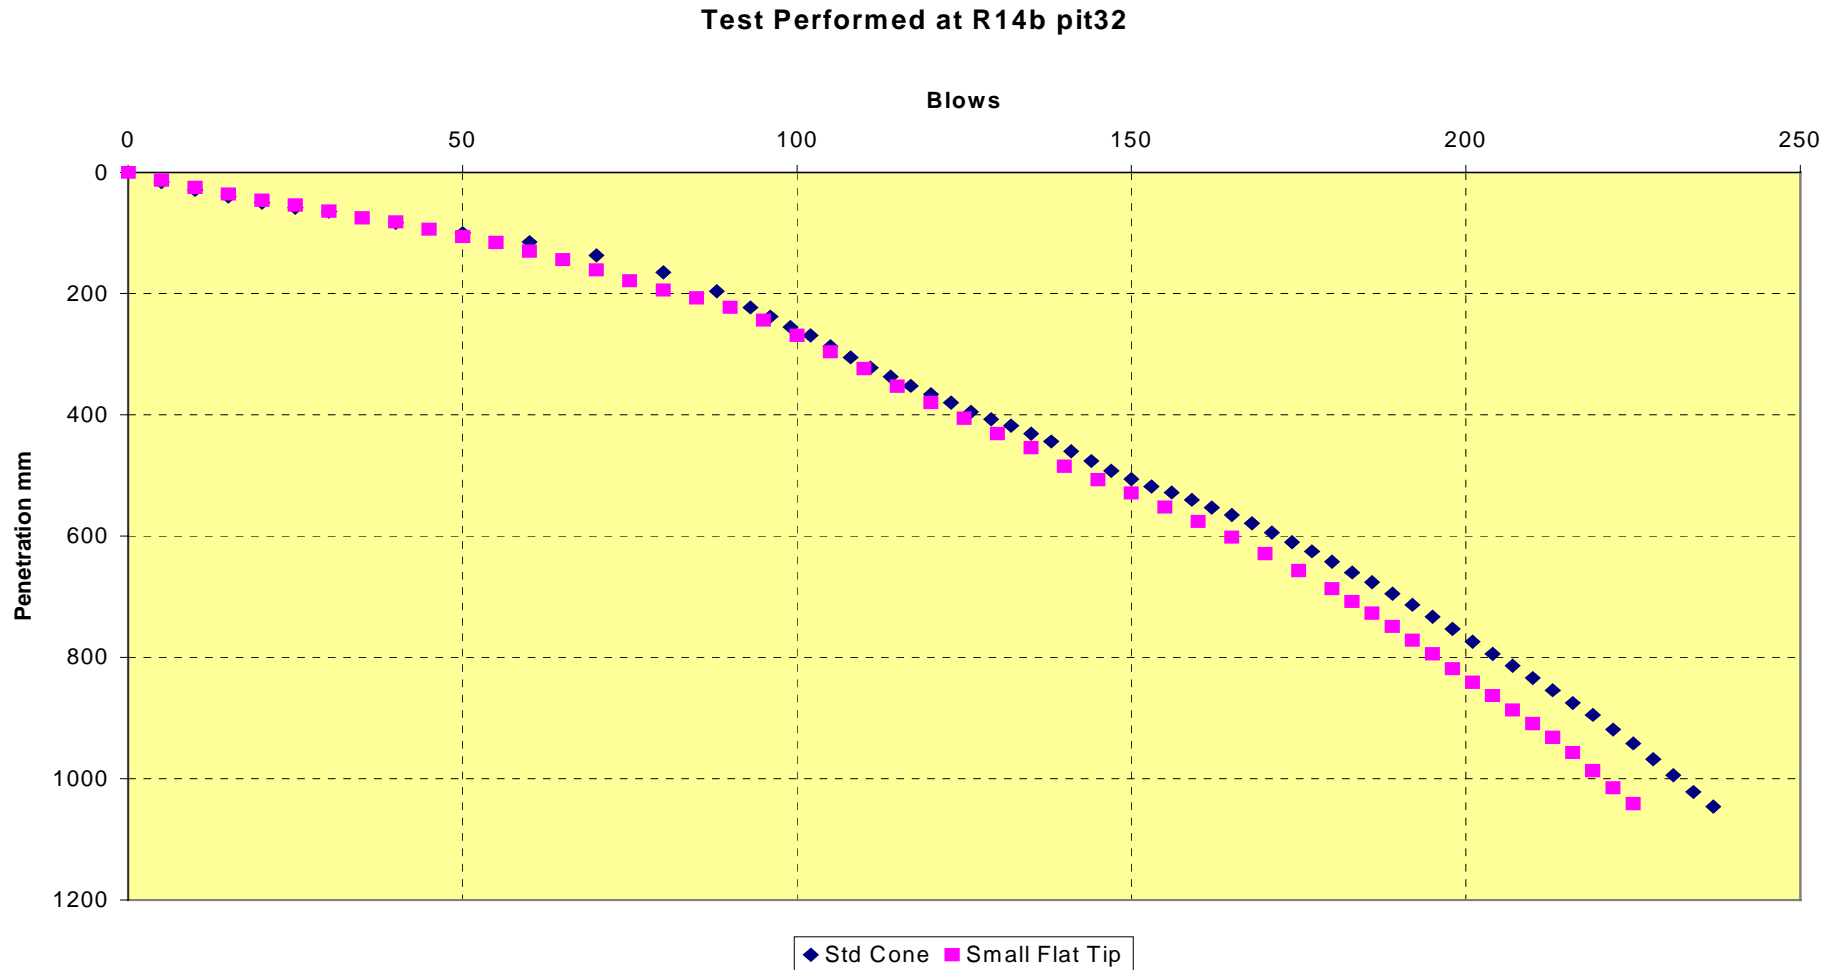
Figure 5-1 - Comparison of a Standard DCP Cone with a Small Flat Tip

The results from the DCP testing, including routine and sample lengths are presented in Table 4-2 and Table 4-4 in a summarised form. The full set of DCP results can be seen in Appendix I. For the comparison purpose with the work undertaken at the Bardon trial we can see from Figure 5-1 and Appendix I that in Malawi very little difference was in results were obtained, whether using the standard DCP cone, or the modified version. The Figure 5-1 shows a comparison of a standard DCP test with the small flat tip in almost identical locations. The curves are surprisingly similar in shape, given that such a relationship was not evident in the trials at Bardon, UK.

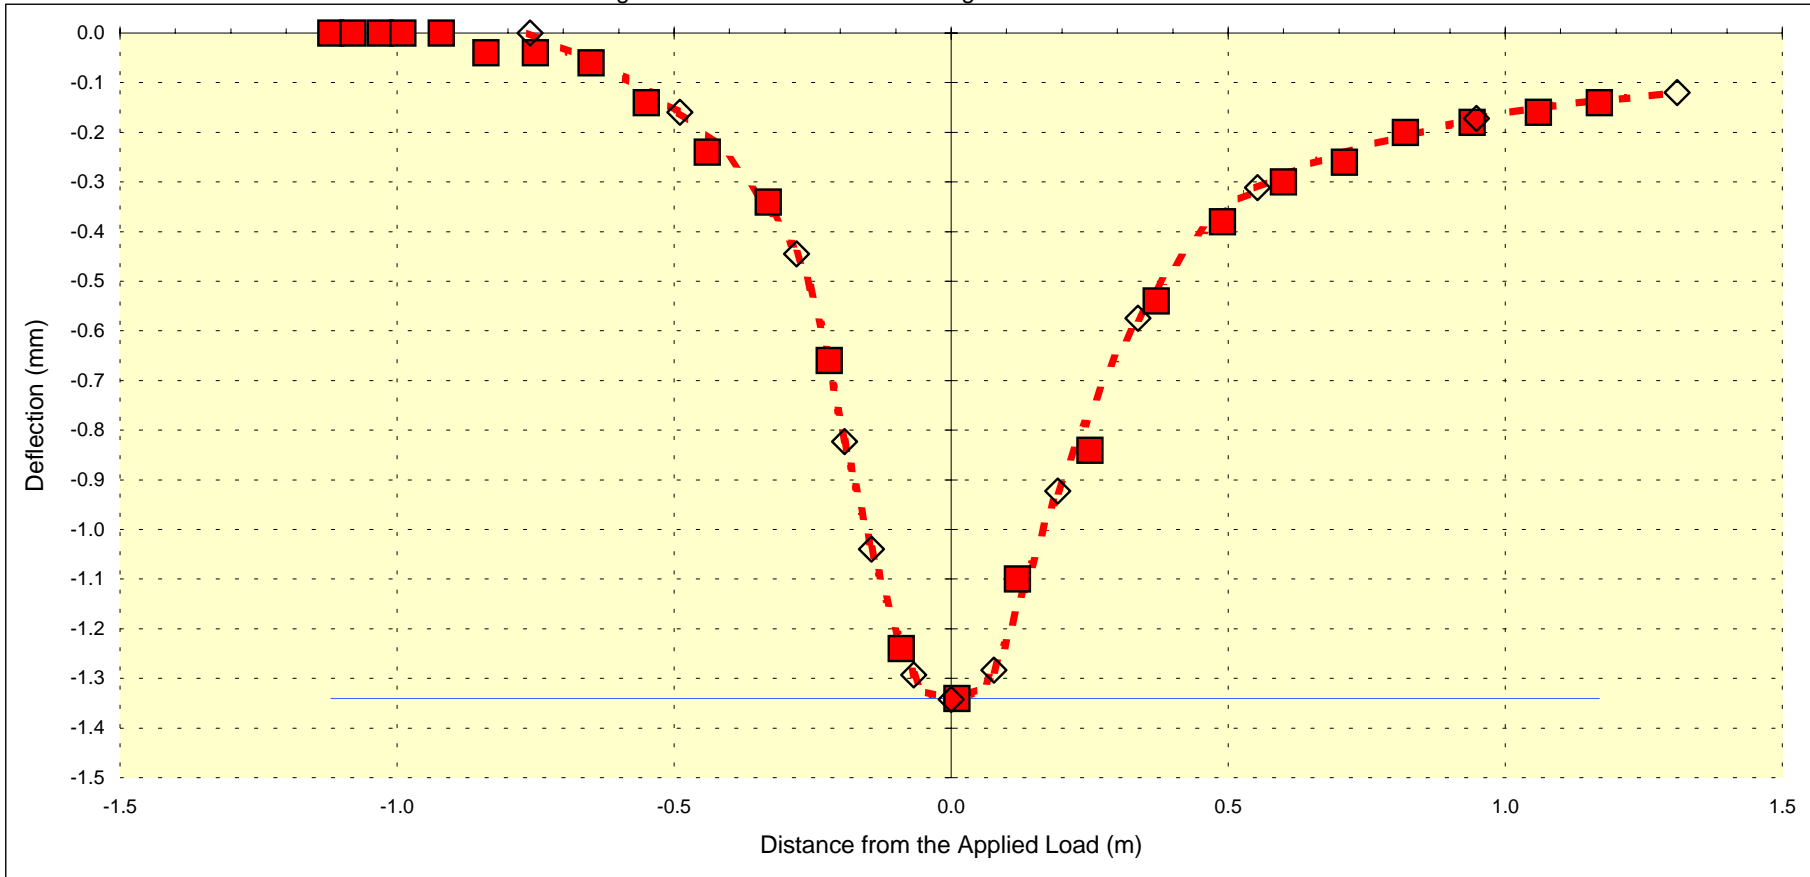
Chainage: 23.1

Resultant	Layer Description	Surface & Base	Subbase	Subgrade	Layer Description	Surface & Base	Subbase	Subgrade
Movement	Layer Thickness (mm)	175	265	1000	Layer Thickness (mm)	175	265	1000
	- Mr (MPa)	30	36	33	- Mr (MPa)	51	41	22
0.80 mm				Infinite				5000

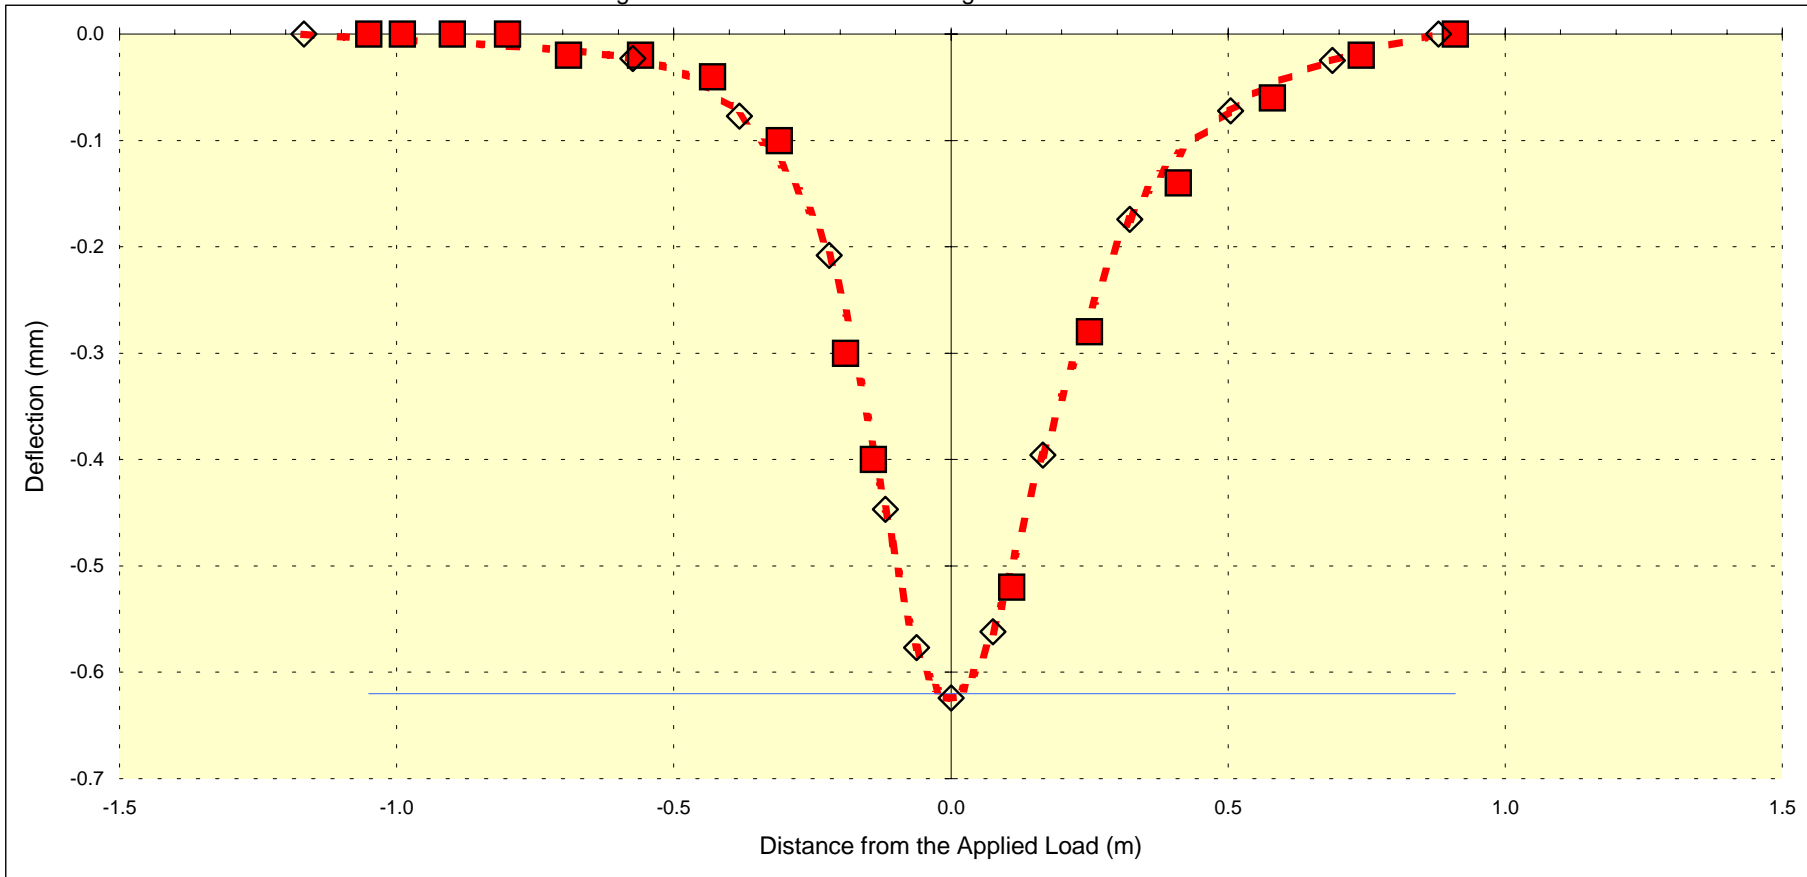
Chainage: 12.1

Resultant	Layer Description	Surface & Base	Subbase	Subgrade	Layer Description	Surface & Base	Subbase	Subgrade		
Movement	Layer Thickness (mm)	190	160	1000	Infinite	Layer Thickness (mm)	190	160	1000	Infinite
	- Mr (MPa)	75	36	283	768	- Mr (MPa)	87	52	97	5000

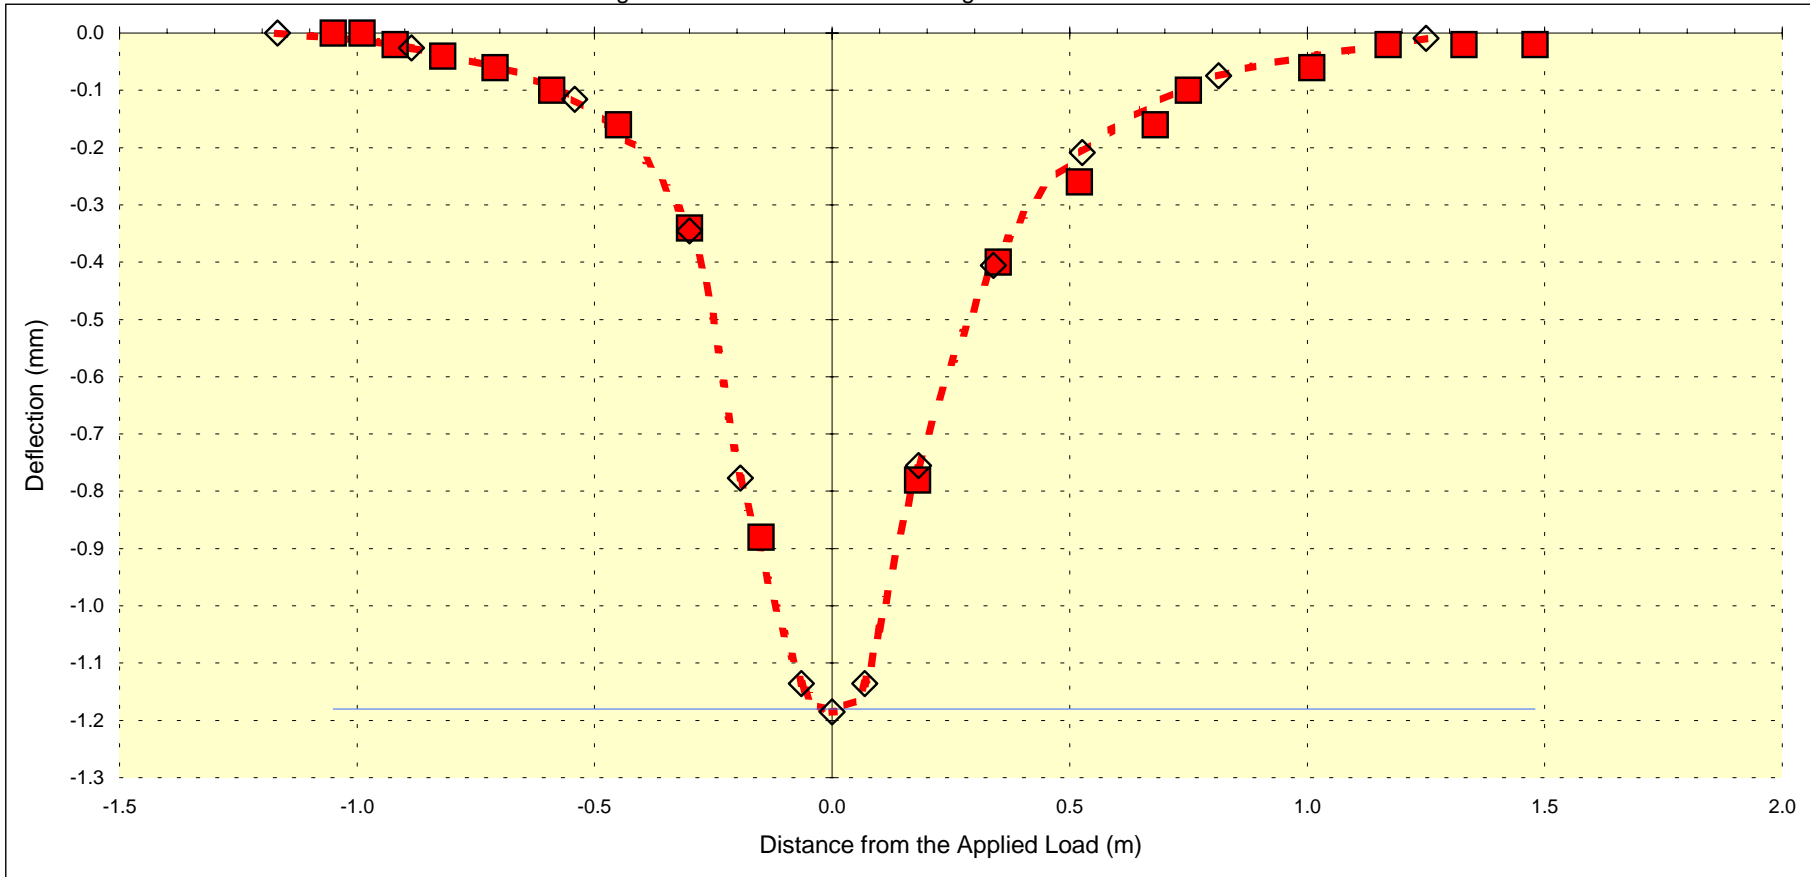
Chainage: 59.3

Resultant	Layer Description	Surface & Base	Subbase	Subgrade	Layer Description	Surface & Base	Subbase	Subgrade	
Movement	Layer Thickness (mm)	210	100	1000	Layer Thickness (mm)	210	100	1000	Infinite
	- Mr (MPa)	38	23	54	- Mr (MPa)	48	43	35	5000

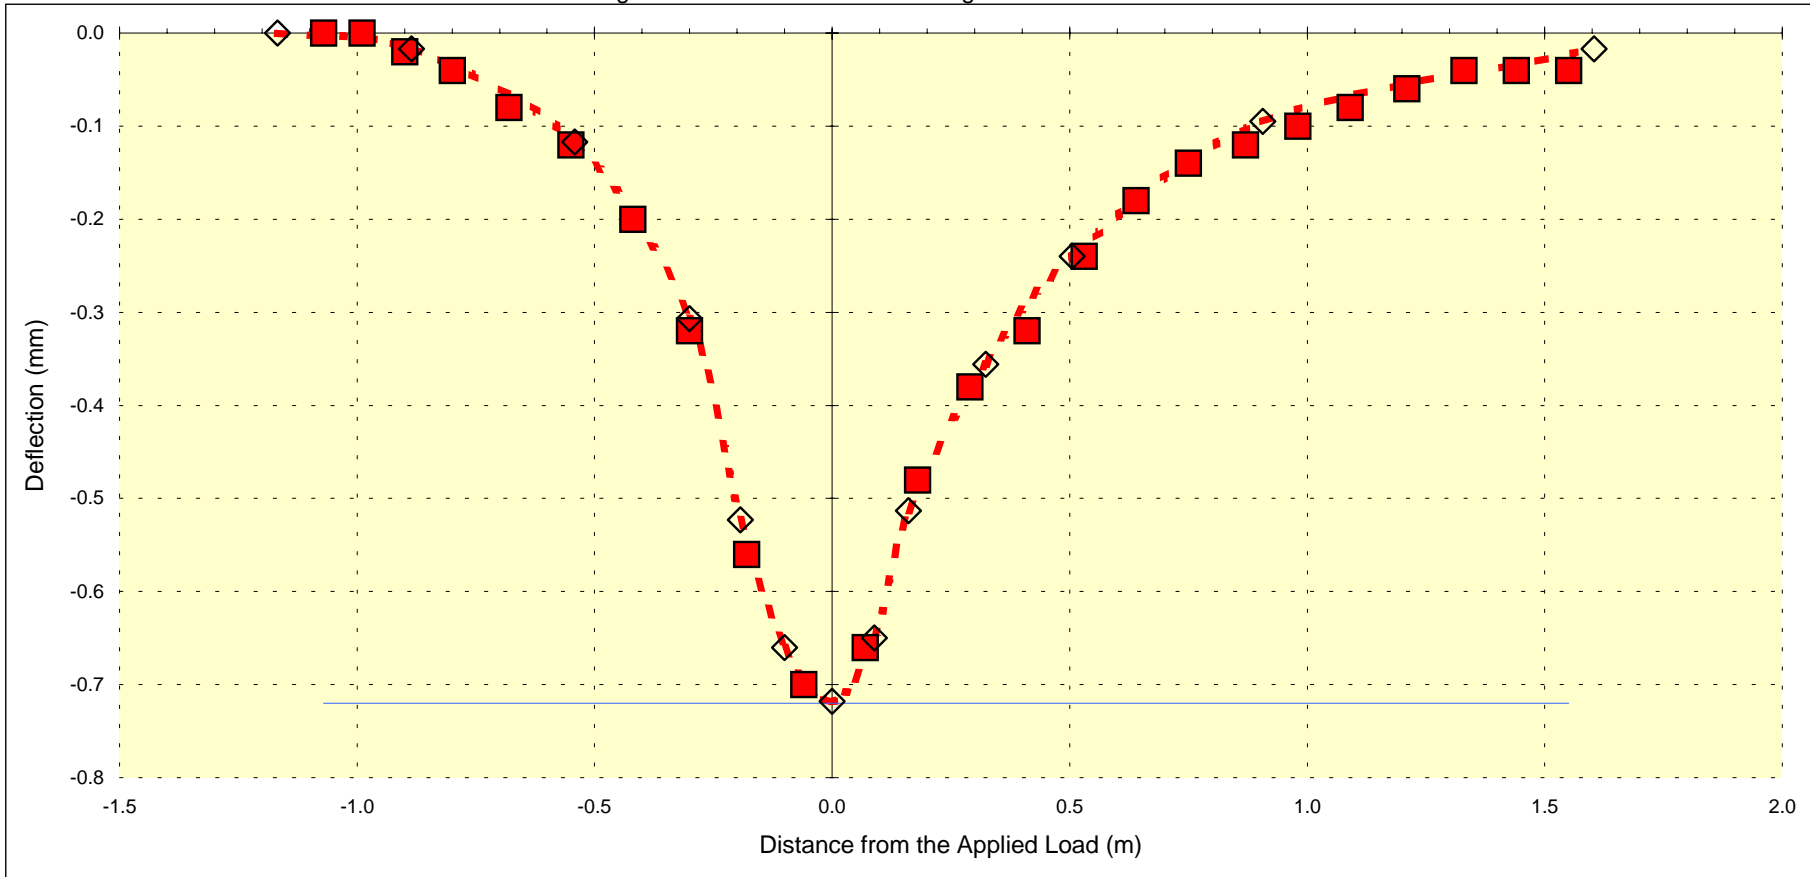
Chainage: 61.5

Resultant	Layer Description	Surface & Base	Subbase	Subgrade	Layer Description	Surface & Base	Subbase	Subgrade
Movement 0.02 mm	Layer Thickness (mm)	230	100	1000	Layer Thickness (mm)	230	100	1000
	- Mr (MPa)	118	29	67	- Mr (MPa)	79	605	35

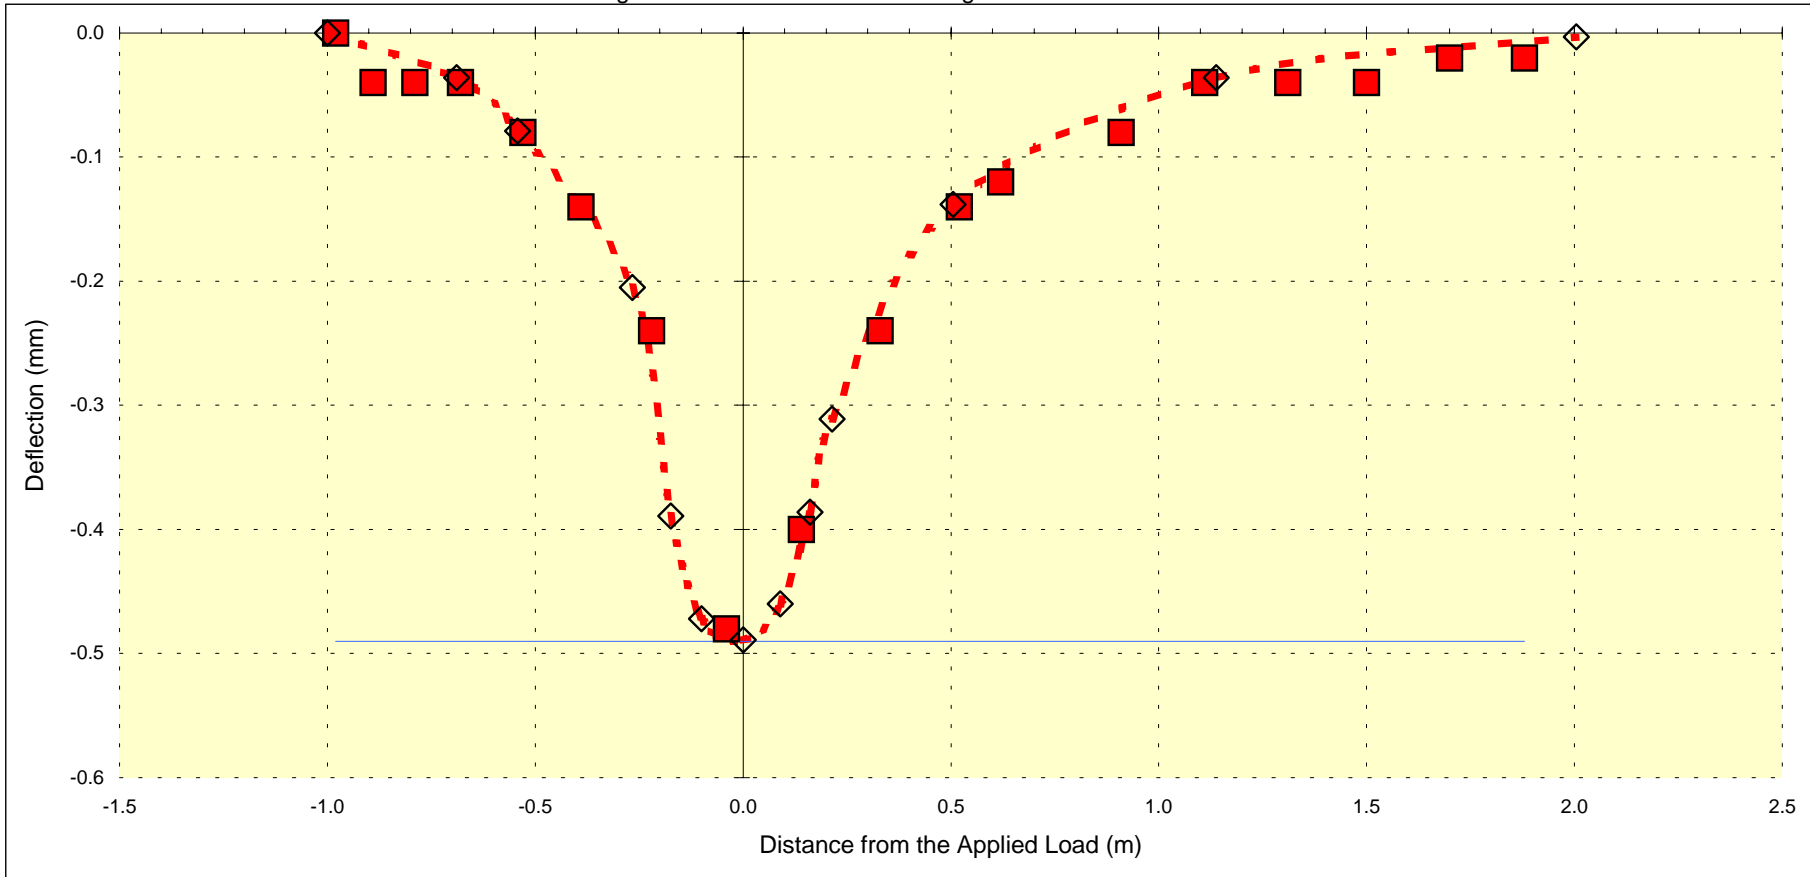
Points: 28 -29

**Existing Pavement Structure**

Resultant	Layer Description	Surface & Base	Subbase	Subgrade		Layer Description	Surface & Base	Subbase	Subgrade	
Movement	Layer Thickness (mm)	100	120	1000	Infinite	Layer Thickness (mm)	100	120	1000	Infinite
	- Mr (MPa)	148	299	91	1993	- Mr (MPa)	425	372	90	227

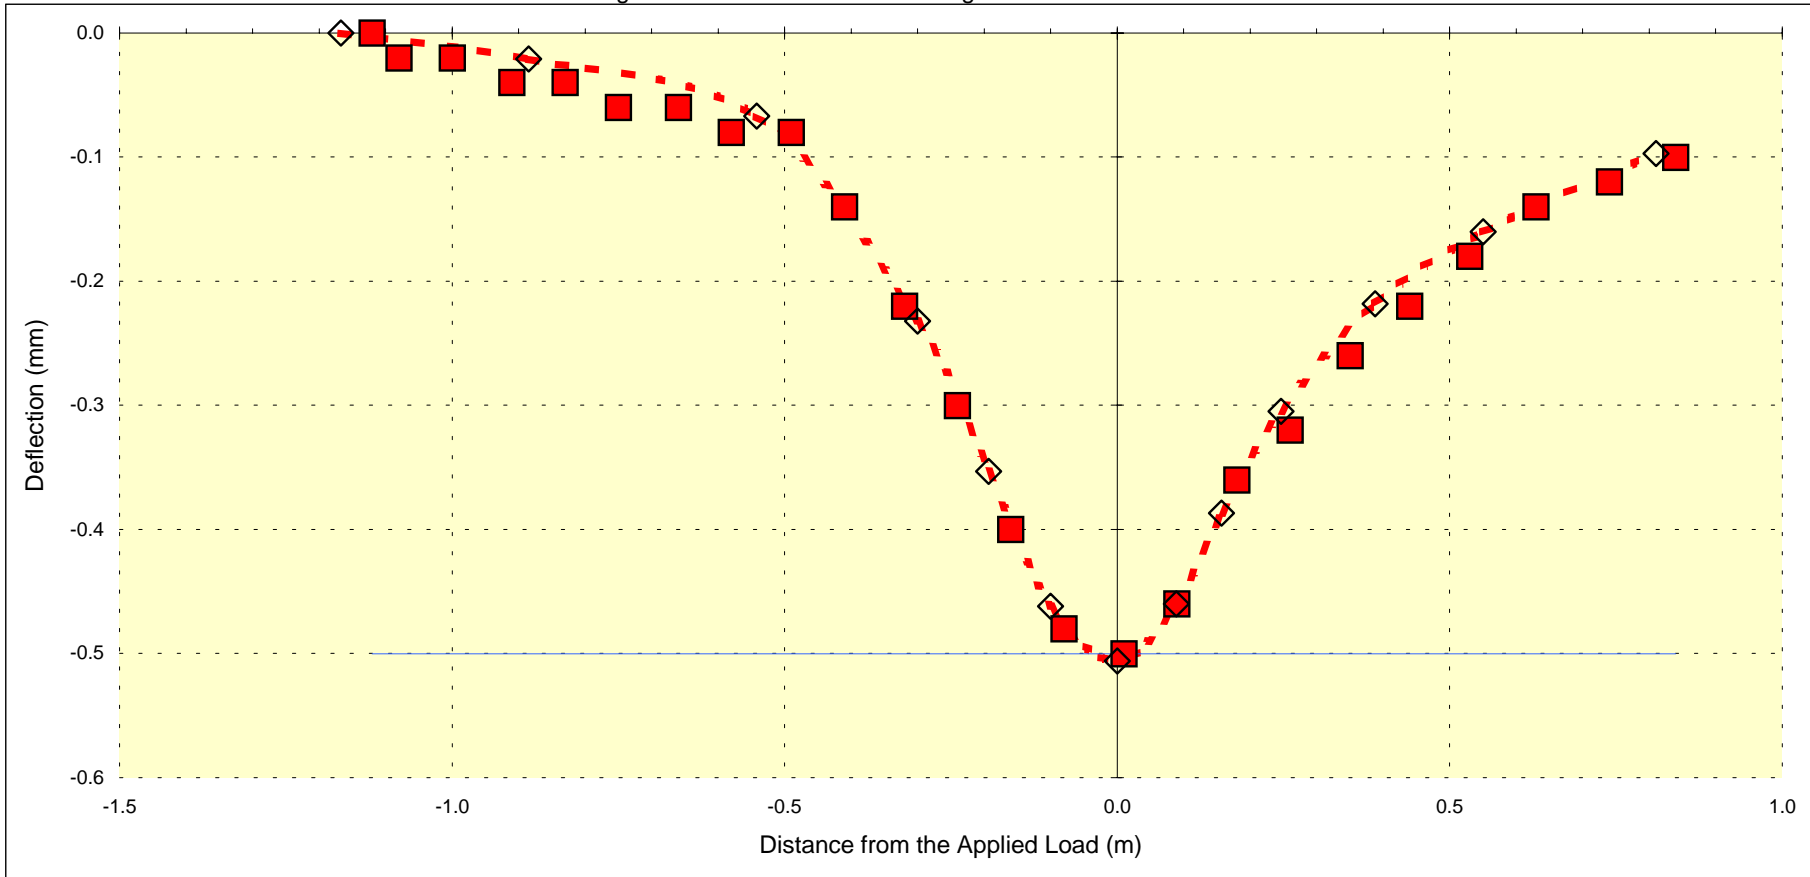
Points: 24 -25

**Existing Pavement Structure**

Resultant	Layer Description	Surface & Base	Subbase	Subgrade		Layer Description	Surface & Base	Subbase	Subgrade	
Movement	Layer Thickness (mm)	270	130	1000	Infinite	Layer Thickness (mm)	270	130	1000	Infinite
	- Mr (MPa)	158	20	264	614	- Mr (MPa)	139	204	61	185

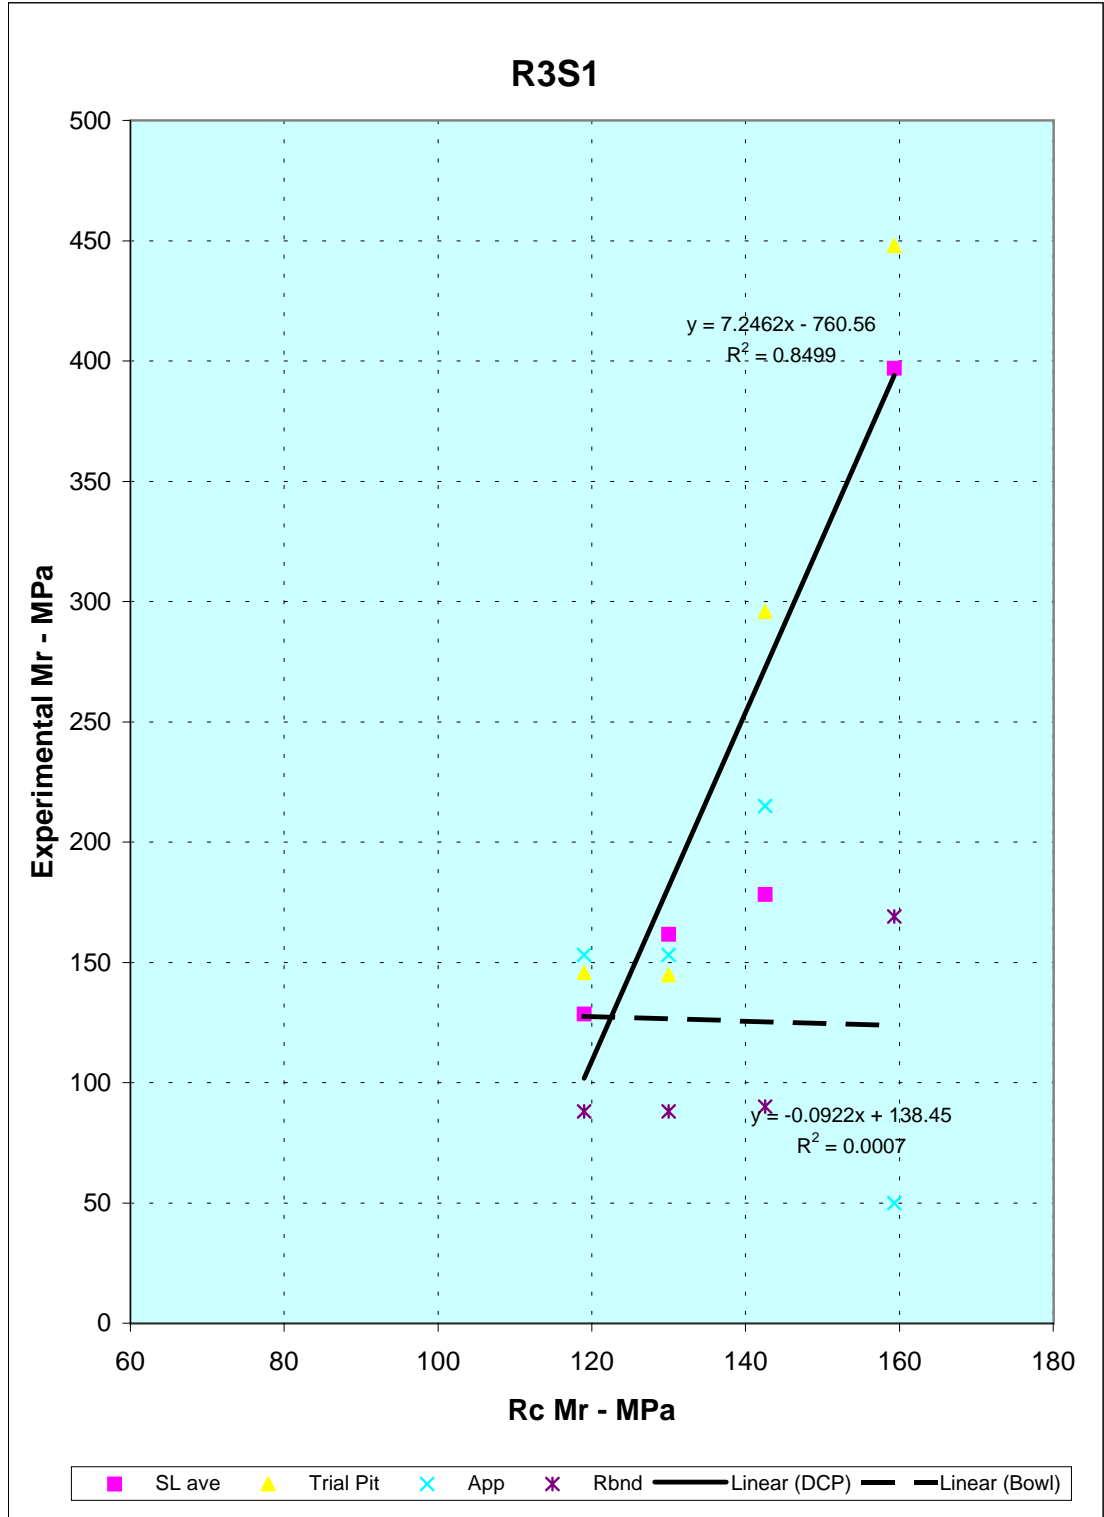
Road No: <b>R3S1</b> Jenda - Chikangawa										Soaked CBR %			
	Resilient Modulus (Mpa)					Soil Properties					Dry In Situ Density		%Comp	
	Rc	DCP		Deflection Bowl		Description	% 75um	LL	PI	2067	%Comp			
		SL ave	Trial Pit	App	Rbnd						98	95		
Base	159	397	448	50	169	Crushed Stone	6	N	NP	2067	90	58		
Subbase	143	178	296	215	90	Clayey Quartz/Lat Gravel	23	24	9	-	-	-		
SSG	130	162	145	153	88	Clayey Sand	31	50	28	-	-	-		
SG	119	128	146	153	88

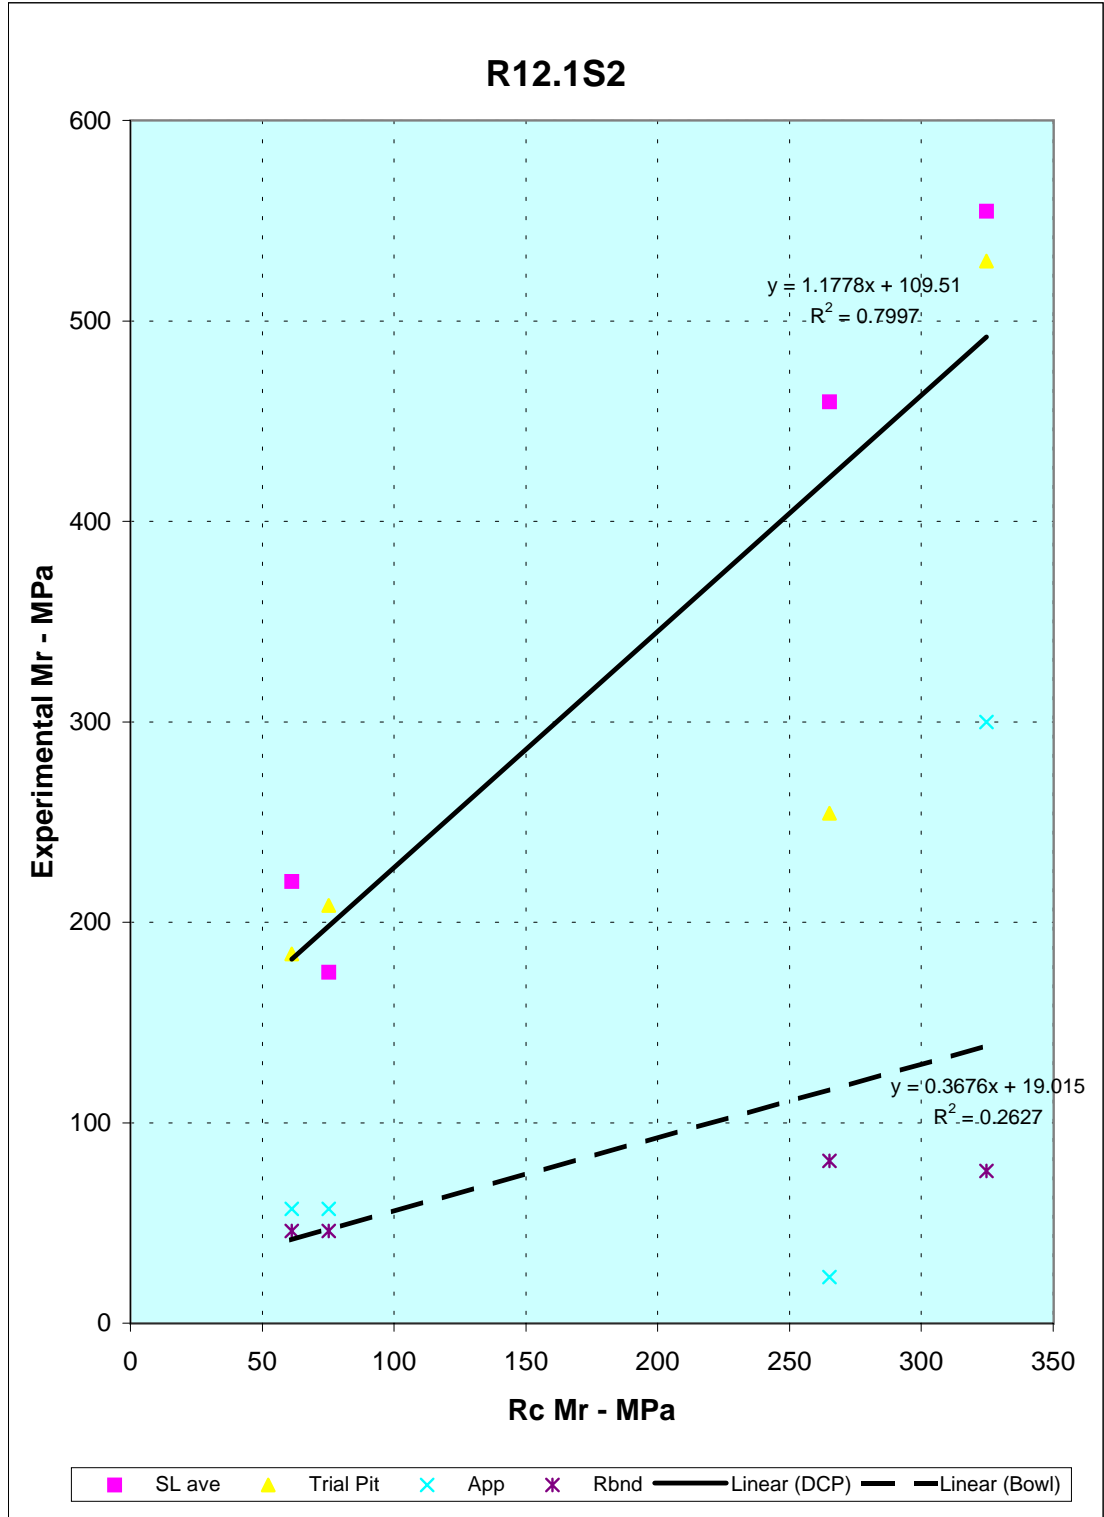
Road No: <b>R12.1S2</b>		Benga - Nkhotakota							Soaked CBR %	
	Resilient Modulus (Mpa)					Soil Properties				Dry In Situ Density	
	Rc	DCP		Deflection Bowl		Description	% 75um	LL	PI	%Comp	
		SL ave	Trial Pit	App	Rbnd					98	95
Base	325	555	530	300	76	Stab Crushed Stone	5	N	NP	-	-
Subbase	265	460	254	23	81	Clayey Lat Gravel	18	44	28	-	-
SSG	75	175	208	57	46	Clayey Lat Gravel	10	41	22	-	-
SG	61	220	184	57	46

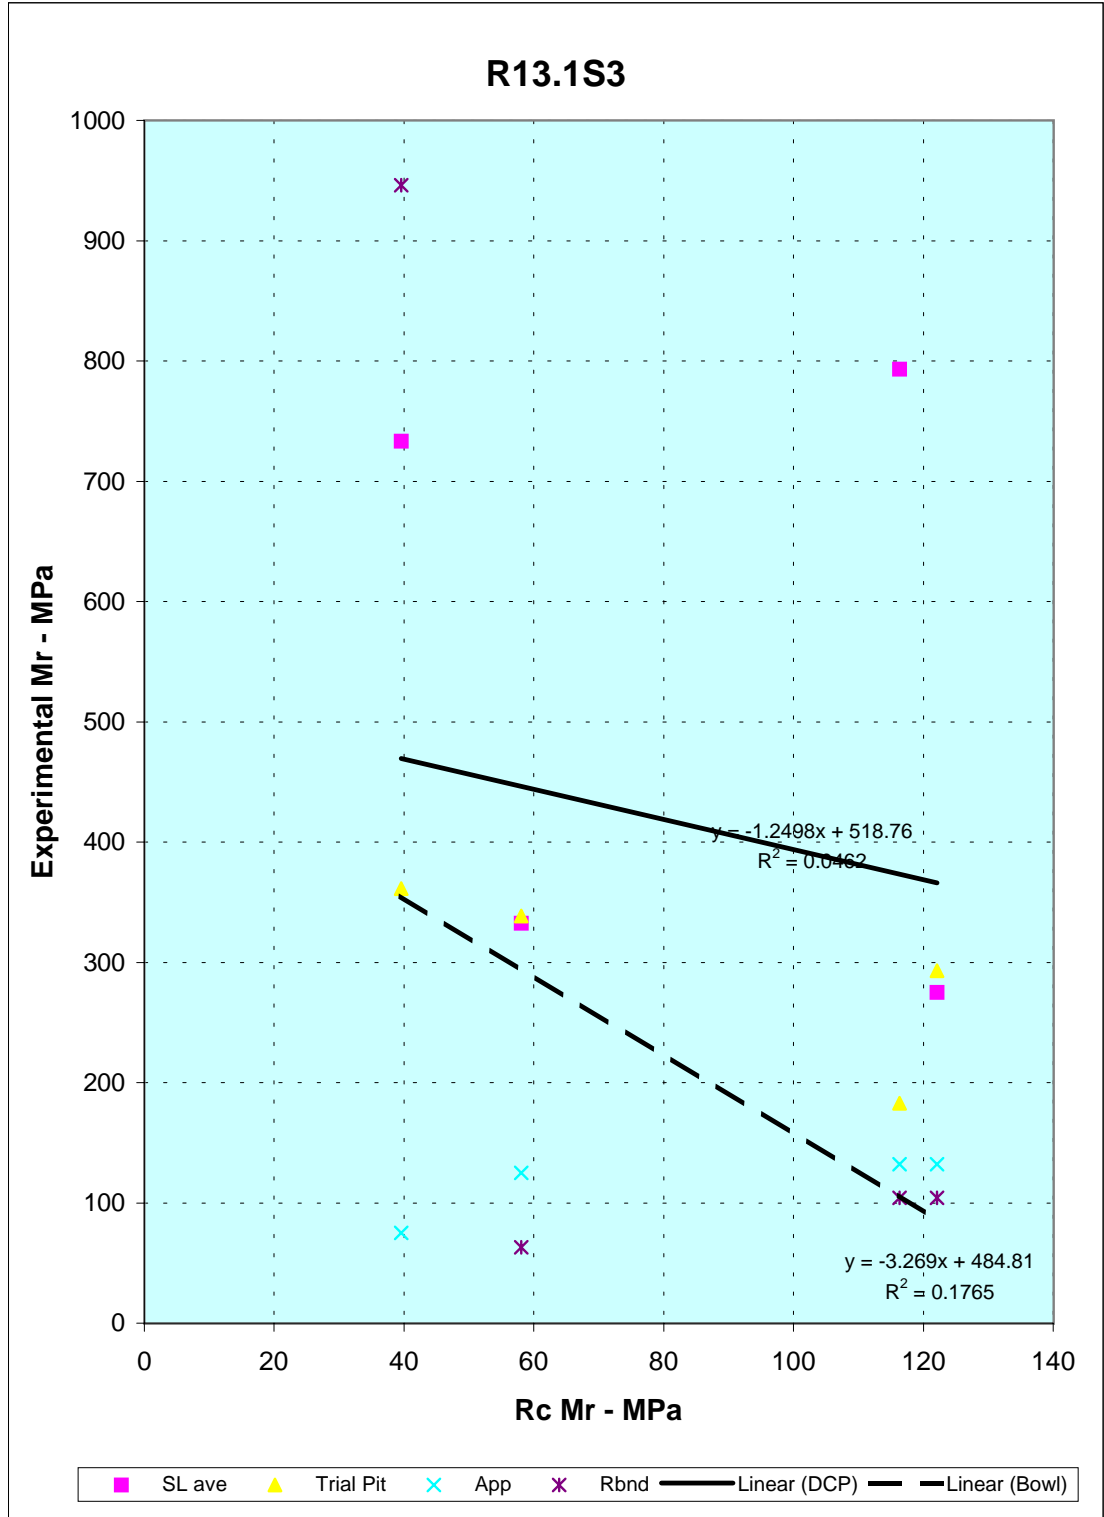
Road No: <b>R13.1S3</b>		Chingeni - Liwonde						Soaked CBR %			
	Resilient Modulus (Mpa)				Soil Properties				Dry In Situ Density			
	Rc	DCP		Deflection Bowl		Description	% 75um	LL	PI	%Comp		
		SL ave	Trial Pit	App	Rbnd					98	95	
Base	58	332	339	125	63	Stab Gneiss Gravel	15	N	NP	-	42	37
Subbase	40	733	361	75	946	Sandy Gravel	14	29	22	-	-	-
SSG	122	275	293	132	104	Clayey Sand	32	36	21	-	-	-
SG	116	793	183	132	104
