Annual Safety Review 2016

Benefits of Using Drones at Aircraft Accident Sites

Flight Simulators and
Air Accident Investigation

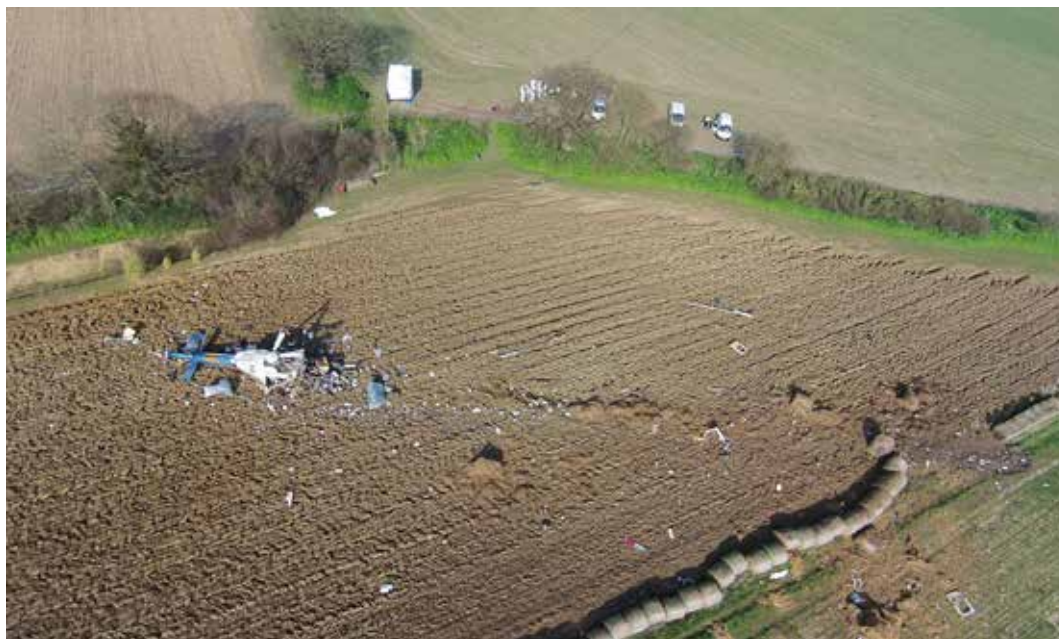
Figure 1

First use of the AAIB's Phantom 2 Vision drone at an accident site on 14 March 2014

The AAIB bought their first drone, a DJI Phantom 2 Vision in February 2014 and first used it at an accident site on 14 March 2014 (Figure 1). The drone's 14-megapixel camera provided excellent stills, although the video quality was shaky due to a lack of a gyro-stabilized mount. After using it at five different accident sites an upgraded model, the Phantom 2 Vision Plus, with a gyro-stabilized mount was purchased in July 2014 (Figure 2, left), and has been used at 11 accident sites. As well as taking stable video, the additional benefit of the newer model was that the camera could be tilted 90 degrees downwards to take a series of overlapping images to map the whole accident site.

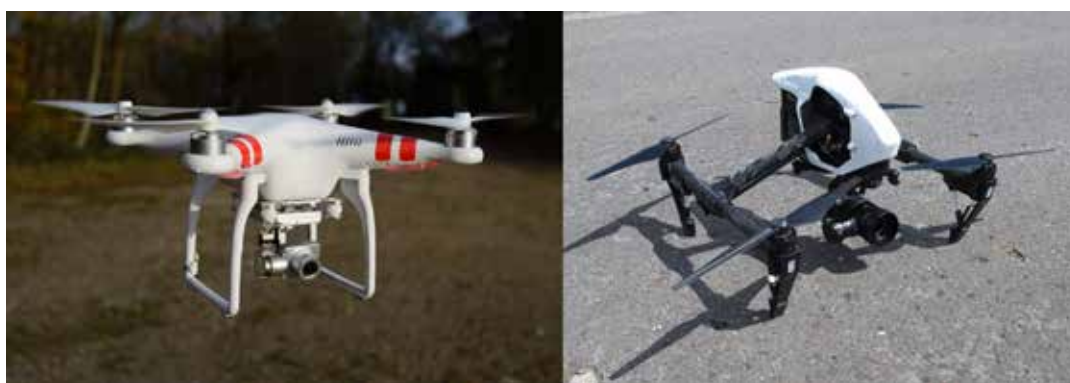
Figure 2

DJI Phantom 2 Vision Plus (left) and DJI Inspire Pro (right)

The photogrammetry software the AAIB purchased was called Pix4Dmapper Pro. This provided some good photogrammetry results using the drone. In September 2015 the AAIB upgraded to the DJI Inspire Pro drone (Figure 2, right), which can operate in winds up to 20 kt and has a higher quality camera that can stream high-definition (HD) video to two tablet devices. This model is also available with dual controls for the pilot and camera operator.

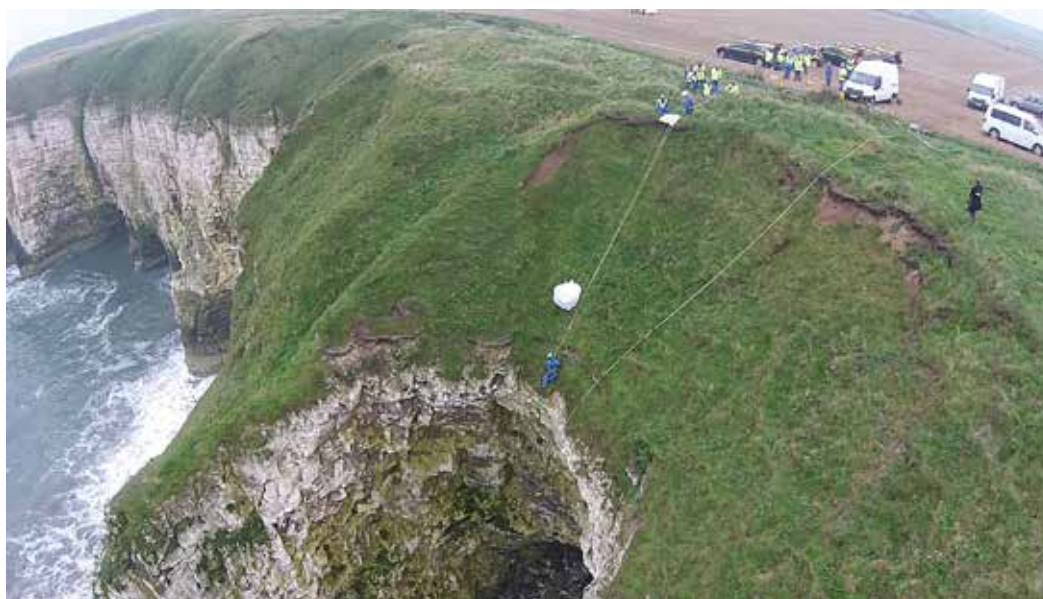
Figure 3

The AAIB's Phantom 2 Vision Plus being used to supervise the recovery of wreckage from a Jet Ranger helicopter that crashed in the sea below the cliffs

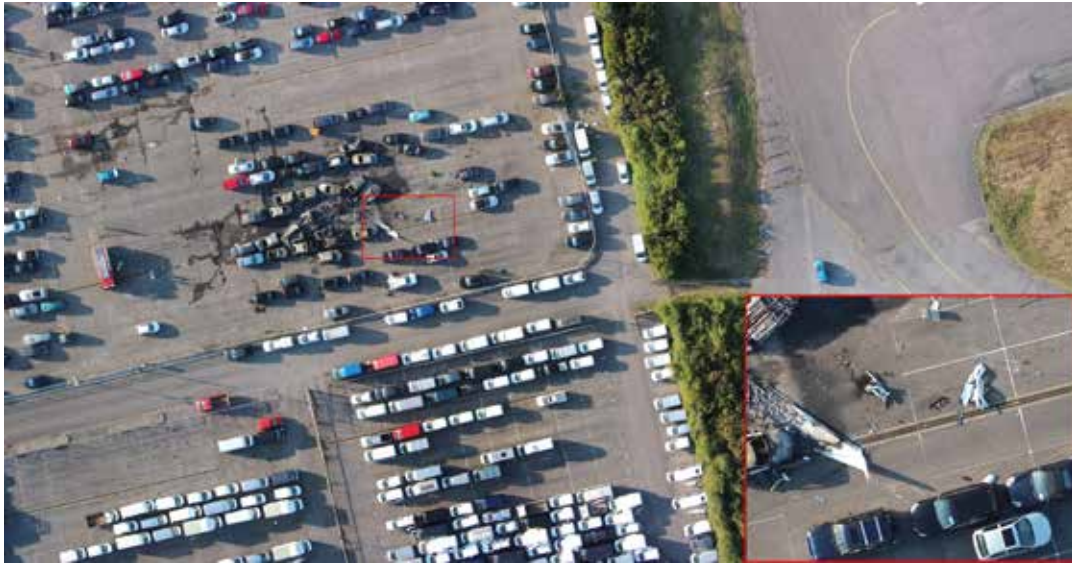
Pix4D orthomosaic generated from 59 overlapping images taken with a Phantom 2 Vision Plus from a height of 50 metres (a digitally zoomed-in section of this orthomosaic is shown in the lower right corner)

With photogrammetry software like Pix4Dmapper Pro orthomosaic images and 3D models of accident sites can be produced using drone imagery. An orthomosaic is an image that is composed of multiple overhead images and is corrected for both perspective and scale, which means that it has the same lack of distortion as a map (Figure 4). The images are obtained by pre-programming the drone to fly in a grid pattern and to automatically take a series of overlapping shots with the camera pointing 90° down. The total flight time to capture the 59 images used to create Figure 4 was 9 minutes using our Phantom 2 Vision Plus. The processing time using a typical PC took about 2 hours but it can take longer for larger projects.

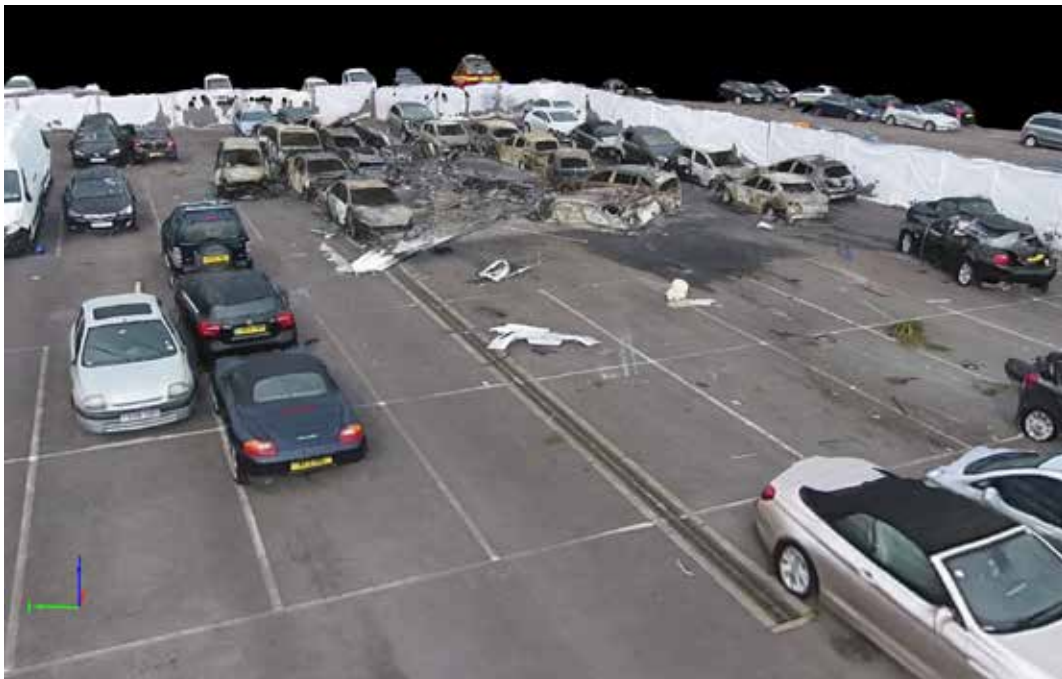
Figure 5

3D mesh created from oblique video from Phantom 2 Vision Plus while flying two circles at two different heights around the main wreckage

The photogrammetry software also generates a 3D point cloud and a 3D mesh from the images. An example 3D mesh is shown in Figure 5. The quality of the 3D model is improved by taking oblique images, and in this case we took images while flying the drone around the aircraft wreckage at two different heights with the camera pointing at the centre of the wreckage.

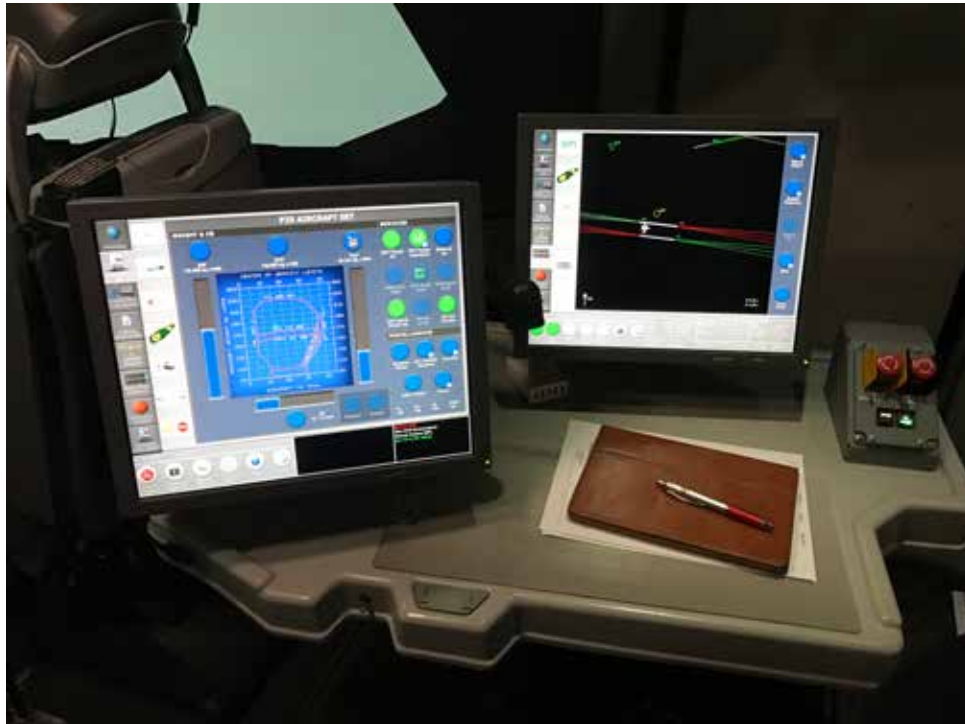
Figure 2

Instructor Operating Station

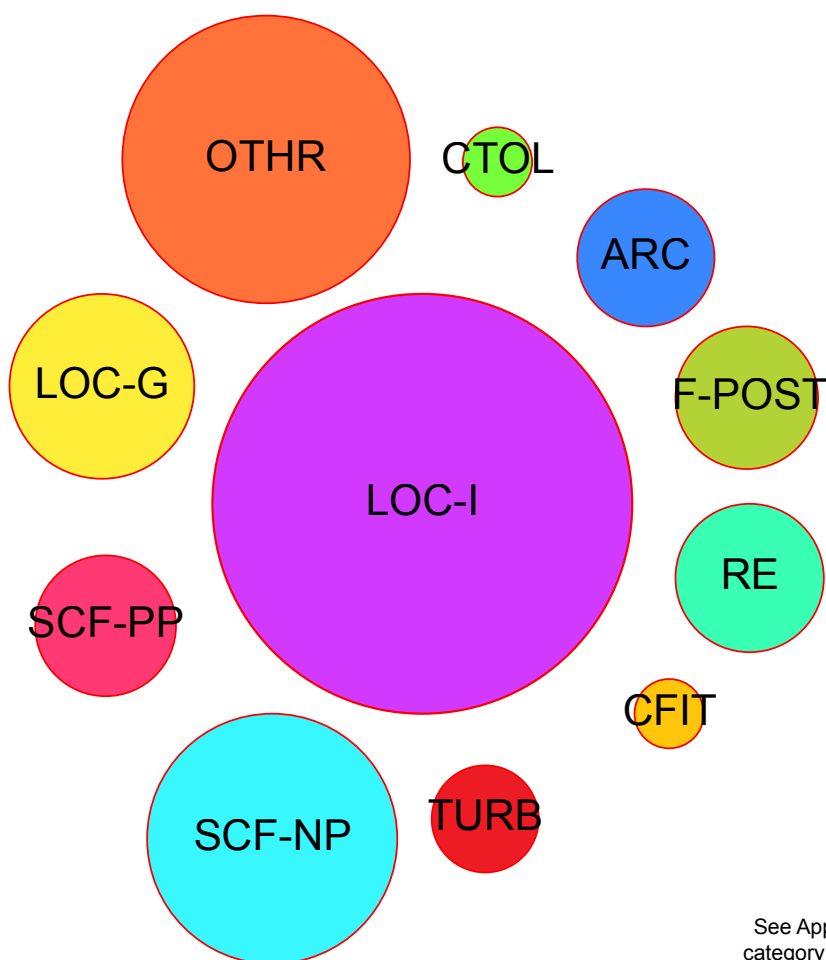
Factors for field investigations reported on by AAIB in 2016

In 2016 the AAIB reported on 36 field investigations, 17 of which involved fatal accidents in the UK and 19 were non-fatal accidents or serious incidents. The analysis of the CICTT factors for each of these reveals that the major factor in fatal accidents reported on in 2016 was LOC-I. Of note, two fatal accidents were attributed to medical incapacitation (MED) and one was caused by a catastrophic structural failure recorded under SCF-NP.

The 19 non-fatal field investigations reported in 2016 concerned mostly serious incidents to commercial air transport (CAT) aircraft. The majority of CAT serious incidents were attributed to system/component failure or malfunction (SCF-NP) followed by power plant failure or malfunction (SCF-PP), runway excursion (RE) and abnormal runway contact (ARC). However in general aviation (GA), the statistics show the most prolific cause of accidents and serious incidents was again LOC-I.

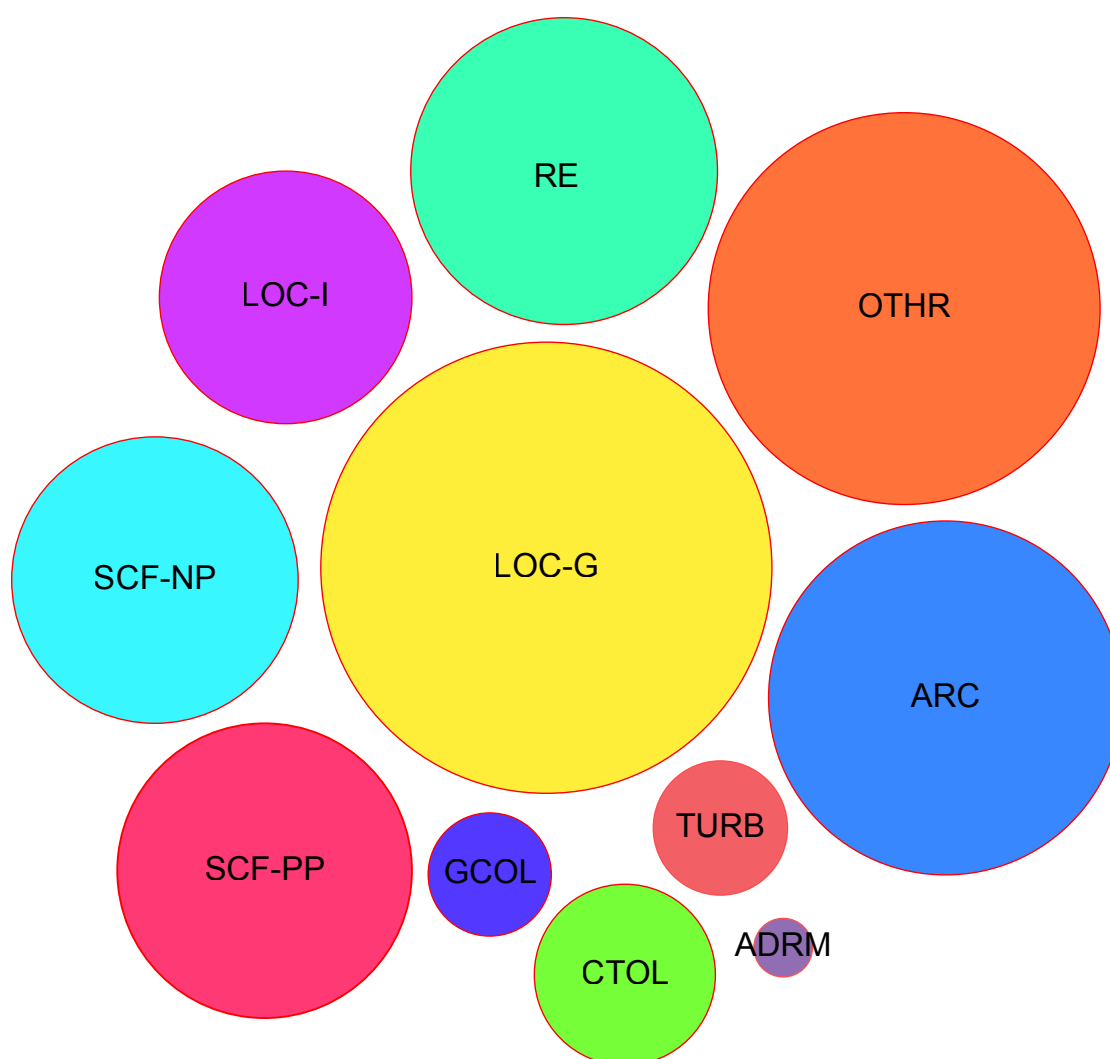
Factors for correspondence investigations reported on by AAIB in 2016

Correspondence investigations are usually conducted on non-fatal accidents on GA aircraft and to some serious incidents on CAT aircraft. The factors in that the majority of these reports were classified as loss of control on the ground (LOC-G), abnormal runway contact (ARC) and powerplant failure (SCF-PP).
