## **SITE EVENT REPORT COMMITTEE (SERC) - ANNUAL REPORT FOR 2010**

1. The purpose of this report is to update the Site Safety Committee on nuclear and radiological event reporting and to provide a summary of trends and emergent issues at HM Naval Base Devonport during 2010.

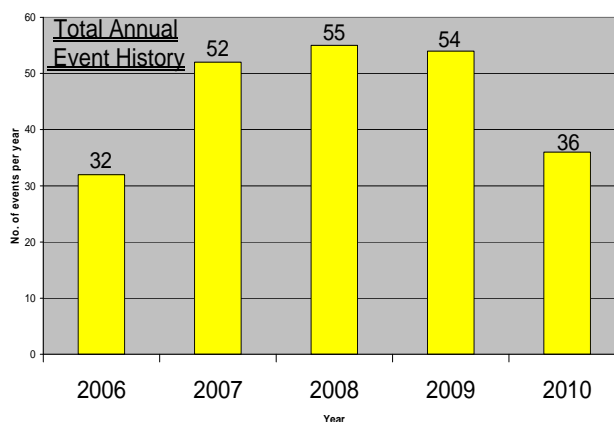
Table 1. No of events over past 5 Years.

6. **History.** A total of 36 events were reported during 2010. The 5 year history is:

It can be seen from the above event history that the number of events reported in 2010 was less than the previous 3 years. Similar fluctuations in the number of events have been noted in the past (50 events in 2004 followed by 35 in 2005 and 32 in 2006). Two of the factors that may have contributed to this reduction are considered below. Firstly in 2009, there were 8 events related to Diesel Generator (DG) derived shore supplies when submarines required a primary and alternative shore supplies energised from independent sources over an extended period. In 2010, such supply arrangements were not required on the MOD Site and there were no shore supply failure events reported. Secondly and subjectively in discussion with the TXB PAG Chairman, it is assessed that apart from routine maintenance work, there was a lower level of nuclear activity at the TXB Berths in 2010 in comparison to 2009. In 2009 HMS [REDACTED] undertook the later stages of a major repair and revalidation period followed by a substantial testing package and HMS [REDACTED] undertook the final stages of her LOP(R) at the TXB. With less non-routine nuclear activity it would be reasonable to expect an associated reduction in the number of events.

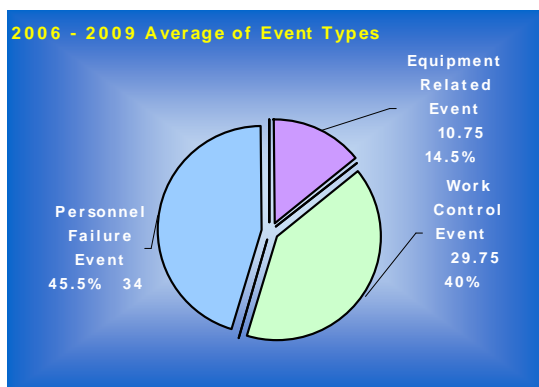
Chart 1.

12. A comparison of cause codes allocated for the year 2010 against the average for the period between 2006 to 2009 is illustrated in the pie charts below:

13. These charts indicate that as a percentage of the total number of IC codes allocated, personnel failure is up marginally on 2009 (up to 57% from 51%) and once again is above the average of 2006 – 2009. There has been a marked decrease in the amount of equipment related events in 2010 compared to 2009. It is assessed that 2009 data was significantly influenced by the number of DG derived shore supply failures of which there were none (affecting the MOD Site) in 2010.

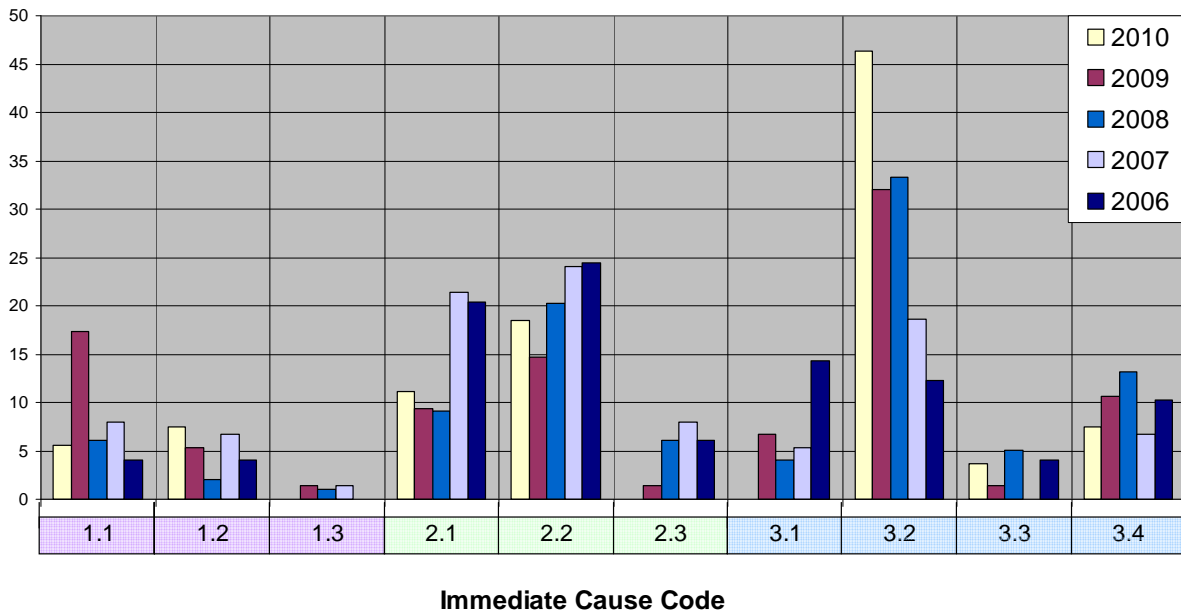
15. **Trends.** Table 2 and Graph 1 give a breakdown of the Immediate Causes of these events. Incorrect action taken despite suitable guidance (3.2) remains the most significant IC. This is followed by written control and planning (2.2 and 2.1).

### Immediate Cause as a percentage over 5 year Period

16. When considered in greater detail, the most frequent Underlying Causes<sup>3</sup> for these particular IC codes are:

- Personal error (3.2.1)
- Written instruction not followed or ineffective (2.2.3)
- Action not completed in full (3.2.3)
- Ineffective written control (2.2.2)
- Failure to comprehend risk present / impact on safety (3.4.2)
- Ineffective plan or preparation (2.1.2)
- Failure to seek/obtain assistance/guidance (3.4.4)

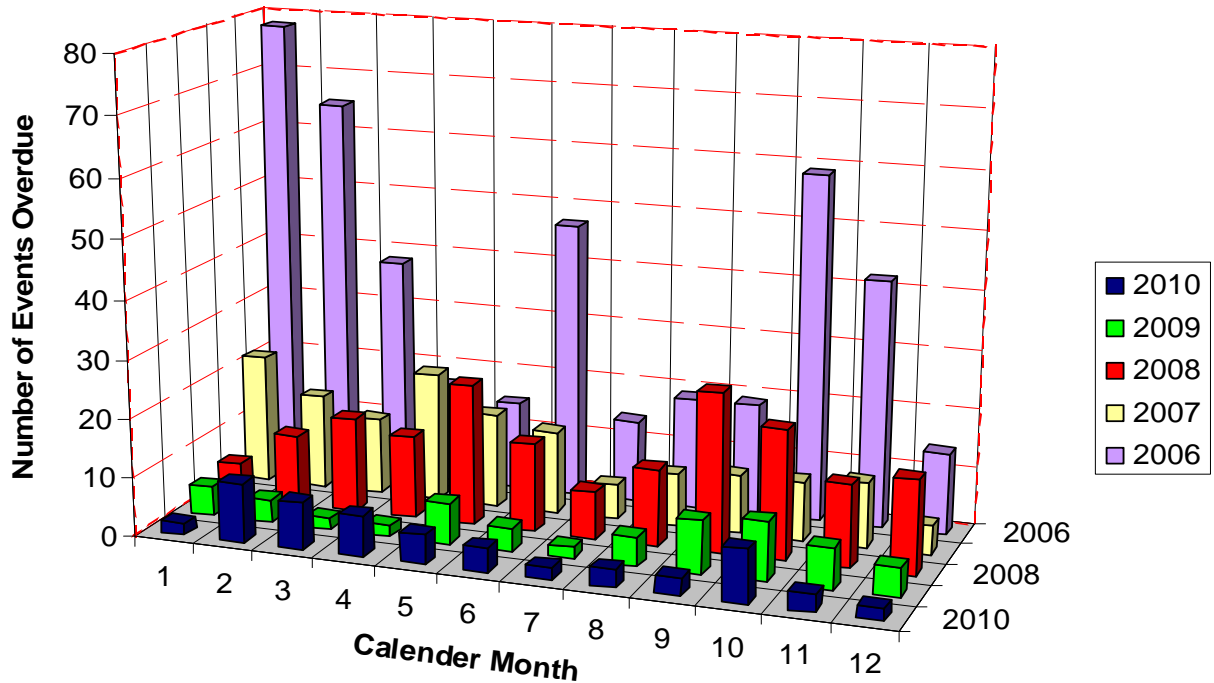
### 2006 to 2010 Overdue Events

Graph 2. No of events report submissions overdue each month<sup>4</sup>.

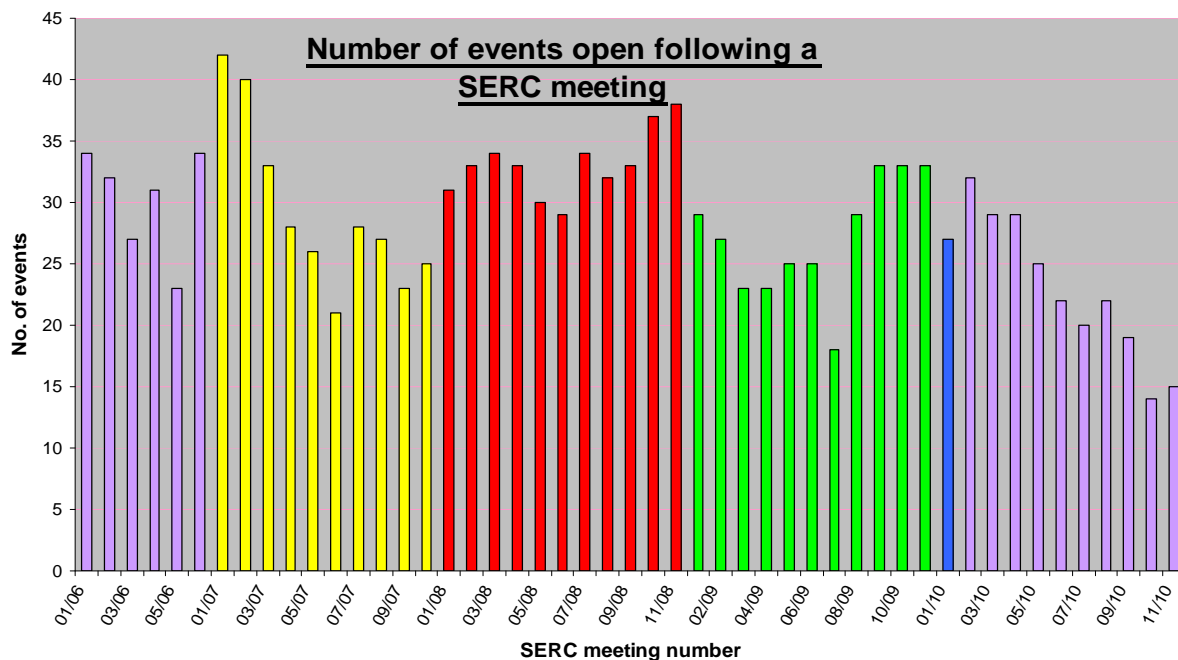
Graph 3. No of NSERs remaining open following a SERC meeting<sup>5</sup>.

19. Graph 3 illustrates the number of events open following each SERC meeting. The reduction in the number of events open following a SERC meeting during 2010 broadly coincides with the reduction of the total number of events raised during 2010.

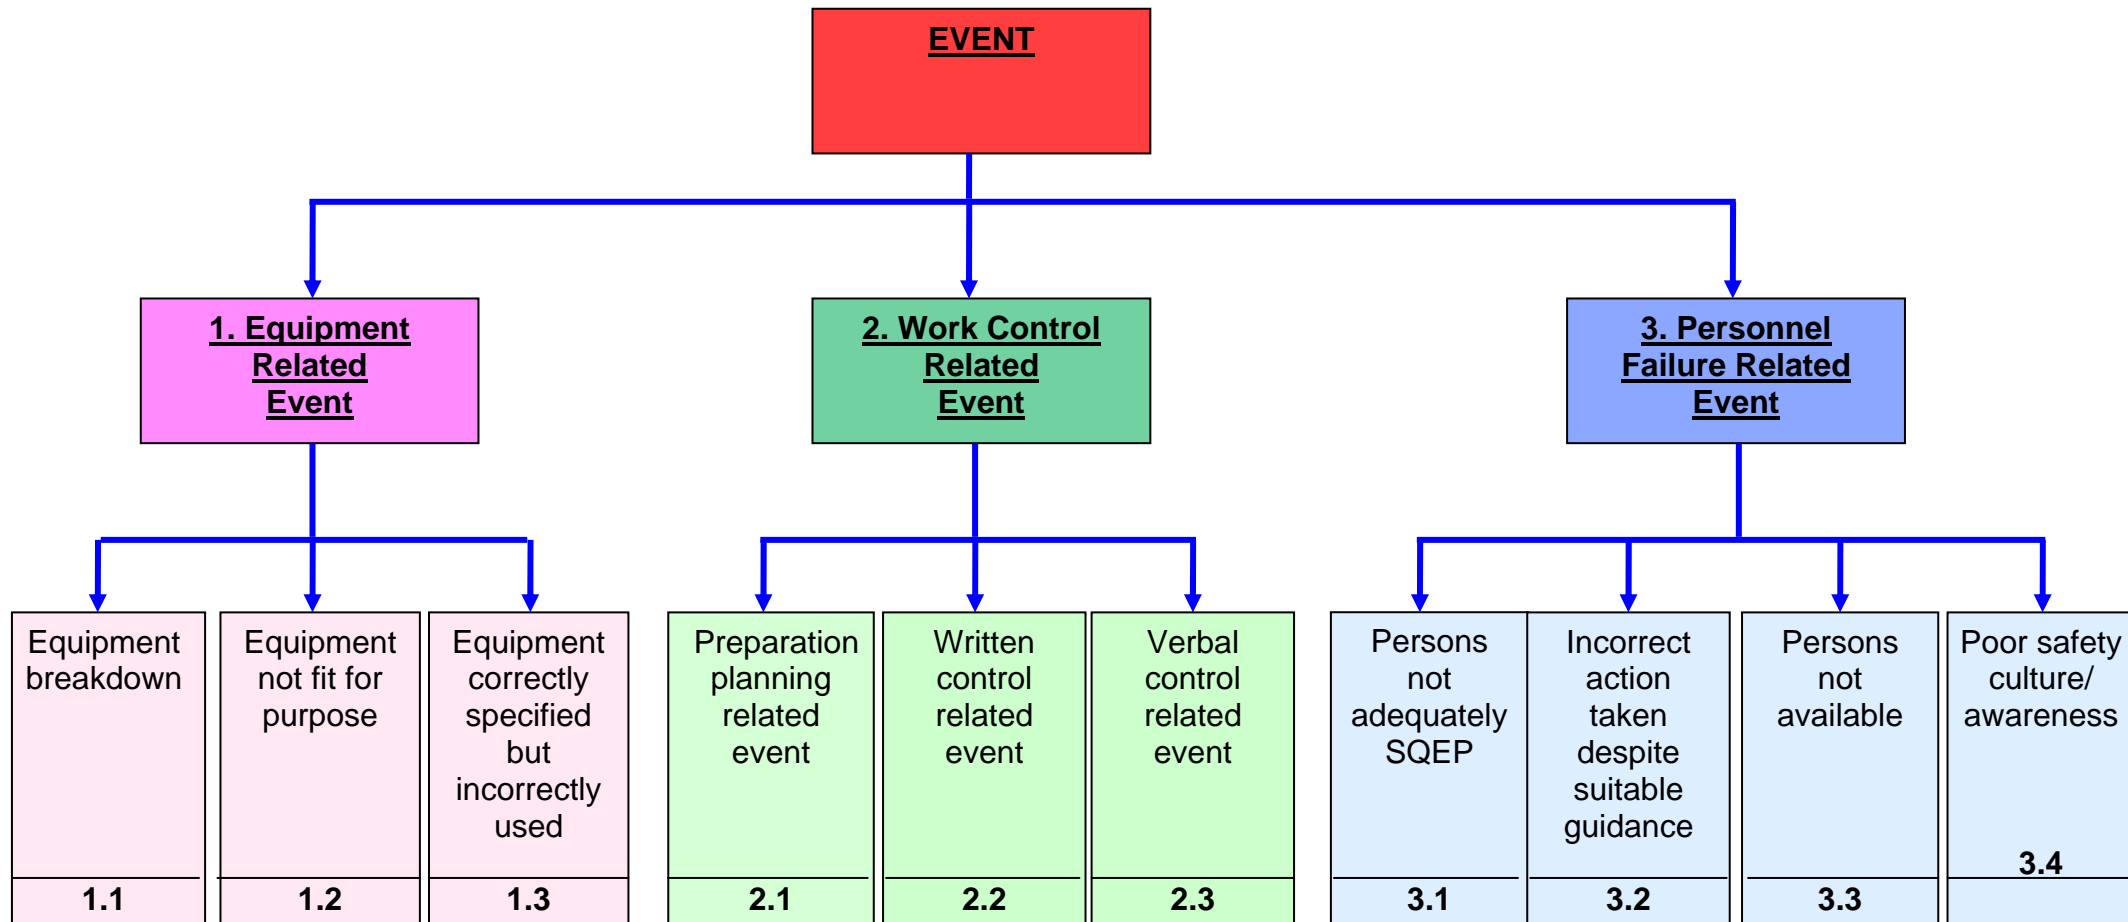
## Nuclear Site Event Reporting Immediate Cause (IC) Code Determination Diagram
