Rail Accident Investigation Branch

Annual Report 2015

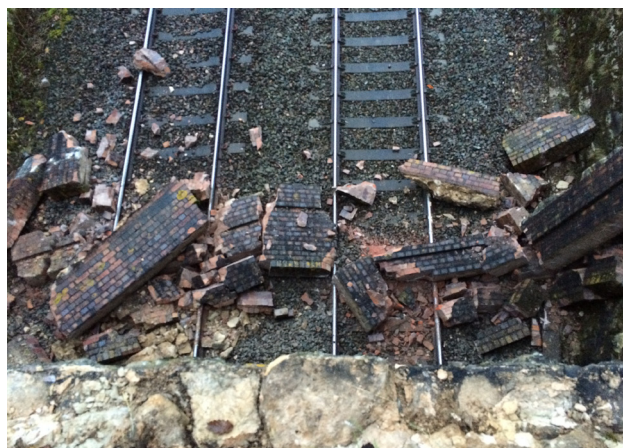
Froxfield - Image supplied by Mr John Brown

- At Froxfield (02/2016) a heavily loaded passenger train hit brick debris while travelling about 90 mph (145 km/h). The impact lifted the front of the train but fortunately the train did not derail.

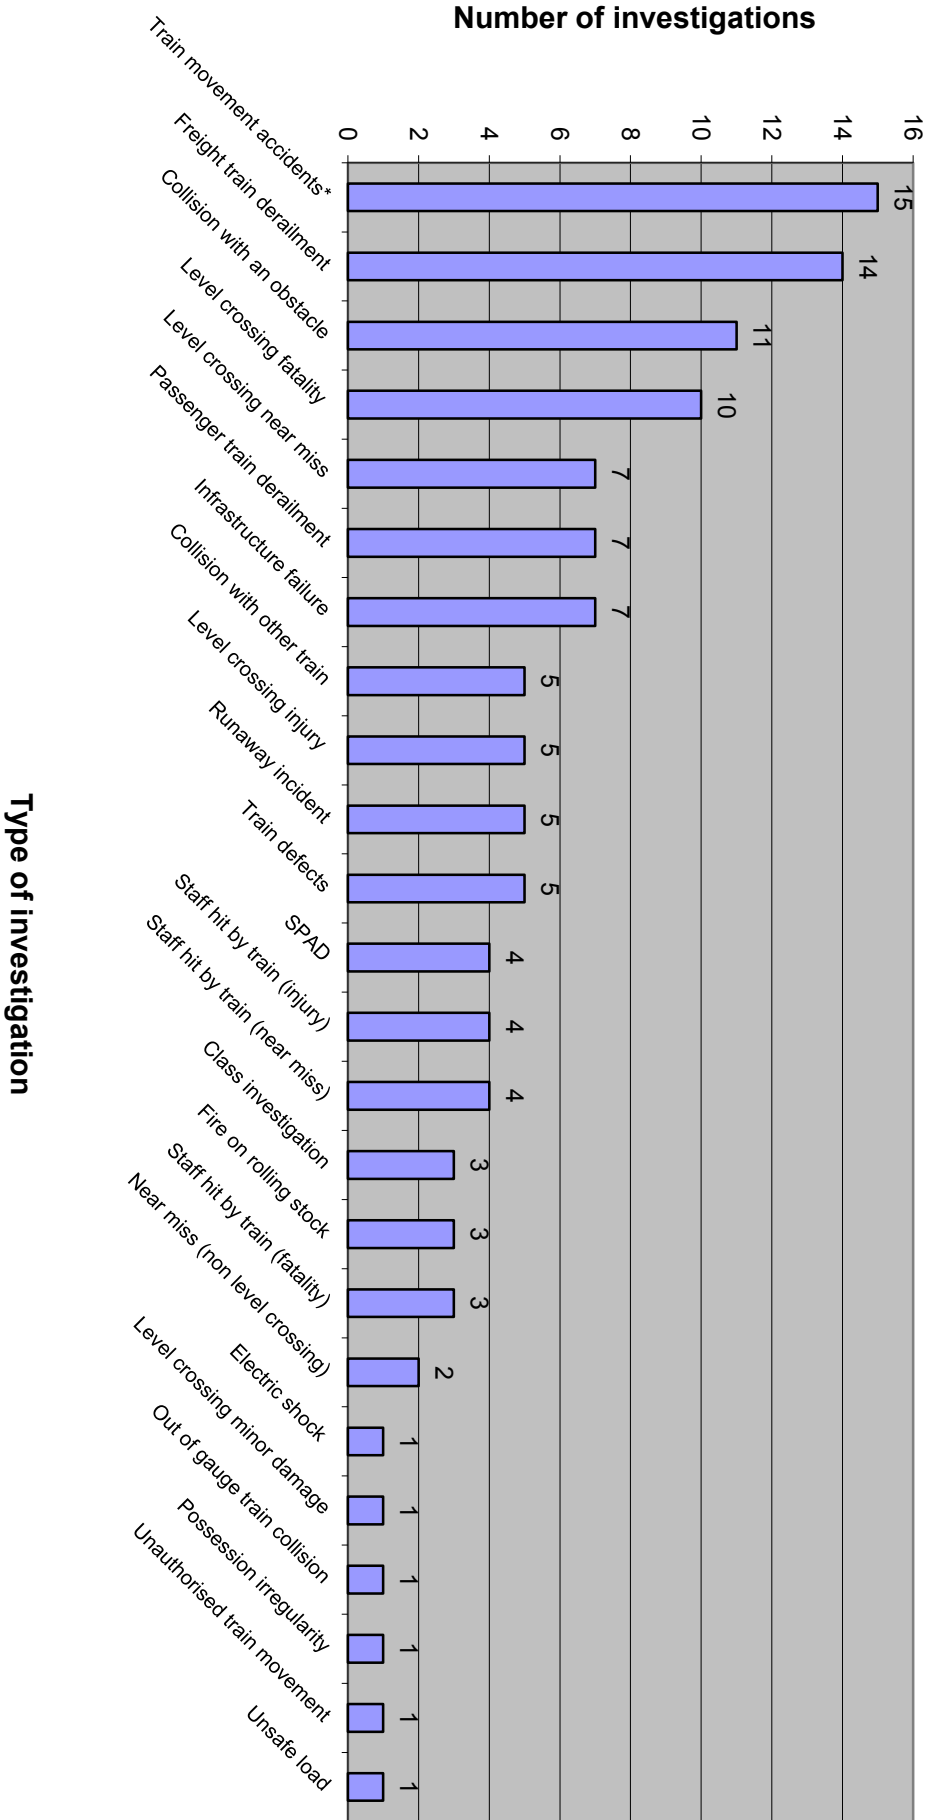
Chart 1 - Types of incidents/accidents investigated 2011 - 2015

Note: "Train movement accidents" include passengers and members of public (not staff).

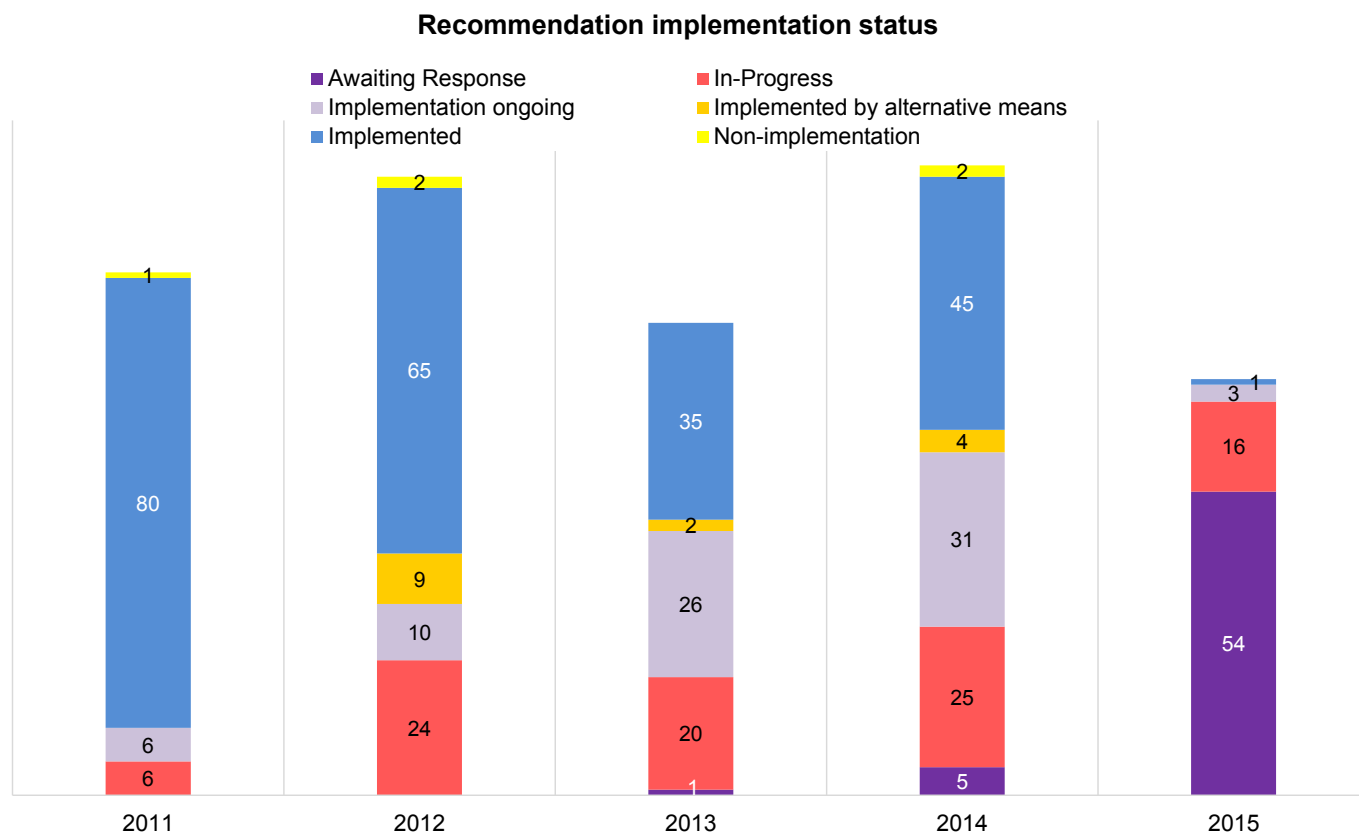
Chart 2 – Recommendation implementation status per year (includes recommendations made not only to safety authorities but also public bodies).

The following chart provides the status of recommendations made between 1 January 2011 and 31 December 2015.

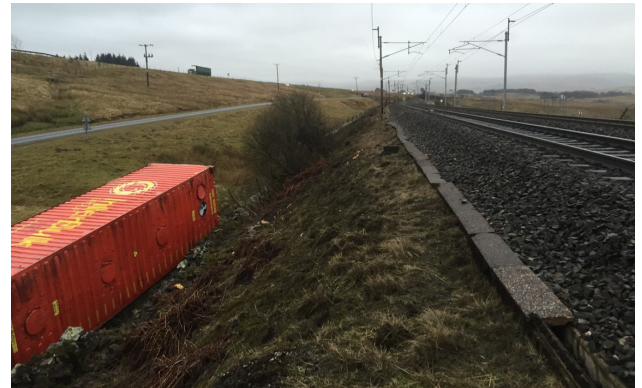
The spigots of FEA wagons were a factor in the container detachments at Scout Green and Deeping St Nicholas (19/2015). The spigots on FEA-B and FEA-S wagons did not work as envisaged by the UIC standard because they were designed to rotate inwards beyond the permitted two degrees of rotation.

The circumstances of these events in 2015 were very similar to other container detachments at Hardendale and Cheddington in 2008 which were investigated by RAIB. Although the subsequent report (12/2009) acknowledged the need for short-term measures to manage the risk of deficient spigots it also recommended that modifications be made so that the spigots would operate as designed. It is disappointing to RAIB that by the time of the incidents at Scout Green and Deeping St Nicholas these modifications had still to be implemented.
