**REPORT
OF THE
OPERATIONAL SAFETY REVIEW TEAM
(OSART)
MISSION
TO THE
SIZEWELL B
NUCLEAR POWER STATION
5 – 22 OCTOBER 2015
AND
FOLLOW UP MISSION
24 – 28 APRIL 2017**

**DIVISION OF NUCLEAR INSTALLATION SAFETY
OPERATIONAL SAFETY REVIEW MISSION
IAEA-NSNI/OSART/017/185F**

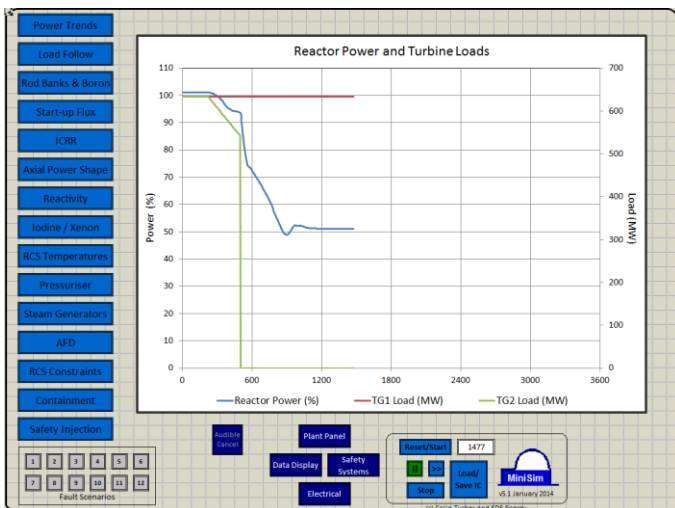
2.2(a) Good Practice: Desktop Simulator written in Visual Basic for Microsoft Excel is available for all Station personnel.

MiniSim provides a *Sizewell-specific desktop simulator* for use in introducing the principles of PWR operations. Unlike other such packages, it is written in *Visual Basic for Microsoft Excel* and so can be easily copied and run on any computer at work or at home.

It has developed in response to requests from trainers and it can be easily adapted as future requests or training needs arise. Detailed instructions are included, together with Station Operating Instructions for station start-up and power-raising, station cool-down/heat-up, post-trip actions load-follow operations.

The key use for the package is in introducing new starters/graduates to the main station systems and to the behaviour of the station in both automatic and manual modes. The package includes modelling of Safety and Electrical Systems and covers a range of fault scenarios (e.g. station blackout, small LOCAs etc.) in addition to normal station operations.

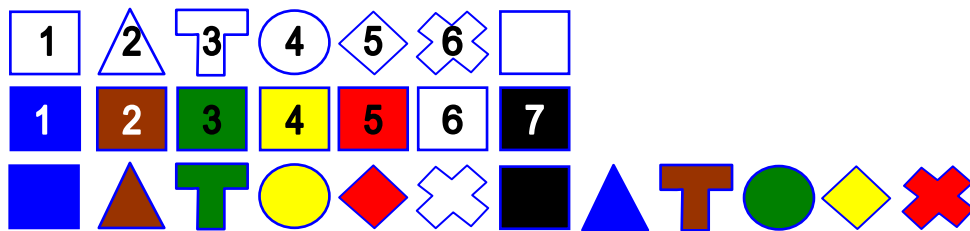
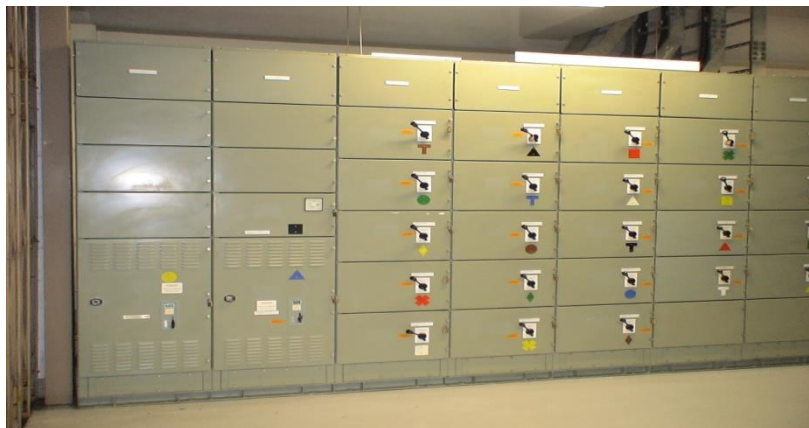
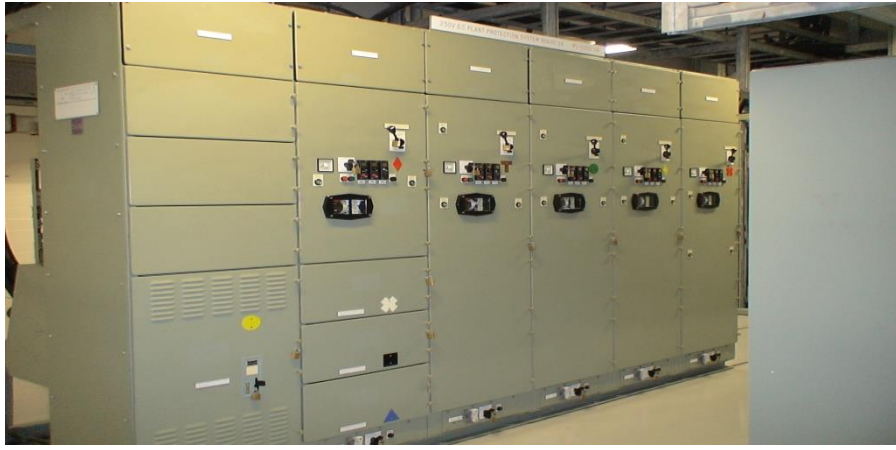
Picture of colour coded symbols

These coloured shapes are used in secured communication, especially when people are working at the front and the back of the cubicle at the same time, insuring they are working on the same components, avoiding a mismatch.

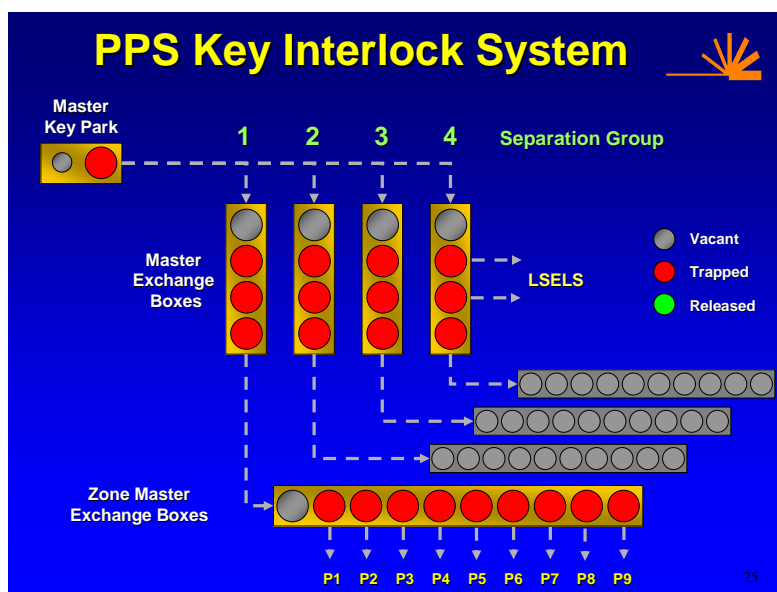
This supplements Human Performance and administrative controls to give an additional layer of defense during Nuclear Safety related equipment work.

There have been no cases of unauthorized access to the Reactor Protection System as a result of this interlock scheme.

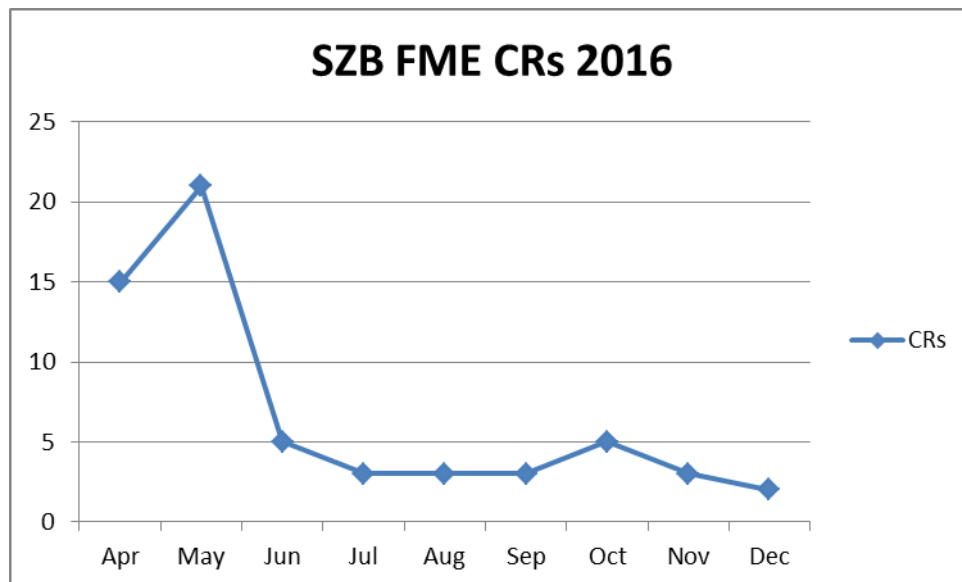
FME events are being tracked and trended as part of the work of the FME Working Group. FME-related CRs are reviewed and non-genuine records stripped-out [e.g. FME training requests, positive findings etc.] leaving genuine FME transgressions to be trended.

The trend from April 2016 is as follows:

Following the peak in RO14, FME-related CRs are now averaging 3 low-severity events per month.

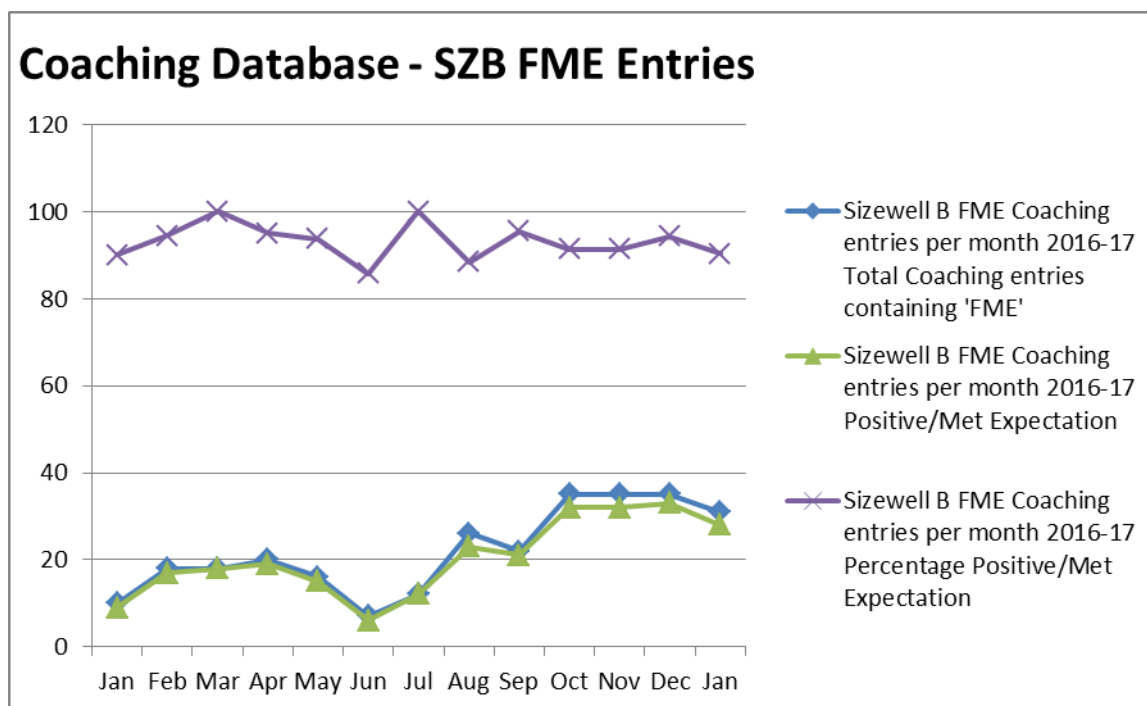
Targeted observations have been carried out through Cycle 15 on the effectiveness of FME Controls. Over this period since enhanced observation commenced in October 2016, FME-related observations have increased from 20 per month to 35 per month on average. Overall, 'met or exceeded expectation' responses are now averaging 93% of reported findings.

The trend since January 2016 is as follows:

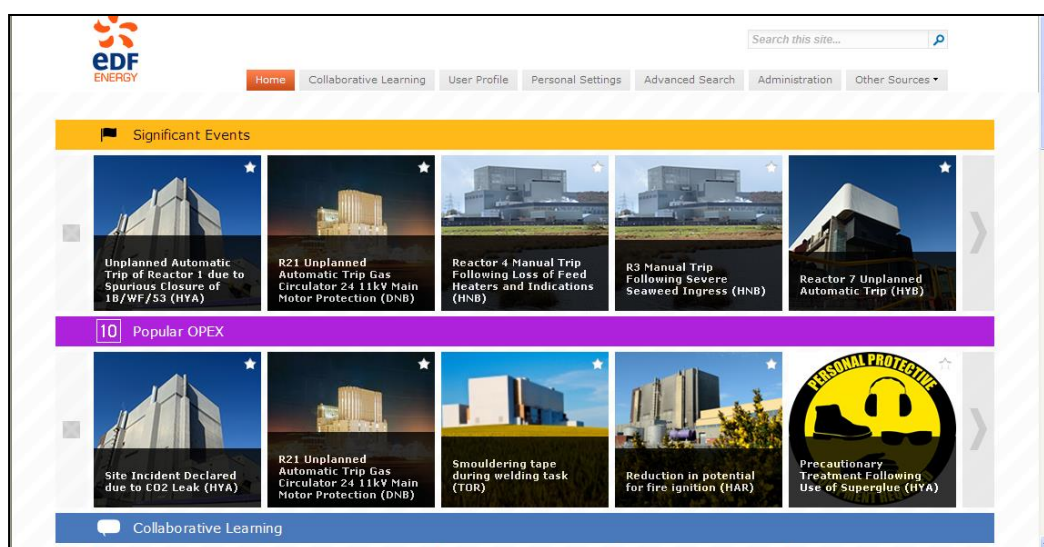
The Organisational Learning Portal is a cross fleet operational experience database. Any one on site with computer access can access the database to view fleet, international and industry operating experience.

Results: During May 2015 the station saw more than 500 unique individuals accessing the database to review the Operating Experience.

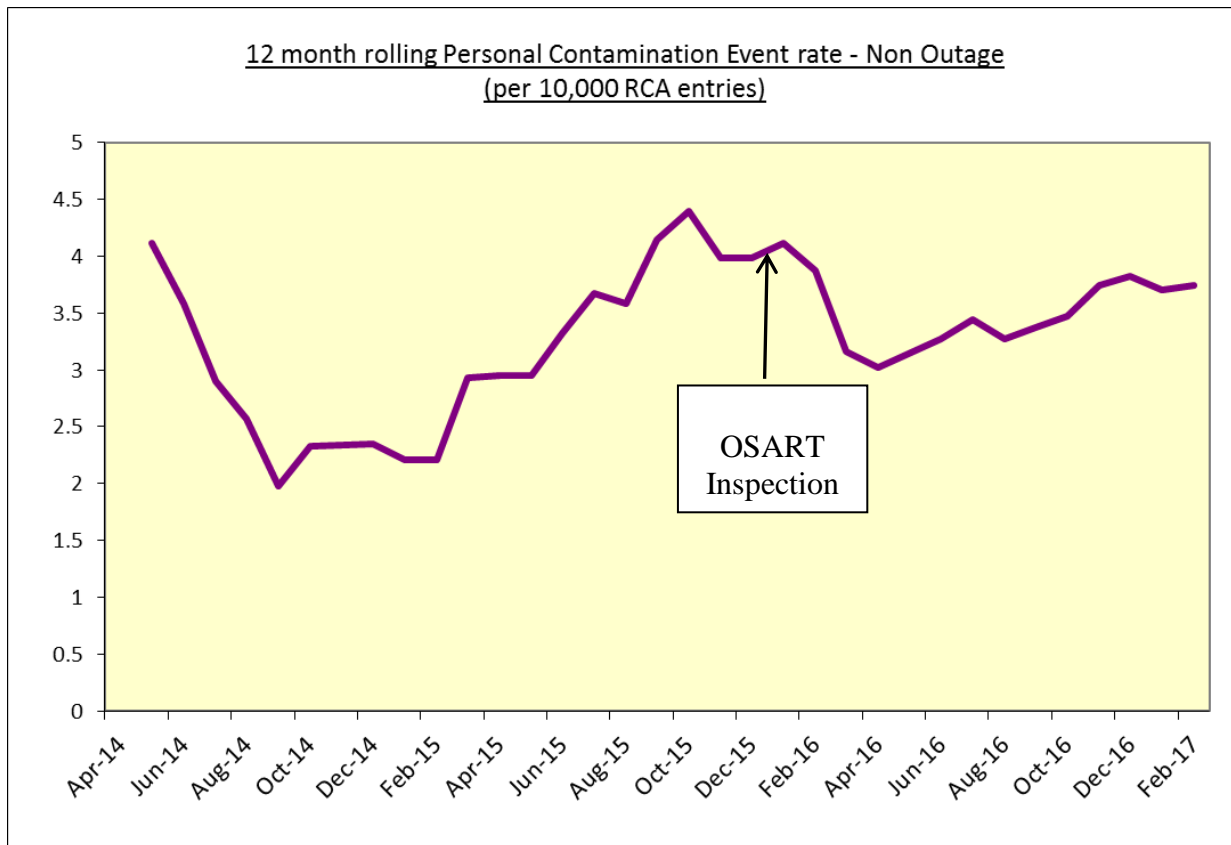
Sizewell's contamination control performance since OSART is summarized in the graph below. This shows some improvement since OSART although the longer term trend is fairly static. The trend reflects the challenge of driving an improvement where (i) performance is already at a good international standard and (ii) the gaps to excellence are the result of long-standing behavioural and cultural issues that will inevitably take a longer period to address. Most of the simple or high-impact actions on contamination control have already been adopted by EDF Energy and/or Sizewell before the OSART inspection, with the consequence that what remains is inevitably a long journey of small incremental steps to the peak of international contamination control performance.

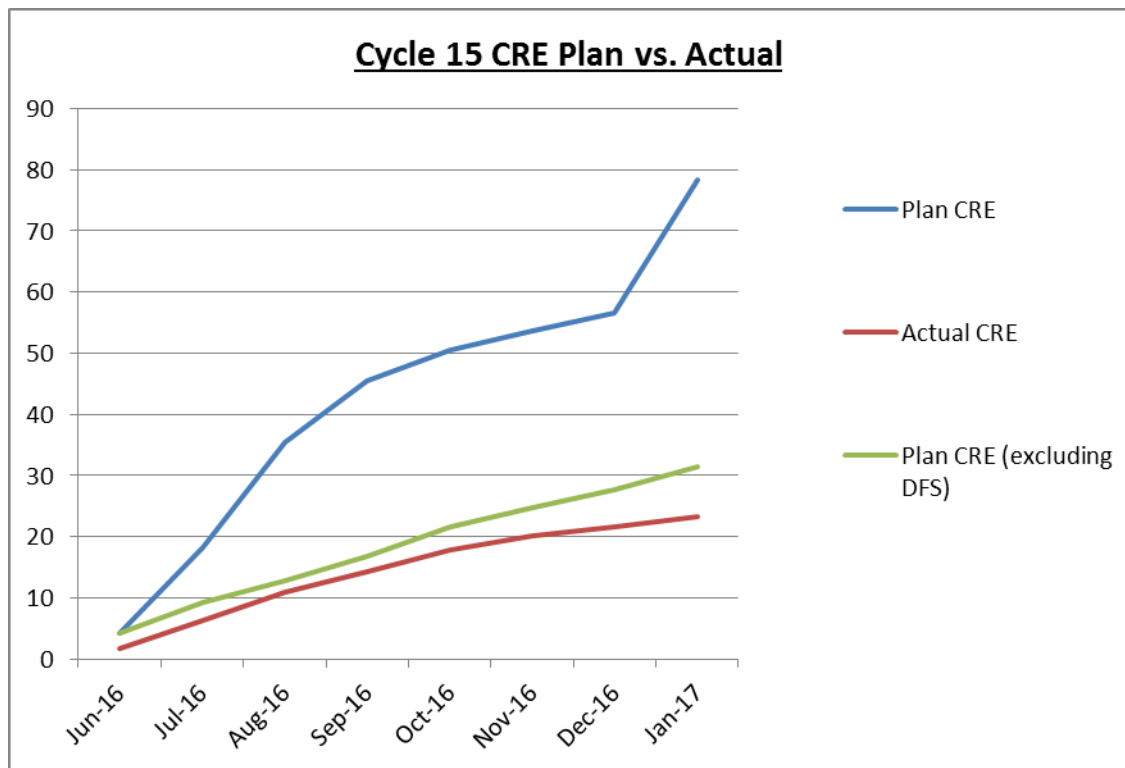
Cycle 15 doses are significantly below budget because of delays in Dry Fuel Store commissioning. If the contribution of the Dry Fuel Store work is removed from the projections then the CRE is only 80% of the dose budget (see graph below) which supports the conclusion that radiation doses are being managed well.

Calendar year 2016 end CRE was around 6% above budget principally due to an overrun in Refuelling Outage 14, which contributed 93% of the annual CRE. However for the on-line period doses were around 50% of budget and showed a reduction of 30% for the same period in the previous calendar year. In 2016 on line doses were the lowest value since 2012. For
