Annual Safety Review 2017

Foreword

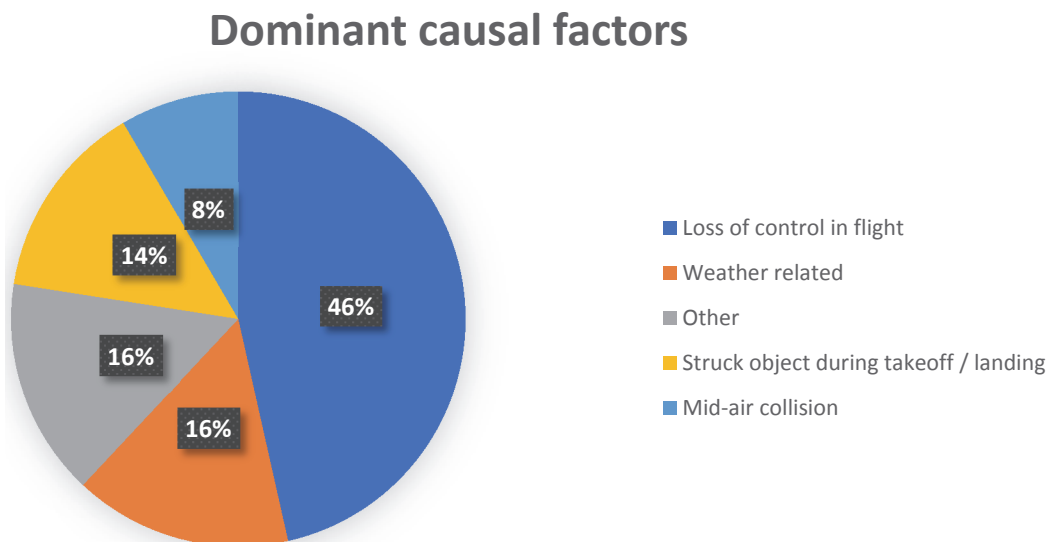
Figure 1 shows a breakdown of the dominant causal factors in these accidents:

The predominant causal factor was loss of control in flight, which accounted for almost half of the accidents. Of these, most involved the aircraft entering an inadvertent stall and/or spin following engine failure, or during aerobatics.

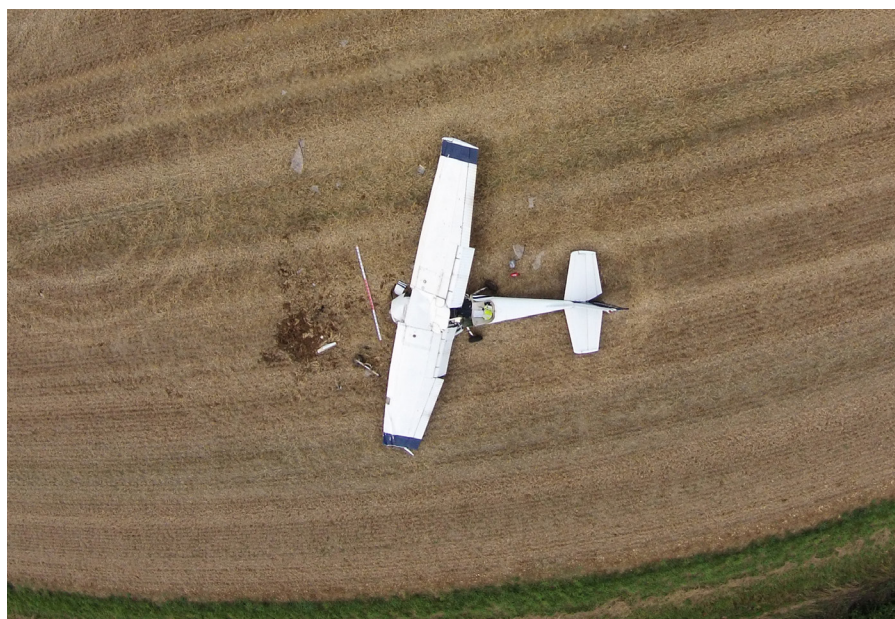
Figure 2

Where the accident involved a complete or partial engine failure, the loss of control was often associated with inadequate airspeed, particularly whilst manoeuvring at low level (Figure 2).

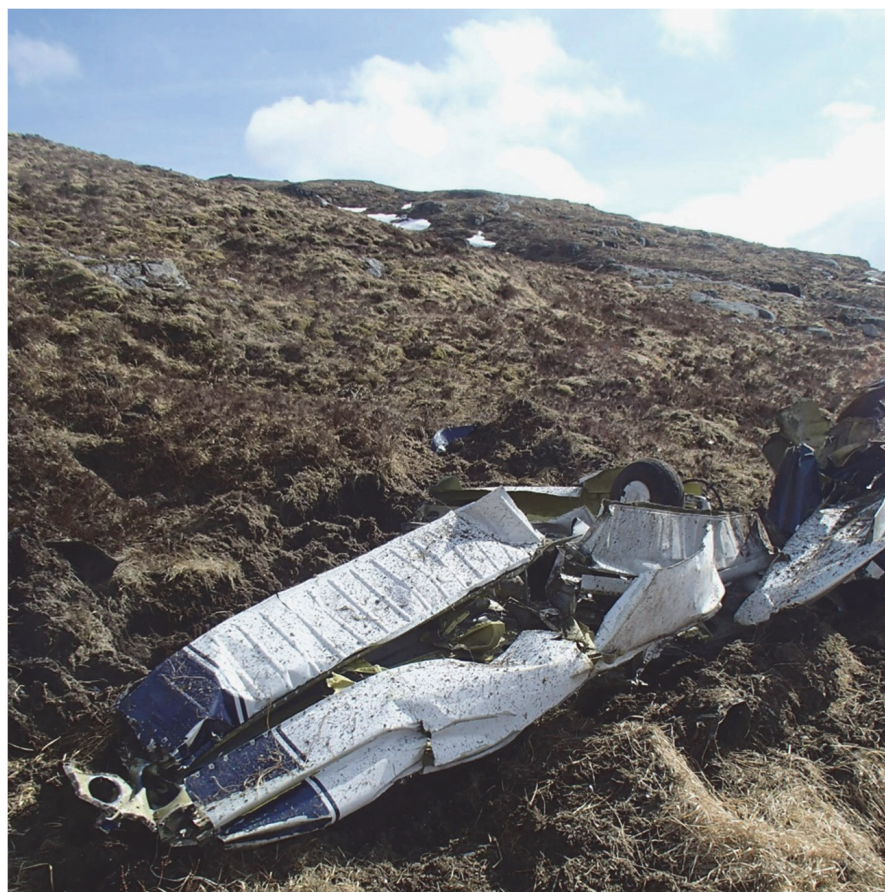
Figure 3

A significant number of the accidents reviewed in this study were weather-related. Common themes were: collision with terrain due to flying below the minimum safe altitude (MSA) in IMC (Figure 3) and flying in IMC without the appropriate training and qualifications. Whilst new technology has undoubtedly made the tasks of flight planning and navigation easier, poor weather remains a constant threat to GA pilots and should not be underestimated.

[Piper PA-28-140 Cherokee, G-BHXK](#)
Near Loch Etive, Oban, Argyll and Bute
4 April 2015

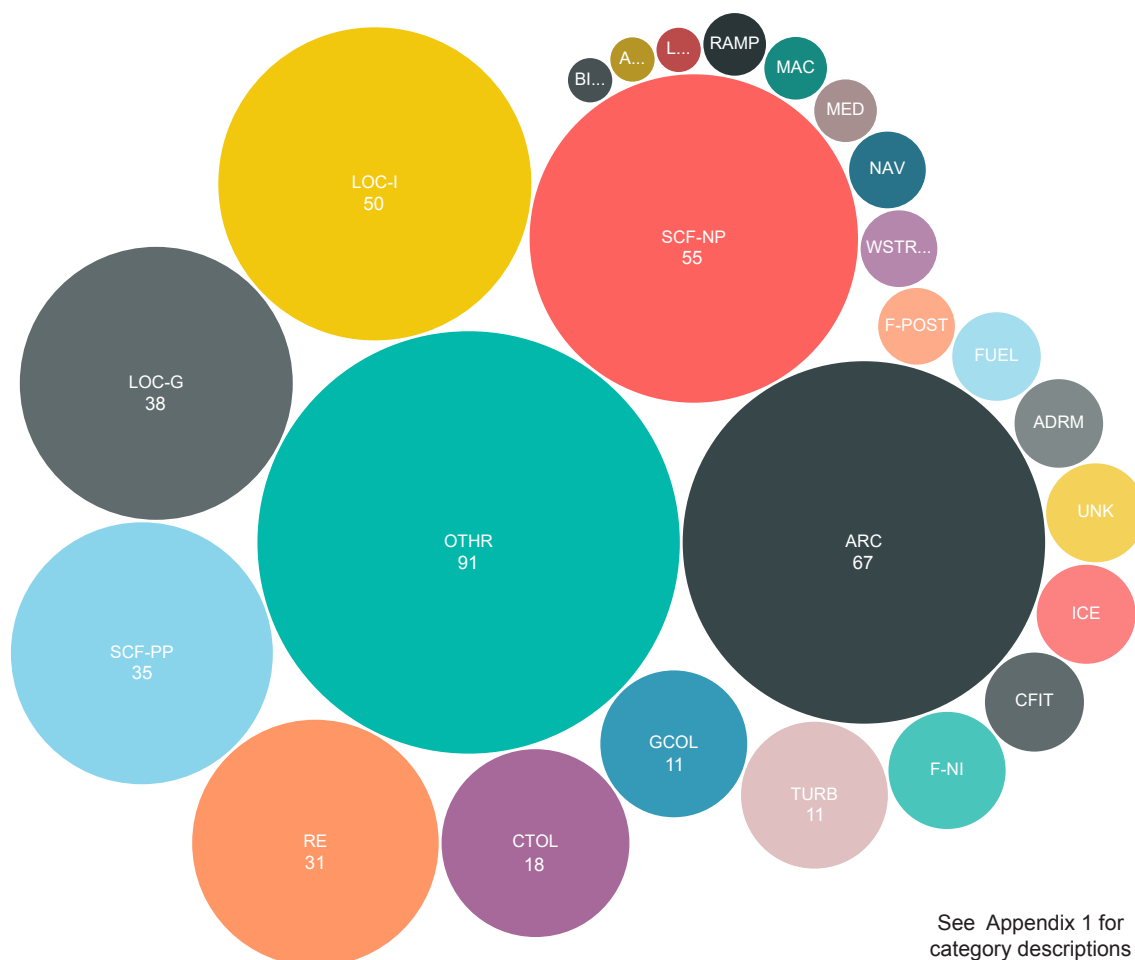
Factors for all investigations reported on by AAIB in 2017

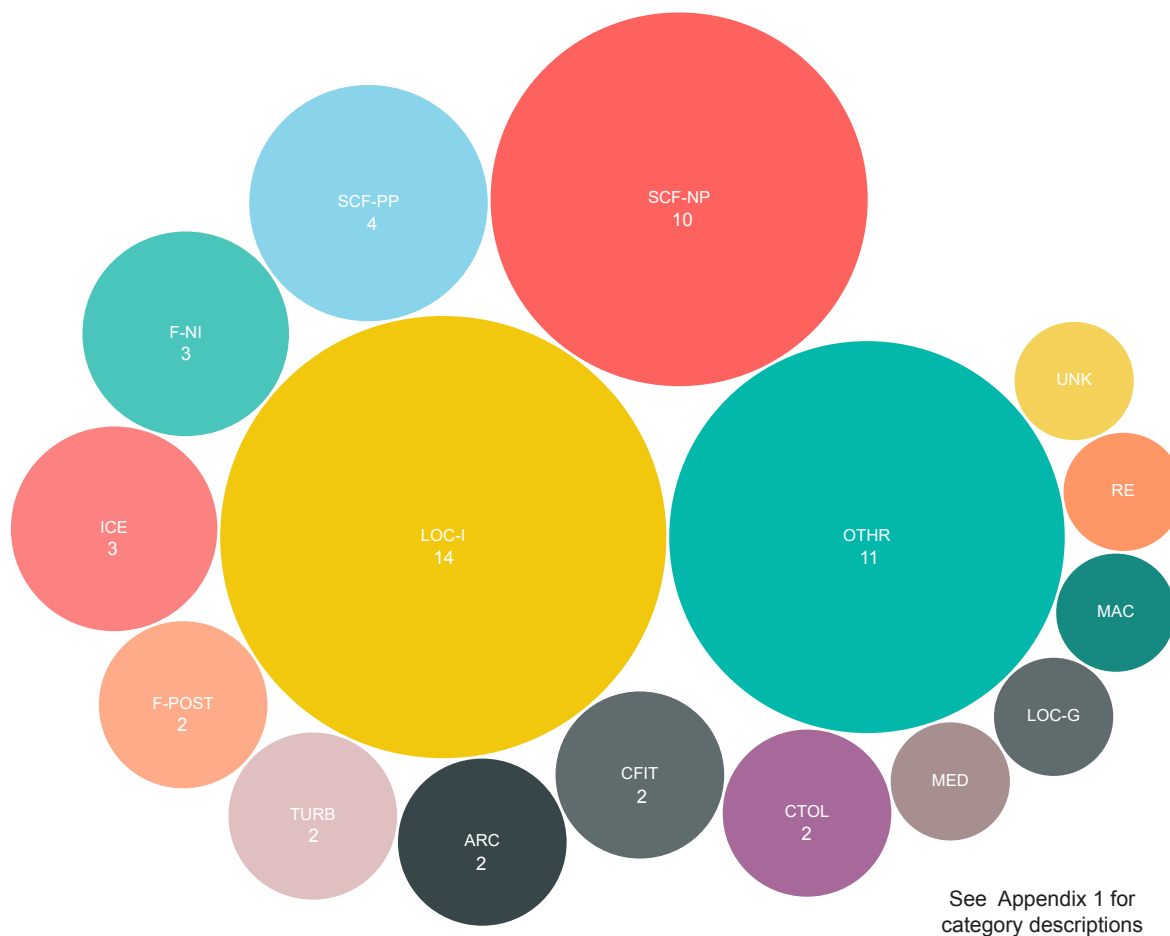
Factors for field investigations reported on by AAIB in 2017

In 2017 the AAIB reported on 38 field investigations, 16 of which were fatal accidents in the UK and 22 were non-fatal accidents or serious incidents. The analysis of the CICTT factors for each of these reveal that the overall major factor in fatal accidents reported on in 2017 was LOC-I.

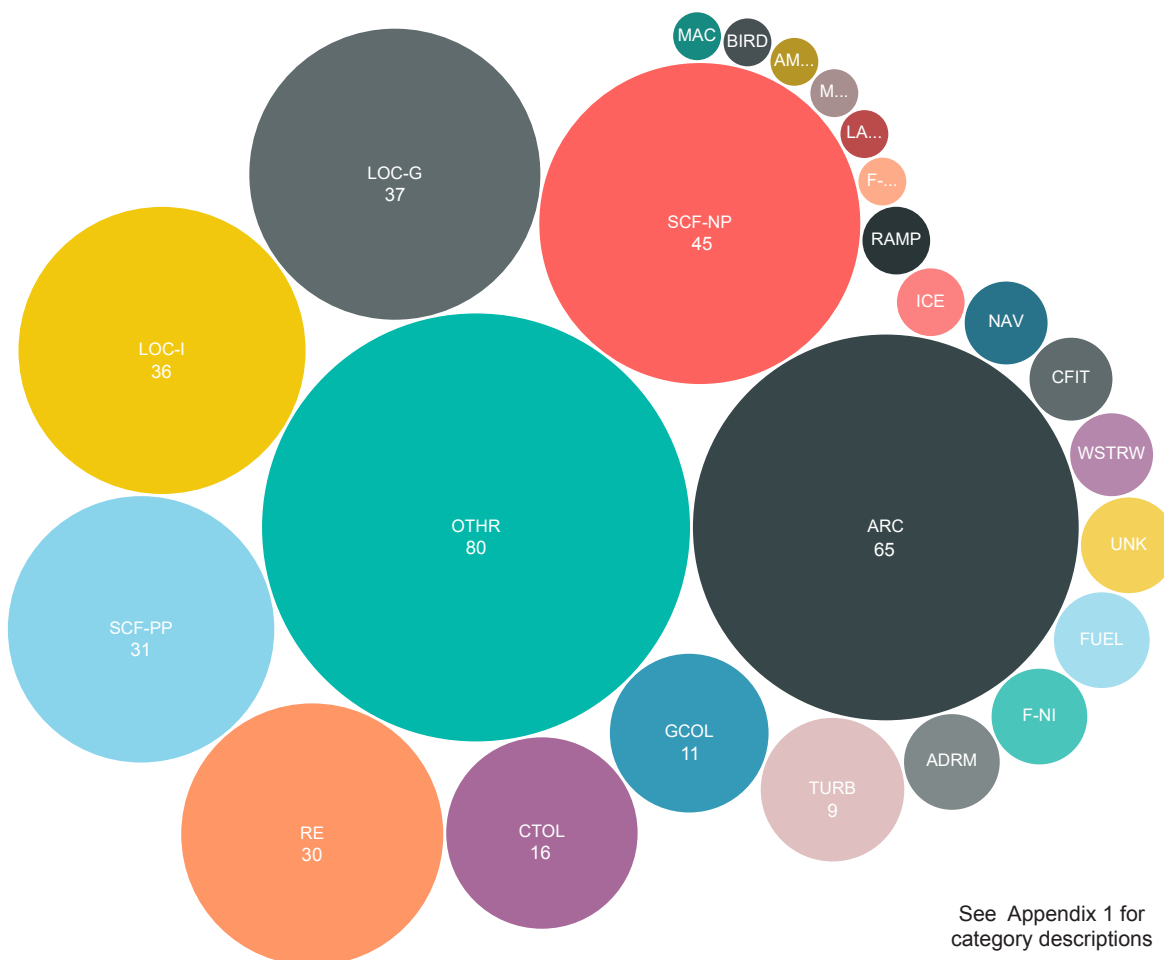
Factors for correspondence investigations reported on by AAIB in 2017

Correspondence investigations are usually conducted on non-fatal accidents on GA aircraft and to some serious incidents on CAT aircraft. The factors most predominant in these occurrences were classified as other followed by abnormal contact with the ground (ARC).

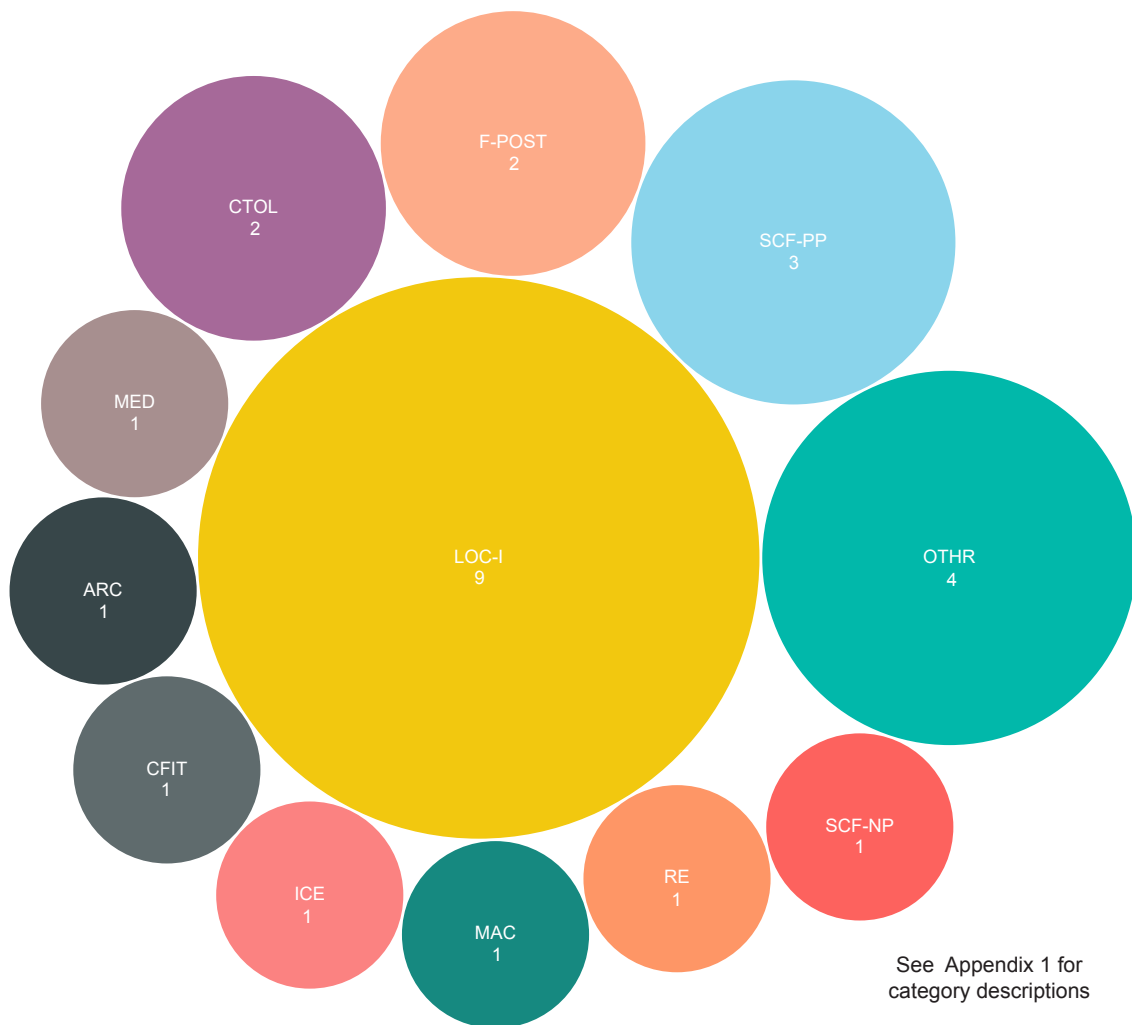
Factors for fatal investigations reported on by AAIB in 2017

The predominant cause of fatal accidents in general aviation, in common with previous years, was loss of control in flight (LOC-I). The article at the beginning of this Annual Safety Review explores the reasons behind this in more detail.

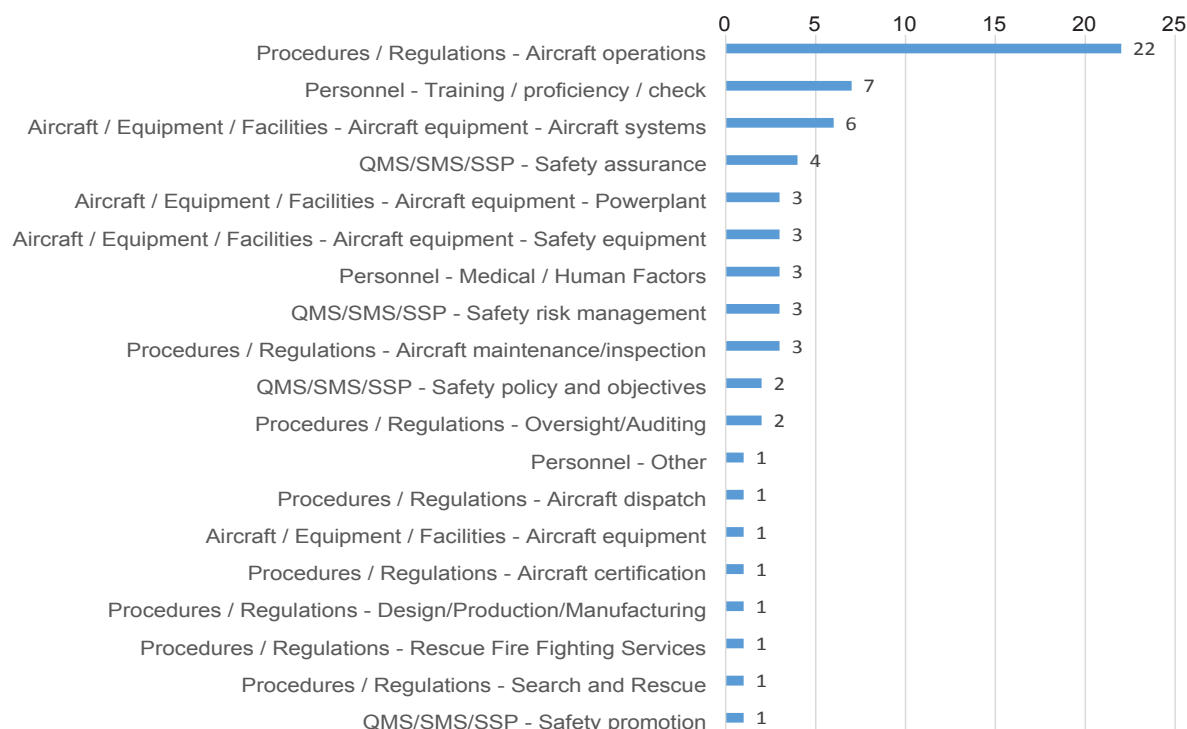
Safety Recommendation Topics

The chart above shows the recommendation topics. It should be noted that a recommendation can encompass several topics within the classification system.

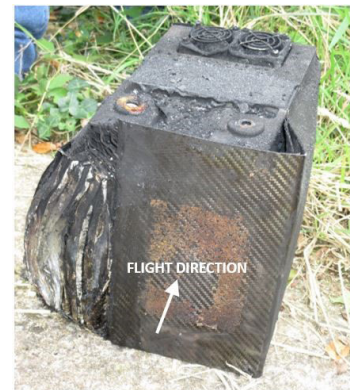
G-GSGS Glasflugel 304 ES on 10 August 2017

It is recommended that the European Aviation Safety Agency (EASA) requires that all powered sailplanes, operating under either an EASA Restricted Type Certificate, or an EASA Permit to Fly, and fitted with a Front Electric Sustainer (FES) system, are equipped with a warning system to alert the pilot to the presence of a fire or other hazardous condition in the FES battery compartment.

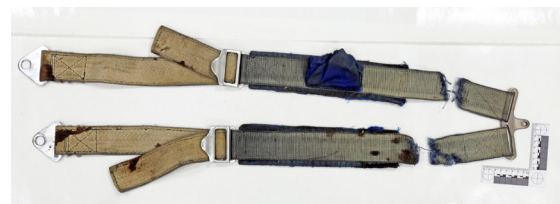
G-YAKB YAK-52 on 8 July 2016

The Civil Aviation Authority should review the maintenance requirements for seat belts and harnesses, and, if necessary, revise the maintenance requirements to ensure that seat belts and harnesses remain in a condition with an acceptable residual strength.

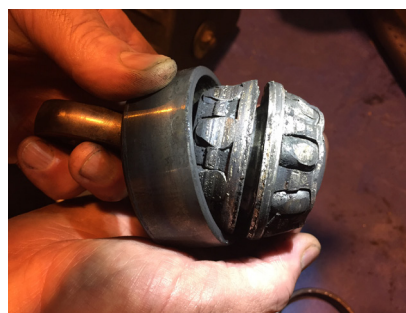
On 31 December 2016, the helicopter manufacturer issued to all operators an 'All Operators Letter' (AOL), CCS-92-AOL-16-0019, which described the event. It emphasises the use of the HUMS Tail Gearbox Bearing Energy Tool, provided on the ground station, which will detect a TRPCS bearing that is experiencing degradation, and recommends that this Tool should be utilised as often as reasonably possible.

This was followed by an Alert Service Bulletin (ASB) issued by the manufacturer on 10 January 2017. ASB 92-64-011 introduces a one-time inspection of the TRPCS and bearing assembly for ratcheting, binding, or rough turning. The manufacturer has recommended that compliance is essential and is to be accomplished prior to the next flight from a maintenance facility; three flight hours are

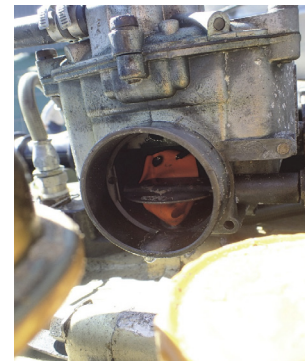
Safety issue – Aircraft system design

The operators of the aircraft developed a modification to fit a screen to the engine’s carburettor intake, with the intention of preventing the ingress of similar debris to the balloon fragment. Should this screen become blocked, air can still be supplied to the carburettor via the alternative hot air supply, thereby allowing the engine to operate normally. After satisfactory testing, the modification was approved by the Light Aircraft Association.

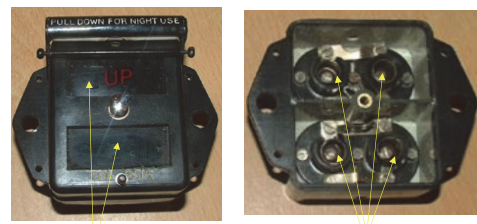
Spitfire IXT, G-LFIX on 15 September 2016

Safety issue – Cockpit indicator visibility

In order to prevent the illumination of the complete word “DOWN” in the landing gear position indicator in the event that one landing gear has not achieved the fully locked position, the maintenance organisation modified the landing gear indicator to prevent light from either of the indicator bulbs illuminating the complete DOWN caption.

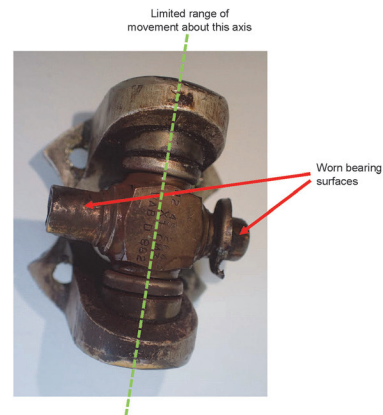
Westland Wasp HAS1, G-KAXT on 23 September 2016

Safety issue – Continued airworthiness of historic aircraft and servicing policy

The investigation findings were highlighted to the CAA at an early stage. The CAA took urgent action to ensure the continued airworthiness of Westland Wasp and Scout helicopters on the UK register by issuing Emergency Mandatory Permit Directive (EMPD) No 2017-002-E. (<http://publicapps.caa.co.uk/modalapplication.aspx?appid=11&mode=detail&id=7759>)

The EMPD requires operators to perform a visual check of the condition of the universal joint and conduct periodic lubrication of the joint.
