# Annual Safety Review 2017

## Foreword

This article is intended to provide pilots with a summary of the most common causes of GA fatal accidents in the UK, so that lessons may be learnt and actions taken to prevent similar accidents in the future.

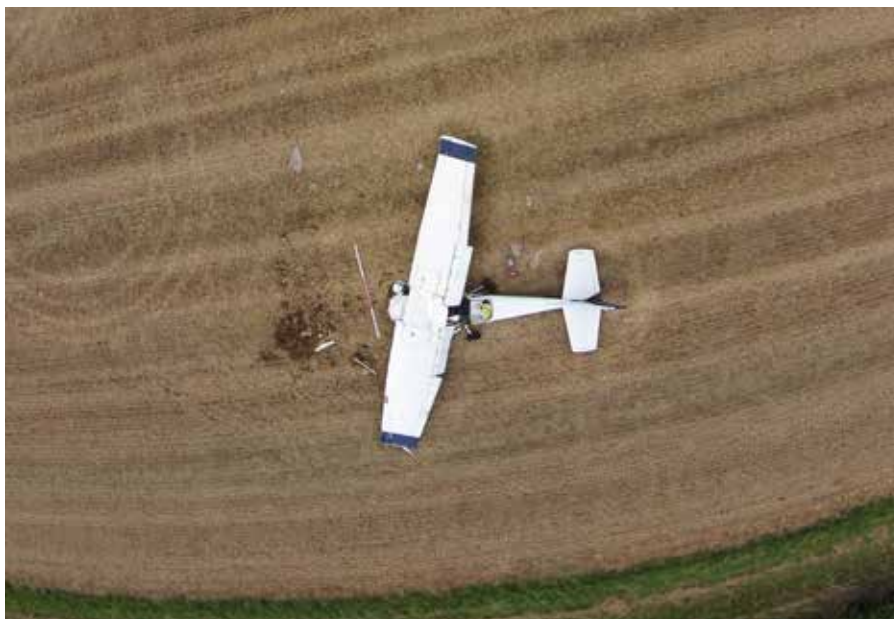
**Figure 2**

Where the accident involved a complete or partial engine failure, the loss of control was often associated with inadequate airspeed, particularly whilst manoeuvring at low level (Figure 2).

[Cessna 150F, G-ATKF](#)

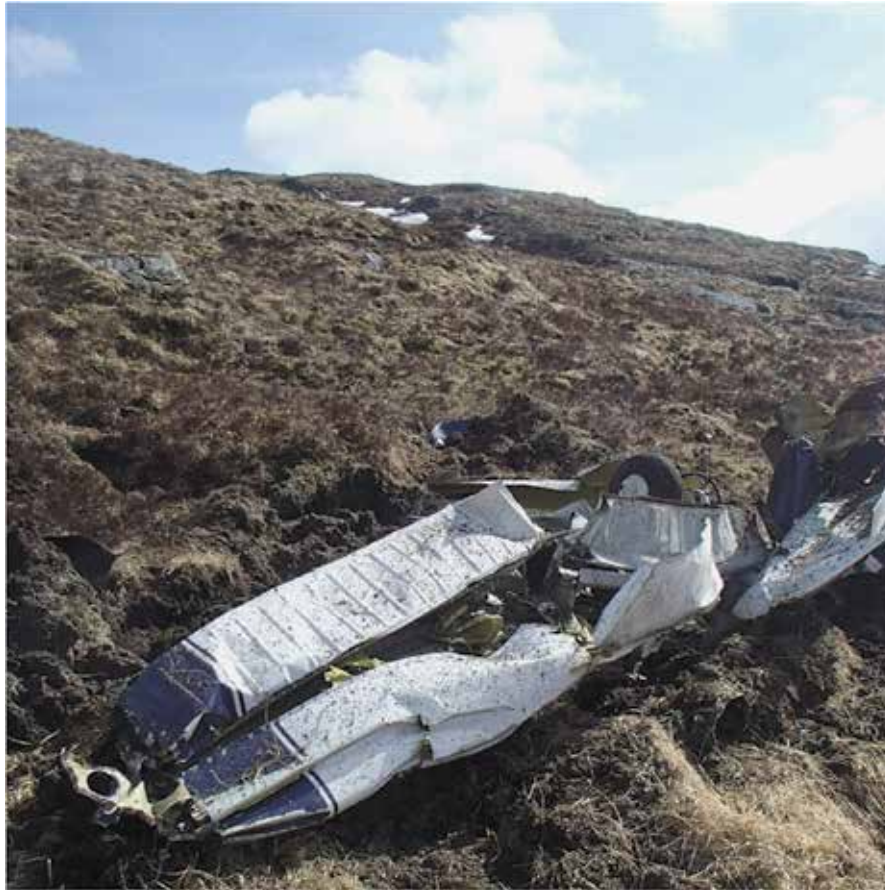
**Figure 3**

A significant number of the accidents reviewed in this study were weather-related. Common themes were: collision with terrain due to flying below the minimum safe altitude (MSA) in IMC (Figure 3) and flying in IMC without the appropriate training and qualifications. Whilst new technology has undoubtedly made the tasks of flight planning and navigation easier, poor weather remains a constant threat to GA pilots and should not be underestimated.

[Piper PA-28-140 Cherokee, G-BHXX](#)  
Near Loch Etive, Oban, Argyll and Bute  
4 April 2015

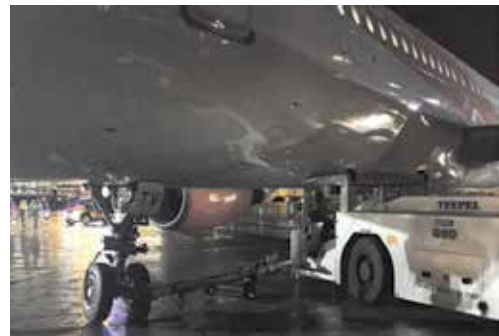
**Airbus A320-214, G-EZTM on 26 March 2017**

**Safety issue – Aircraft ground movements and support procedures**

The operator's engineering department is reviewing the AMM task (324200710001-A Rev.55) and will make recommendations to the aircraft manufacturer to amend the AMM accordingly.
