Marine Accident Investigation Branch
First Floor, Spring Place, 105 Commercial Road
Southampton, United Kingdom
SO15 1GH

June 2018

MAIB ANNUAL REPORT 2017

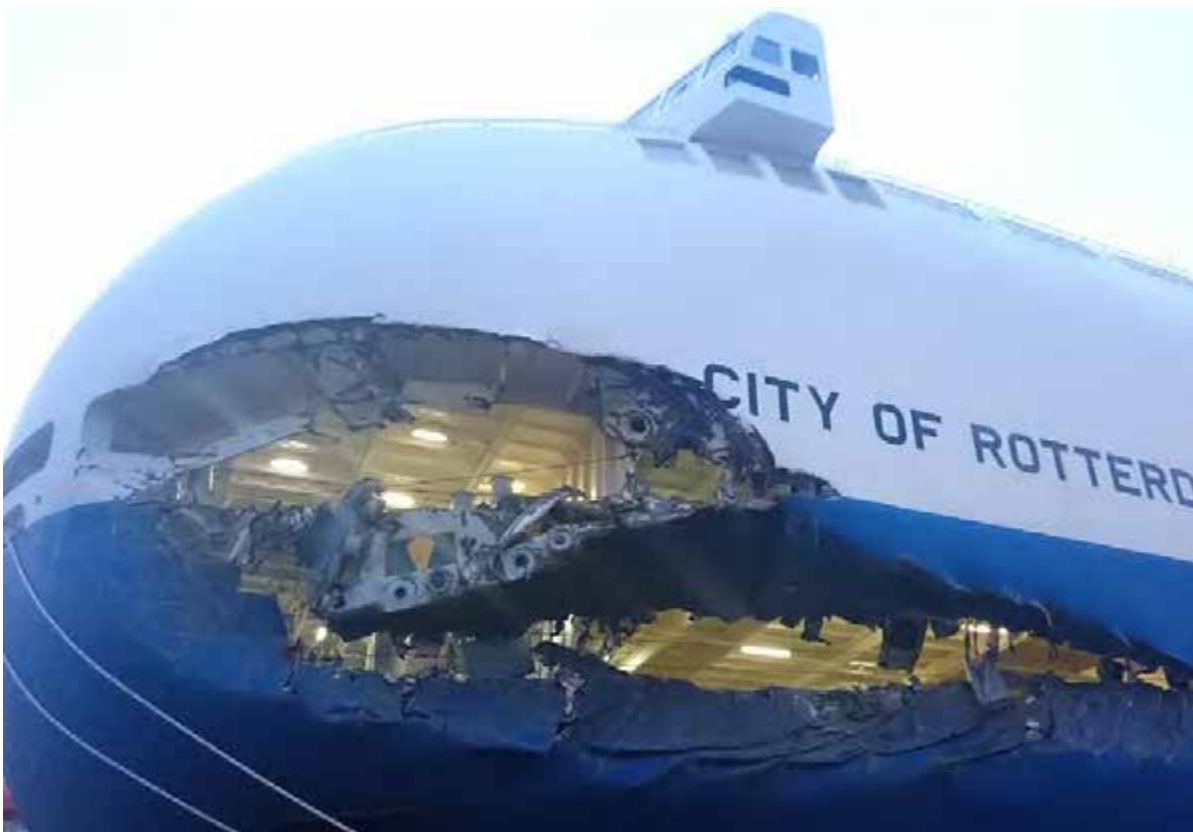
Collision on the River Humber

- ▶ Unforeseen consequence of novel bridge design was relative motion illusion
- ▶ Problem known to ship’s team but not addressed
- ▶ Had bridge team management been effective, accident could have been prevented

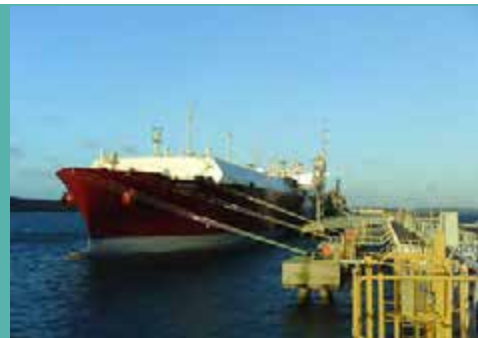
Failure of a mooring line while alongside the South Hook Liquefied Natural Gas terminal, Milford Haven resulting in serious injury to an officer

- ▶ Elastic pennant on HMPE mooring introduced snap-back hazard
- ▶ Jacketed rope construction prevented inspection of load bearing yarns
- ▶ Conflict between rope manufacturers' guidance on factors of safety and the ship industry operating guidance

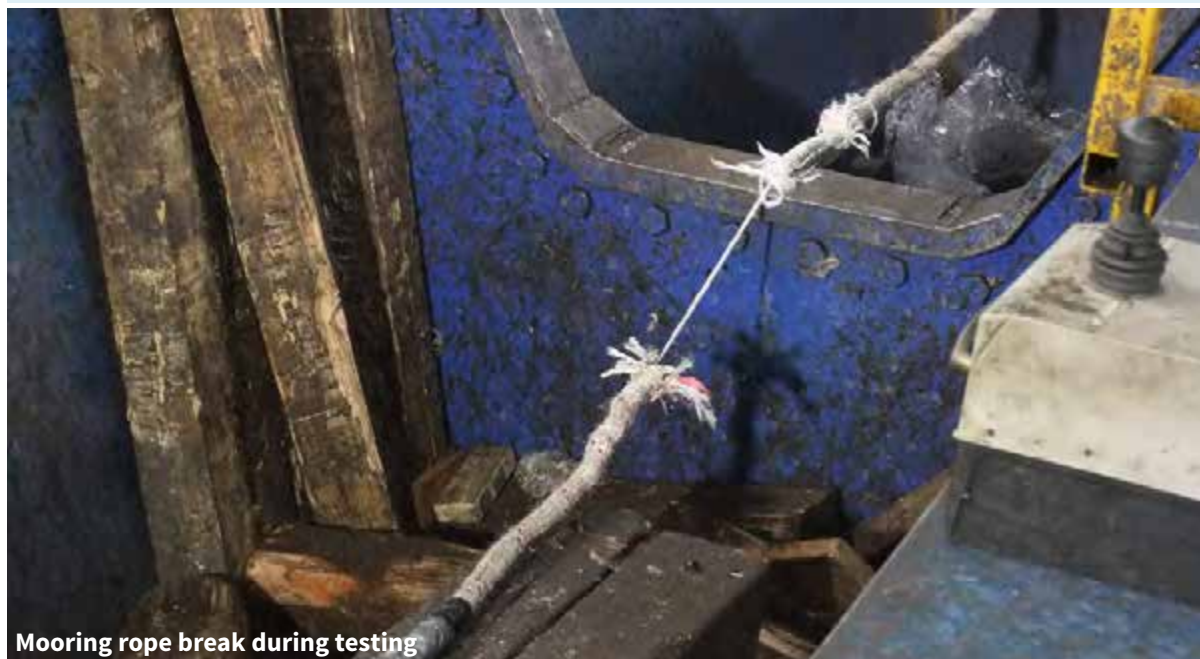
Mooring rope break during testing

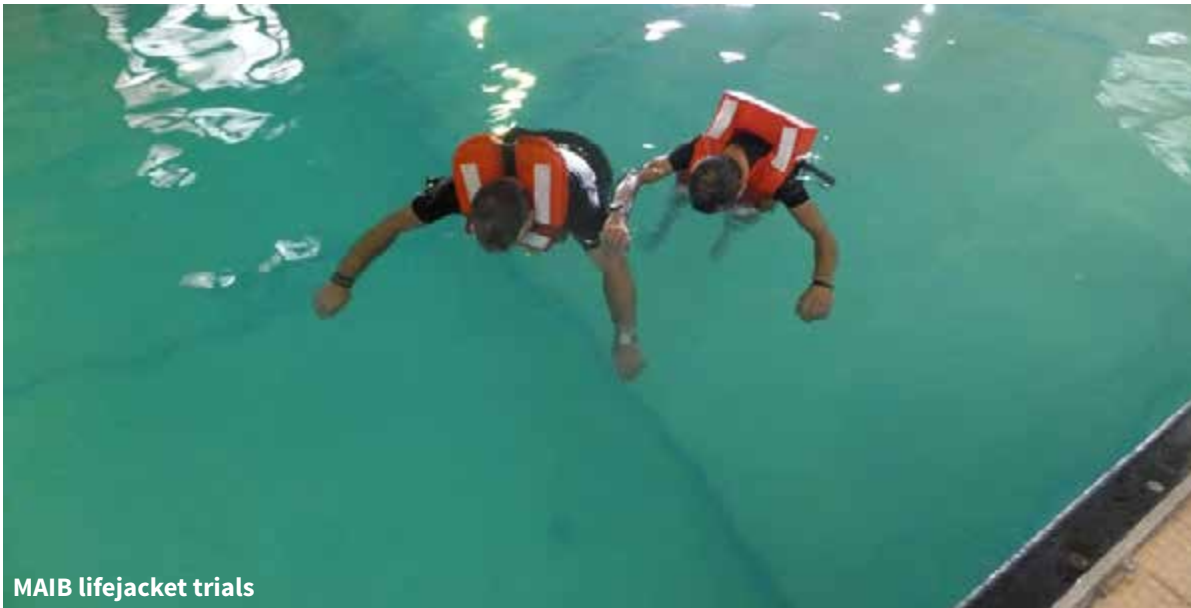
MAIB lifejacket trials

- 130 Urgently conduct research to confirm or otherwise the effectiveness of SOLAS lifejacket water performance test requirements to ensure approved lifejackets will satisfactorily turn a face-down, unconscious person onto their back with sufficient orientation and buoyancy to maintain their airway clear of the water. Any shortcomings in the water performance test requirements that may be identified should be brought to the attention of the International Maritime Organization for action.

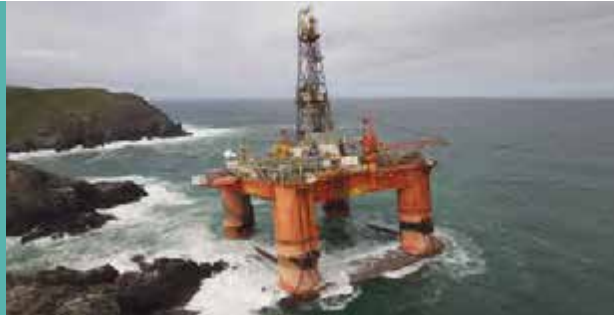
Grounding of *Transocean Winner* following the loss of tow from *ALP Forward* on the Isle of Lewis

- ▶ Inadequate allowance for weather during planning stages
- ▶ Effects of wind on rig not assessed during planning stages
- ▶ Length, load and catenary of tow line inadequately managed

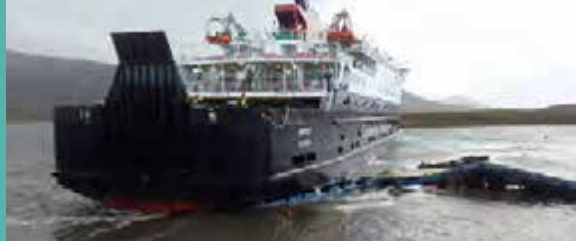
Loss of control and grounding of ro-ro passenger ferry at Lochmaddy, North Uist

- ▶ Machine service instructions not available to staff and not followed during routine maintenance

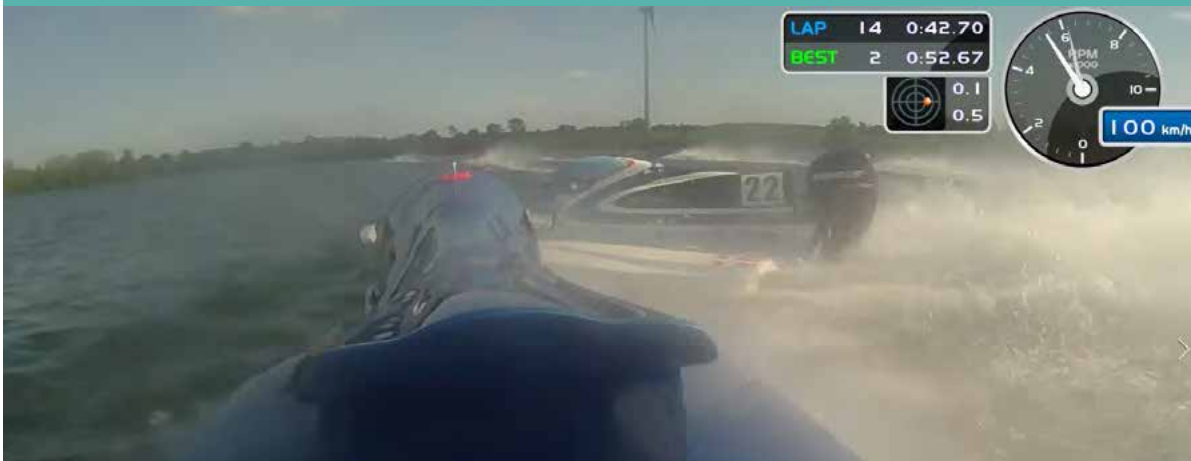
F4 powerboats

- ▶ Driver's escape equipment did not function as intended
- ▶ Race continued under yellow flag conditions following the accident
- ▶ Some roles and responsibilities of race officials (i.e. safety officer) were unclear

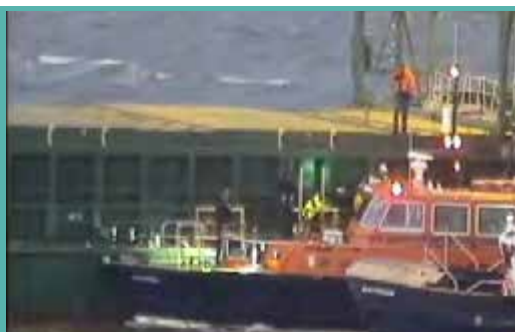
Sunmi/Patrol

- ▶ Pilot used inappropriate width deck gate to board vessel
- ▶ Insufficient risk assessment carried out for 'step across' boarding
- ▶ Pilot had consumed alcohol
- ▶ Pilot fitness levels

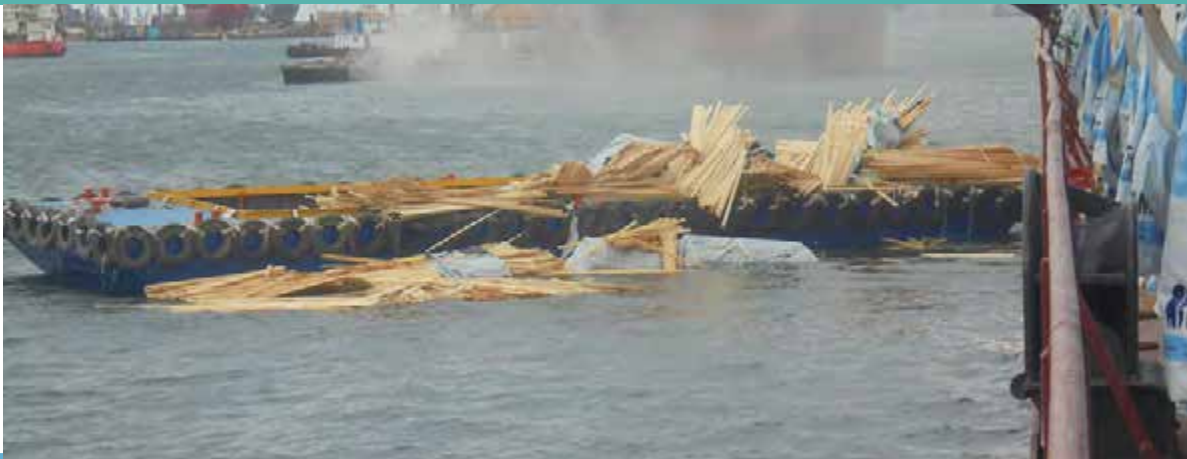
Fatal accident during a cargo discharge at Alexandria Port, Egypt

- ▶ No fall prevention measures in place for crew working on cargo
- ▶ Poor stevedoring practices
- ▶ Insufficient racking strength with deck cargo lashings removed

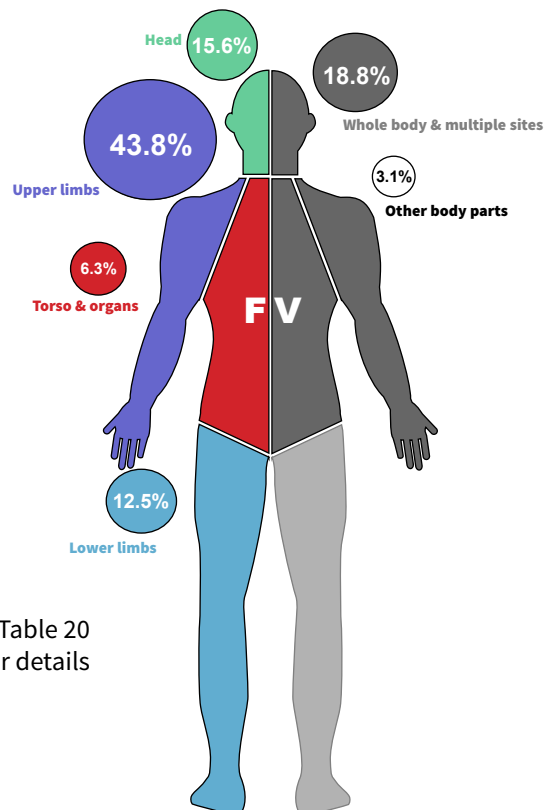
Charts 6 and 7: Deaths and injuries of merchant vessel and fishing vessel crew by part of body injured
