Annual Safety Review 2018

Foreword

Foreword	iii
How we communicate and why.....	3
Investigating UAS accidents	7
CICTT Factors on Investigations by the AAIB in 2018.....	13
Field investigations.....	14
Correspondence investigations.....	15
Fatal investigations	16
Statistics for 2018.....	17
Category Definition.....	18
Notifications 2018.....	19
Notifications 2017.....	20
Notifications 2016.....	21
Safety Recommendations in 2018	23
Safety Actions from investigations reported on in 2018	35
Formal Investigations	35
Special Bulletins.....	38
Field Investigations	40
Correspondence Investigations.....	55
Appendix 1 - CICTT Occurrence Categories.....	67

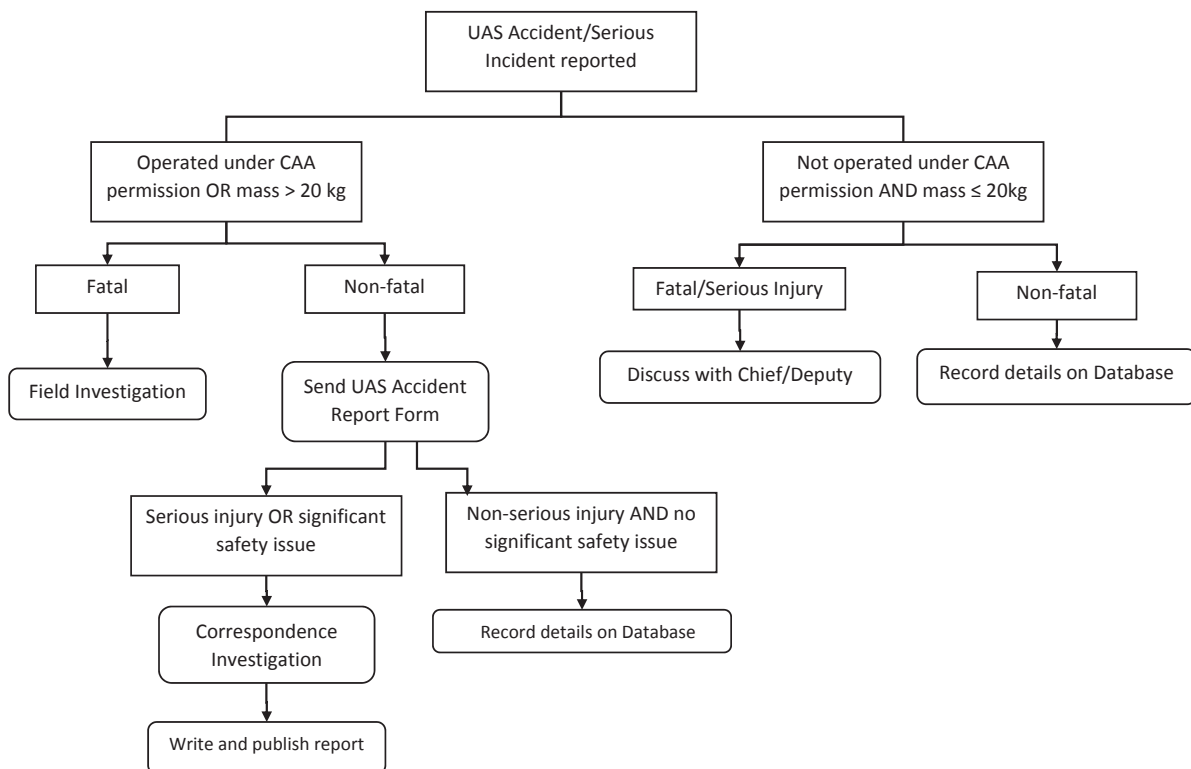
Figure 1
UAS Investigation Decision Tree

If the UAS accident involves a fatality and the UA was being operated under a CAA permission or it was above 20 kg, then the AAIB will deploy a team to the accident site and carry out a field investigation. If it isn't a fatal accident, the AAIB will send a 'UAS Accident Report Form' to the pilot to collect the details. If there was a serious injury or there appears to be a significant safety issue then an investigation by correspondence will be carried out. This might include calling the pilot, analysing any recorded data and contacting the UAS manufacturer. At the end of the investigation a report will be published on our website. If none of these conditions are met then the information will be recorded on our database. Our decision tree for investigating UAS accidents is shown in Figure 1.

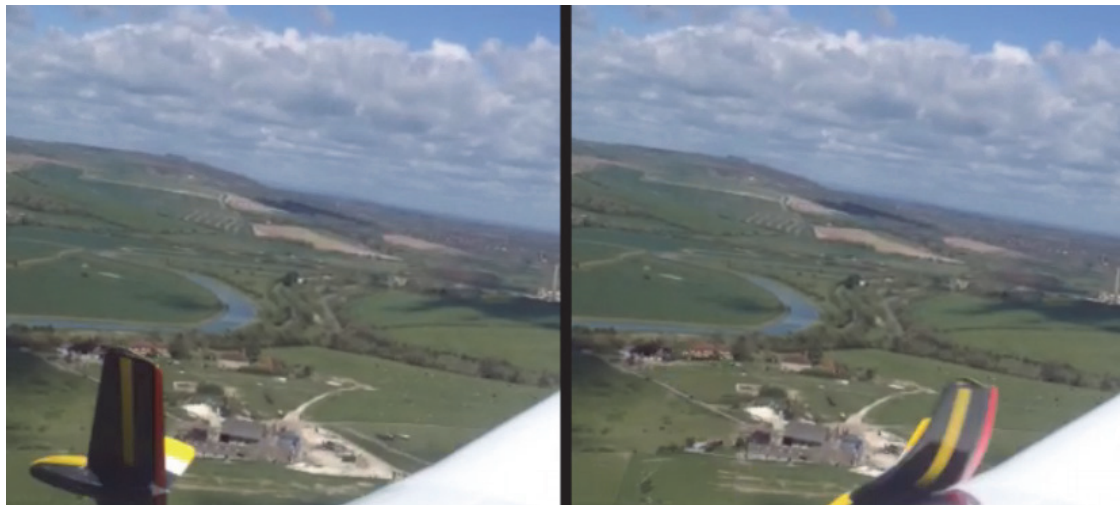
Figure 2

Mid-air collision between SAS Wildthing model glider and Robin DR400 light aircraft

One of the mid-air collisions occurred between an SAS Wildthing model glider (weighing 615 grams) and a Robin DR400 light aircraft near the final approach path to Shoreham airport at about 220 to 320 ft agl. The collision was caught on video and still frames are shown in Figure 2. Despite the light weight of the glider it caused scuffing and scraping damage to the leading edge of the Robin's wing which cost £1,400 to repair. The full report can be found [on our website](#)⁵. The other mid-air collision between a model glider and a light manned aircraft occurred in uncontrolled airspace away from an airfield at about 600 ft agl and the report can be found [on our website](#)⁶. In both mid-air collisions, the pilots of the model gliders heard the light aircraft approaching but by then it was too late for them to take avoiding action. Both pilots of the light aircraft initially thought they had hit a bird. The third mid-air collision reported to the AAIB was a collision between two UA.

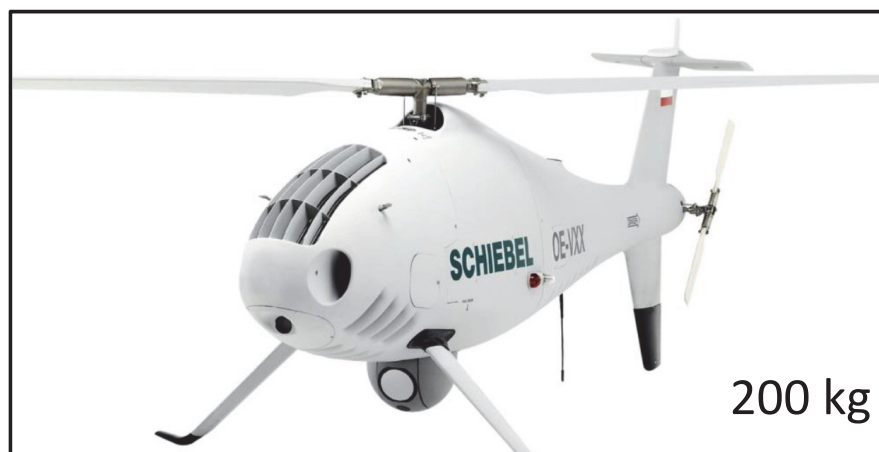
Figure 3

Schiebel Camcopter S-100 unmanned helicopter

Table 2 lists the type of UA that was involved in the 36 accidents in Table 1. The vast majority were multirotor UA. The accident involving the single rotor UA was a Schiebel Camcopter S-100 unmanned helicopter. It had a maximum takeoff weight of 200 kg (Figure 3). While taking off from a ship's helideck it transited rearwards with insufficient height to clear a 19-cm high gunwale. It hit the gunwale causing damage to its tail and resulting in it spiralling into the sea. The aircraft manufacturer came up with a software fix that prevented inadvertent pilot lateral control inputs during the initial phase of takeoff.

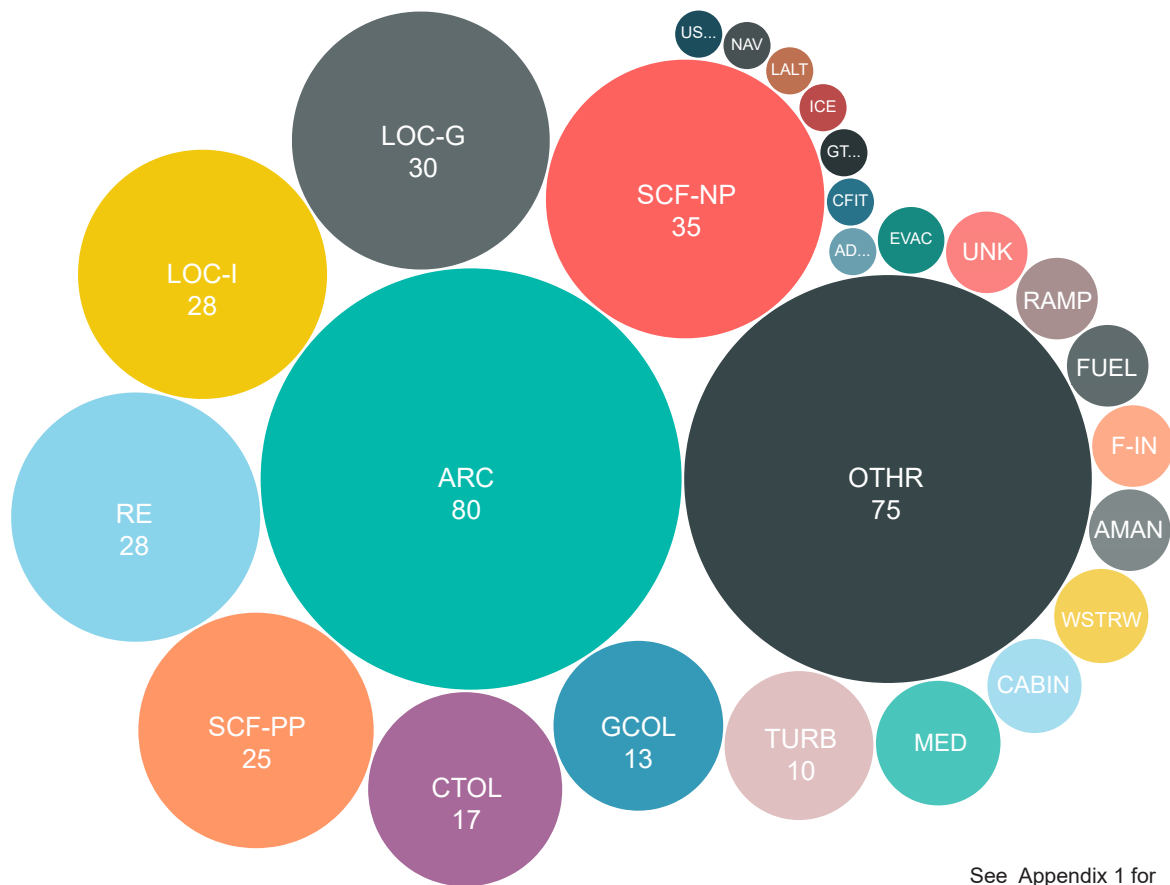
Factors for correspondence investigations reported on by AAIB in 2018

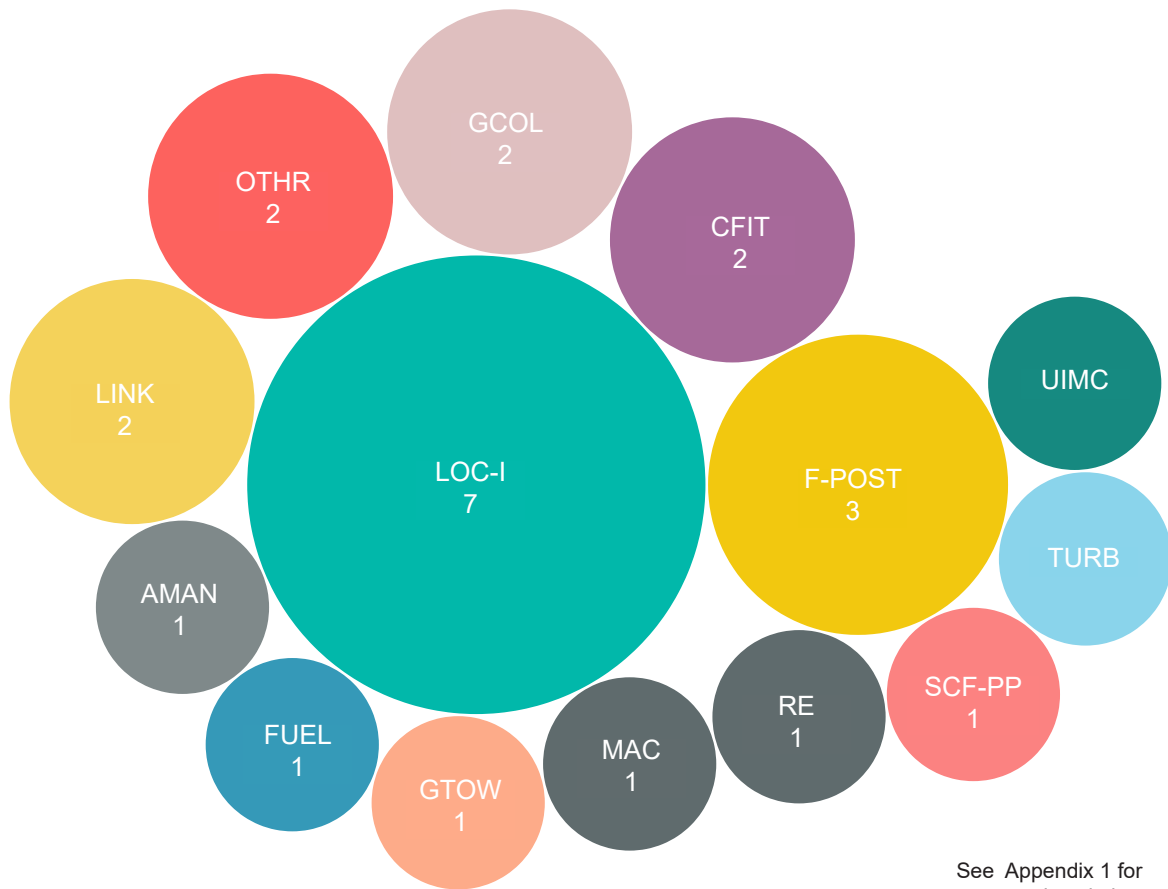
Factors for fatal investigations reported on by AAIB in 2018

The predominant cause of fatal accidents in general aviation, in common with previous years, was loss of control in flight (LOC-I). However, other factors were also identified during our investigations. The post-crash fire (F-POST) is a factor which relates to survivability for the occupants once they are on the ground.

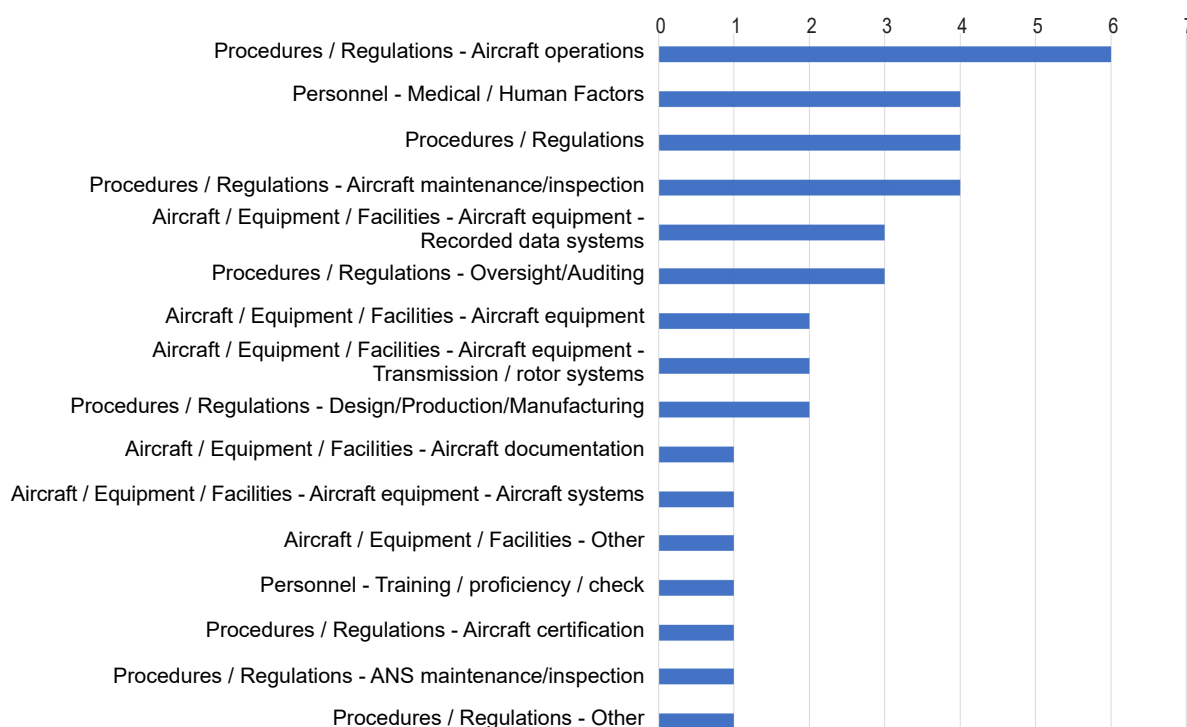
Safety Recommendation Topics

The chart above shows the recommendation topics. It should be noted that a recommendation can encompass several topics within the classification system.

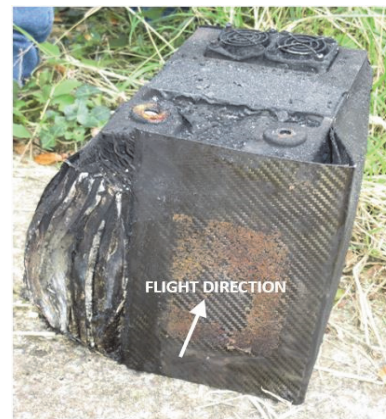
The existing fleet of FES batteries was withdrawn from use and is currently being refurbished to a new design standard, to which new production batteries are also being produced. The new design standard includes replacement of the battery case with a stronger glass fibre case, constructed using high-temperature resin, that has been demonstrated in testing to remain structurally intact during a battery fire. The new battery case also features an impact label that permanently records if the battery has been subjected to a shock loading of 50g or more, to allow the battery to be withdrawn from use for inspection if subjected to abuse.

The new FES battery features additional nomex-mylar insulation between the cells and an increased quantity of silicone encapsulation of the battery cells to prevent foreign objects from falling between the cells. The edges of the battery cells pouches are covered in an electrically-insulating tape to prevent electrical discharge of the cell should the cell pouch seal fail. The stainless steel battery cell connector plates have been replaced with anodized aluminium plates which have been demonstrated not to eject machining swarf from screw threads when the connector screws are inserted during assembly.

The HPH 304 eS sailplane manufacturer has replaced the composite battery compartment forward bulkhead with a stainless steel bulkhead to improve the fire-resistance of the bulkhead in the event of a battery compartment fire. The internal surfaces of the battery compartment are now painted in an intumescent fireproof paint finish.

Sailplanes equipped with the FES system also now feature a pressure-relief valve in the battery compartment cover, designed to allow the cover to remain attached to the sailplane in the event of over-pressurisation of the battery compartment should a battery fire occur.
