# **Annual Safety Review 2018**

## Foreword

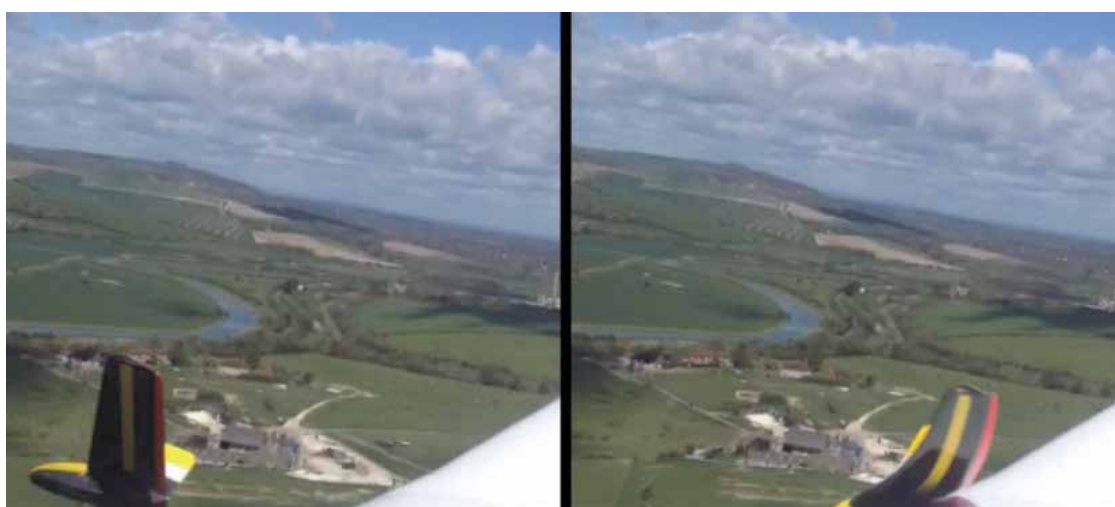
**Figure 2**

Mid-air collision between SAS Wildthing model glider and Robin DR400 light aircraft

One of the mid-air collisions occurred between an SAS Wildthing model glider (weighing 615 grams) and a Robin DR400 light aircraft near the final approach path to Shoreham airport at about 220 to 320 ft agl. The collision was caught on video and still frames are shown in Figure 2. Despite the light weight of the glider it caused scuffing and scraping damage to the leading edge of the Robin's wing which cost £1,400 to repair. The full report can be found [on our website](#)<sup>5</sup>. The other mid-air collision between a model glider and a light manned aircraft occurred in uncontrolled airspace away from an airfield at about 600 ft agl and the report can be found [on our website](#)<sup>6</sup>. In both mid-air collisions, the pilots of the model gliders heard the light aircraft approaching but by then it was too late for them to take avoiding action. Both pilots of the light aircraft initially thought they had hit a bird. The third mid-air collision reported to the AAIB was a collision between two UA.

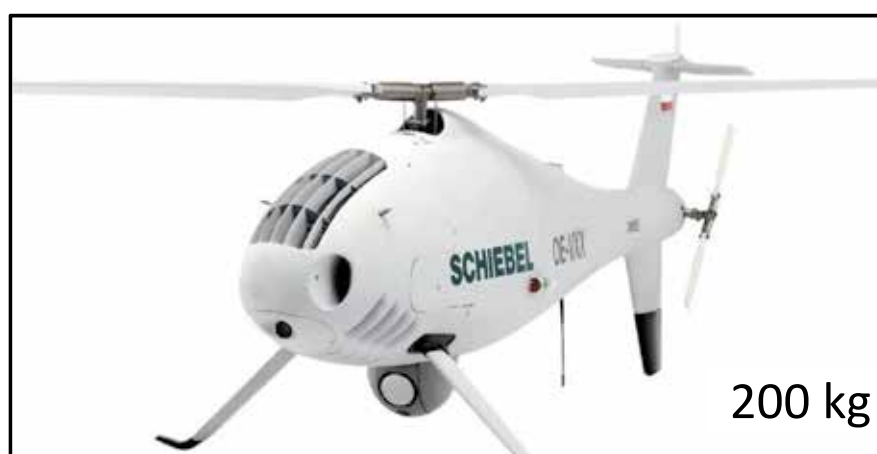
**Figure 3**

Schiebel Camcopter S-100 unmanned helicopter

Table 2 lists the type of UA that was involved in the 36 accidents in Table 1. The vast majority were multirotor UA. The accident involving the single rotor UA was a Schiebel Camcopter S-100 unmanned helicopter. It had a maximum takeoff weight of 200 kg (Figure 3). While taking off from a ship's helideck it transited rearwards with insufficient height to clear a 19-cm high gunwale. It hit the gunwale causing damage to its tail and resulting in it spiralling into the sea. The aircraft manufacturer came up with a software fix that prevented inadvertent pilot lateral control inputs during the initial phase of takeoff.

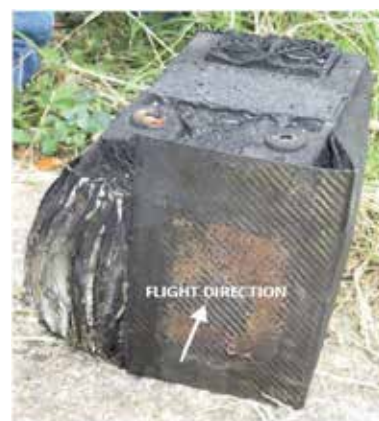
The existing fleet of FES batteries was withdrawn from use and is currently being refurbished to a new design standard, to which new production batteries are also being produced. The new design standard includes replacement of the battery case with a stronger glass fibre case, constructed using high-temperature resin, that has been demonstrated in testing to remain structurally intact during a battery fire. The new battery case also features an impact label that permanently records if the battery has been subjected to a shock loading of 50g or more, to allow the battery to be withdrawn from use for inspection if subjected to abuse.

The new FES battery features additional nomex-mylar insulation between the cells and an increased quantity of silicone encapsulation of the battery cells to prevent foreign objects from falling between the cells. The edges of the battery cells pouches are covered in an electrically-insulating tape to prevent electrical discharge of the cell should the cell pouch seal fail. The stainless steel battery cell connector plates have been replaced with anodized aluminium plates which have been demonstrated not to eject machining swarf from screw threads when the connector screws are inserted during assembly.

The HPH 304 eS sailplane manufacturer has replaced the composite battery compartment forward bulkhead with a stainless steel bulkhead to improve the fire-resistance of the bulkhead in the event of a battery compartment fire. The internal surfaces of the battery compartment are now painted in an intumescent fireproof paint finish.

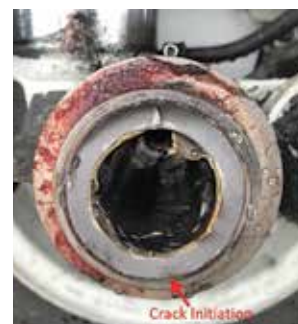
In addition, the MRO is carrying out Barkhausen inspections on all 12 Boeing 737NG NLGs that were overhauled during the one-year period covering six months before and after the date of EI-DLV's NLG overhaul. These inspections are carried out on the aircraft, on the line, after removing the wheel and bearings. Out of these 12, nine have already been inspected and no evidence of abusive grinding was found.

The nosewheel was found to have separated from the aircraft because the nose landing gear axle had failed at the left inboard journal (the part of the axle that rests on bearings). This was the result of heat-induced cracking and material property changes due to abusive grinding of the chrome plate during the part's last overhaul almost three years earlier. The Maintenance and Repair Organisation (MRO) that performed the overhaul has introduced a new inspection for detecting abusive grinding.

To ensure that any abusive grinding is detected, the MRO of EI-DLV has introduced a new process to perform a Barkhausen inspection on all journals after grinding. The MRO has also introduced a Barkhausen inspection early in the overhaul process, prior to the Nital etch test.
