Construction noise and vibration Monthly Report – May 2019

London Borough of Camden

Non-technical summary

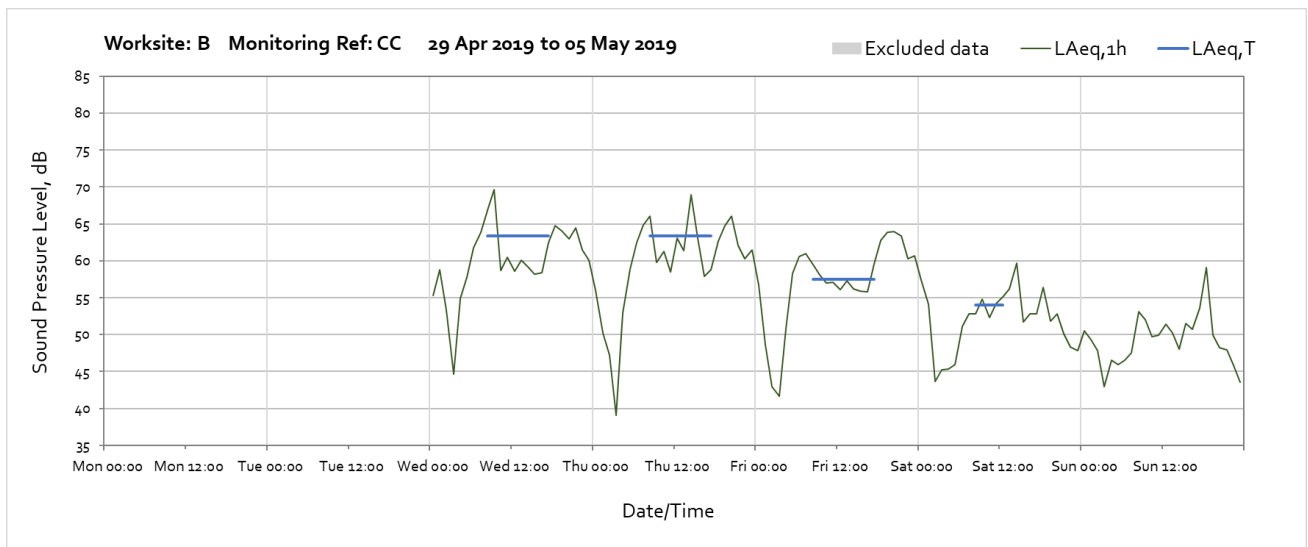
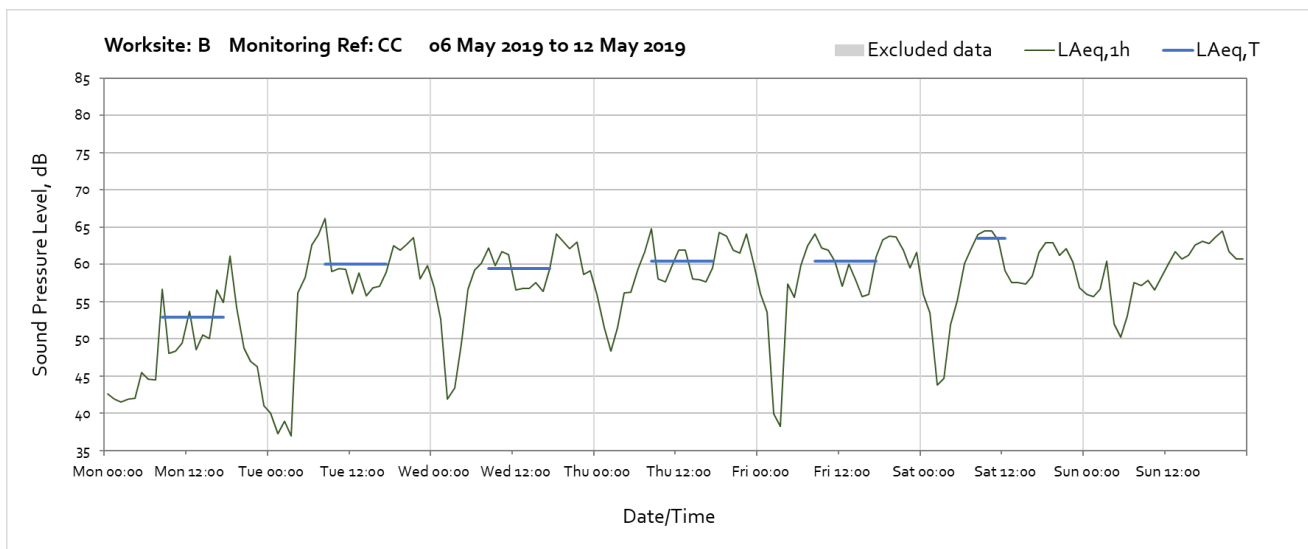
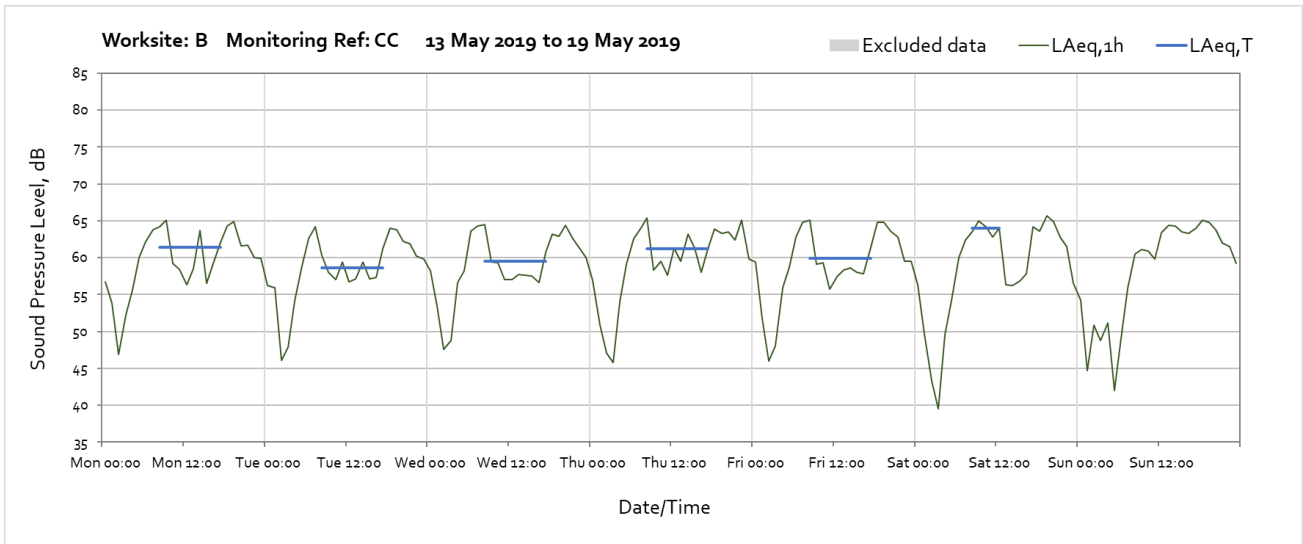
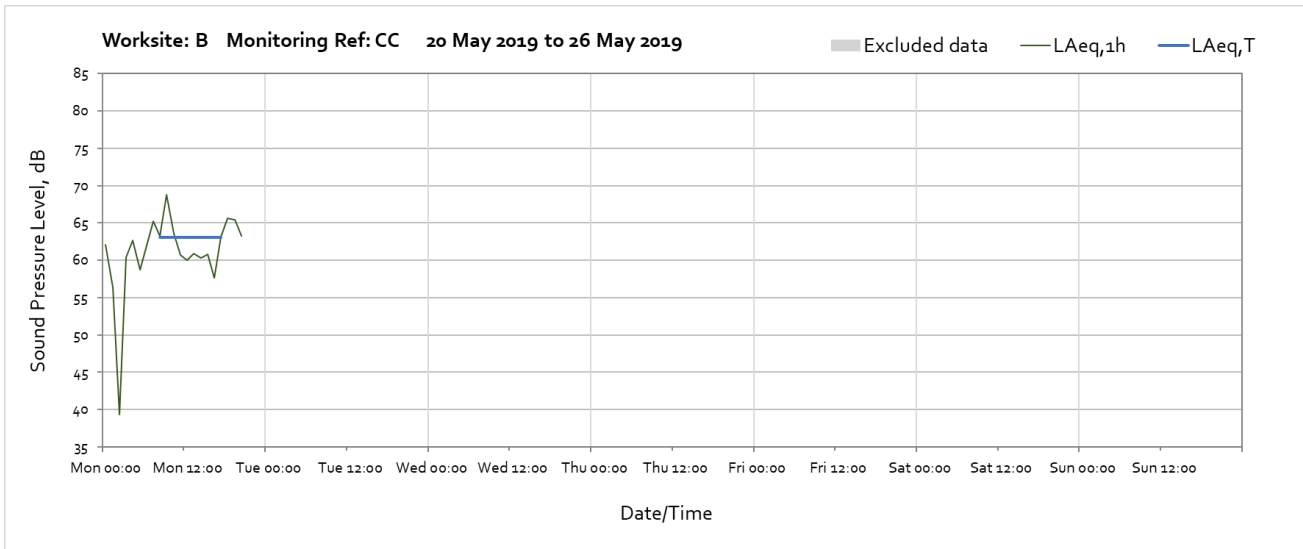
Worksite: B – Monitoring Ref: CC

The following graphs show the hourly measured ambient noise level $L_{Aeq,1h}$ and, where relevant, the averaged noise level $L_{Aeq,T}$ values, where the time period T is as specified in Table 1 of HS2 Information Paper E23. Periods with adversely weather affected noise levels are greyed out and have been excluded from the calculation of the $L_{Aeq,T}$ values in Table 5.

Note: Missing data from 20:00 on Monday 20th were due to a power cut affecting the site.

2.2.4 Appendix C presents graphs of noise and vibration monitoring data over the month for each of the measurement locations. Noise data presented consist of the hourly L_{Aeq} values and, where relevant, the $L_{Aeq,T}$ values (where the time period T has been taken to be the averaging period as specified in Table 1 of HS2 Information Paper E23). Vibration data presented consist of hourly PPV values. The full data set for the monitoring equipment can be found at the following location: <https://data.gov.uk/dataset/24542ae7-dd44-444f-b259-871c4cc43b5e/environmental-monitoring-data>.

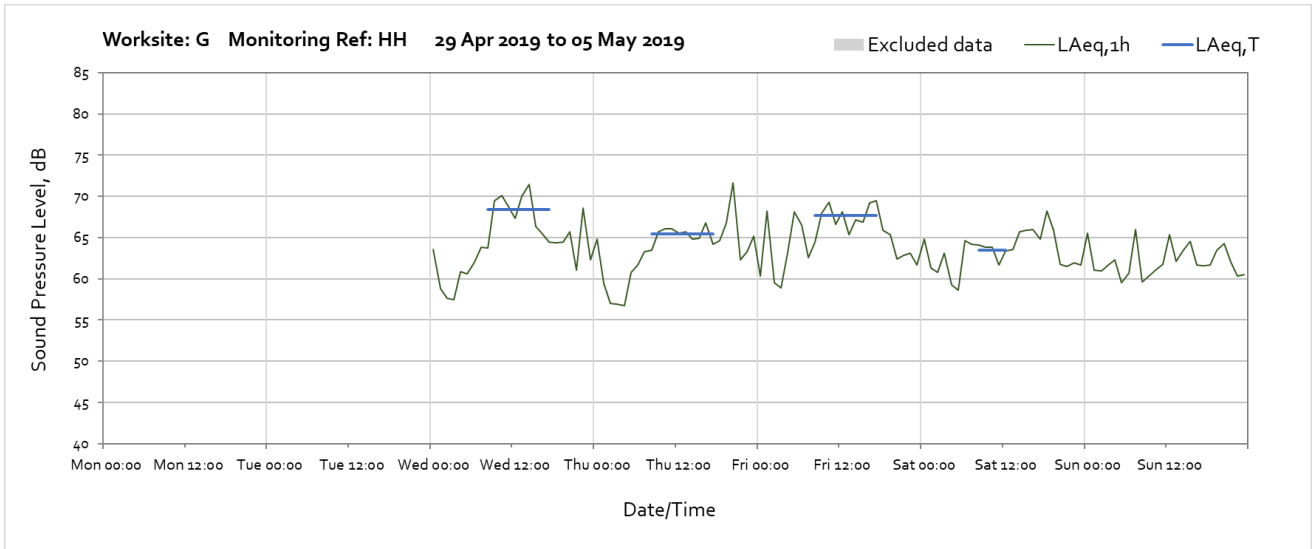
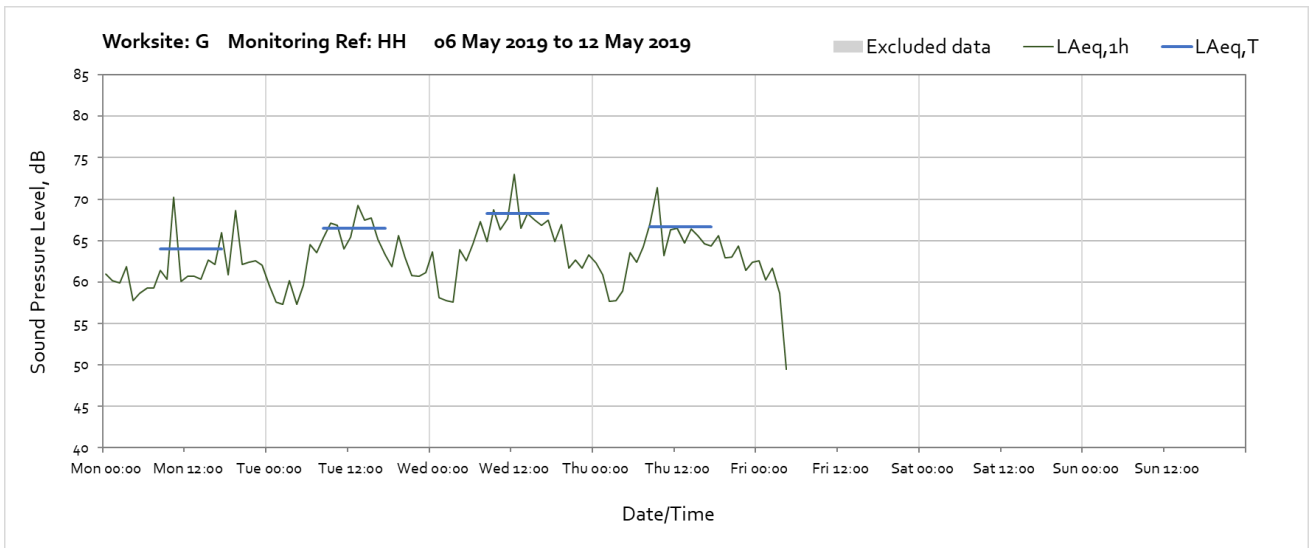
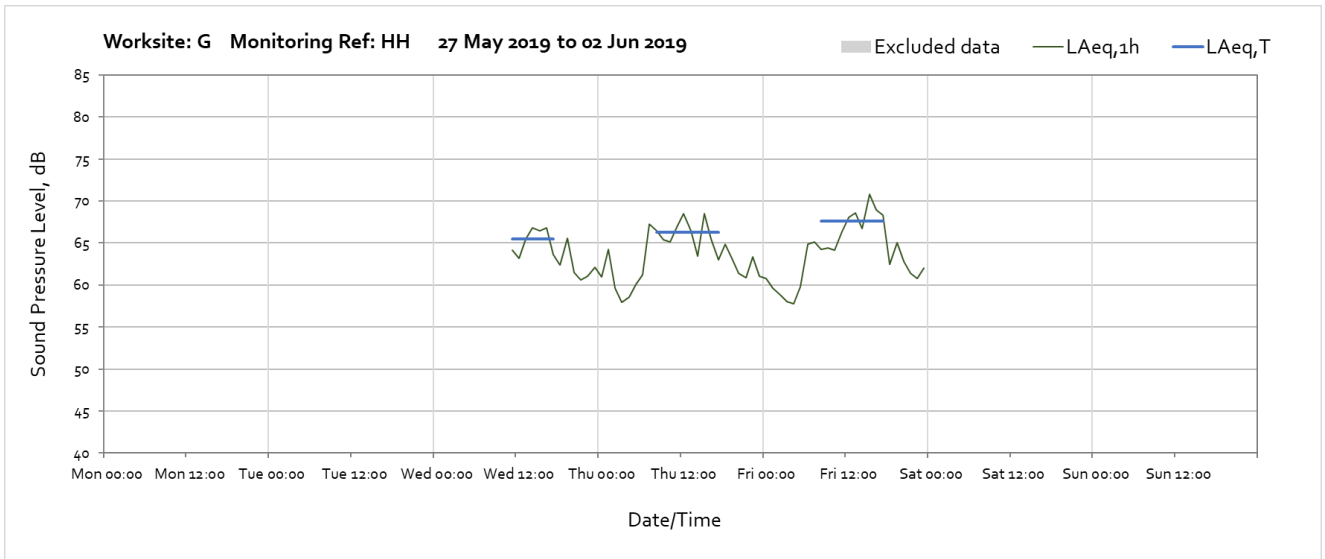
Worksite: G – Monitoring Ref: HH

Note: Missing data between 04:00 on Friday 10th and 11:00 on Wednesday 29th were due to a power cut affecting the site.

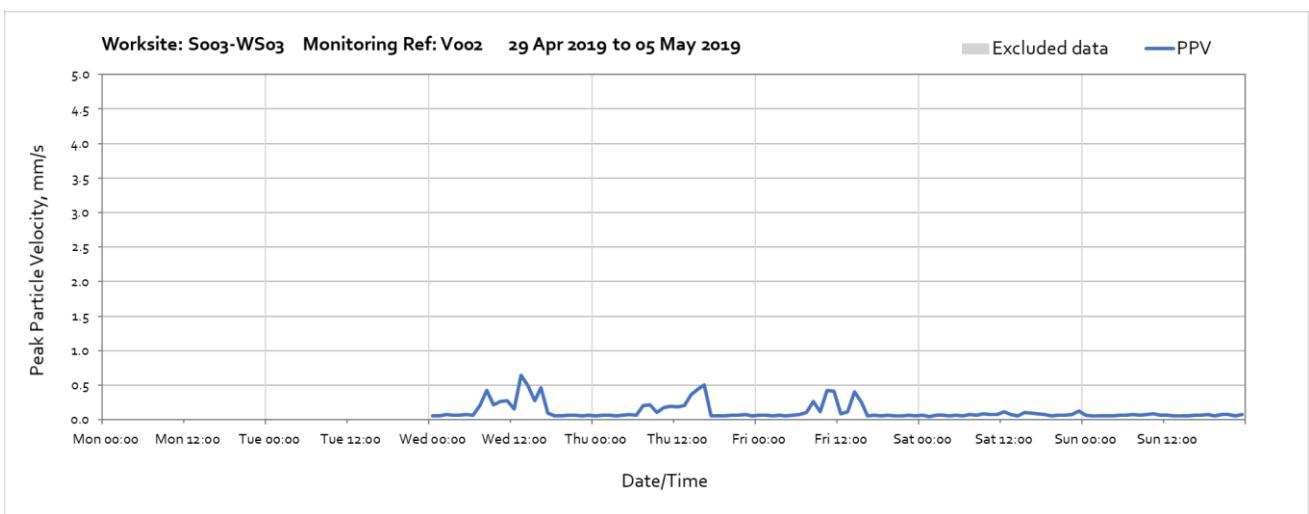
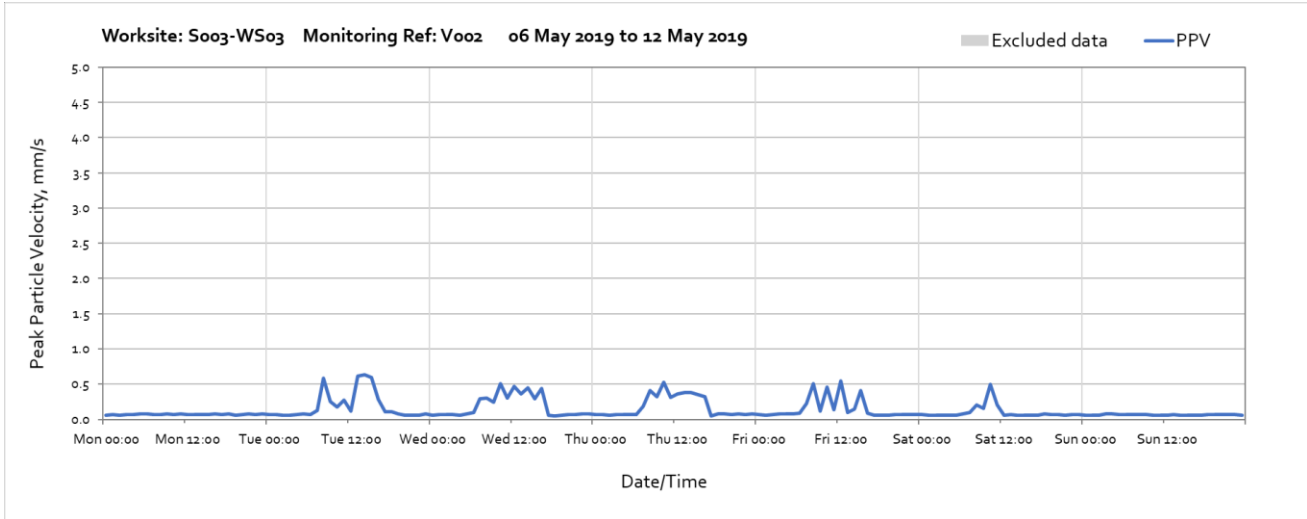
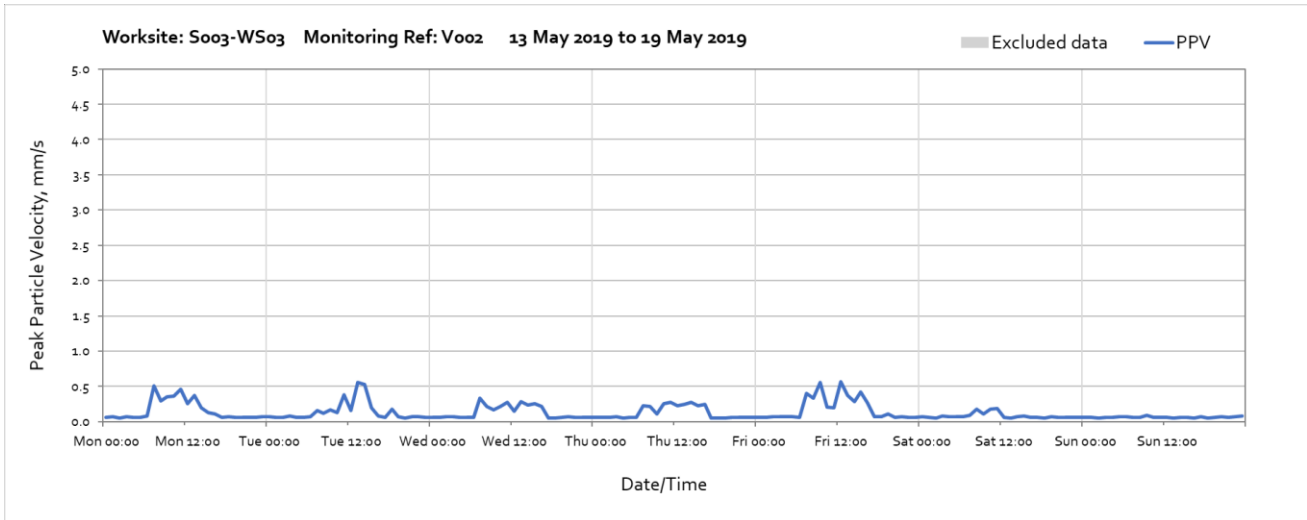
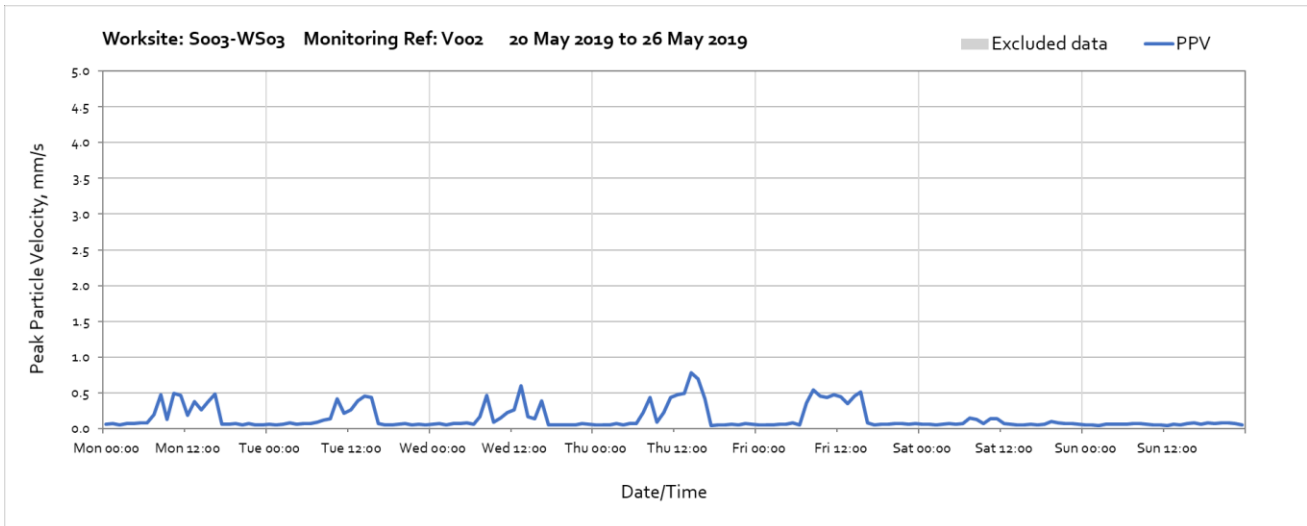
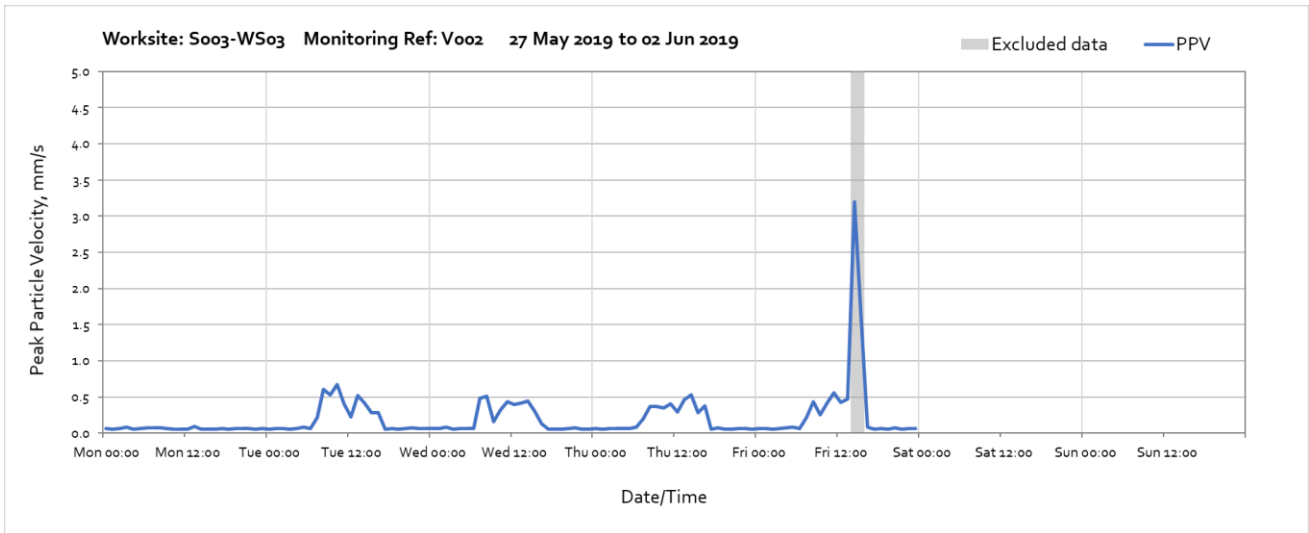
Worksite: S003-WS03 – Monitoring Ref: V002

The following graphs show the hourly measured peak particle velocity PPV recorded during the monitoring period. The graphs show the resultant PPV due to vibration components on three orthogonal axis x, y and z. High values of PPV were measured on occasions at V021. These were due to local interference with the vibration monitor and are not representative of HS2 construction works. These data entries have been greyed out in the following charts and have been excluded to calculate values in Table 6.

Note: The cause of high vibration levels at 14:00 and 15:00 on Friday 31st is unknown, but there were no HS2 construction activities ongoing at that time that are likely to have caused such levels of vibration. These are not considered representative of HS2 construction vibration levels at this location.

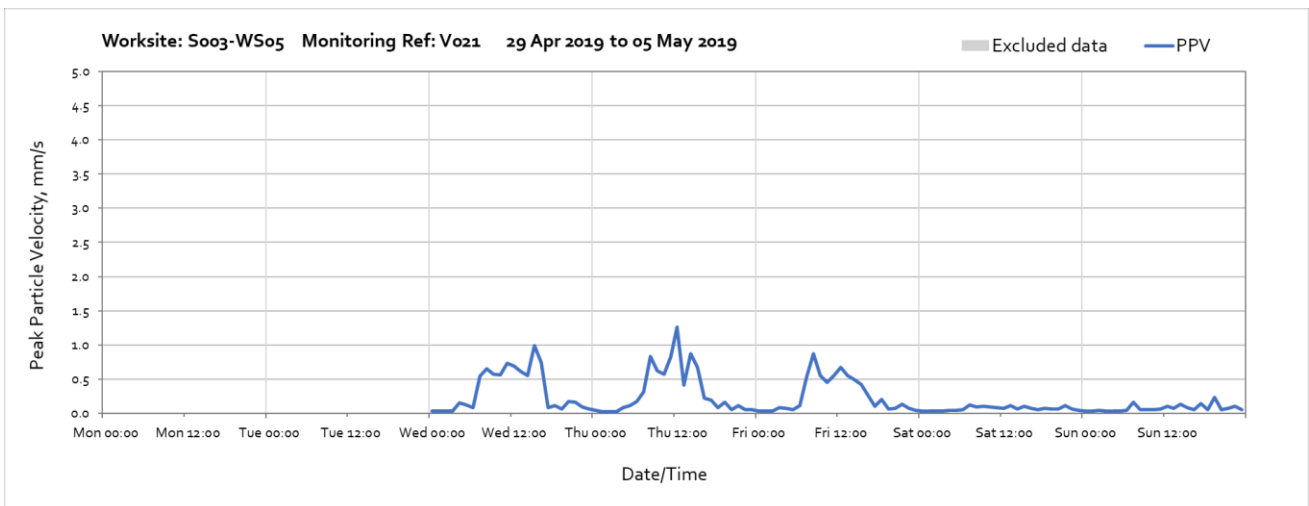
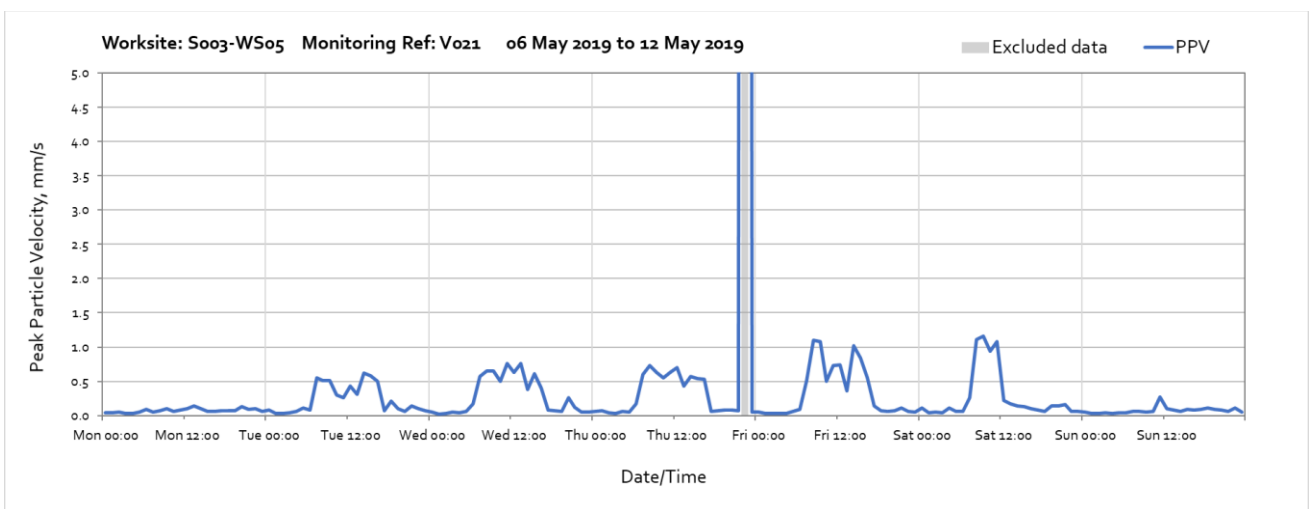
Worksite: S003-WS05 – Monitoring Ref: V021

Note: High vibration levels at 22:00 on Thursday 9th were due to local disturbance of the vibration monitor and are not representative of HS2 construction vibration levels at this location.

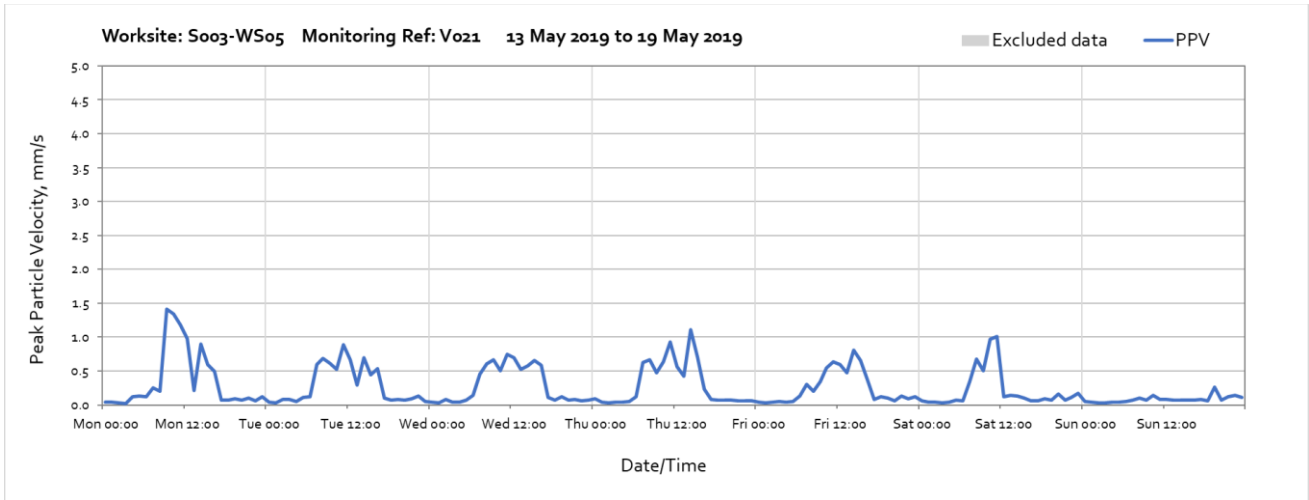
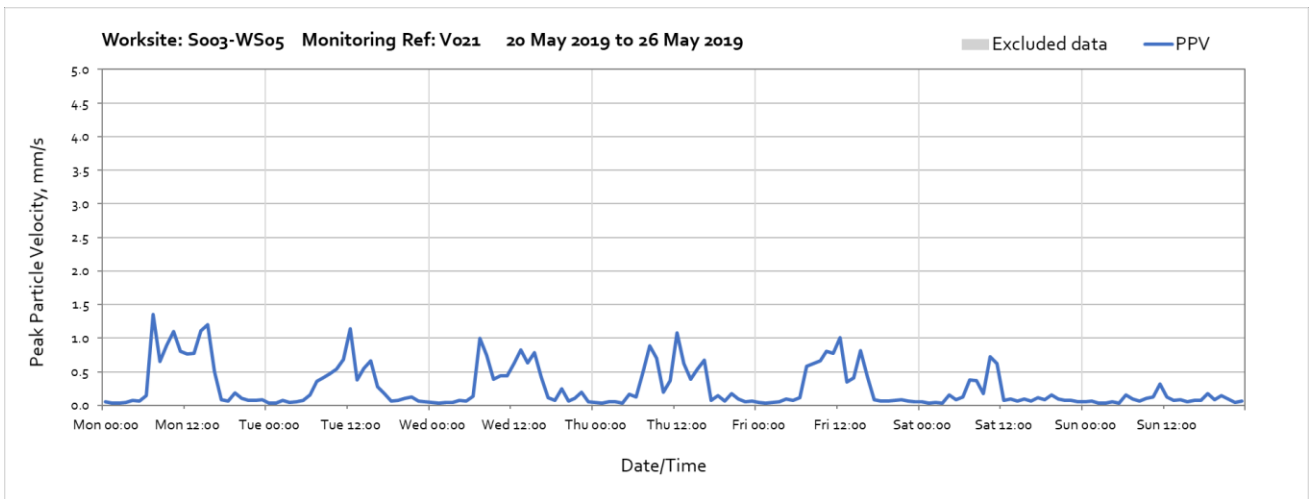
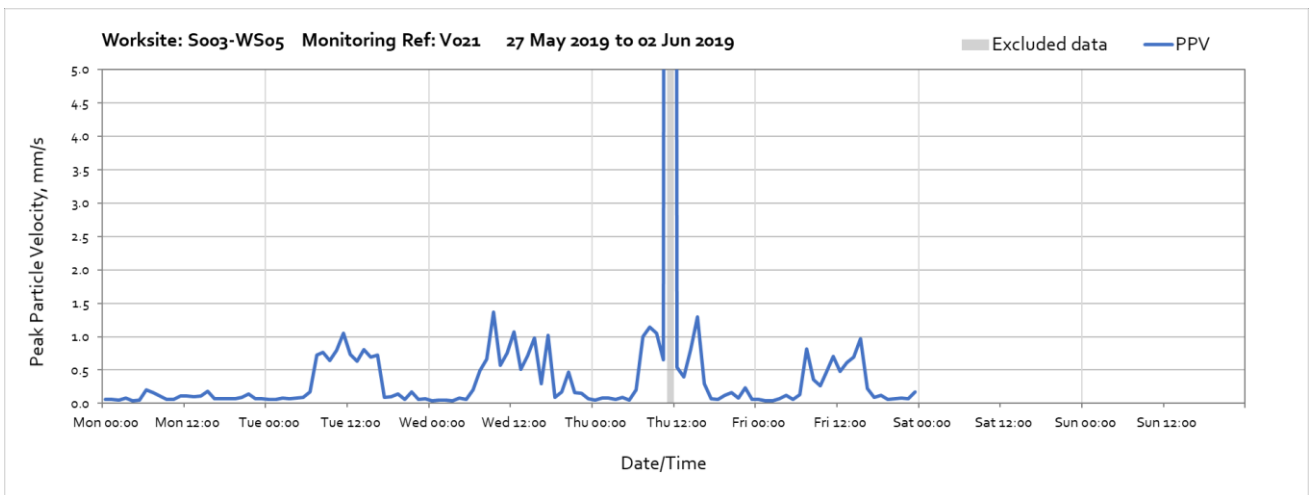
Note: High vibration levels at 23:00 on Thursday 30th were due to local disturbance of the vibration monitor and are not representative of HS2 vibration levels.
