Construction noise and vibration Monthly Report – August 2019

London Borough of Camden

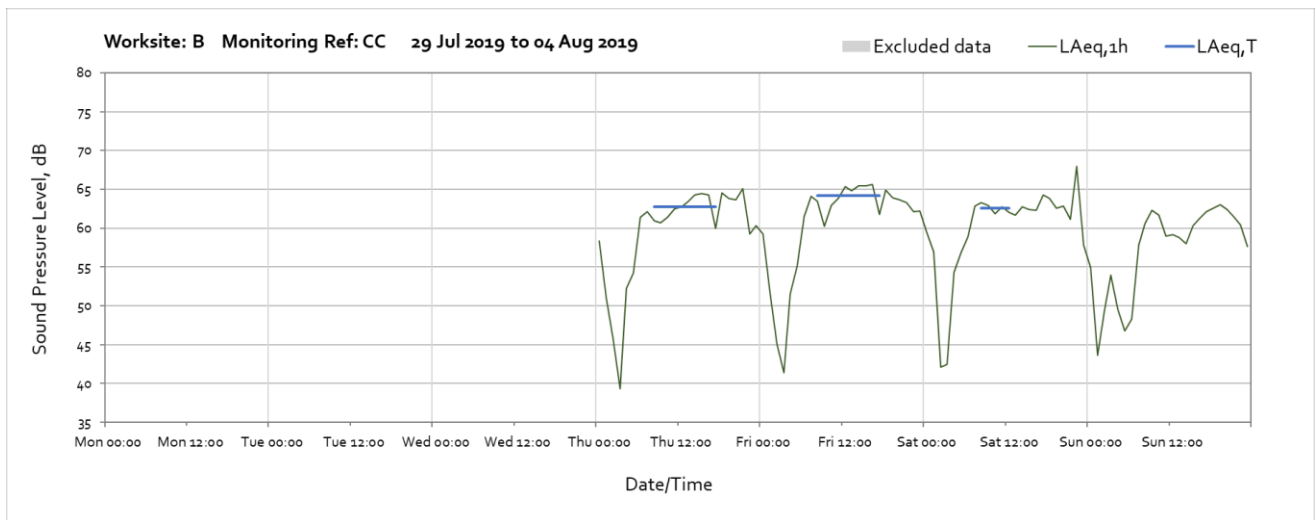
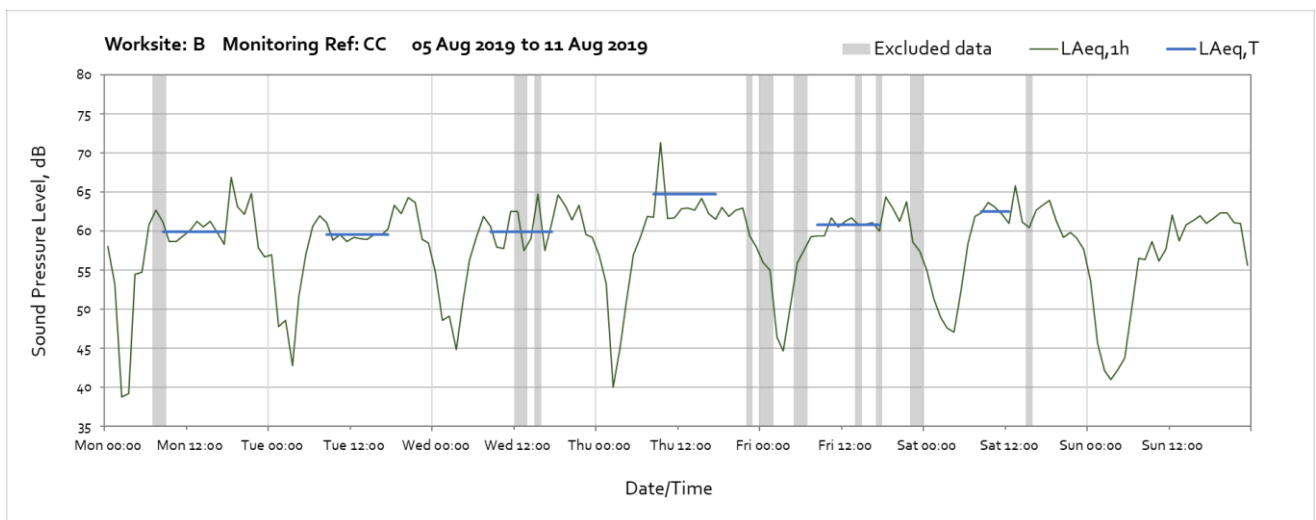
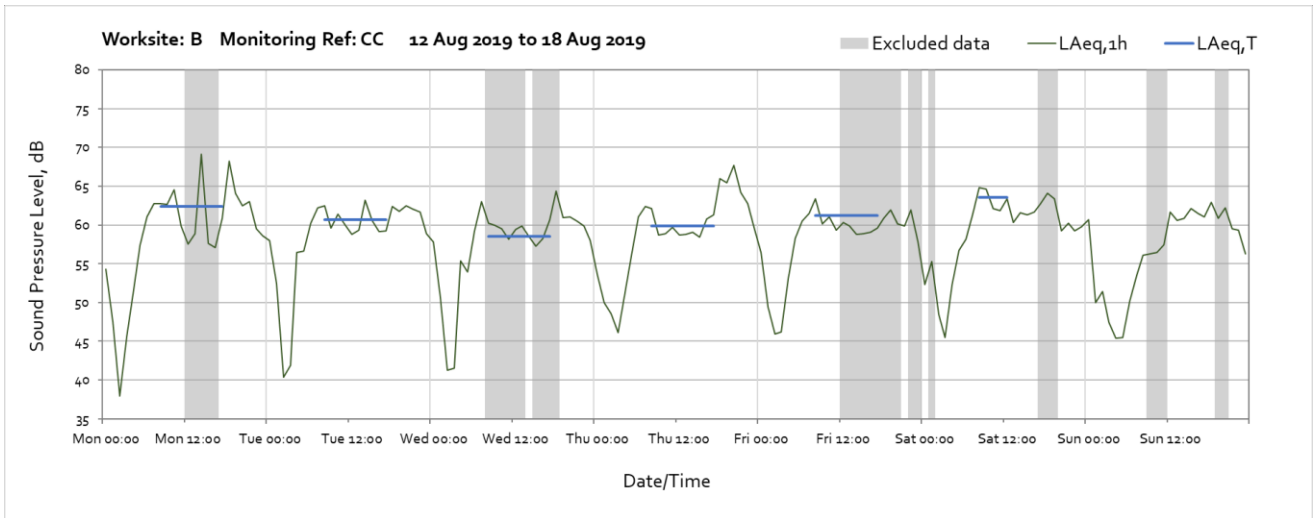
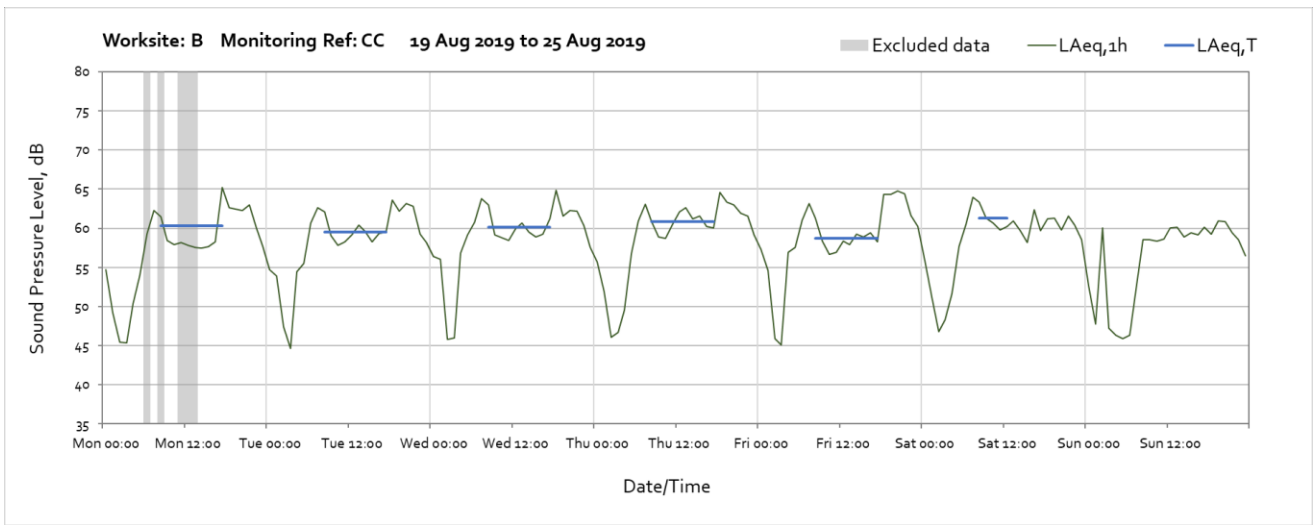
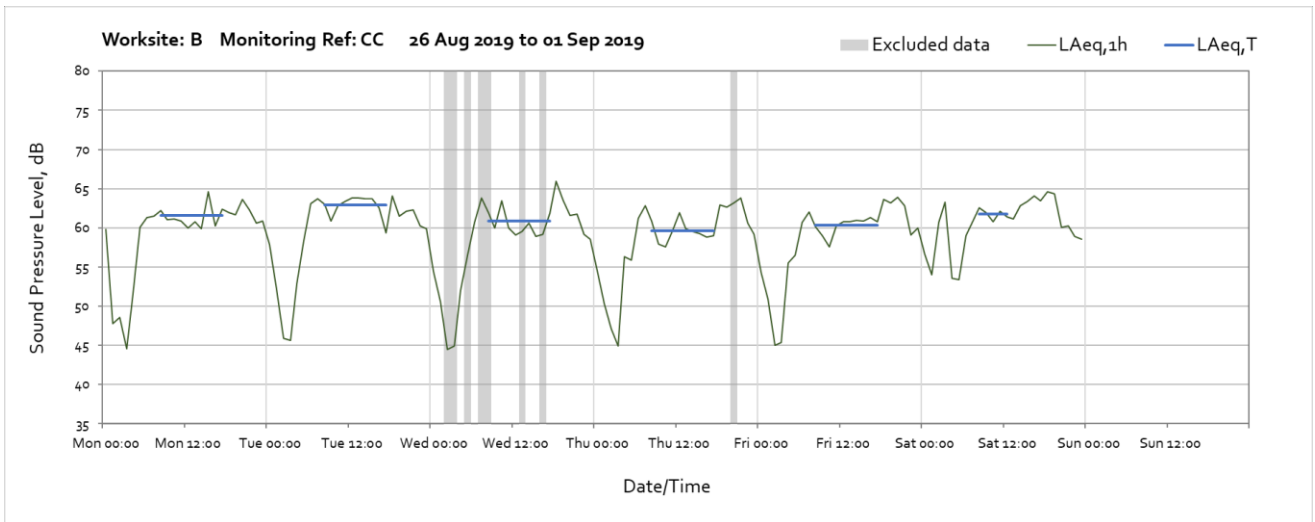
Worksite: B – Monitoring Ref: CC

The following graphs show the hourly measured ambient noise level $L_{Aeq,1h}$ and, where relevant, the averaged noise level $L_{Aeq,T}$ values, where the time period T is as specified in Table 1 of HS2 Information Paper E23. Periods with adversely weather affected noise levels are greyed out and have been excluded from the calculation of the $L_{Aeq,T}$ values in Table 5.

2.2.4 Appendix C presents graphs of noise and vibration monitoring data over the month for each of the measurement locations. Noise data presented consists of the hourly L_{Aeq} values and, where relevant, the $L_{Aeq,T}$ values (where the time period T has been taken to be the averaging period as specified in Table 1 of HS2 Information Paper E23). Vibration data presented consist of hourly PPV values. The full data set for the monitoring equipment can be found at the following location: <https://data.gov.uk/dataset/24542ae7-dd44-444f-b259-871c4cc43b5e/environmental-monitoring-data>.

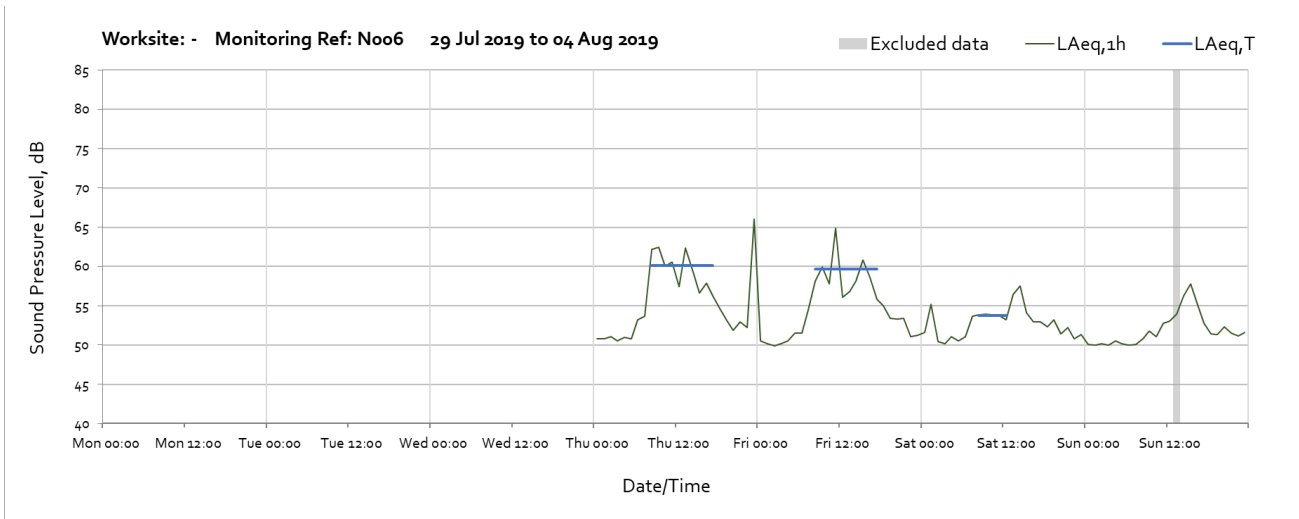
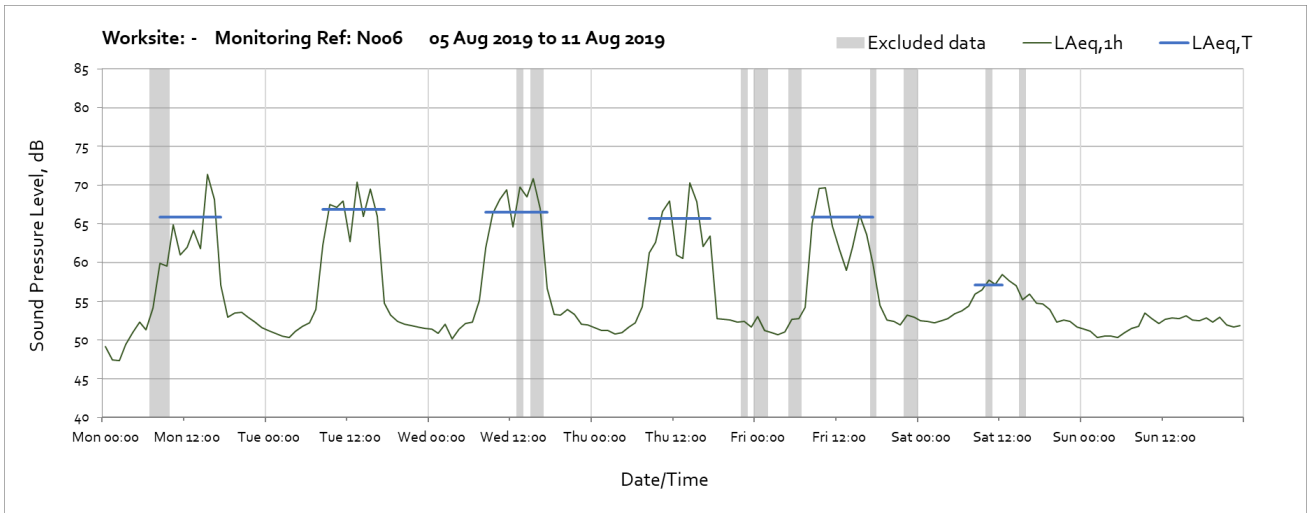
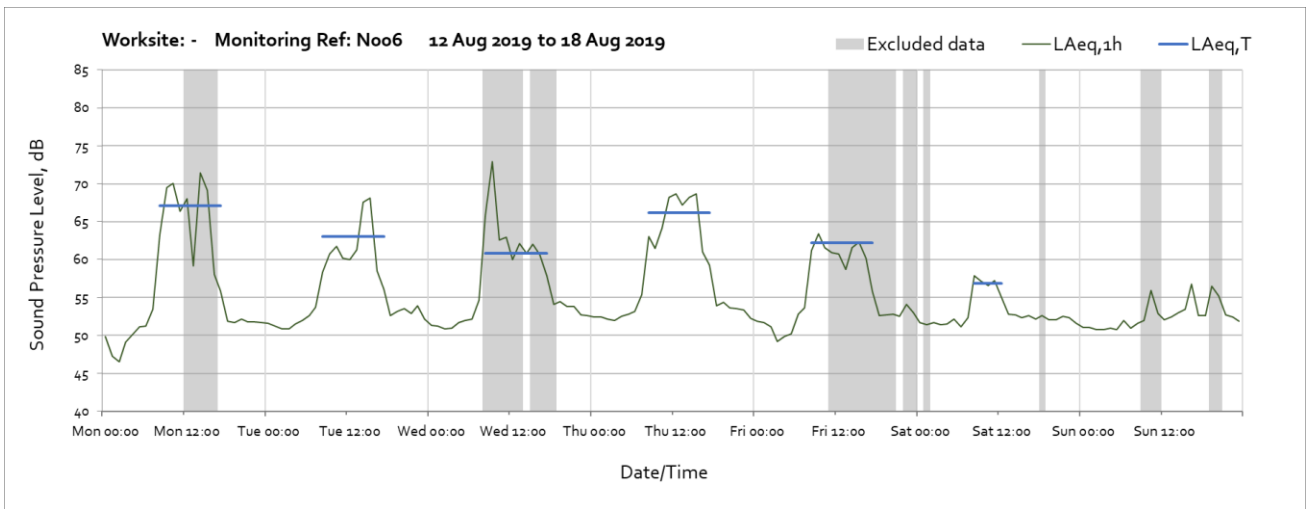
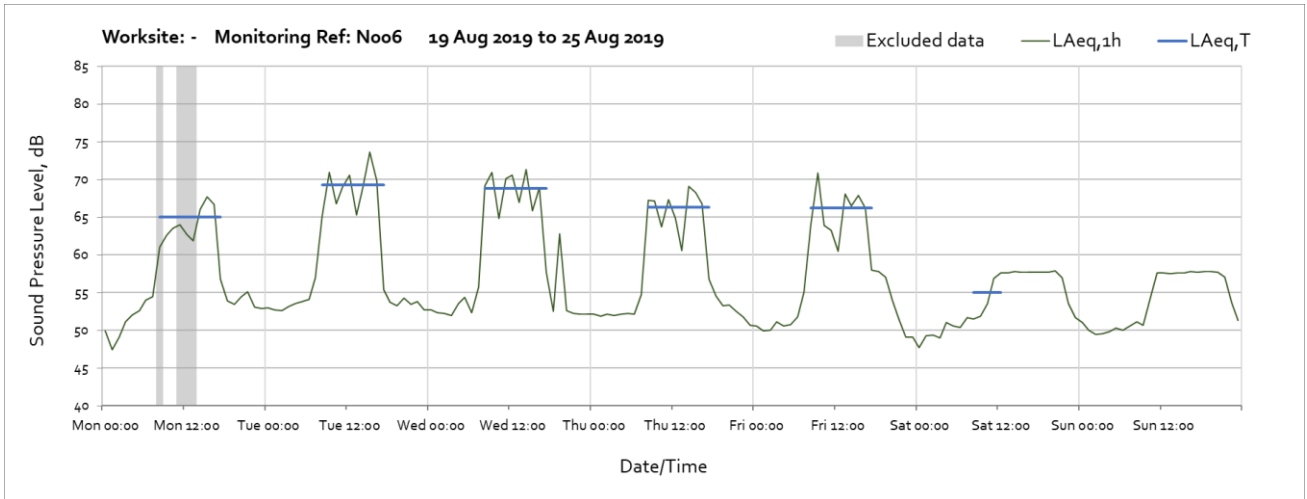
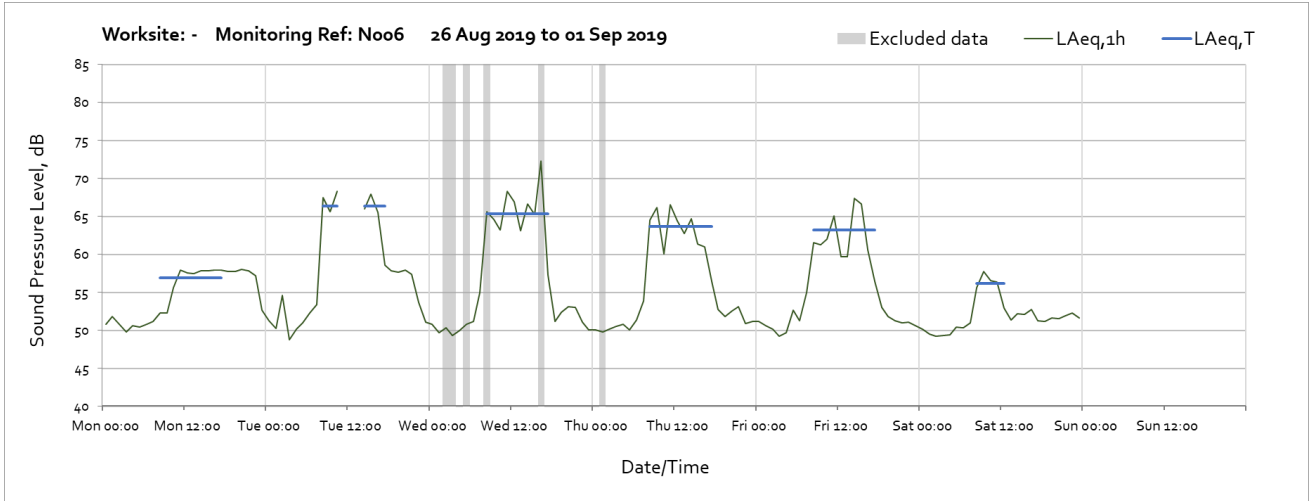
Worksite: S003-WS03 – Monitoring Ref: N006

Note: missing data between 11:00 and 14:00 on Tuesday 27th of August was due to temporary switch off to allow changes of the monitoring configuration.

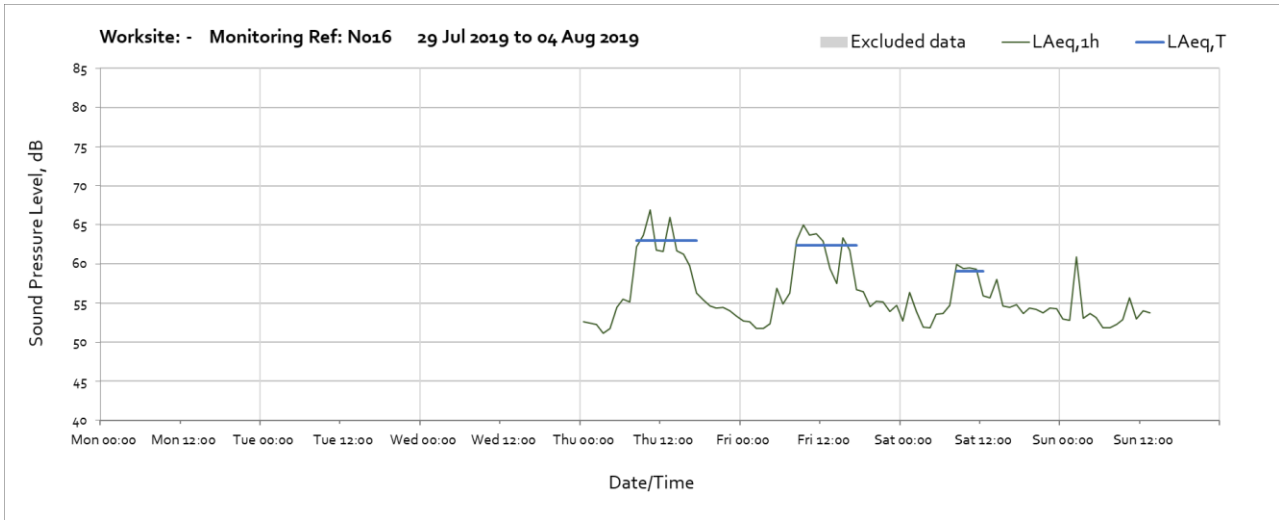
Worksite: S003-WS06 – Monitoring Ref: N016

Note: missing data between 14:00 on Sunday 4th and 15:00 on Monday 5th of August was due to a cut of the monitor power supply.

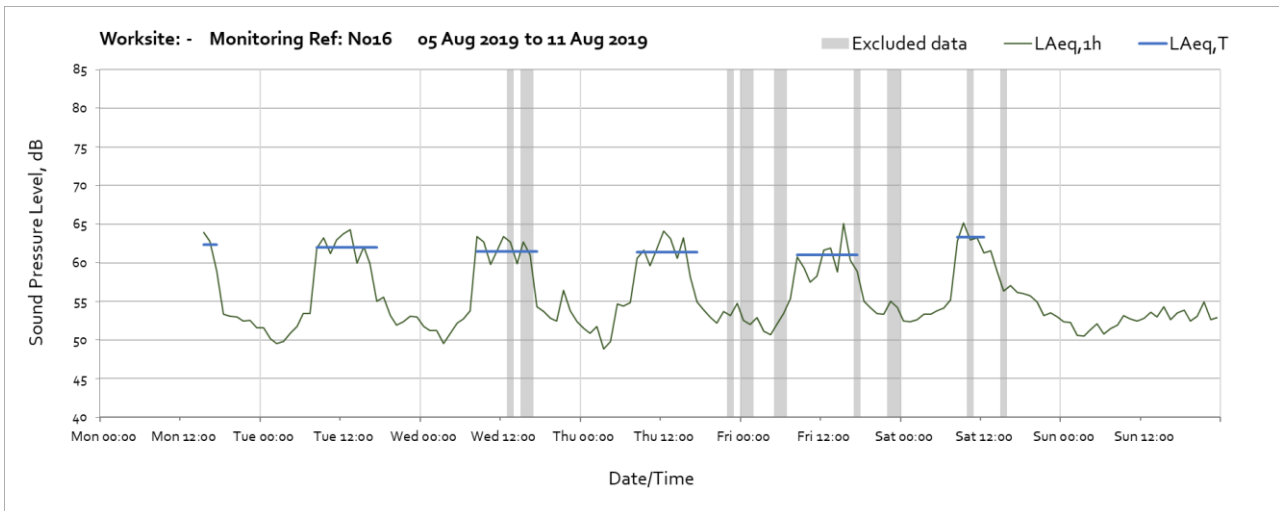
Note: missing data between 14:00 on Sunday 4th and 15:00 on Monday 5th of August was due to a cut of the monitor power supply.

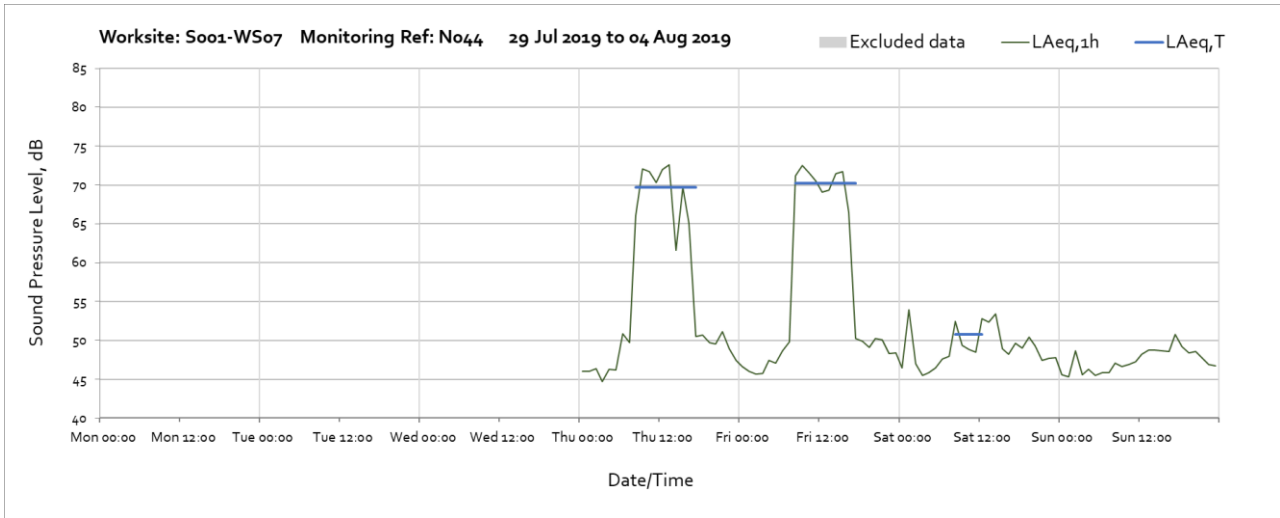
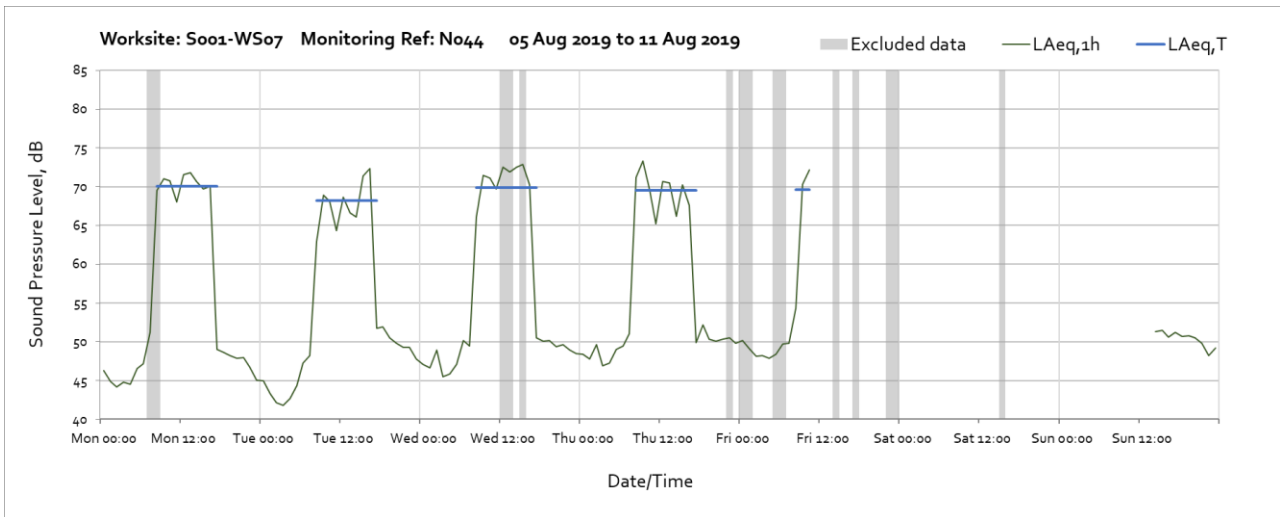
Worksite: S003-WS07 – Monitoring Ref: N044

Note: Missing data between 11:00 on Friday 9th and 14:00 on Sunday 11th of August was due to the monitor not being restarted following a change of configuration.

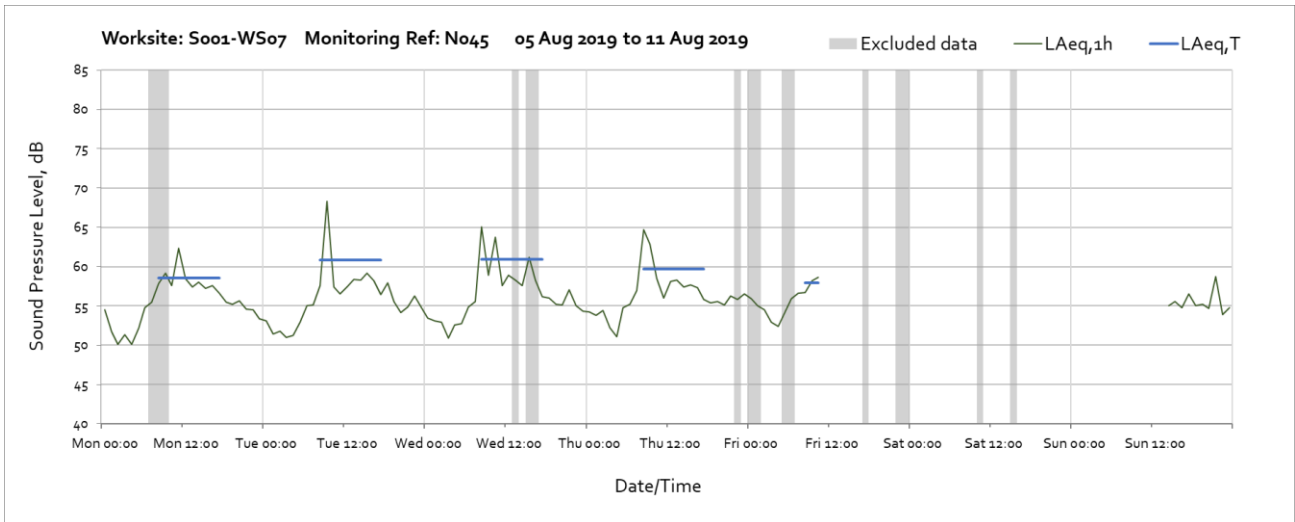
Worksite: S003-WS07 – Monitoring Ref: N045

Note: Missing data between 11:00 on Friday 9th and 13:00 on Sunday 11th of August was due to the monitor not being restarted following a change of configuration.

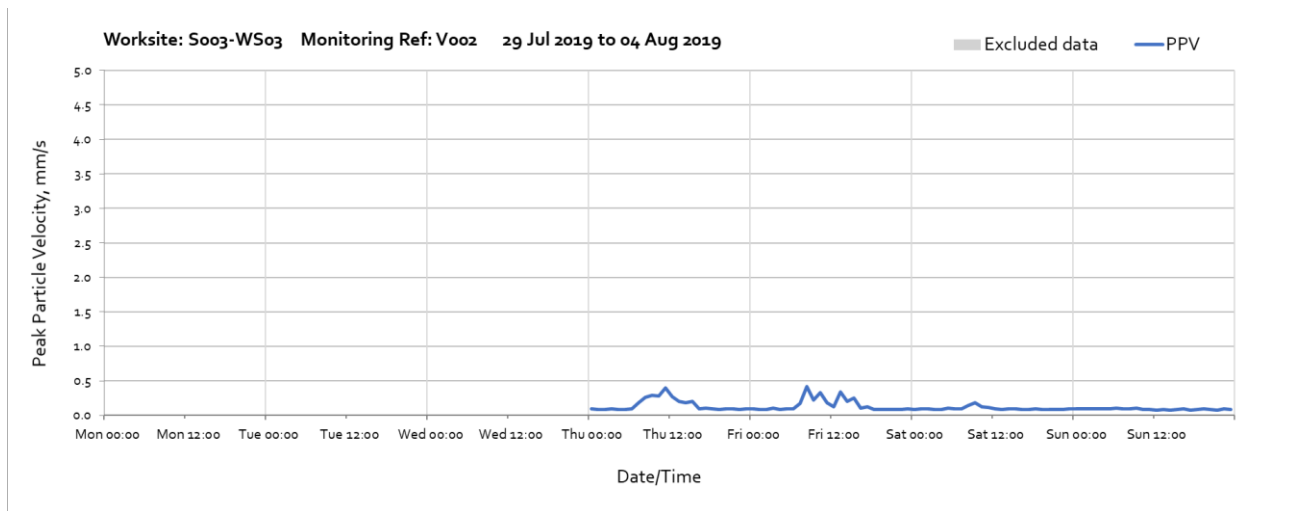
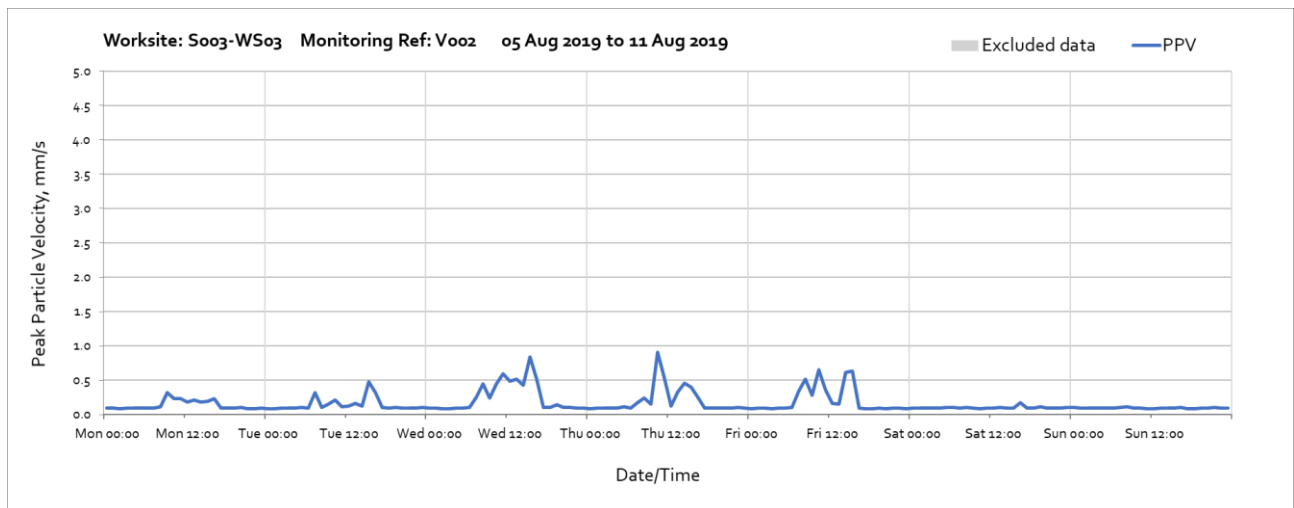
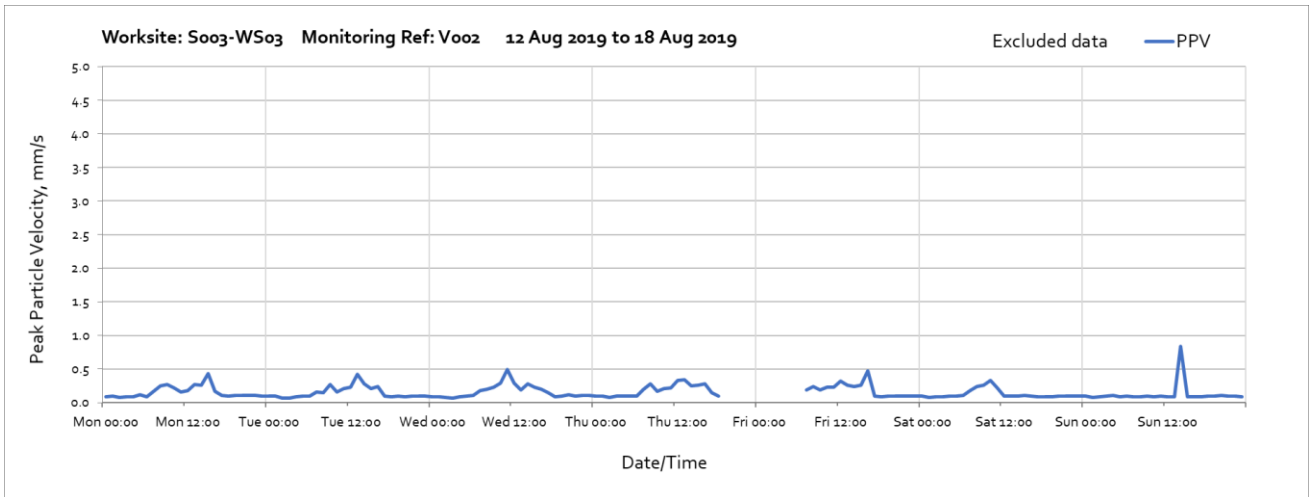
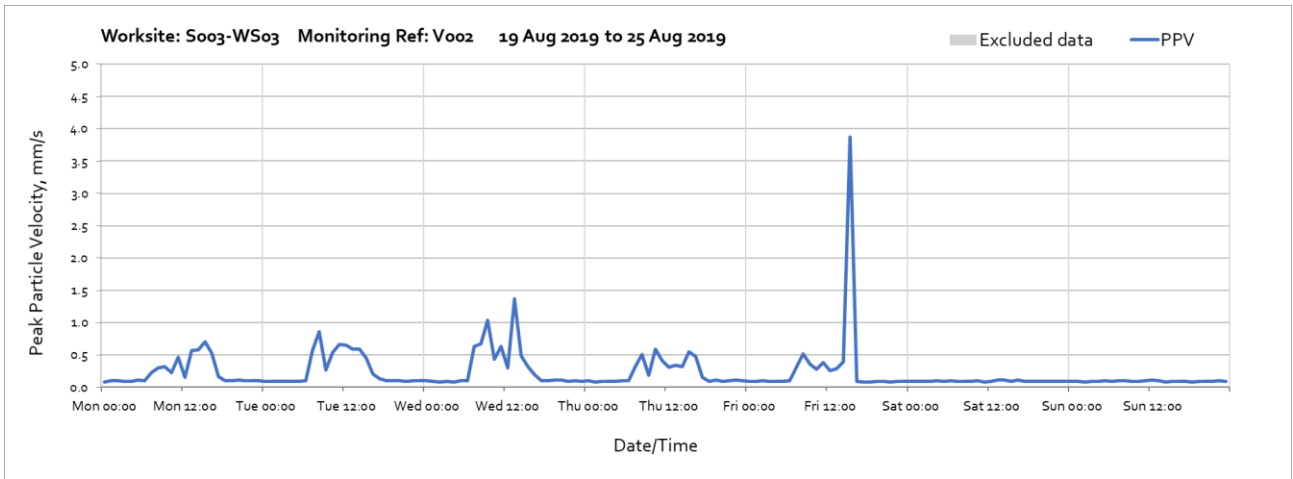
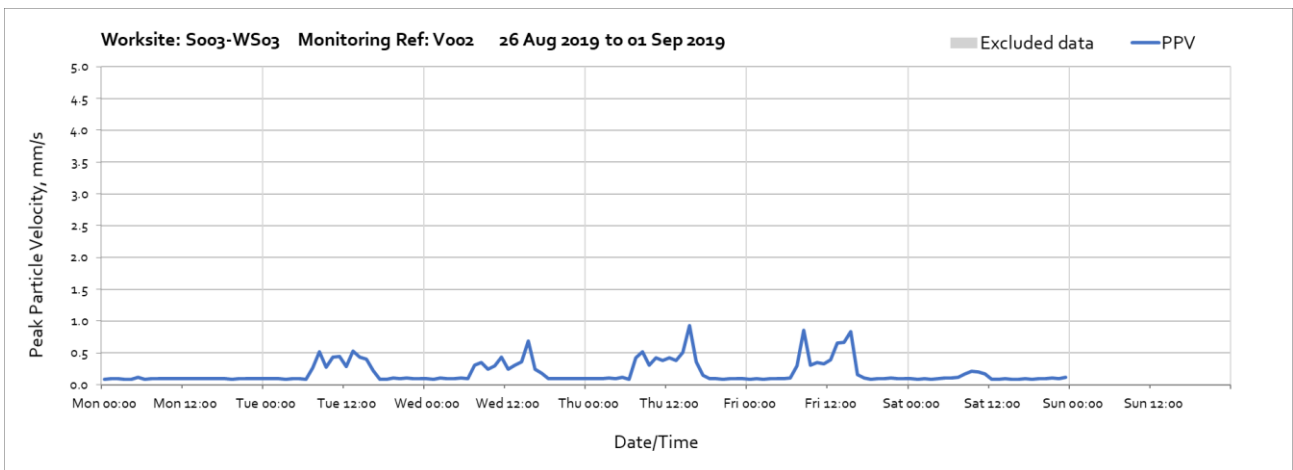
Worksite: S003-WS03 – Monitoring Ref: V002

The following graphs show the hourly measured peak particle velocity PPV recorded during the monitoring period. The graphs show the resultant PPV due to vibration components on three orthogonal axis x, y and z. High values of PPV were measured on occasions at locations V021. These were due to local interference with the vibration monitor and are not representative of HS2 construction works. These data entries have been greyed out in the following charts and have been excluded to calculate values in Table 6.

Note: Missing data between 19:00 on Thursday 15th and 07:00 on Friday 16th of August was due to an outage of the vibration monitor data server.

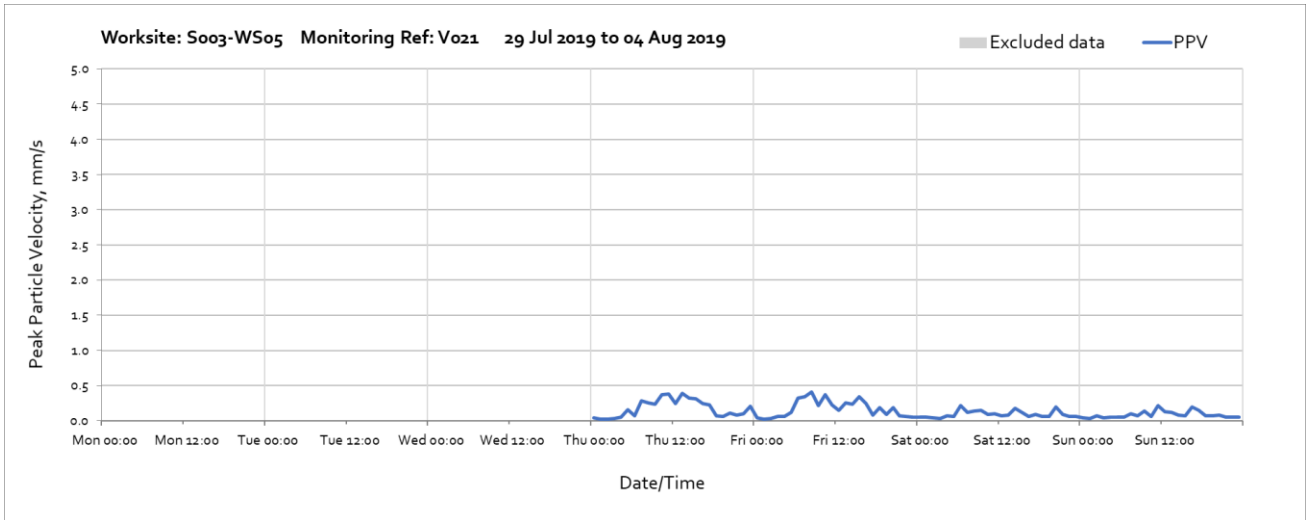
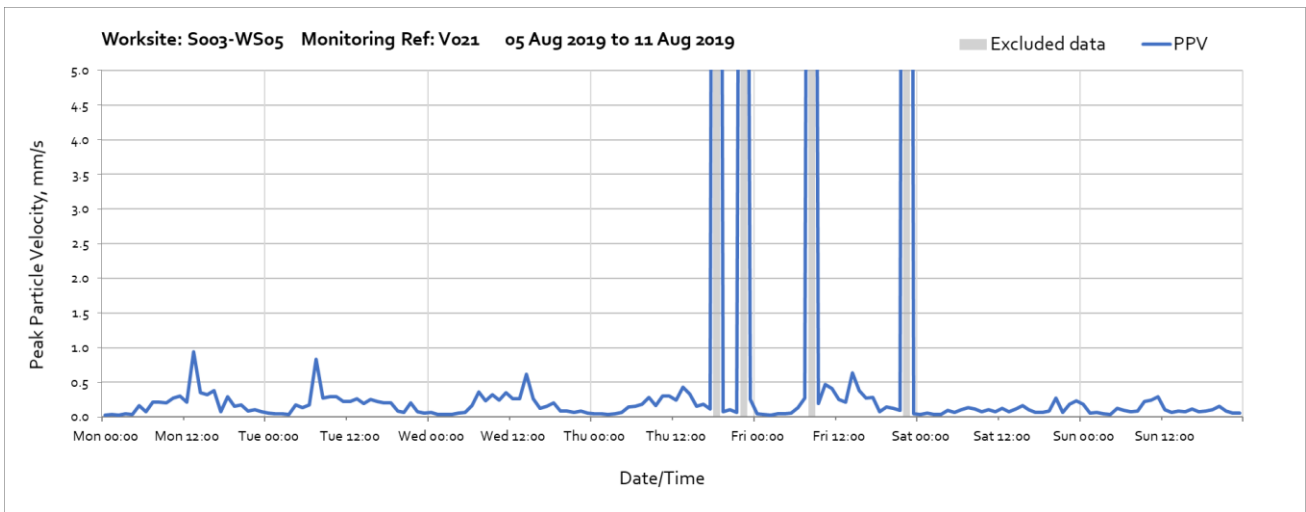
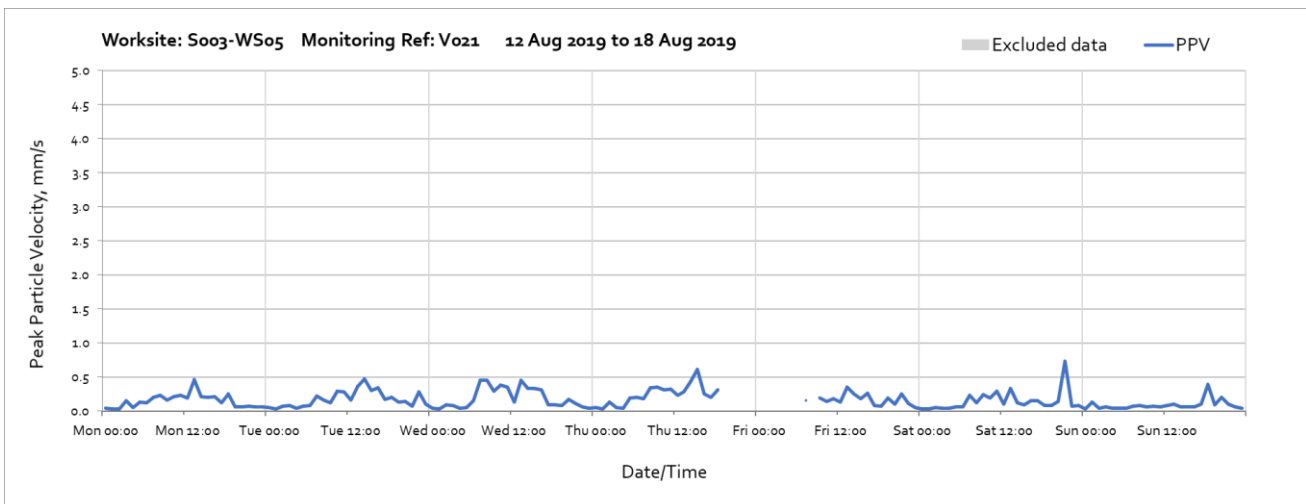
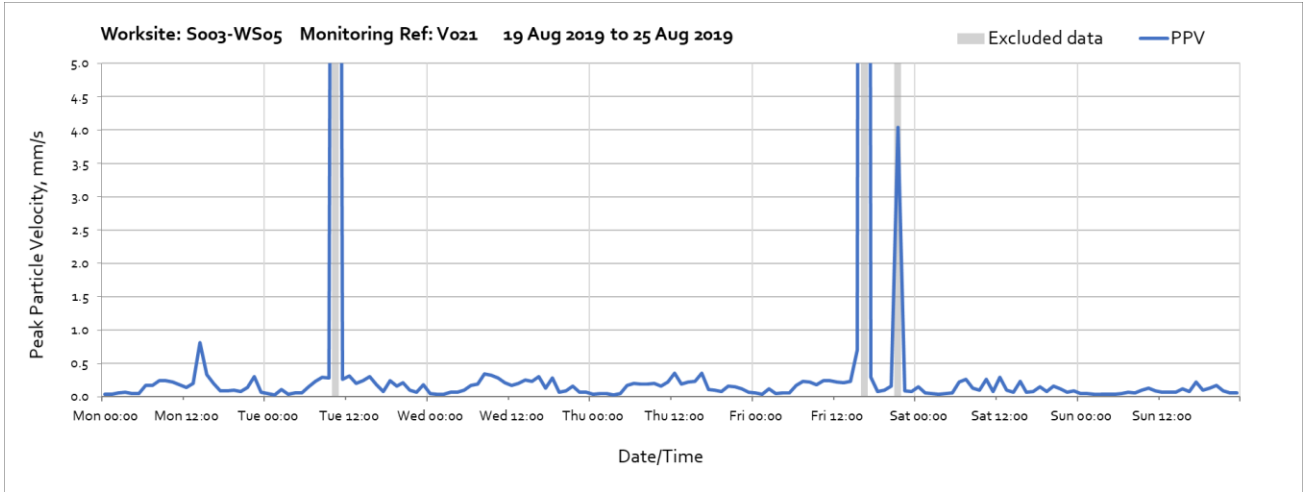
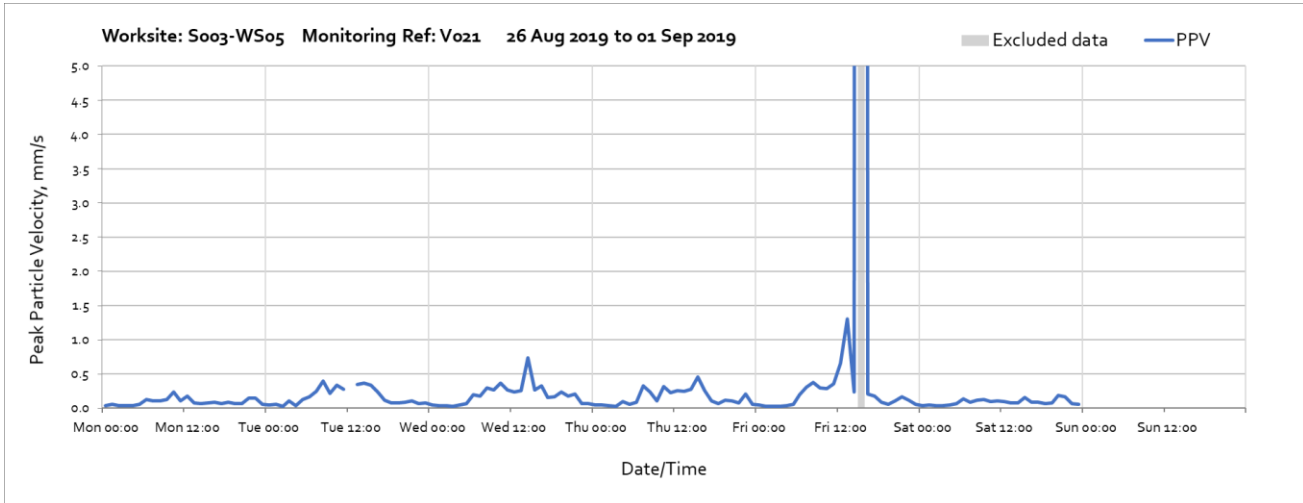
Worksite: S003-WS05 – Monitoring Ref: V021

Note: High vibration levels at 18:00 and 22:00 on Thursday 8th and at 08:00 and 22:00 on Friday 9th of August were due to local disturbance of the vibration monitor and are not representative of HS2 vibration levels.

Note: Missing data between 19:00 on Thursday 15th and 07:00 on Friday 16th of August was due to an outage of the vibration monitor data server. Missing data at 08:00 on Friday 16th of August was due to a temporary switch off of the monitor to allow maintenance operations.

Note: High vibration levels at 10:00 on Tuesday 20th and at 16:00 and 21:00 on Friday 23rd of August were due to local disturbance of the vibration monitor and are not representative of HS2 vibration levels.

Note: Missing data at 12:00 on Tuesday 27th of August was due to a temporary switch off of the monitor to allow maintenance operations. High vibration levels at 15:00 on Friday 30th of August were due to local disturbance of the vibration monitor and are not representative of HS2 vibration levels.

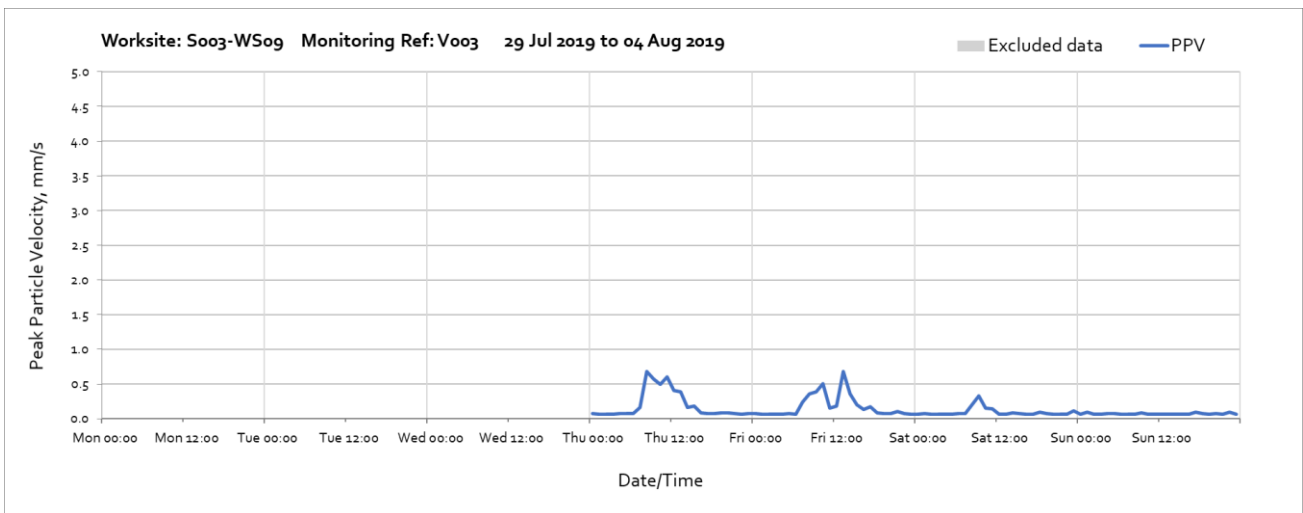
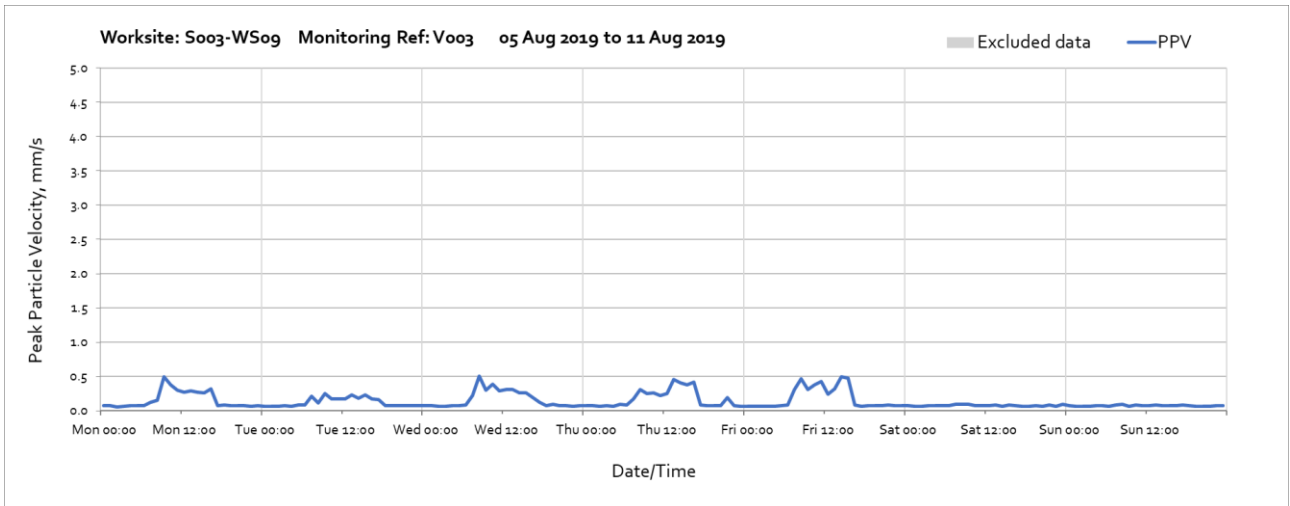
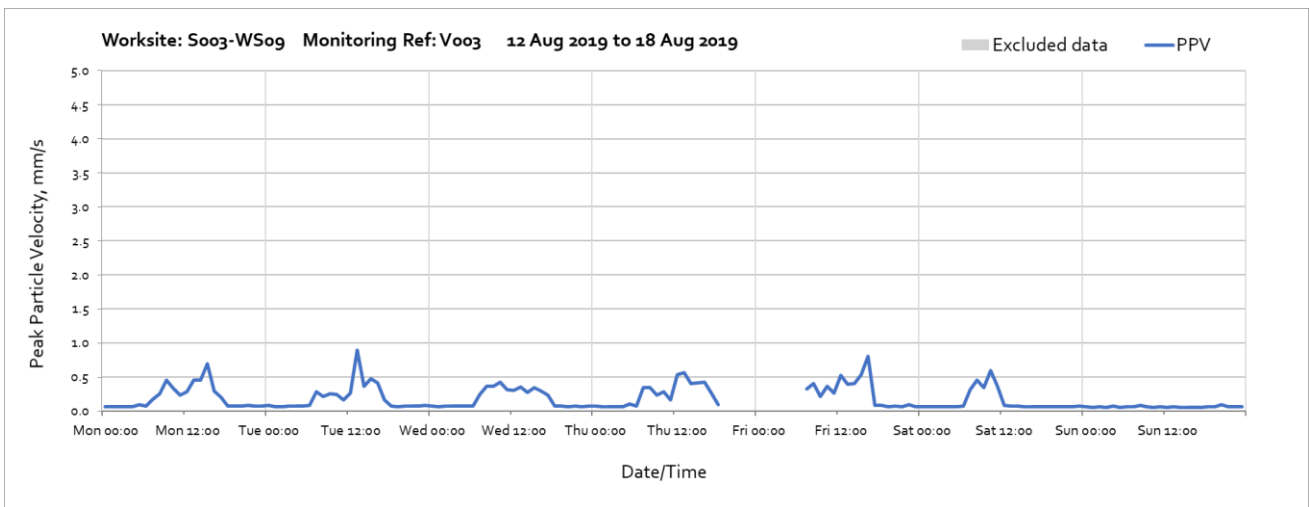
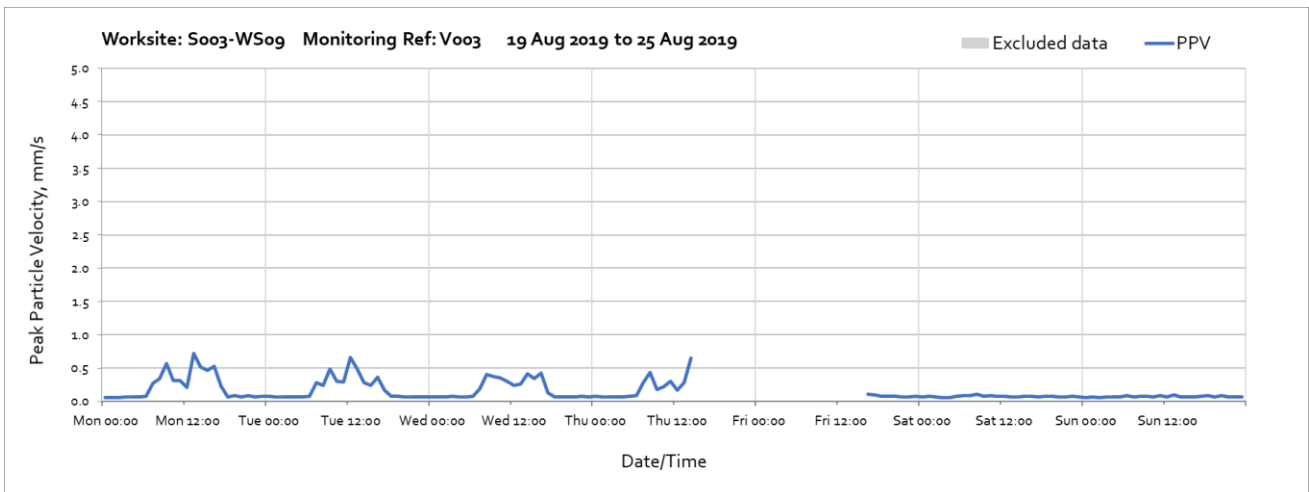
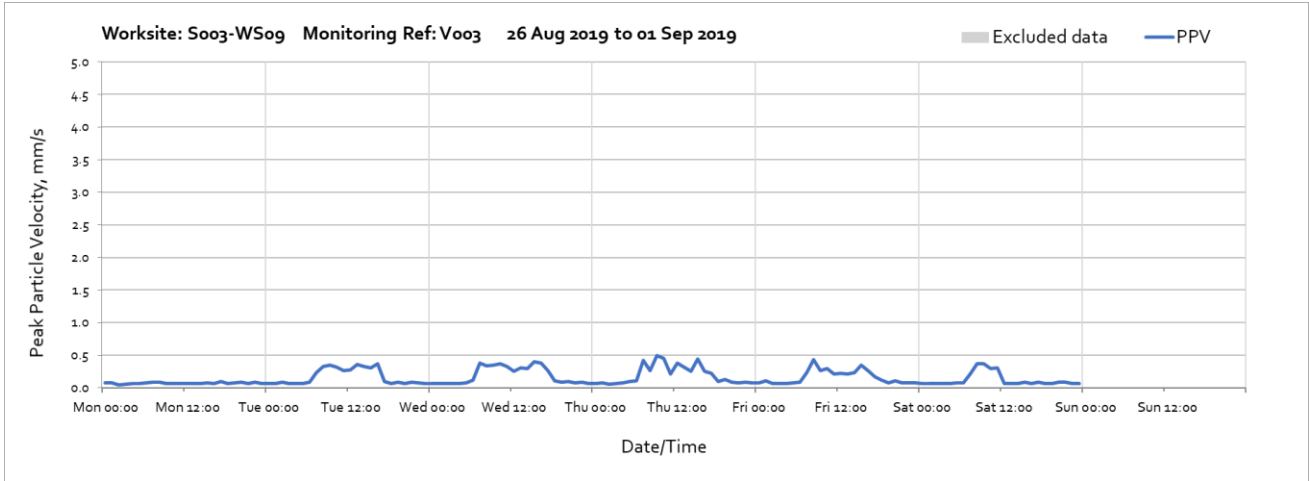
Worksite: S003-WS09 – Monitoring Ref: V003

Note: Missing data between 19:00 on Thursday 15th and 07:00 on Friday 16th of August was due to an outage of the vibration monitor data server.

Note: Missing data between 15:00 on Thursday 22nd and 16:00 on Friday 23rd of August was due to a firmware failure on the monitoring station.
