Construction noise and vibration Monthly Report – August 2019

London Borough of Camden

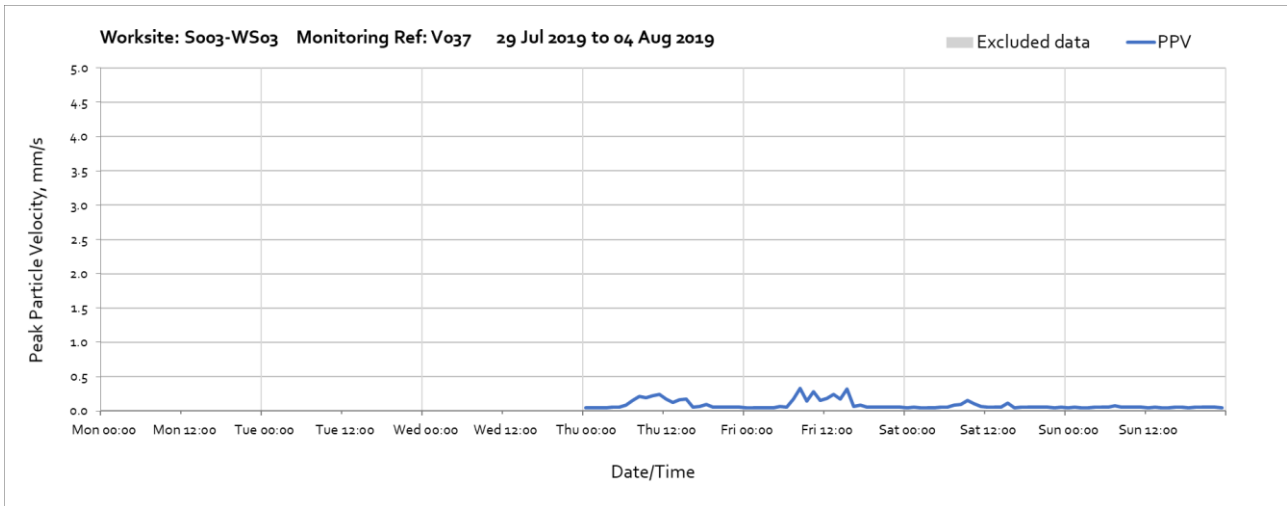
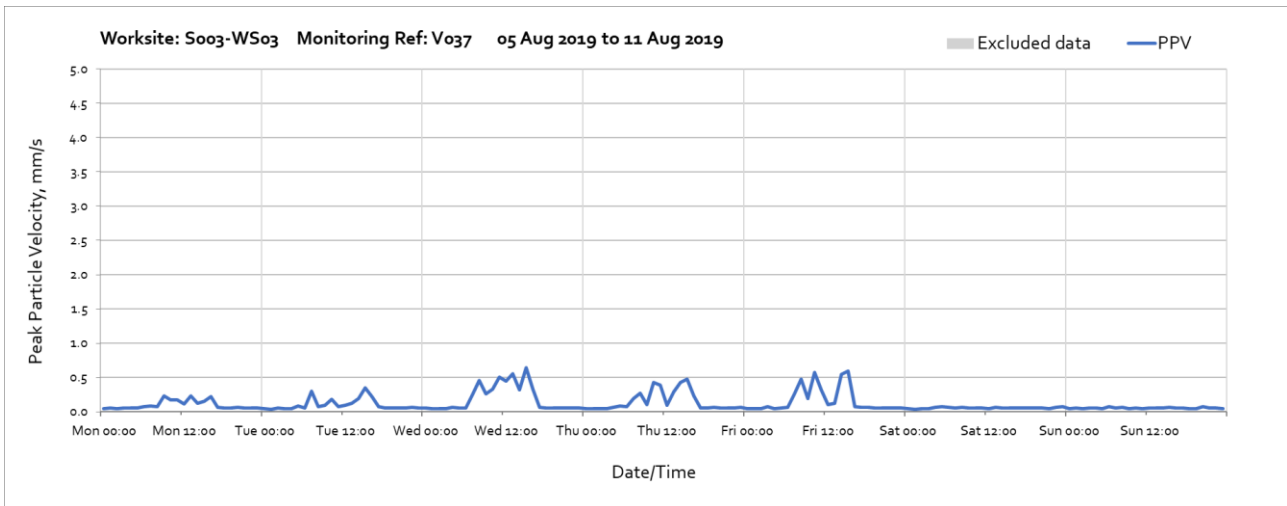
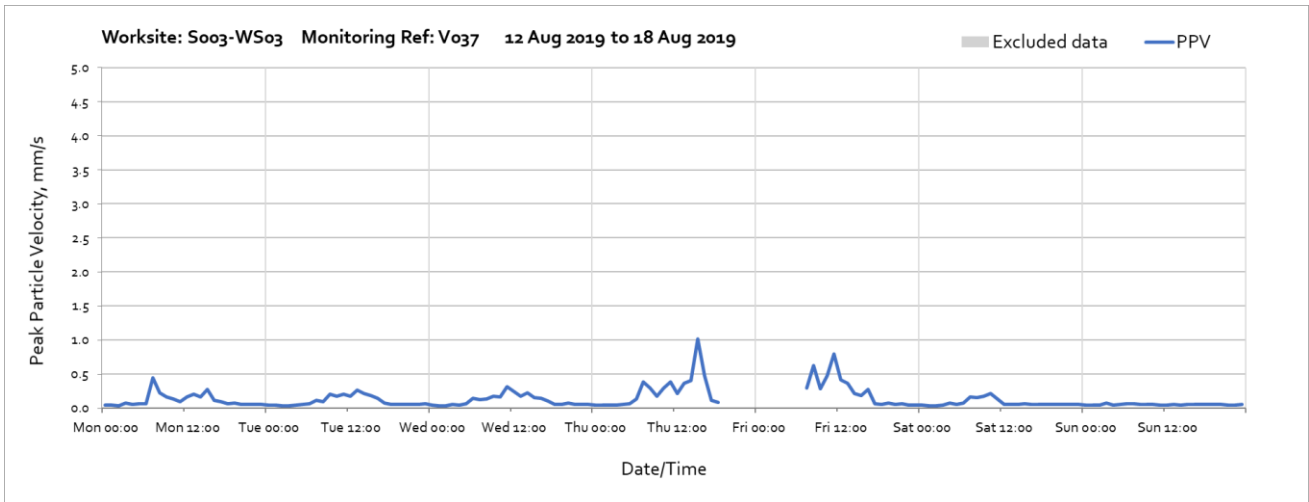
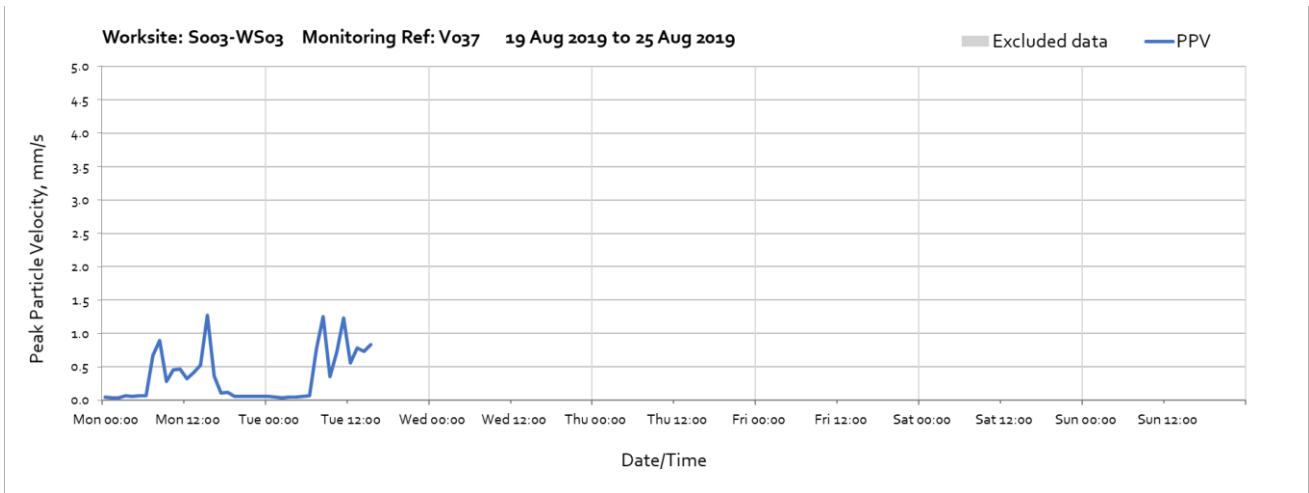
Worksite: S003-WS03 – Monitoring Ref: V037

Note: Missing data between 19:00 on Thursday 15th and 07:00 on Friday 16th of August was due to an outage of the vibration monitor data server.

Note: Missing data from 16:00 on Tuesday 20th of August until the end of the month was due to loss of power at the monitoring station.

2.2.4 Appendix C presents graphs of noise and vibration monitoring data over the month for each of the measurement locations. Noise data presented consists of the hourly L_{Aeq} values and, where relevant, the $L_{Aeq,T}$ values (where the time period T has been taken to be the averaging period as specified in Table 1 of HS2 Information Paper E23). Vibration data presented consist of hourly PPV values. The full data set for the monitoring equipment can be found at the following location: <https://data.gov.uk/dataset/24542ae7-dd44-444f-b259-871c4cc43b5e/environmental-monitoring-data>.

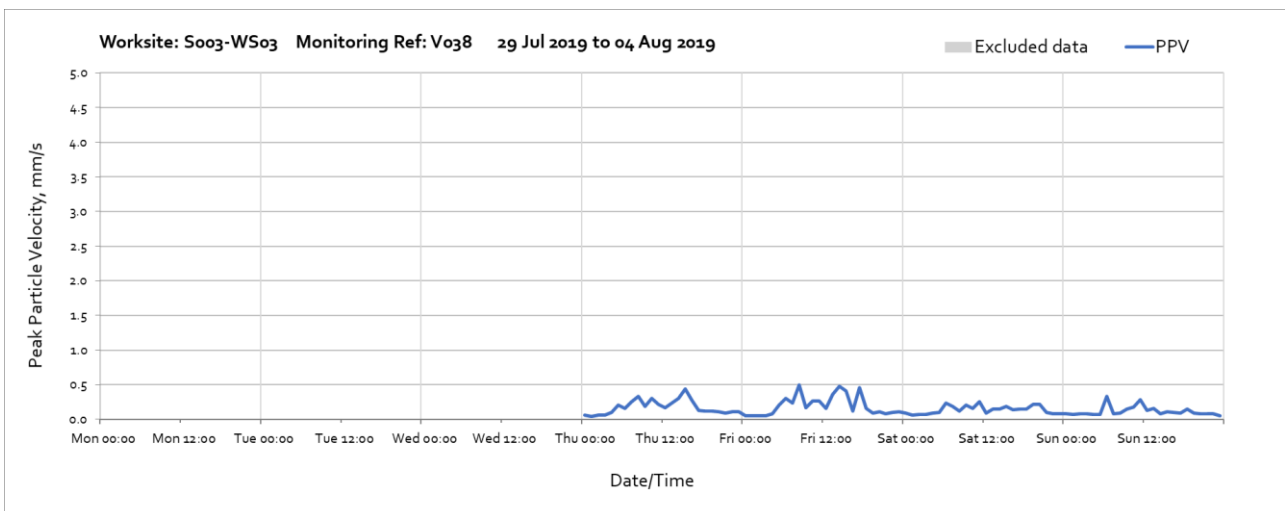
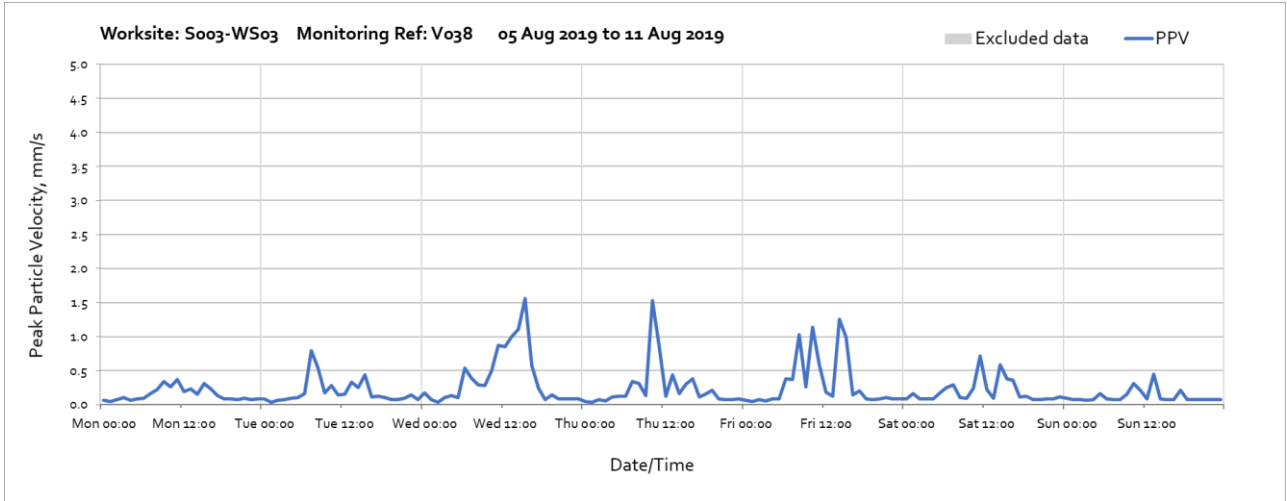
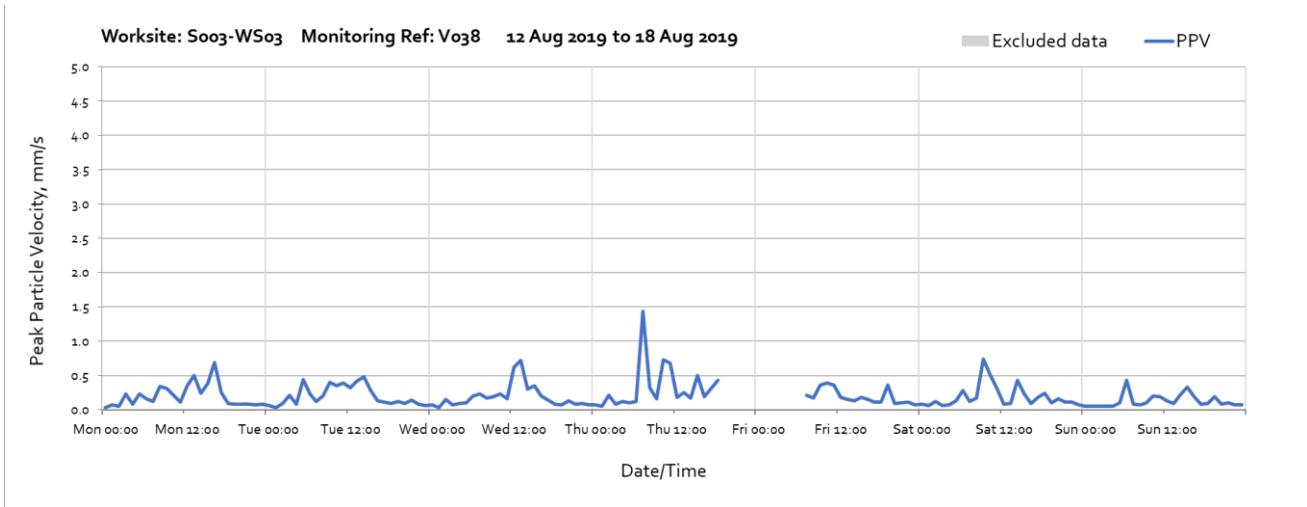
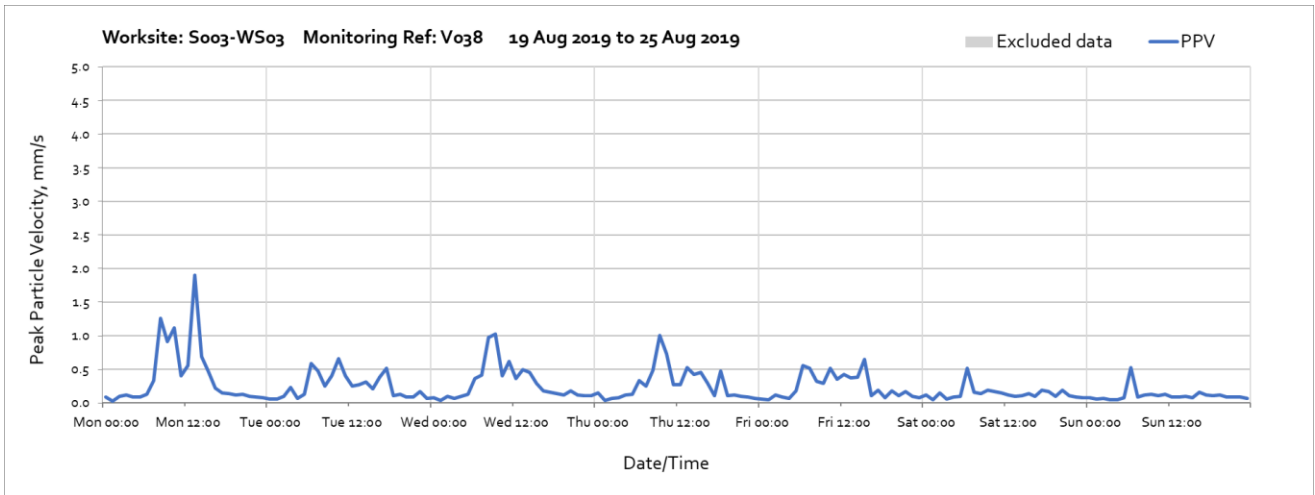
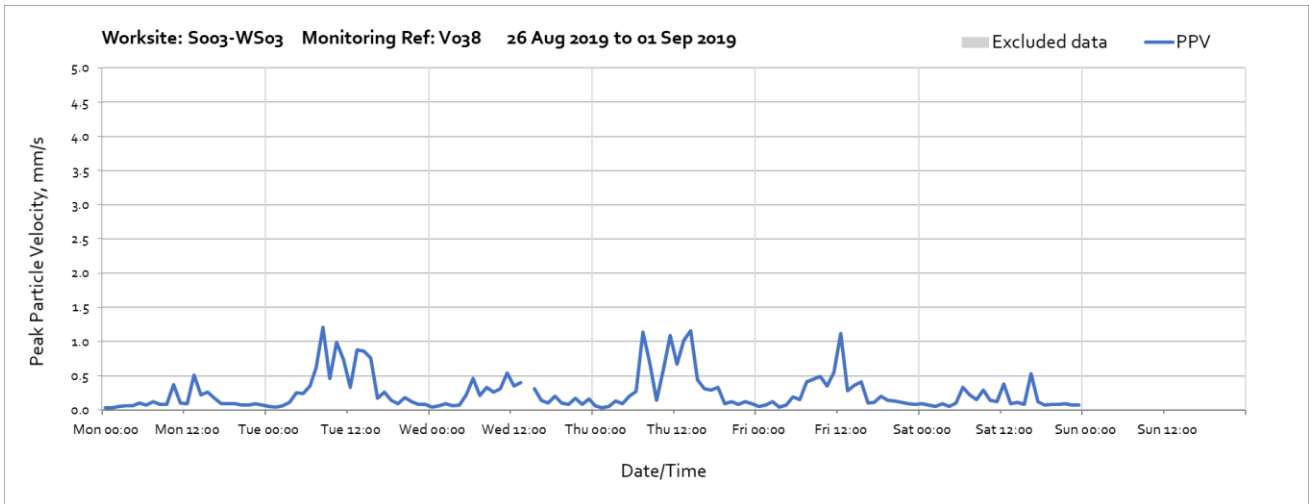
Worksite: S003-WS03 – Monitoring Ref: V038

Note: Missing data between 19:00 on Thursday 15th and 07:00 on Friday 16th of August was due to an outage of the vibration monitor data server.

Note: Missing data at 14:00 on Wednesday 28th of August was due to a temporary switch off of the monitor to allow maintenance operations.

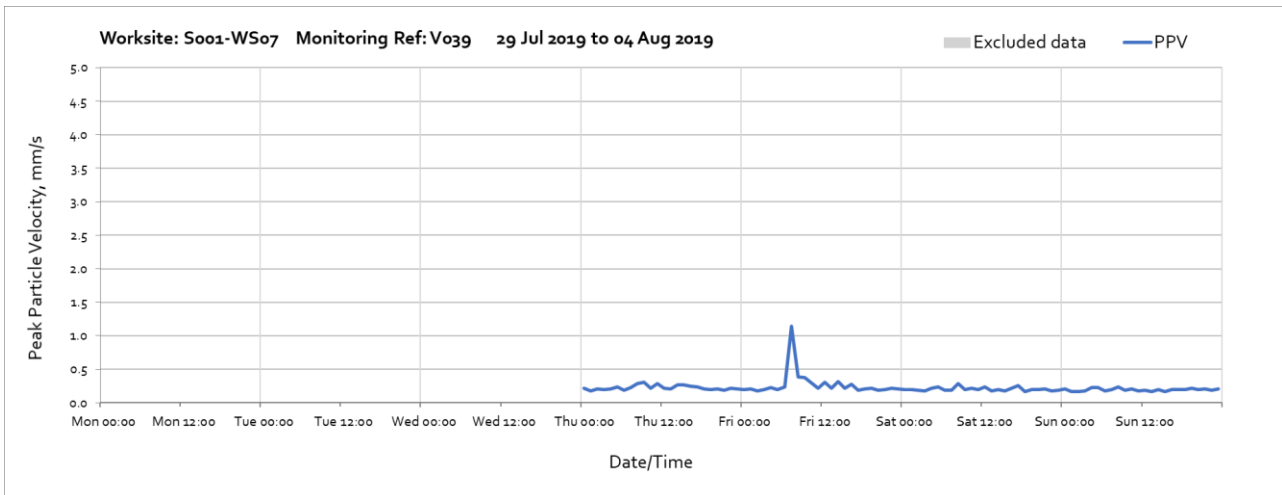
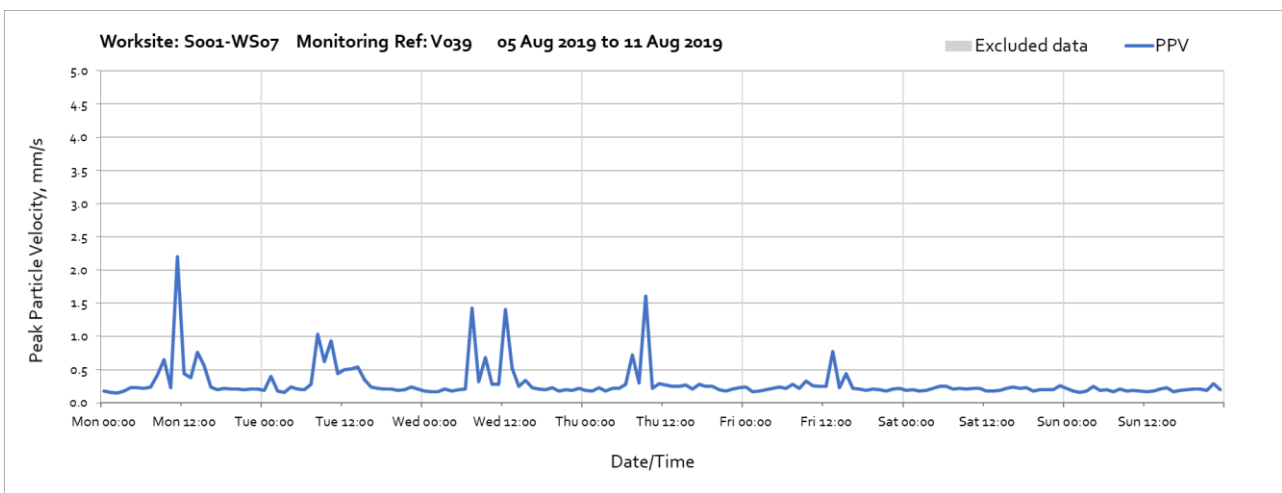
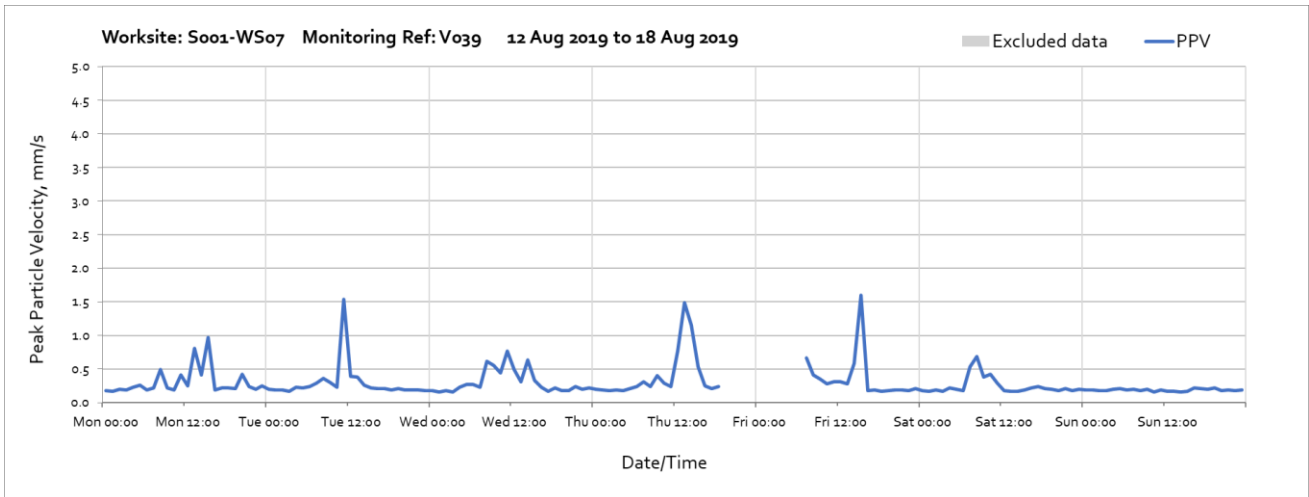
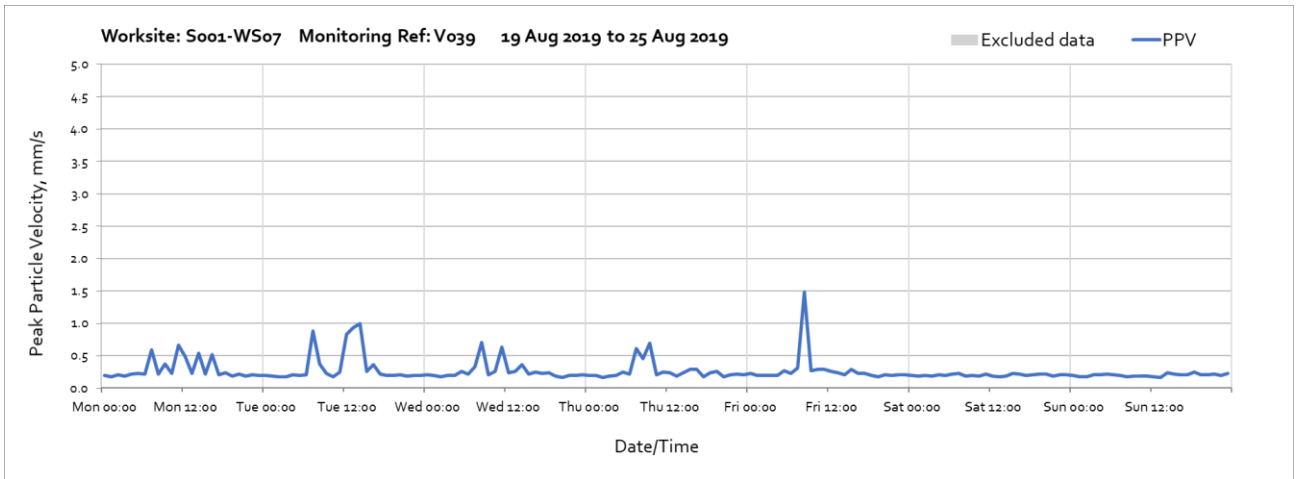
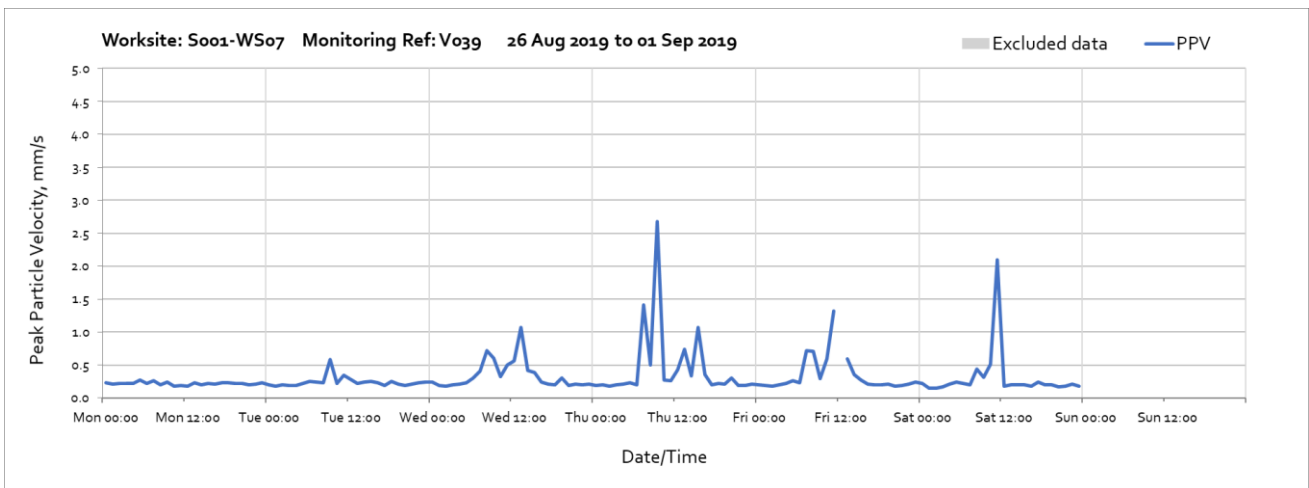
Worksite: S003-WS07 – Monitoring Ref: V039

Note: Missing data between 19:00 on Thursday 15th and 07:00 on Friday 16th of August was due to an outage of the vibration monitor data server.

Note: Missing data at 12:00 on Friday 30th of August was due to a temporary switch off of the monitor to allow maintenance operations.
