Air Quality and Dust Monitoring Monthly Report – May 2020

London Borough of Ealing

A report prepared by Costain Skanska on behalf of HS2 Ltd.

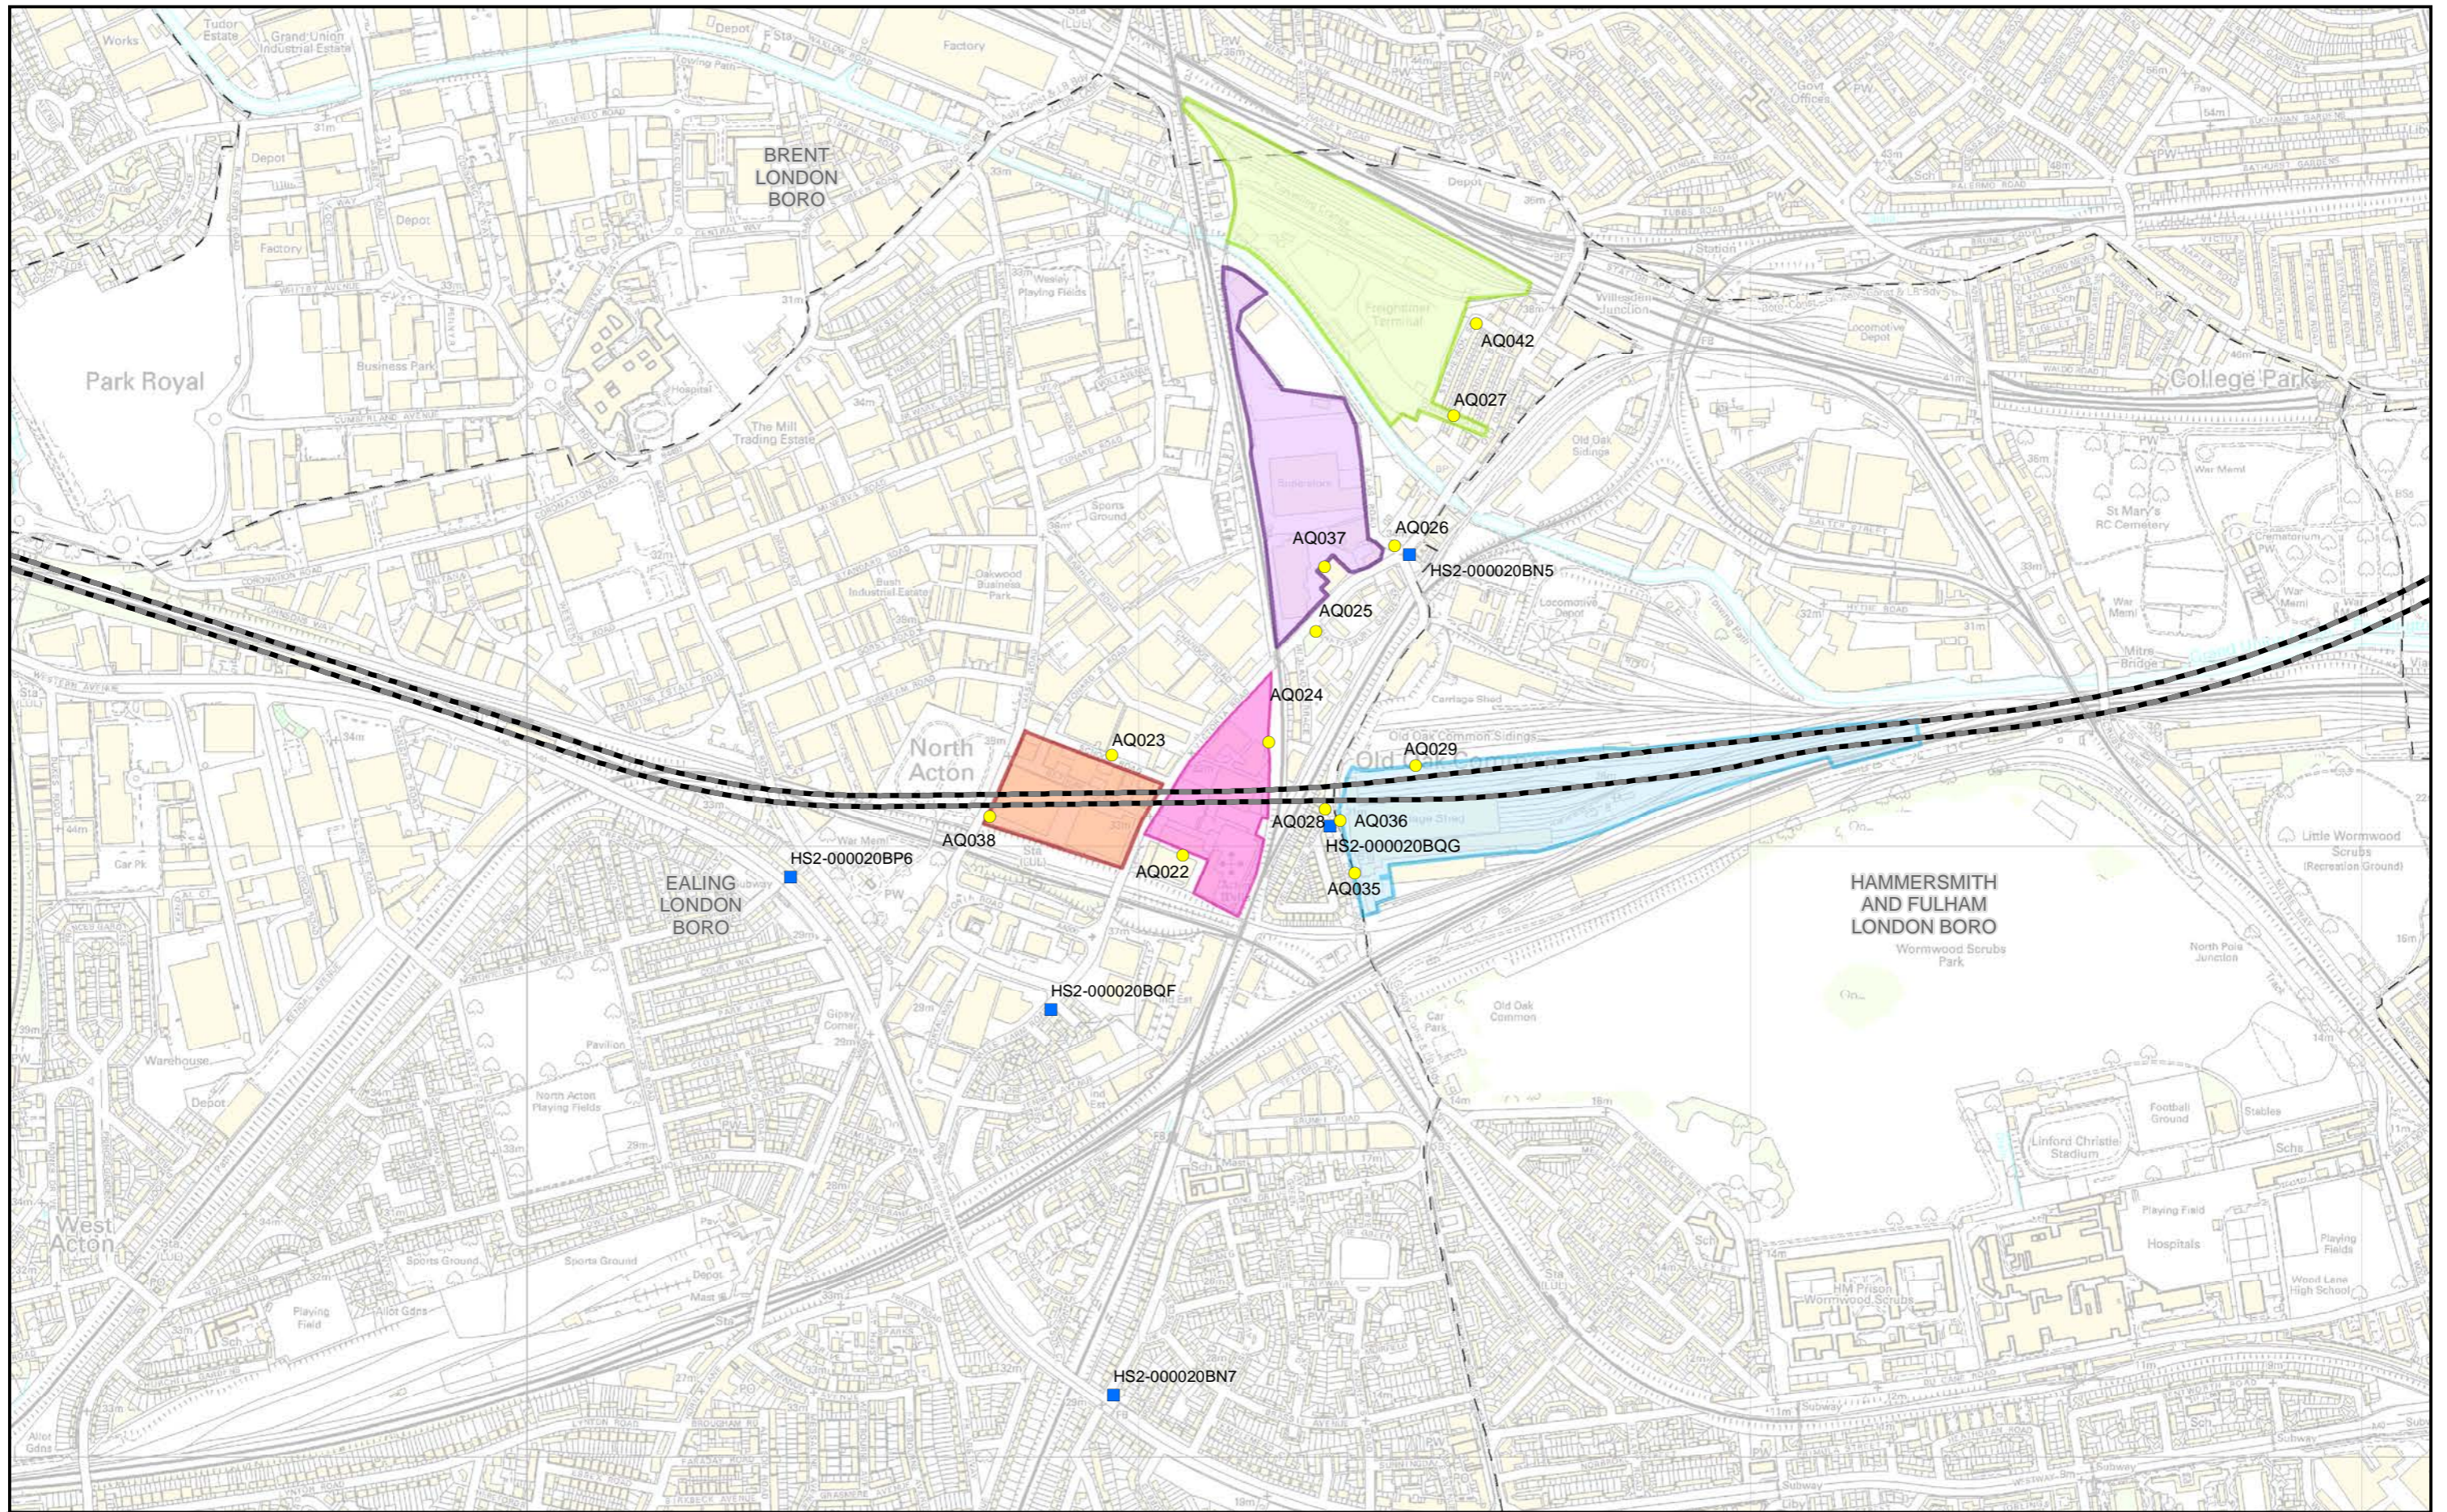
- Legend**
- Route in tunnel
 - Route on surface
 - Diffusion tube monitoring location
 - Dust monitoring location
 - Willesden Euro worksite
 - Victoria Road Crossover Box
 - Old Oak Common worksite
 - Atlas Road worksite
 - Flat Iron Compound

Figure Name
Worksites and Monitoring locations in LBE
 (sheet 1)

- 1.1.2 Figure 1 and Figure 2 in Appendix A indicate the current worksites together with air quality and dust monitoring locations.
- 1.1.3 This summary should be read in conjunction with the overview monitoring report available from www.gov.uk/government/collections/monitoring-the-environmental-effects-of-hs2, which highlights: the applicable standards and guidance, as well as the air quality and dust monitoring methodologies to be implemented by nominated undertakers throughout construction.

- 1.1.4 The current phase of construction works commenced in October 2019 and is expected to be completed by 2025. The current worksites, as presented in Appendix A, Figure 1 and Figure 2, include:

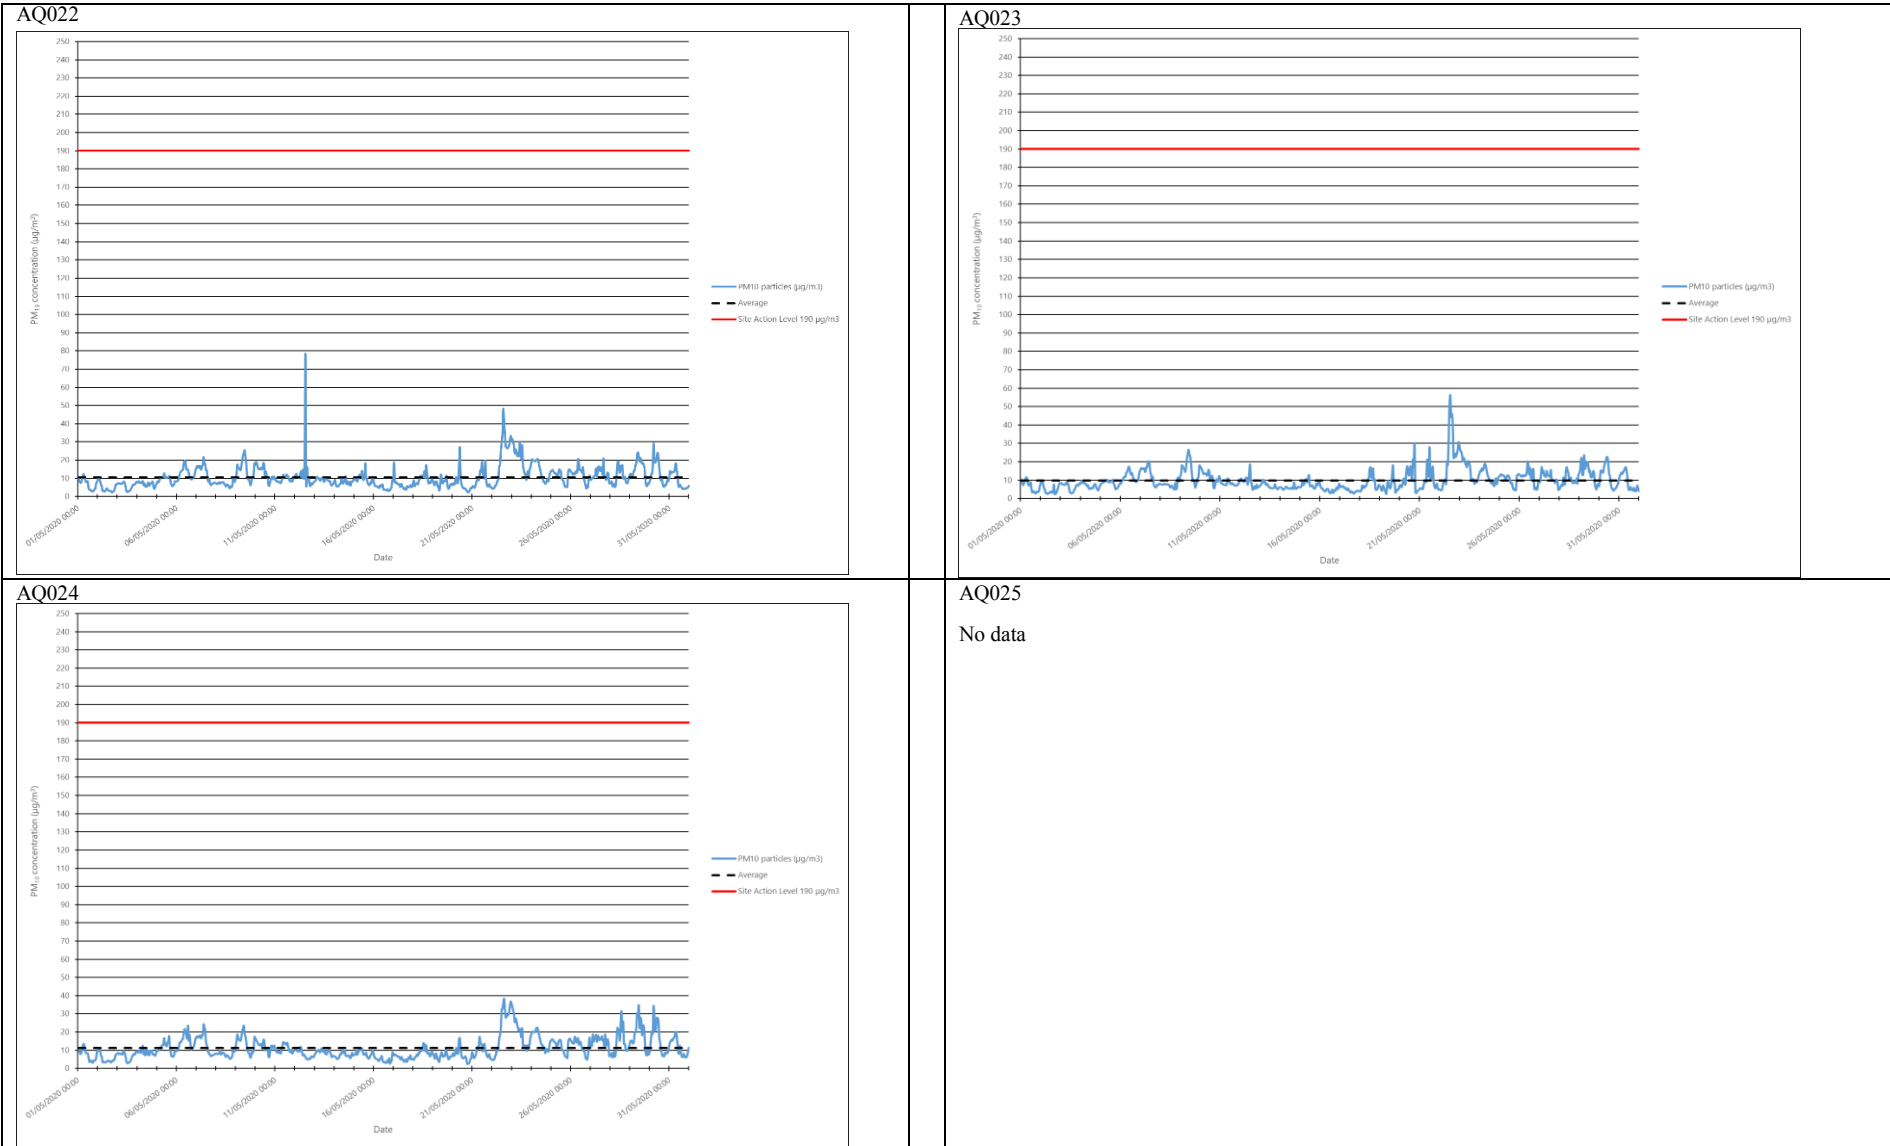
Figure 1: Construction dust 1-hour mean indicative PM₁₀ concentration for dust monitors
