SERIOUS INCIDENT

Aircraft Type and Registration:	Airbus A320-232, G-EUYB
No & Type of Engines:	2 International Aero Engine V2527-A5 turbofan engines
Year of Manufacture:	2008 (Serial no: 3703)
Date & Time (UTC):	23 September 2019 at 0710 hrs
Location:	On approach London Heathrow Airport
Type of Flight:	Commercial Air Transport (Passenger)
Persons on Board:	Crew - 6 Passengers - 139
Injuries:	Crew - 2 (Minor) Passengers - None
Nature of Damage:	None
Commander's Licence:	Airline Transport Pilot's Licence
Commander's Age:	43 years
Commander's Flying Experience:	12,700 hours (of which 6,000 were on type) Last 90 days - 150 hours Last 28 days - 52 hours
Information Source:	AAIB Field Investigation

Synopsis

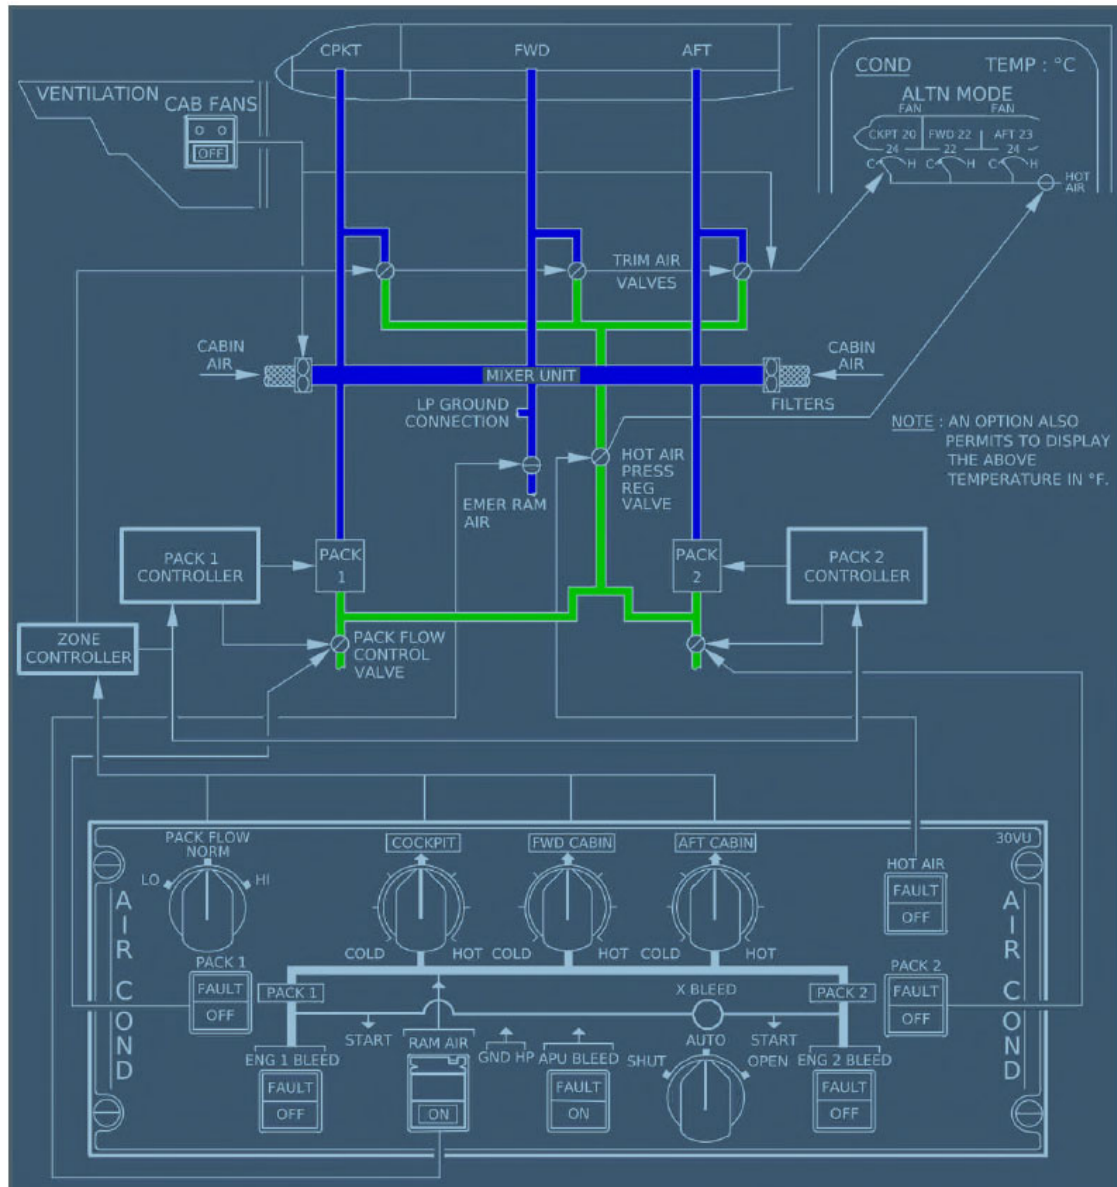
Figure 1
ECS schematic

It separates the fuselage into three independently controlled zones which are: the flight deck, the forward cabin and the aft cabin. A schematic of the ECS is shown in Figure 1.

In normal operations, the left engine supplies bleed air to the left pack⁶ and the right engine supplies bleed air to the right pack. When the engines are not running, the APU can supply bleed air to both packs.

The bleed air from the engines or APU passes through electronically controlled heat exchangers, valves and mechanical devices to produce conditioned air. The conditioned air is at a temperature and flow rate that is suitable to enter the mixer unit where it is mixed with the recirculated cabin air prior to distribution to the flight deck and cabin to maintain a comfortable environment. Trim valves allow hot bleed air to mix downstream of the mixer units to optimise temperature regulation. During normal pack operation with the trim air system operative the cockpit is only supplied with air from pack 1 mixed with the recirculated air. The temperature in each zone can be selected and set from the AIR COND panel on the flight deck and can be fine-tuned for each cabin zone through the temperature control panel installed on the Flight Attendant Panel (FAP).
