ACCIDENT

Aircraft Type and Registration:	Velos Single Rotor, (UAS, registration n/a)	
No & Type of Engines:	2 Xnova 4035-400KV 3Y	
Year of Manufacture:	2018 (s/n VUAV10417006)	
Date & Time (UTC):	18 September 2019 at 1435 hrs	
Location:	Hangingstone Hill, Dartmoor, Devon	
Type of Flight:	Aerial Work	
Persons on Board:	Crew - N/A	Passengers - N/A
Injuries:	Crew - N/A	Passengers - N/A
Nature of Damage:	Damaged beyond economical repair	
Commander's Licence:	Other	
Commander's Age:	48 years	
Commander's Flying Experience:	533 hours (of which 21 were on type) Last 90 days - 18 hours Last 28 days - 11 hours	
Information Source:	Aircraft Accident Report Form submitted by the pilot

Synopsis

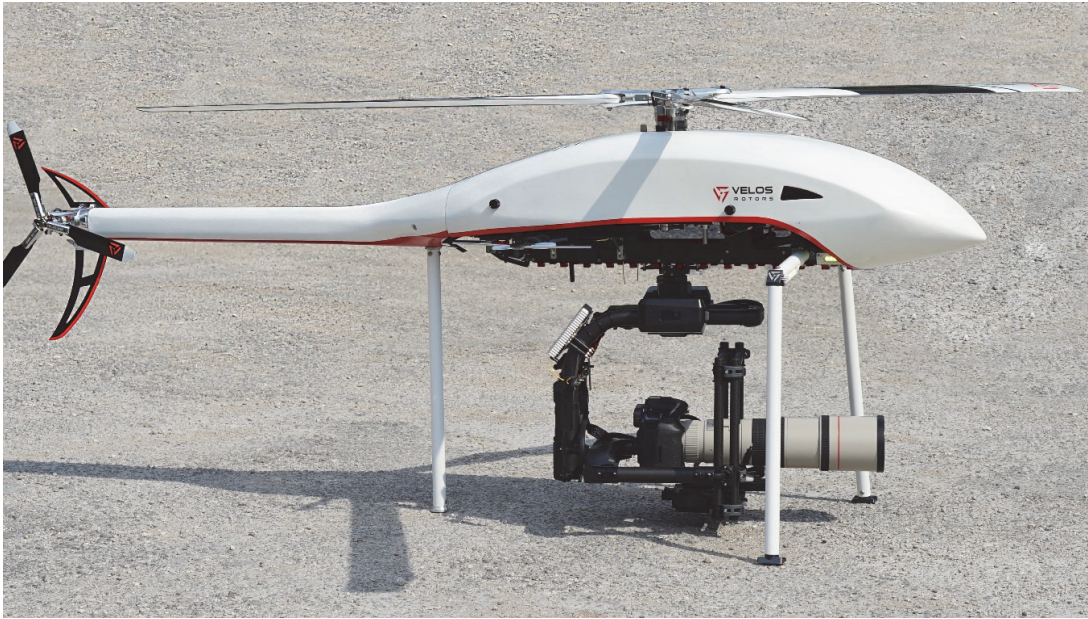
Figure 1

The Velos single rotor UAS helicopter (Figure 1) is capable of carrying varied deployable and fixed payloads such as survey equipment and cameras.

Example of Velos single rotor UAS with underslung camera as payload
(image reproduced with permission)

Two individual Electronic Speed Controller (ESC) controlled motors combine to provide power to a 1,950 mm diameter main rotor. In the event of a single ESC or motor failure, the UAS can fly using the remaining functional ESC and motor. The controls are the same as a conventional helicopter with a collective control which changes the pitch of all the main rotor blades simultaneously to control vertical movement, and a cyclic control which controls the pitch of individual blades to provide pitch and roll control, a yaw control provides directional control through a variable pitch tail rotor. The total mass of the UAS involved in this accident was 19.8 kg.
