Air Quality and Dust Monitoring Monthly Report – **July** 2020

Buckinghamshire Council

A report prepared by Align JV and Fusion on behalf of HS2 Ltd.

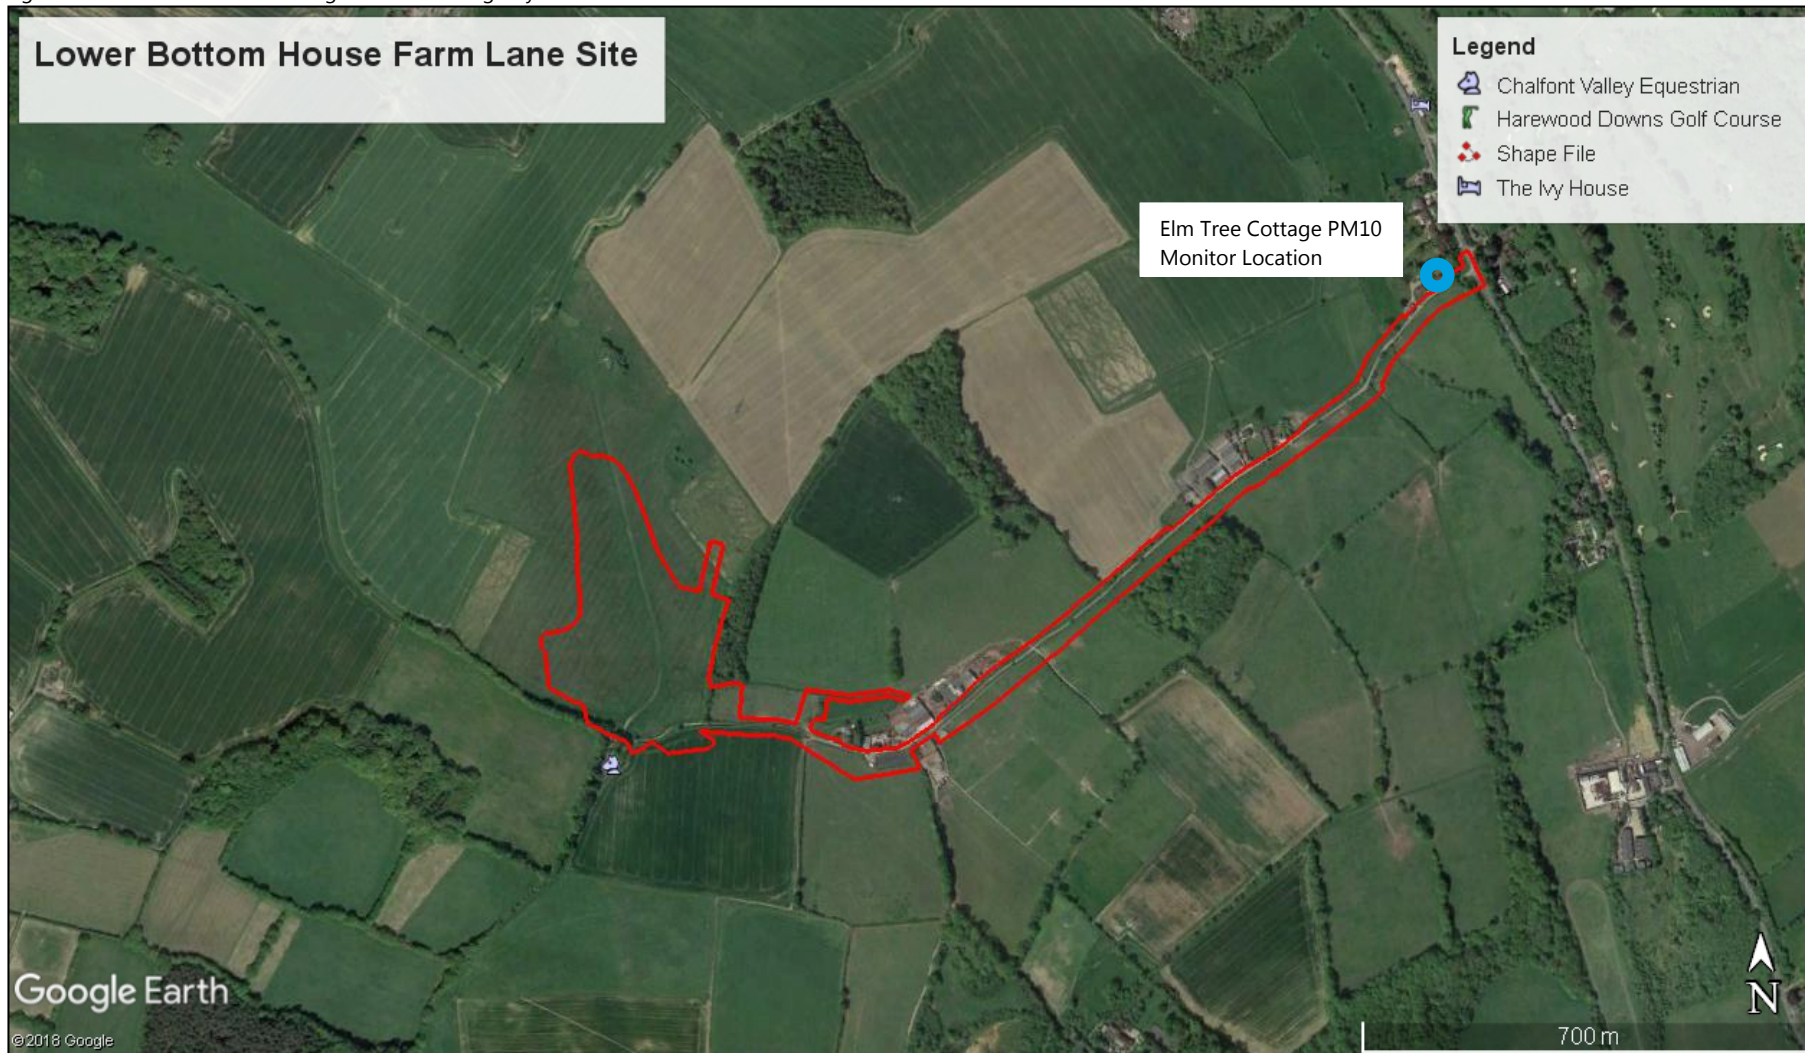
Figure 3: Worksites and Monitoring locations during July 2020

- 1.1.2 Figures 1 to 3 in Appendix A indicates the current worksites together with the dust monitoring locations for July 2020.
- 1.1.3 This summary should be read in conjunction with the overview monitoring report available from www.gov.uk/government/collections/monitoring-the-environmental-effects-of-hs2, which highlights: the applicable standards and guidance, as well as the air quality and dust monitoring methodologies to be implemented by nominated undertakers throughout construction.

- 1.1.4 The current phase of works that commenced within BC during February 2020 and is expected to be completed by the end of May 2021. The current worksites at the Colne Valley Viaduct (CVV) LTP1, Chalfont St. Peter Compound and Chalfont St. Giles are presented in Appendix A, Figure 1 to 3. Activities in July included:

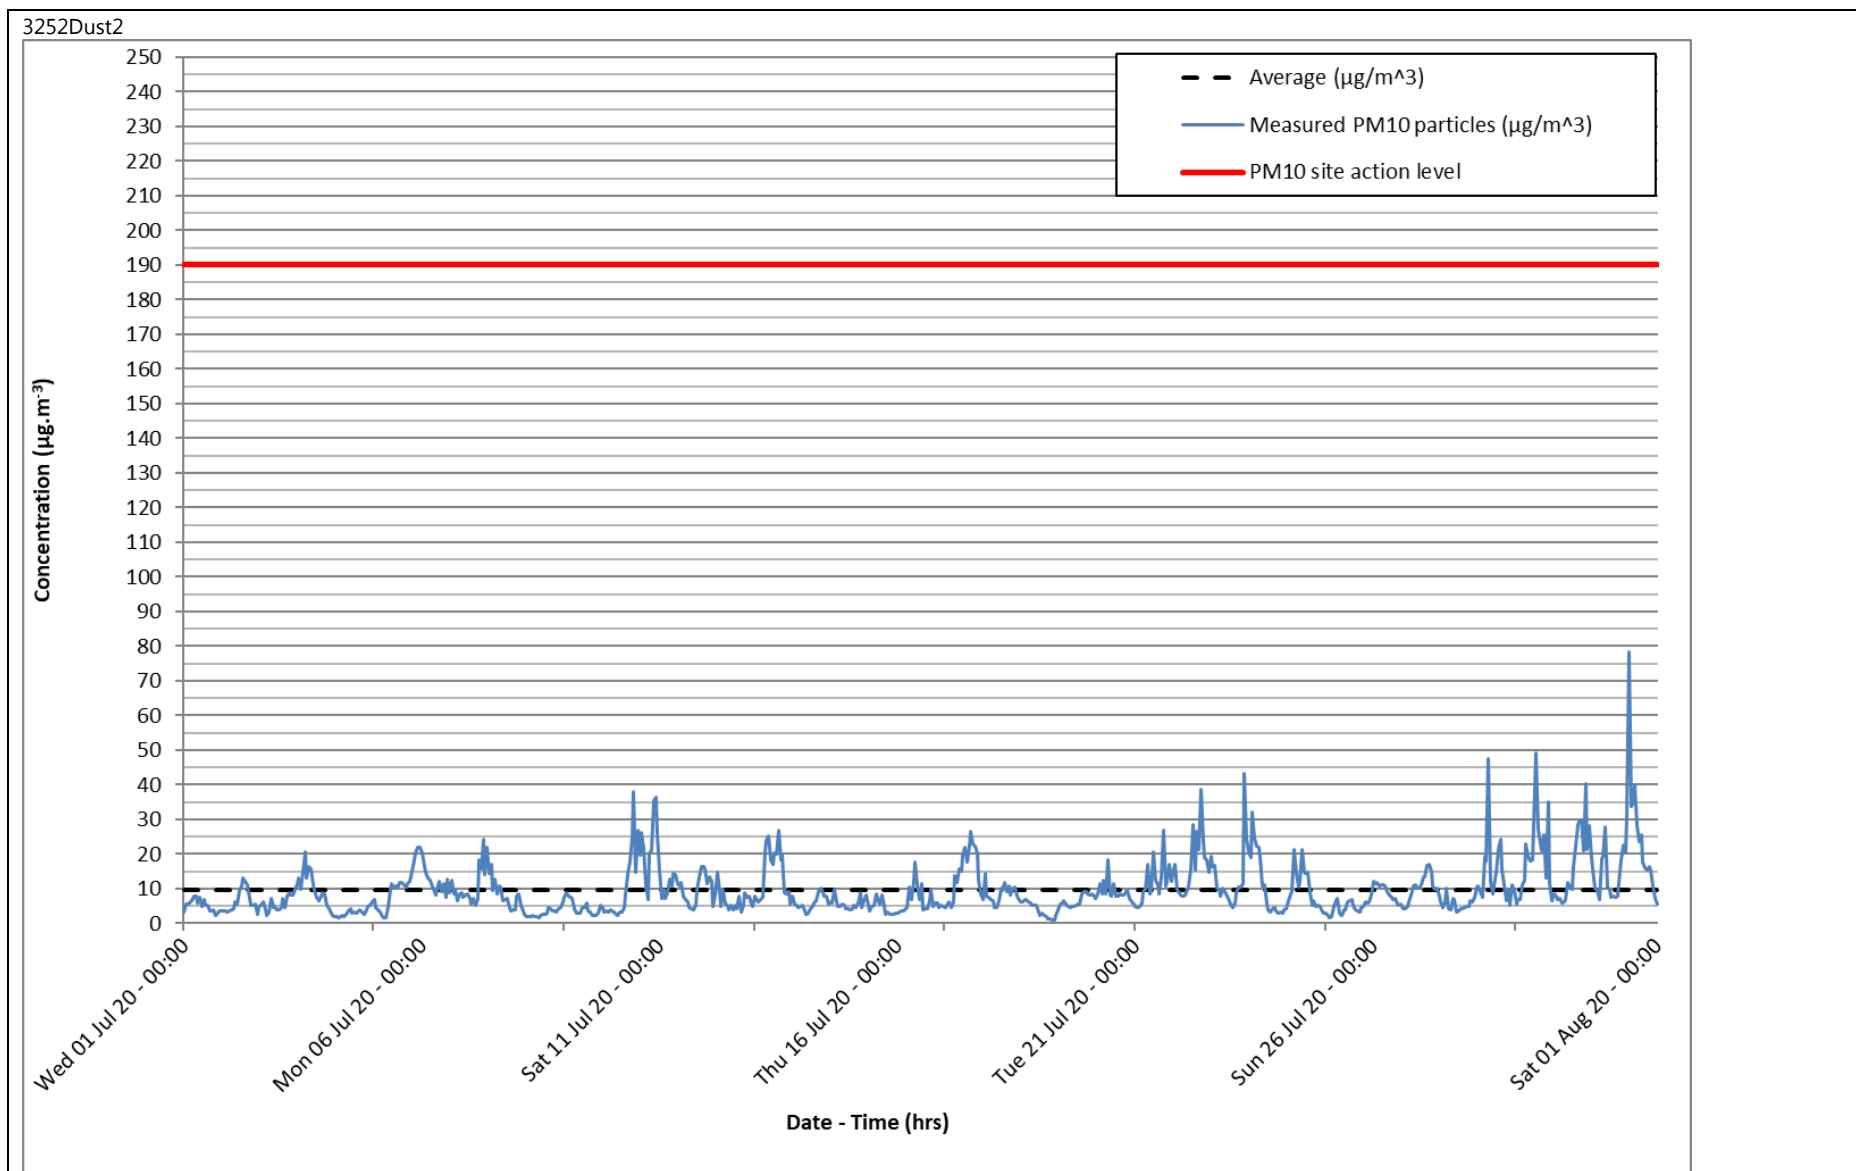
Figure 8: Construction dust 1-hour mean indicative PM₁₀ concentration for dust monitors

- 1.1.6 Dust monitoring locations and results are presented in Appendix B, Table 2, together with a line chart of monthly data from each dust monitor presented in Figures 4 to 8. All continuous dust monitoring is undertaken using indicative monitors. Despite being Environment Agency
