# Annual Safety Review 2019

## AAIB underwater wreckage operations

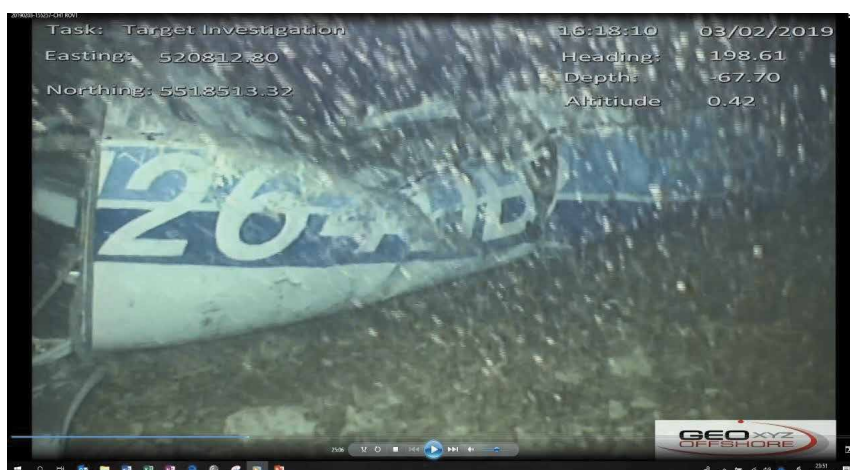
The tail section of N264DB at a depth of 68 m

The AAIB is responsible for investigating all accidents within the UK, its Crown Dependencies and its Overseas Territories, that occur on land and within their territorial waters. We are also responsible for investigating accidents involving UK registered aircraft (or those registered in UK's Crown Dependencies or Overseas Territories) that occur in international waters. Other States may also delegate their investigations to us. A recent example is our investigation into the accident involving the US registered Piper PA-46 (Malibu), N264DB, which occurred in international waters in the English Channel.

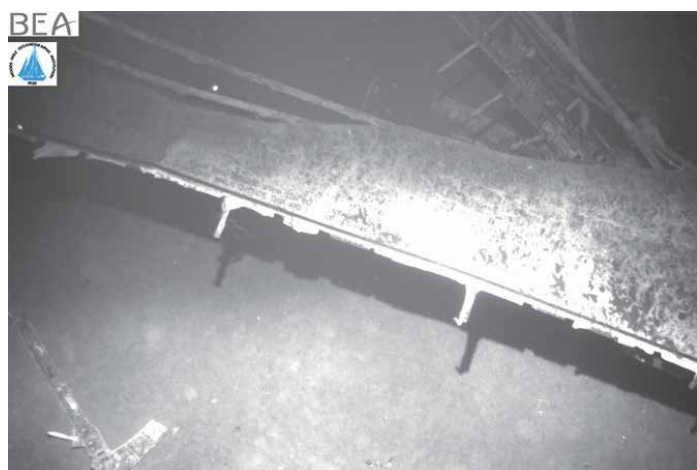
BEA image of wreckage from F-GZCP taken at a depth of 3,980 m

Where the safety investigation is led by another accident investigation authority, the AAIB may also participate in the search, survey and recovery operation as either an Accredited Representative, Expert or Observer. An example was the accident to the Air France Airbus A330, F-GZCP, in the Atlantic on 1 June 2009. The investigation was led by the French accident investigation authority (BEA) who invited the AAIB to participate in the underwater survey as an observer.

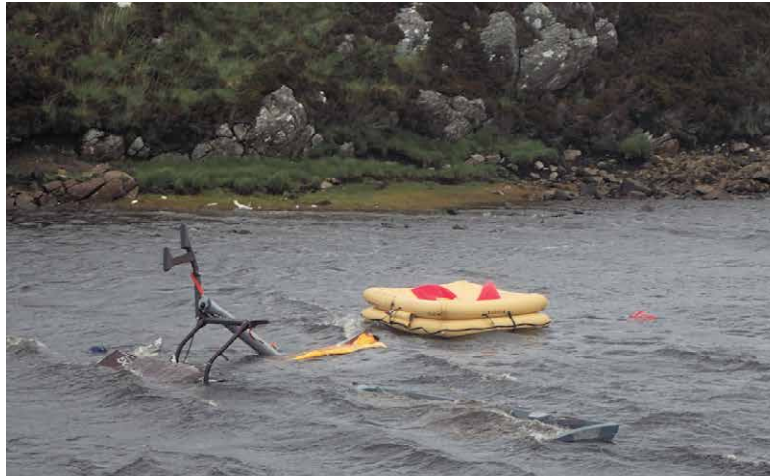
**G-PLMH partially submerged in Loch Scadavay prior to recovery**

An example of a challenging recovery involved an accident to an AS350 in Loch Scadavay in the Western Isles of Scotland. The helicopter was partially submerged in the remote loch and was lifted using floatation devices. It was then towed ashore and recovered using a shore based mobile crane.

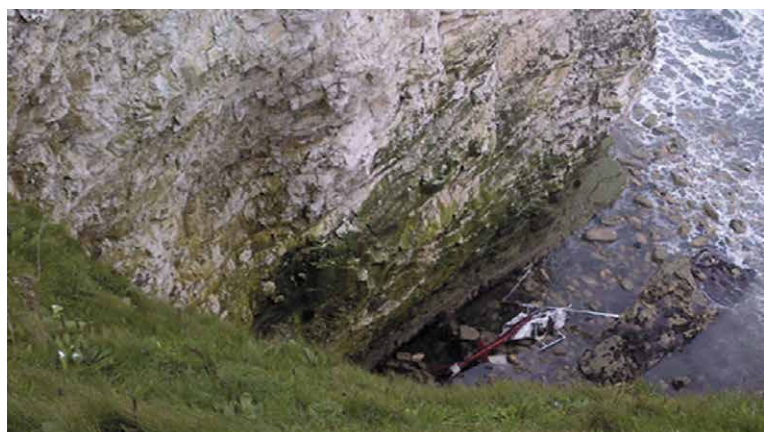
**Recovery of G-SUEX, Flamborough Head, Yorkshire in 2014**

We would normally expect to recover wreckage in coastal waters. An example is an accident involving an Augusta Bell 206B Jet Ranger II helicopter (G-SUEX) next to cliffs near Flamborough Head, Yorkshire. The wreckage came to rest on a shale beach in a small inlet at the foot of the cliffs. Although the wreckage could be accessed by sea, we were unable to recover it by boat and so was lifted it using a cliff top winch.

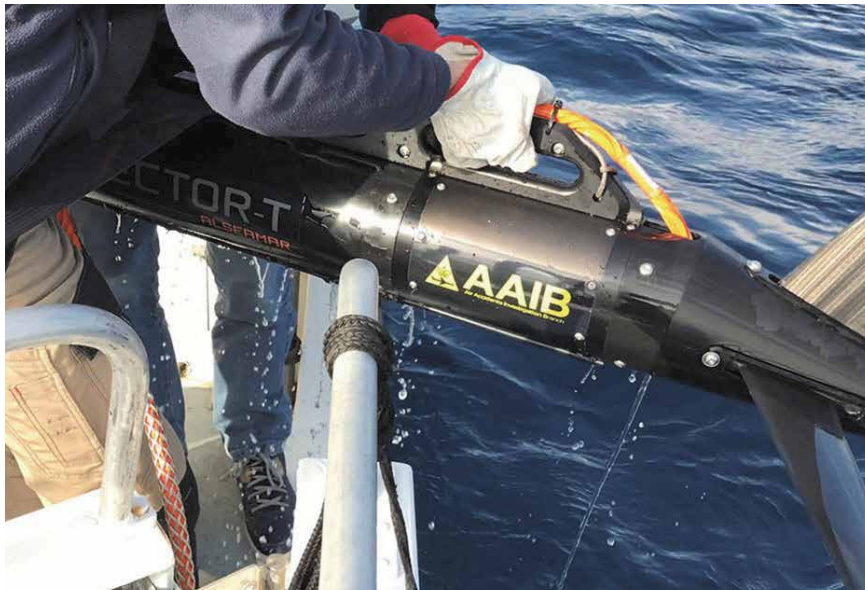
**The towed fish being recovered from the water during sea trials**

Commercial aircraft are normally equipped with cockpit voice and flight data recorders that are fitted with an acoustic beacon which is activated when it is submerged in water. The AAIB has its own handheld detectors that can be held over the side of a small boat and a more capable 'towed fish' that can be deployed from a suitable vessel and can be used to detect a beacon at depths of up to 1,000 m. The AAIB does not just use its equipment to locate missing aircraft; we also deployed to the Red Sea to search for the El Salam Boccaccio 98, a ferry which sank on 2 February 2006, 80 km (50 miles) from Duba, Saudi Arabia.

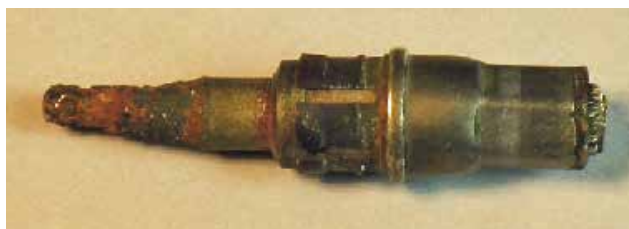
The burnt pins on the feeder cable was a known fault. On 10 October 2018, an engineer correctly identified that there was a FF on Gen 1 and inspected the connector between the engine and pylon but ran out of time to check the connector between the pylon and wing where the burnt pin was located.

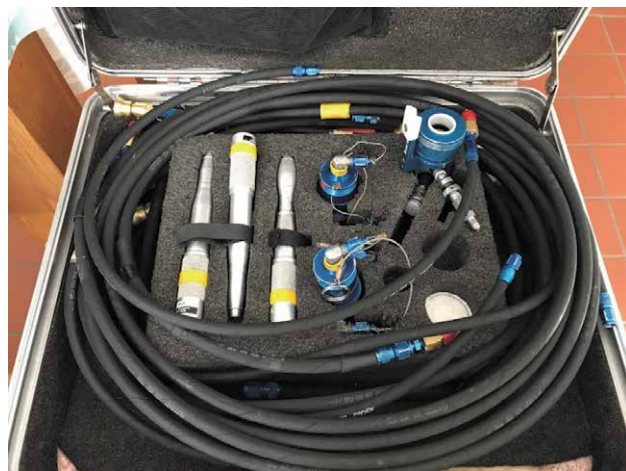
The kit manufacturer stated that the instructions for use of the air data accessory kit should be described in the relevant section of the AMM. The work orders issued by the maintenance organisation state that to accomplish a task it is to be done in accordance with the specific AMM task. However, the AMM does not provide any details on how to install the adaptors, which products should be used, or any additional information to aid the technicians to achieve a good seal between the probe and the adaptor.

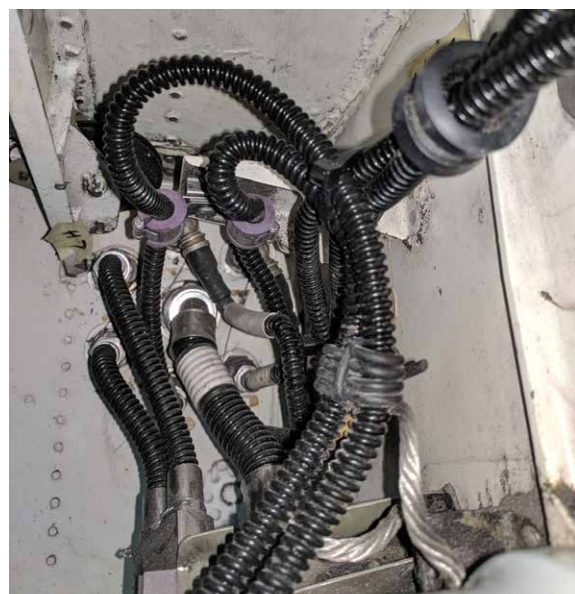
It was determined that a damaged electrical harness on one of the nose landing gear proximity sensors caused an erroneous signal, which resulted in the forward NLG doors starting to close while the NLG was still in transit to the UP position. The nose landing gear tyres contacted the forward doors, causing the NLG to rotate off-centre. Although the NLG subsequently retracted, the forward doors remained open and the tyres became jammed in the NLG bay. This prevented the nose landing gear from extending when subsequently commanded.

The damage to the harness resulted from a cyclically-driven fatigue failure mechanism, which occurred because the harness had been secured with a non-flexible cable tie which restricted it from flexing during normal nose landing gear operation.

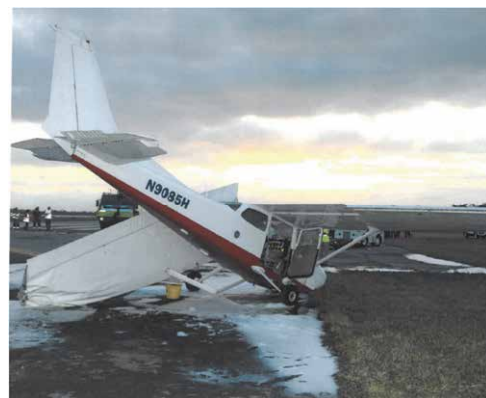
Shortly after takeoff the aircraft exhibited a tendency to pitch nose down despite the application of NOSE UP trim. During the subsequent approach to land, the forces required to maintain the approach path increased to the point where the pilot could no longer control the glidepath and the aircraft struck the ground short of the runway. The investigation found that the drive chain for the elevator trim actuator had been fitted incorrectly, which resulted in the elevator trim tab moving in the opposite sense to the movement of the trim wheel.

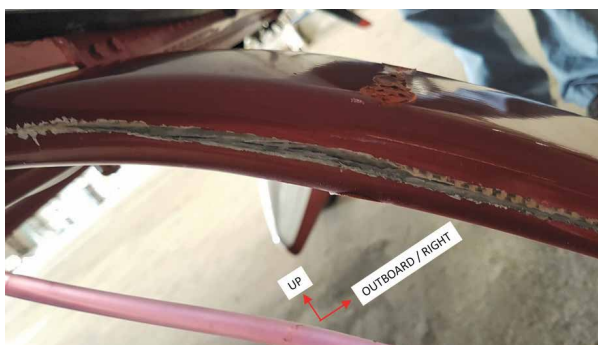
### Czech Sport Aircraft Sportcruiser, G-CGEO on 7 October 2018

The aircraft's right main landing gear (MLG) leg was damaged following a normal landing at Fowlmere Aerodrome. Investigation of the failed MLG leg revealed a manufacturing defect that caused the progressive delamination of the leg during service.

The aircraft manufacturer is currently certifying a reinforced MLG leg, part number SG0160L/P, intended to increase the durability of the legs in service. This new MLG will be available for retrofit to all models of Sportcruiser and PS-28 Cruiser aircraft. In addition to slightly enlarging the MLG leg cross-section, the inflatable tubes and stretch film material used during leg manufacture are now surrounded by a woven glass fibre 'sock', to prevent radial migration of the stretch film into the leg's composite structure.

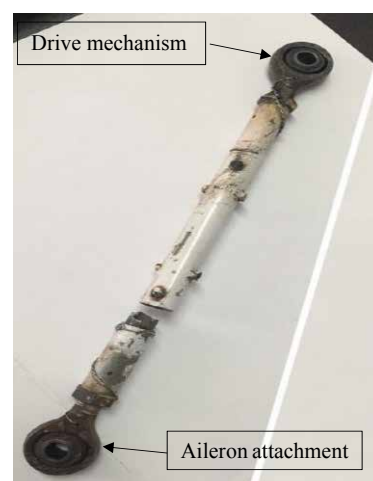
#### Britten-Norman BN-2B-21 Islander, VP-AEJ on 4 July 2018

During a short flight between the islands of Saint Eustatius and Saint Kitts, in the Caribbean, the pilot noticed that the ailerons felt "sluggish" but the aircraft landed successfully at Saint Kitts. It was found that a drive rod for the right aileron had broken and a spherical bearing, fitted to one end of the rod, had corroded heavily and was seized. Several safety actions have been taken to reduce the maintenance interval for control rods due to an increased risk of corrosion from the environmental factors where the aircraft operated. This investigation was delegated by the Dutch Safety Board to the AAIB in accordance with paragraph 5.1 of ICAO Annex 13.

- A reduction in the lubrication task interval from 1,000 hours to 100 hours for the aileron drive rod bearings.
- A fleet-wide corrosion inspection of all drive rod/bearing assemblies.

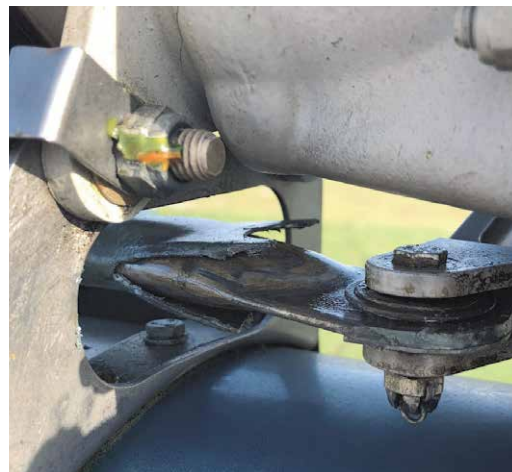
The AS 350 helicopter suffered tail rotor control problems in flight due to a rupture of the tail rotor gearbox (TGB) actuating rod. The pilot carried out a successful run-on landing. On 20 March 2019 the EASA issued Airworthiness Directive 2019-0060, mandating an inspection of TGB actuation rods to check for cracks.

- As a result of these findings, on 20 March 2019 the EASA issued Airworthiness Directive 2019-0060, mandating dye penetrant crack checks of TGB actuating rods on affected AS 350 and AS 355 helicopters.

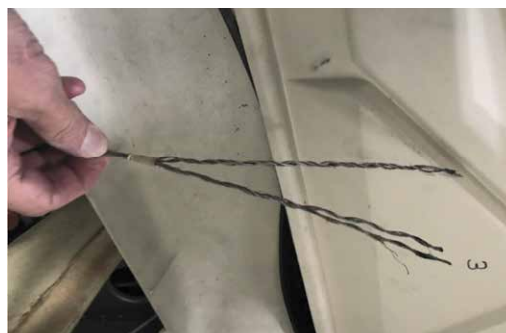
### Piper PA-34-220T Seneca V, G-OXFF on 2 November 2018

The aircraft was about to enter the runway for takeoff when the instructor became concerned about the feel of the left rudder pedal. He aborted the flight and taxied the aircraft back to the hangar. The subsequent engineering inspection found the left rudder cable had parted, with evidence that it had melted through due to chafing against the standby battery cable. Safety actions have been taken by the Civil Aviation Authority and the manufacturer has issued a mandatory Service Bulletin (No 1337) to reroute the emergency power wiring to give more clearance from the rudder cables.

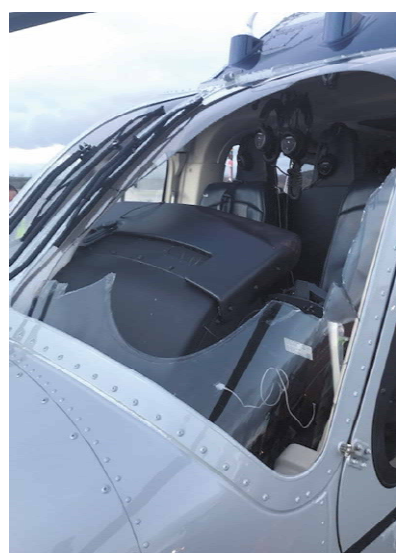
Whilst on short final to Edinburgh Airport, at approximately 100 kt, the helicopter suffered a bird strike to the left windscreen. The windscreen shattered and debris entered the cockpit, injuring the occupant in the left seat, who required hospital treatment.

The Bell 429 windscreen is not designed to withstand bird strikes and the design certification requirements do not require it to do so. A recent study by the Rotorcraft Bird Strike Working Group has recommended the introduction of bird strike protection requirements for Normal category rotorcraft to minimise the risk of damage or injury.

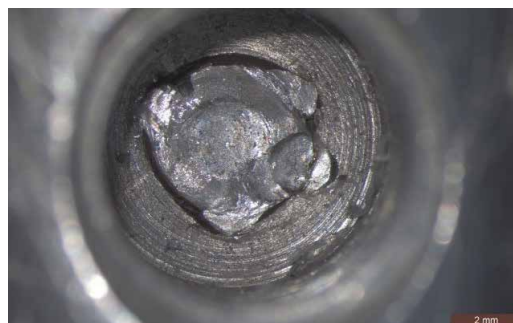
During the climb to cruising altitude the flight crew took the precautionary action of using the fixed oxygen system following a pressurisation event. The aircraft pressurisation system was reset and functioned normally, however the oxygen system failed to provide the pilots with oxygen. The oxygen cylinder regulator was later disassembled, and the crew oxygen supply port was found blocked with a piece of debris. It is

suspected that the debris was the tip of a screw extraction tool, but no evidence could be found to explain how it came to be in the regulator. The operator has changed the 'first flight' checks to ensure the flight deck emergency oxygen system is functioning correctly.

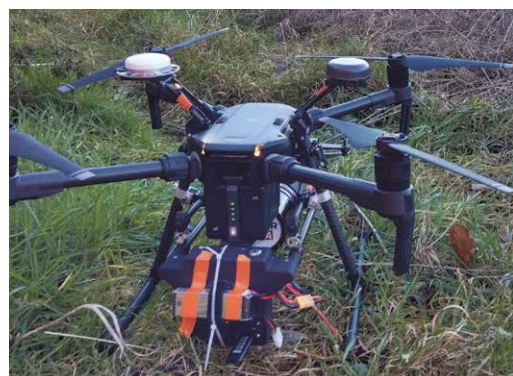
The unmanned aircraft system (UAS) was fitted with a third-party lidar<sup>9</sup> pod for its planned survey mission which involved flights of around 8 minutes duration. As it commenced its pre-programmed route, it appeared to continue to climb above the 30 m height that had been set. The remote pilots observed that it was too high and attempted to land it immediately. The aircraft appeared unresponsive to the remote pilot's inputs and it then commenced an uncontrolled descent, rapidly increasing speed, until it struck the ground.

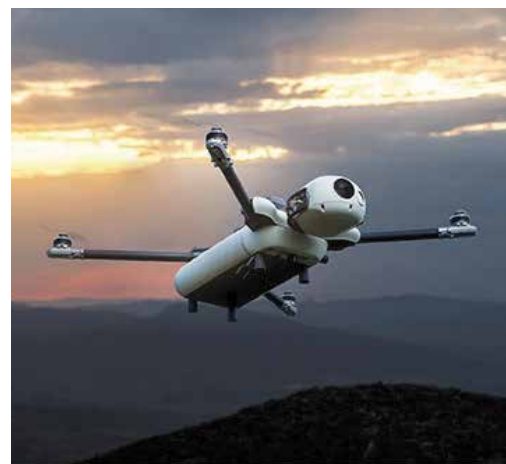
During a demonstration flight, the UAS dropped to the ground from a height of 50 m when the electric motors stopped, despite the battery being fully charged. The UAS struck the ground and was destroyed in the subsequent post-impact fire. The UAS manufacturer determined that the loss of power was caused by the battery not being fully locked in place.

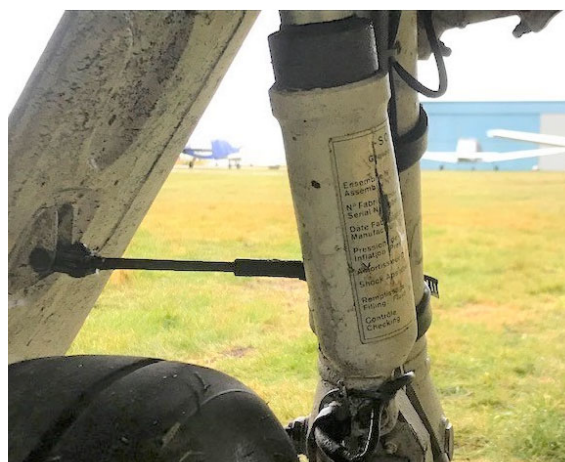
The aircraft, whilst taxiing at night at Dundee Airport, departed the right side of Taxiway E at the point where the taxiway curves to the left prior to joining the main apron. The aircraft's left main landing gear oleo was damaged as it rolled over the paved edge of the main apron. A contributory factor in the pilot's loss of situational awareness of his position on Taxiway E may have been his loss of sight of the taxiway edge lights against the brightly-lit main apron. Excessive taxiing speed may have also been a contributing factor.

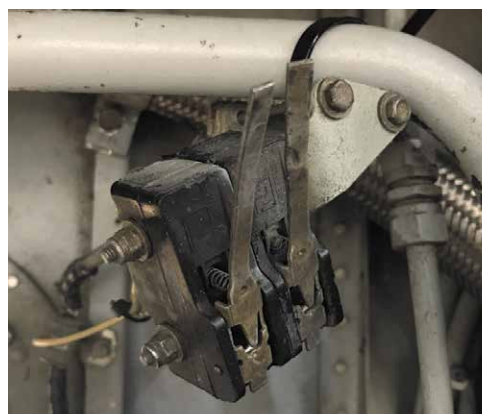
The landing gear warning horn sounded during the approach to land. The undercarriage had been selected down and the green light indicating it was safe was illuminated, but the right undercarriage leg collapsed towards the end of the landing ground roll. Neither occupant was injured. The operator has provided additional information to its pilots concerning the landing gear systems on each of its aircraft and the aircraft will be modified to standardise system functionality with its other Spitfires.

The right main undercarriage was not locked down and retracted under the weight of the aircraft on landing.

It is likely the undercarriage was serviceable and capable of operating correctly, but excessive air load or incomplete selection of the undercarriage lever to the down position meant that the hydraulic system returned to idle before the undercarriage was locked down.

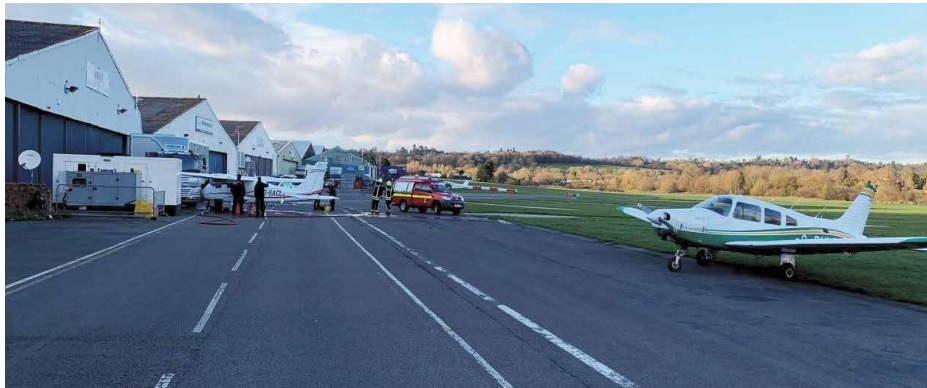
During taxi the pilot manoeuvred the aircraft to the left to avoid a Piper PA-28 parked on the right side of the taxiway. Whilst he was looking to the right to ensure sufficient clearance from the PA-28, he was also looking ahead to identify the centreline, which he found difficult due to road markings on the apron. The road markings were white and faded with older markings visible. As he was attempting to regain the centreline the aircraft's left wing tip struck a large metal generator which was positioned close to the left apron edge. The pilot stated that the colour of the generator blended with the hangar behind and he had not noticed it.

The aircraft slewed to the left and came to rest after the nose struck an articulated lorry parked next to the generator.

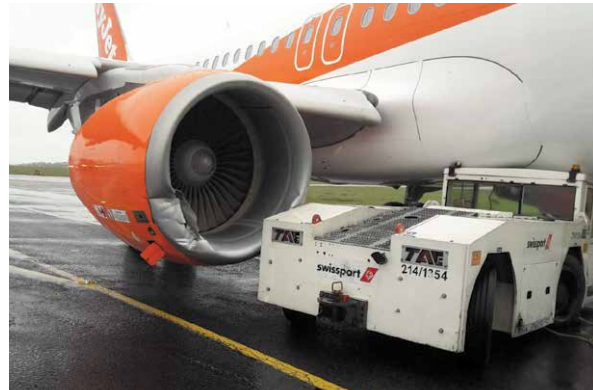
While being pushed back from Stand 18 at Belfast International Airport, the aircraft was stopped with the tug and tow bar positioned at a significant angle to the aircraft's nose. The tow bar disconnected from the nose landing gear, and the aircraft rolled forward and struck the tug.

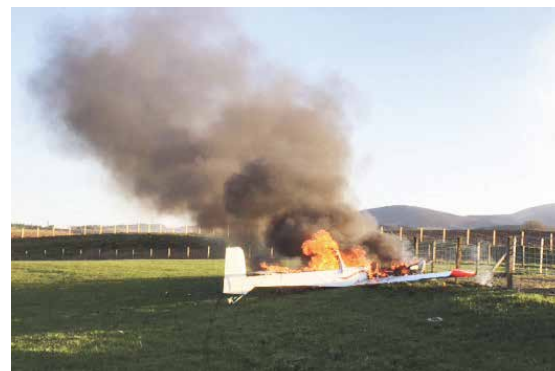
After a local flight, the ground taxi route back to the hangar involved several tight turns and when full left rudder pedal was applied the cockpit filled with smoke. The pilot exited the aircraft without injury and the ensuing fire consumed the aircraft. It is suspected that the terminals of the starter solenoid were not insulated, and the rudder pedal created an electrical short circuit which damaged a fuel pipe and ignited the fuel.

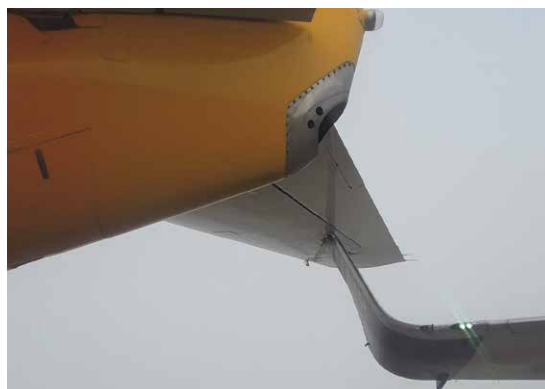
EI-SEV was taxiing to park on Stand 22 (S22) at East Midlands Airport (EMA) and the routing passed behind G-GDFB on Stand 24 (S24). As EI-SEV passed behind G-GDFB its winglet struck the other aircraft's right horizontal stabiliser.

Low Visibility Procedures (LVPs) were in force, and controllers could not see the apron area and were unaware that S24 was occupied. Neither the UK Aeronautical Information Publication (AIP) nor the pilots' airfield charts indicated that wingtip clearance could be compromised when taxiing behind parked aircraft in that location.

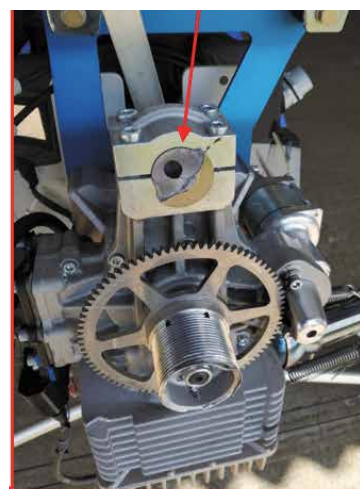
The flex-wing aircraft's single-cylinder engine rotates a pusher propeller using a reduction drive belt, driven by a pulley on the engine crankshaft. Drive belt tension may be adjusted using an eccentrically-mounted bearing on the propeller driveshaft. Inspection of the engine revealed that the eccentric bearing assembly and propeller had detached at the support bracket due to a fatigue failure of the bearing support. The propeller was not located following the event.
