Climate Adaptation: Risk Management and Resilience Optimisation for Vulnerable Road Access in Africa

Visual Assessment Manual

ReCAP Project GEN2014C

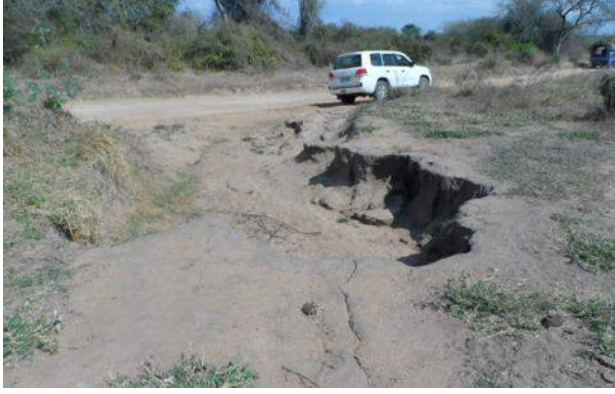
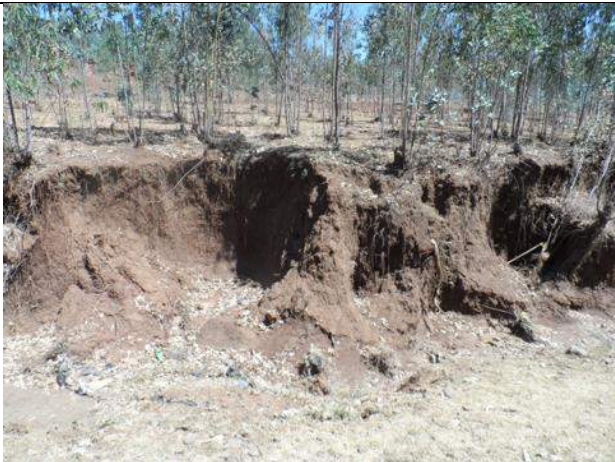
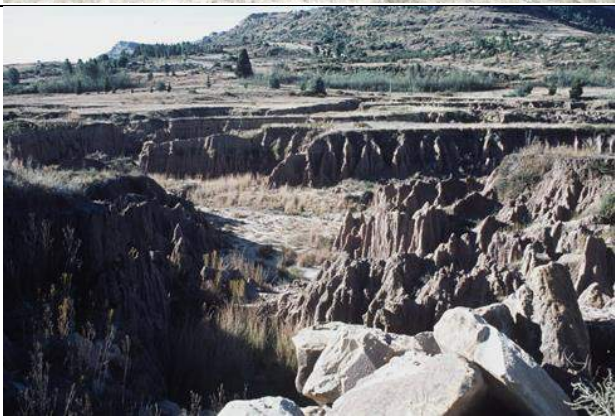
Figure 3 Erosion of areas around the road

| Degree | Description |
|---|---|
| 5 | Severe loss of material and formation of deep erosion gullies – requires urgent adaptation measures |

| | <p style="text-align: center;">Evidence of localised material loss due to channelized water flows</p> | | | | | |
| | <p style="text-align: center;">Obvious surface erosion and channelling of water</p> | | | | | |

The descriptions of degrees of the various types of erosion are presented in Table 3 to Table 6 with degrees 2 and 4 being interpolated between 1 and 3 and 3 and 5 respectively and illustrated in Figure 3 to Figure 6 respectively.

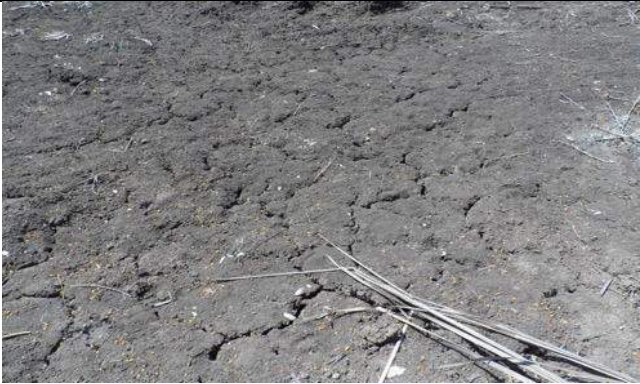
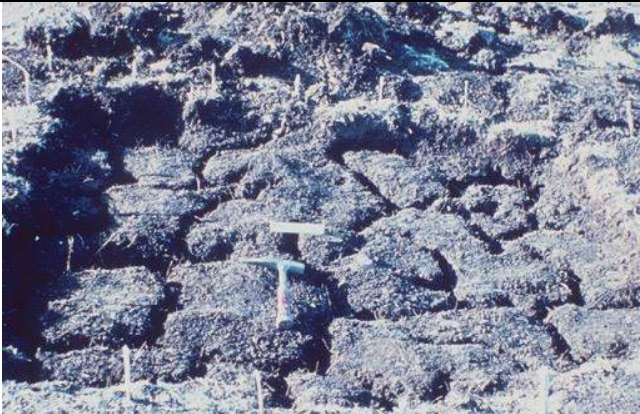
| Figure 7 Expansive clays | | | | | | |

Usually black, dark grey or red. Shows distinctive cracking with wide, open cracks. May be masked by vegetation and so one needs to look for open exposed areas. If no cracks are observed the material will be identified as non-expansive. If wide cracks (Degree 5 in Figure 7) are observed, the material should be identified as highly expansive. These materials also tend to slake (disintegrate to clay) when placed in water.

| Figure 7 Expansive clays | | | | | | |
|---|--|---|---|---|---|---|
| Moderately expansive clays – cracks 5 – 10 mm wide | | | | | | |
| Highly expansive clays – cracks > 10 mm wide | | | | | | |

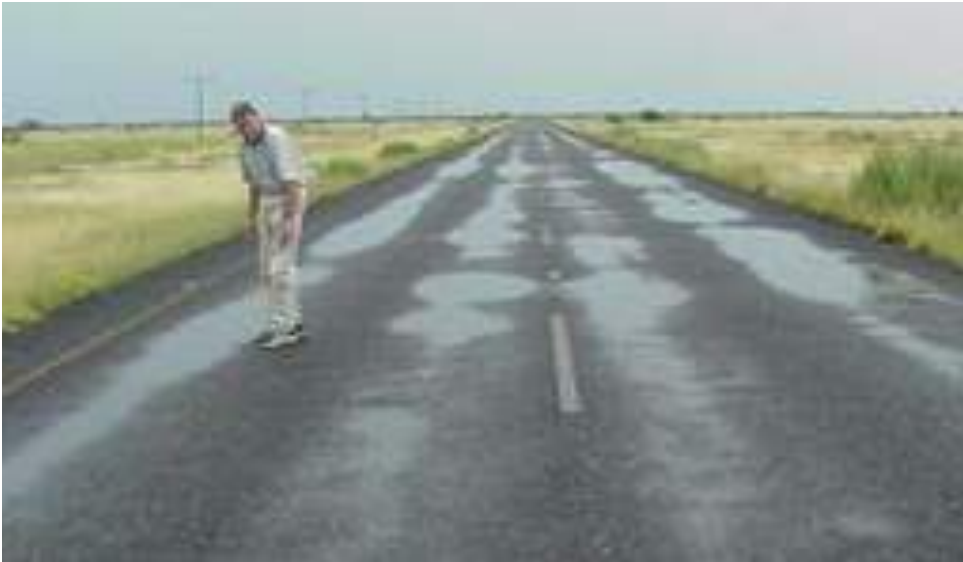
Figure 8 Typical manifestation of collapsible soils in paved road

Collapsible soils are difficult to identify in the field without very close inspection. These soils consist of individual particles of hard sands that are supported by clay, iron or calcite “bridges” and often contain obvious voids (pinholes). When these materials are loaded under wet conditions, the “bridges” collapse and the material decreases in volume, usually manifested as distinctive rutting in the wheel tracks (Figure 8). Most collapsible soils consist of highly weathered granites or sandstones, or else transported sandy soils, although various other materials may have a collapsible structure. In the field, it is thus important to identify the type of material and look for signs of collapse on similar materials in the area. Local engineering knowledge will often be available if collapsible soils are present.

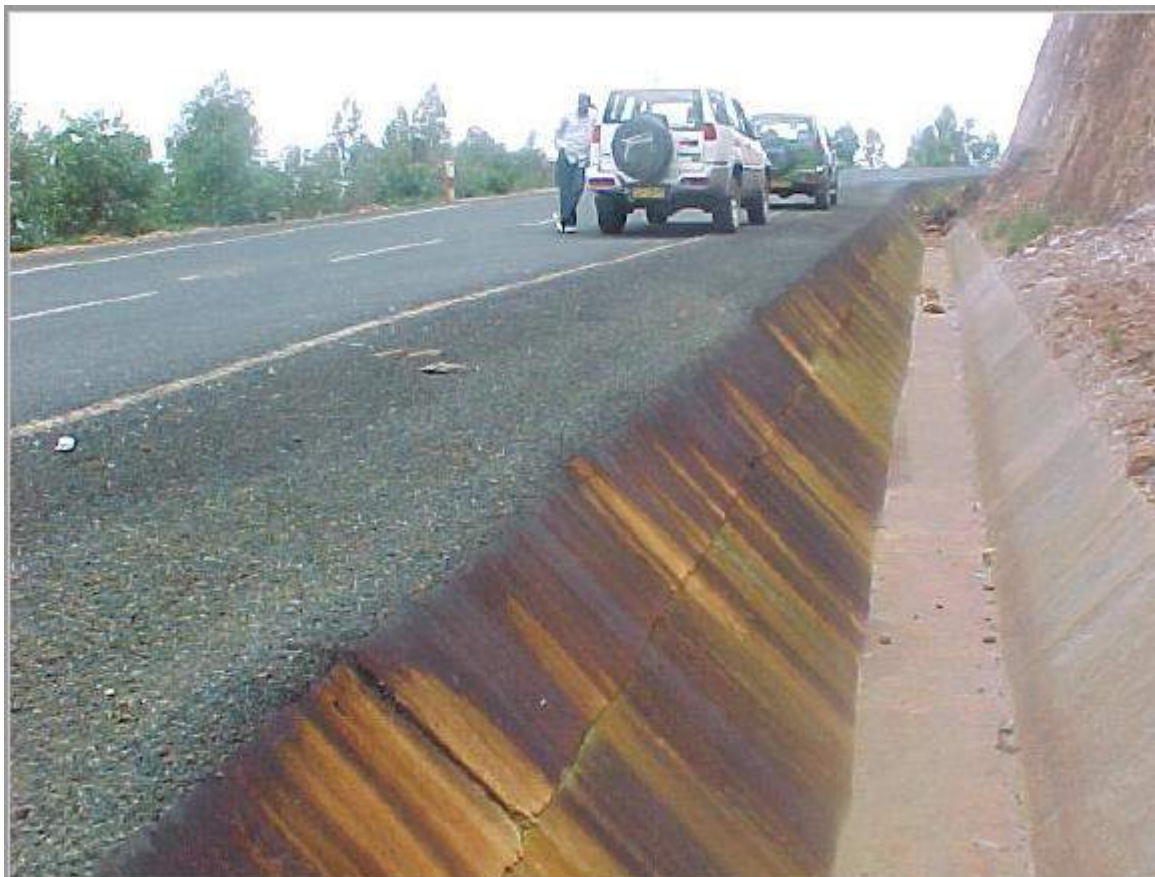
Figure 9: An example of yellow/brown staining of a concrete side drain due to the presence of sulphides

Saline materials are often difficult to identify, but past experience in the area is useful. Yellow/brown staining of local structures often indicates the presence of sulphides. Many salt deposits can be identified by licking them lightly and tasting for salts. Figure 9 shows an example of a side drain with staining from sulphuric acid generated from the oxidation of sulphides in coal used in support layers.

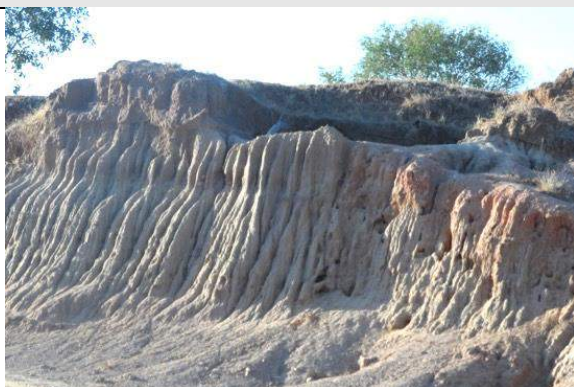
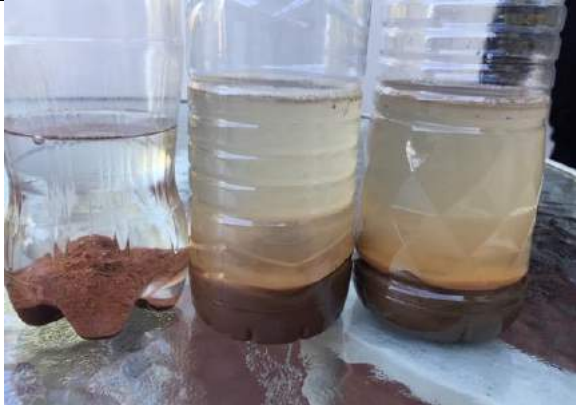
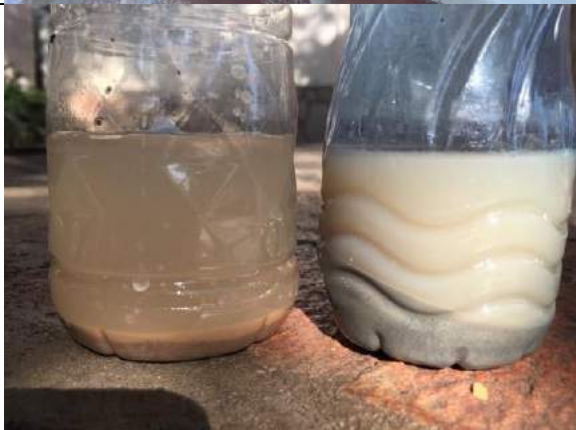
Figure 10 Dispersive soils

Dispersive materials can cause severe problems as they (i.e. the fine clays) are leached out of embankments and subgrade areas leading to the formation of tunnels and “pipes” which then collapse. Dispersive soils in the area are usually indicated by what appear to be highly eroded areas, but specifically with the presence of the pipes and tunnels (Figure 10). Such soils are best identified as potential problems by placing small clods of the soil in pure (drinking) water and checking the state of the clay suspension after 24 hours. The clods may stay intact or slake, but dispersive clays go into suspension and do not settle out (Figure 10).

Dispersive soil showing typical erosion-like features with tunnels in lower central area

| | | <p>Three soils showing slaking but no dispersion (left) and slight dispersion in two samples on right</p> |
| | | <p>Two soils showing slight dispersiveness (left) and highly dispersive (right)</p> |

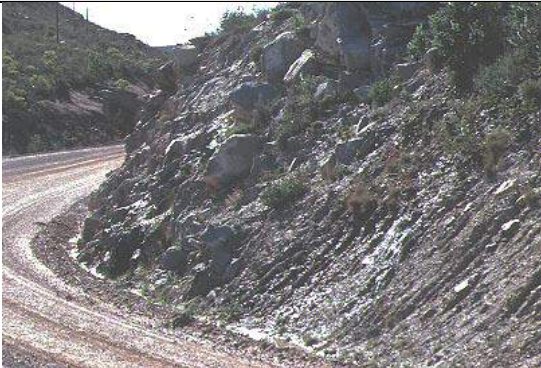
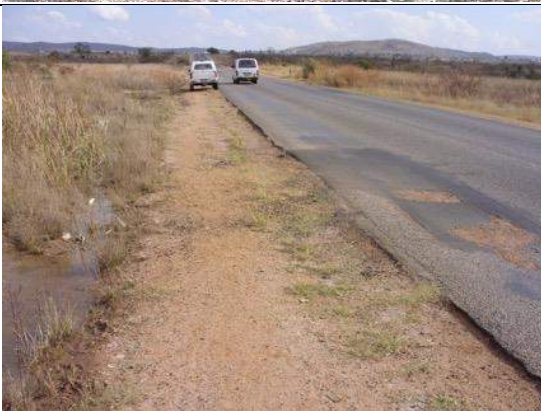
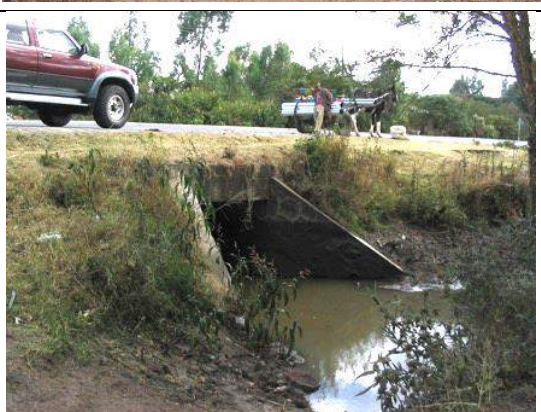
Figure 11 Wet areas

| | | Minor evidence of localised, but controllable water problems | | | | |
| | | Standing water adjacent to road surface or evidence of perennial water accumulation | | | | |
| | | Permanent high water-tables | | | | |

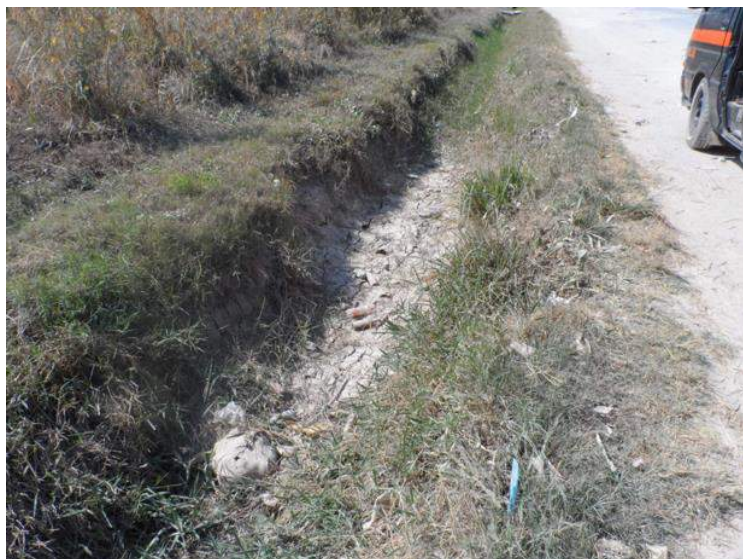
Figure 12 Evidence of ponding of water in side drain

It is often necessary to construct culverts to convey the water collected in side-drains from the road across (under) the road to avoid damage to the road and ensure that the water is moved away from the road. The effectiveness of these needs to be ascertained – this should include both their positioning with respect to the lowest point in the road as well as their grade and surroundings, to ensure that water is not permitted to accumulate near the pavement structure. This is normally plain to see, but the presence of silt and clay deposits with associated drying cracking should be looked for when assessing the road in the dry season (Figure 12). Assessment should include issues such as the adequacy of culvert numbers and apertures, the effectiveness and indications of silting and recording of damage to pipes and head- and wing-walls. It is often seen that the low points in roads move laterally along the road with time (particularly related to flooding and sedimentation) and culverts are no longer in the correct places. This should be noted where observed.

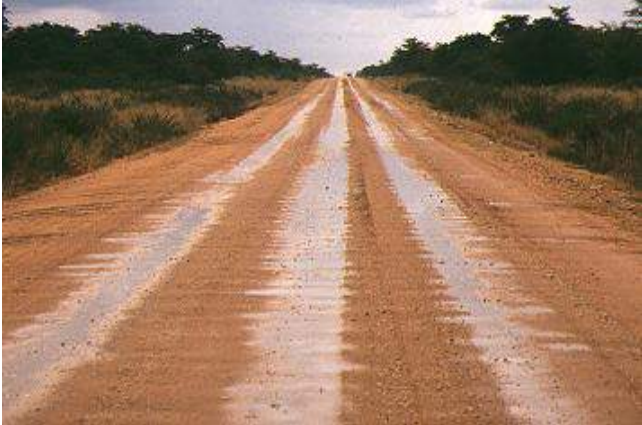
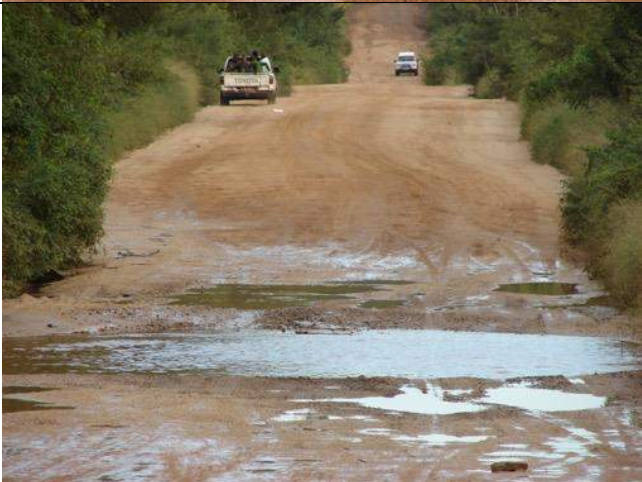
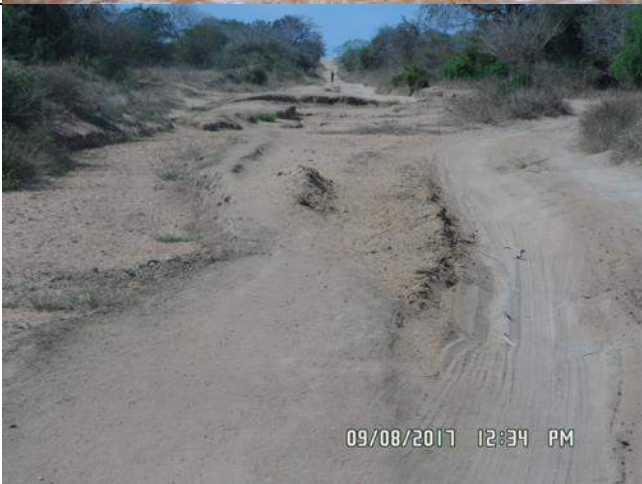
Figure 13 Road shape (unpaved roads)

| | <table border="1"> <tr> <td colspan="5" style="text-align: center;">1</td> </tr> <tr> <td style="text-align: center;">1</td> <td style="text-align: center;">2</td> <td style="text-align: center;">3</td> <td style="text-align: center;">4</td> <td style="text-align: center;">5</td> </tr> <tr> <td colspan="5"> <p>Good shape and crossfall - minor susceptibility to retaining shallow water on the surface</p> </td> </tr> </table> | 1 | | | | | 1 | 2 | 3 | 4 | 5 | <p>Good shape and crossfall - minor susceptibility to retaining shallow water on the surface</p> | | | | |
| | <table border="1"> <tr> <td colspan="5" style="text-align: center;">3</td> </tr> <tr> <td style="text-align: center;">1</td> <td style="text-align: center;">2</td> <td style="text-align: center;">3</td> <td style="text-align: center;">4</td> <td style="text-align: center;">5</td> </tr> <tr> <td colspan="5"> <p>Uneven road with poor camber leading to ponding of water</p> </td> </tr> </table> | 3 | | | | | 1 | 2 | 3 | 4 | 5 | <p>Uneven road with poor camber leading to ponding of water</p> | | | | |
| <p style="text-align: right; font-size: small;">09/08/2017 12:34 PM</p> | <table border="1"> <tr> <td colspan="5" style="text-align: center;">5</td> </tr> <tr> <td style="text-align: center;">1</td> <td style="text-align: center;">2</td> <td style="text-align: center;">3</td> <td style="text-align: center;">4</td> <td style="text-align: center;">5</td> </tr> <tr> <td colspan="5"> <p>Road is below surrounding ground level and water will not be removed before distress is caused</p> </td> </tr> </table> | 5 | | | | | 1 | 2 | 3 | 4 | 5 | <p>Road is below surrounding ground level and water will not be removed before distress is caused</p> | | | | |

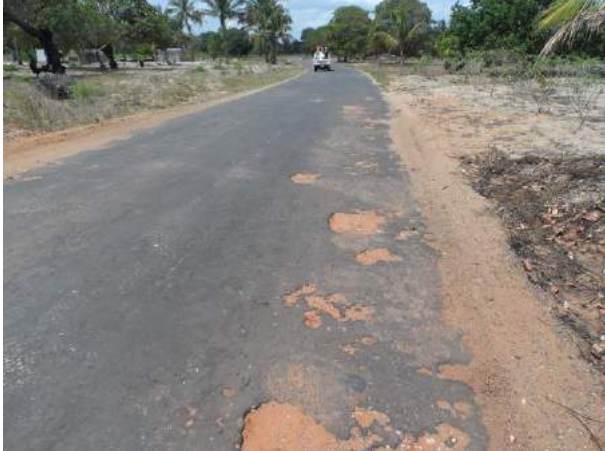
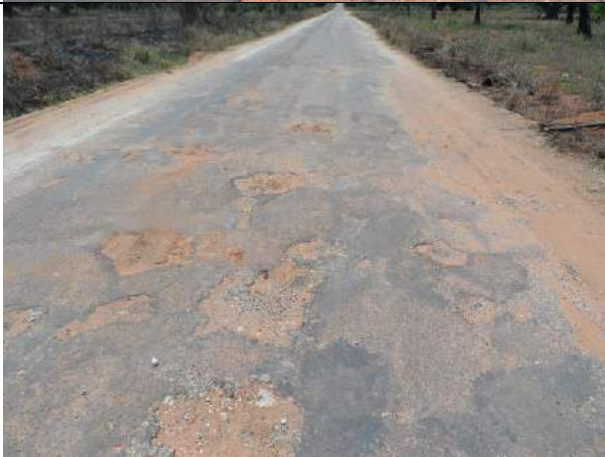
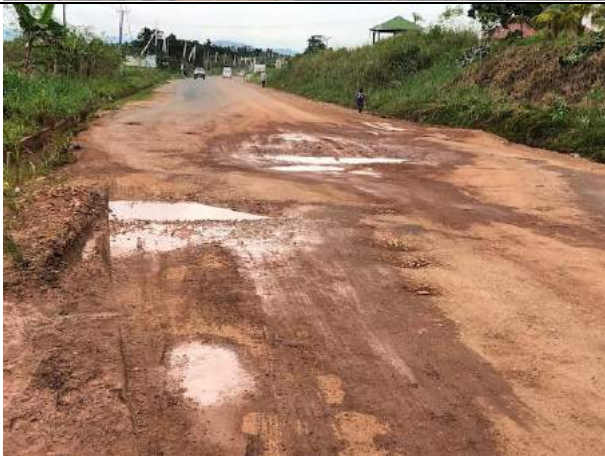
Figure 14 Road shape (paved roads)

| | | <p>Good shape and crossfall - minor susceptibility to retaining shallow water on the surface</p> | | | | | |

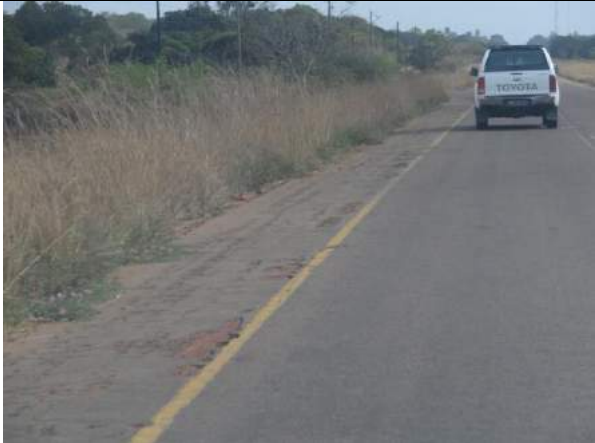
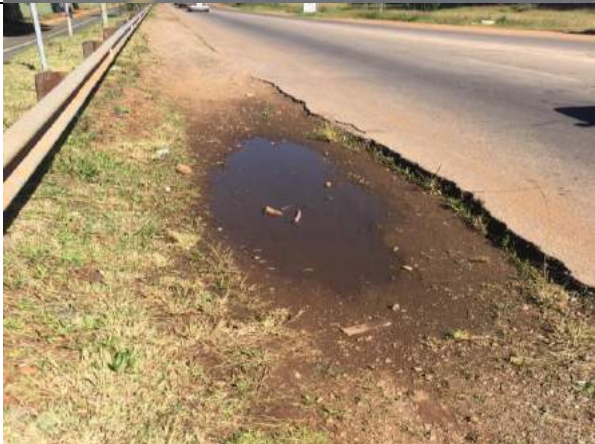
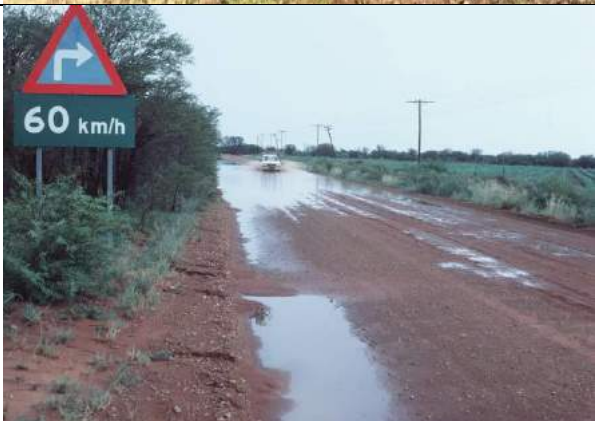
| Figure 15 Shoulders | | | | | | |

| Figure 15 Shoulders | | | | | | |
|---|---|---|---|---|---|---|
| | <p style="text-align: center;">1</p> <table border="1" style="width: 100%; text-align: center;"> <tr> <td style="width: 15%;">1</td> <td style="width: 15%;">2</td> <td style="width: 15%;">3</td> <td style="width: 15%;">4</td> <td style="width: 15%;">5</td> </tr> </table> <p style="text-align: center;">Shoulders allow flow of most water with minor ponding</p> | 1 | 2 | 3 | 4 | 5 |
| | | <p style="text-align: center;">3</p> <table border="1" style="width: 100%; text-align: center;"> <tr> <td style="width: 15%;">1</td> <td style="width: 15%;">2</td> <td style="width: 15%;">3</td> <td style="width: 15%;">4</td> <td style="width: 15%;">5</td> </tr> </table> <p style="text-align: center;">Significant ponding of water occurs on shoulders</p> | 1 | 2 | 3 | 4 |
| | | <p style="text-align: center;">5</p> <table border="1" style="width: 100%; text-align: center;"> <tr> <td style="width: 15%;">1</td> <td style="width: 15%;">2</td> <td style="width: 15%;">3</td> <td style="width: 15%;">4</td> <td style="width: 15%;">5</td> </tr> </table> <p style="text-align: center;">Water retained on shoulders for extended periods allowing weakening of carriage-way materials</p> | 1 | 2 | 3 | 4 |

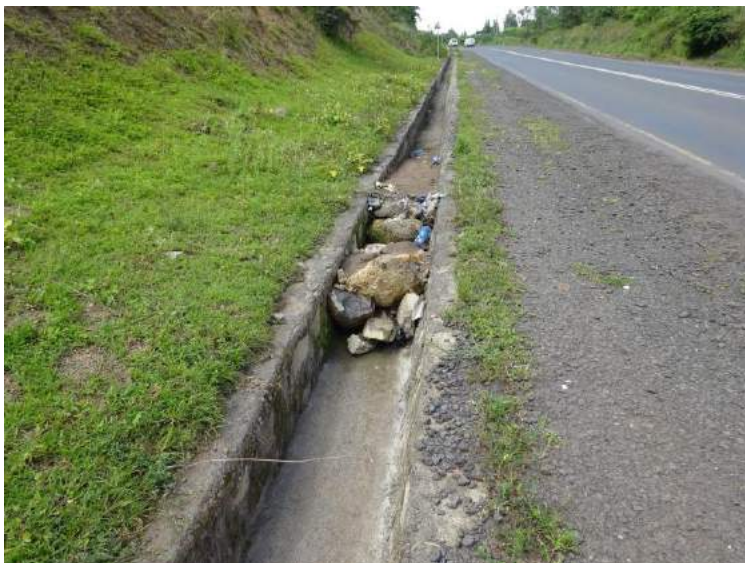
Figure 16 Unpaved area between impervious seal and lined drain allowing access of water into the pavement (Note poor maintenance of side drain as well)

The assessment should indicate whether the shoulders are shaped to remove water from the road surface towards the side slopes and side-drains. A common observation is the presence of unpaved areas between the sealed road pavement and the lined side-drains, which is considered unacceptable (Figure 16) as water will penetrate through these areas into the pavement layers.

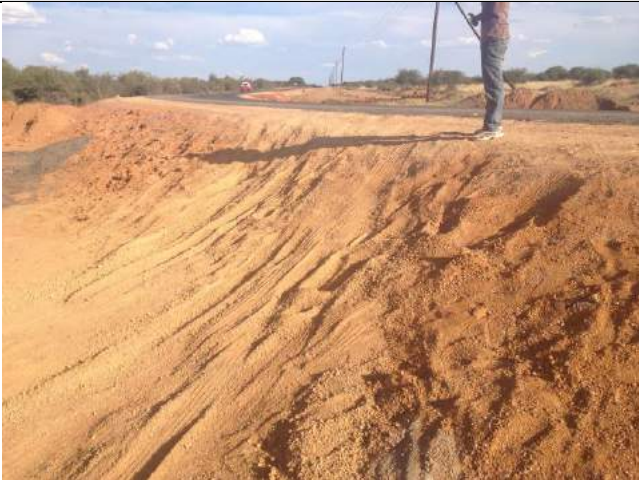
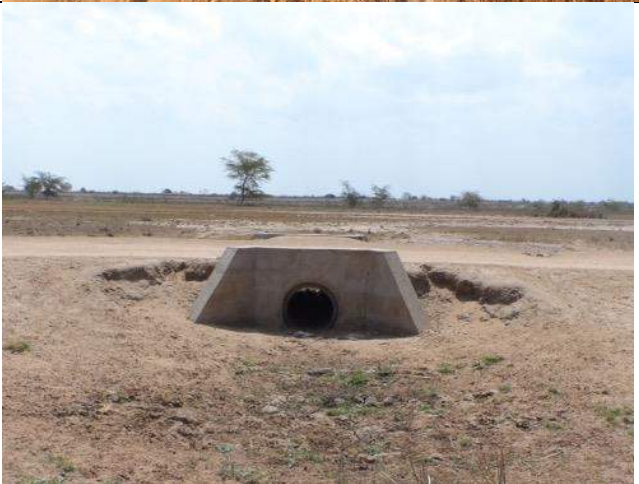
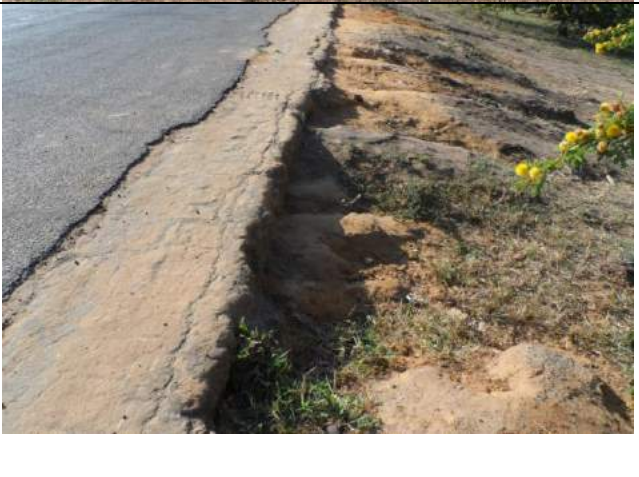
Figure 17 Drainage effectiveness of side slopes

The side-slopes in this case are normal formation (up to 750 mm high) and embankments (> 750 mm) constructed to raise the road, provide for culverts, etc. Poorly shaped side slopes will usually result in erosion and undercutting of the shoulders and even the road structure if not repaired properly. Side slopes that allow accumulation of water are not common but may occur and should be recorded.

| | | Slopes remove water with minimal ponding or erosion damage | | | | | |
| | | Poor removal of water from road and shoulders into side drains – may be erosion that could block drains | | | | | |

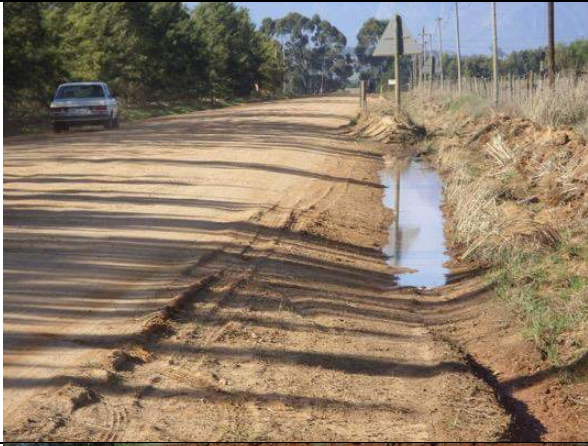
| Figure 18 Effectiveness of side drains | | | | | | | |

| Figure 18 Effectiveness of side drains | | | | | | | |
|---|---|---|---|---|---|---|---|
| | | <p style="text-align: center;">1</p> <table border="1" style="width: 100%; text-align: center;"> <tr> <td style="width: 20px;">1</td> <td style="width: 20px;">2</td> <td style="width: 20px;">3</td> <td style="width: 20px;">4</td> <td style="width: 20px;">5</td> </tr> </table> <p style="text-align: center;">Most water is effectively removed but localised ponding of short duration may occur</p> | 1 | 2 | 3 | 4 | 5 |

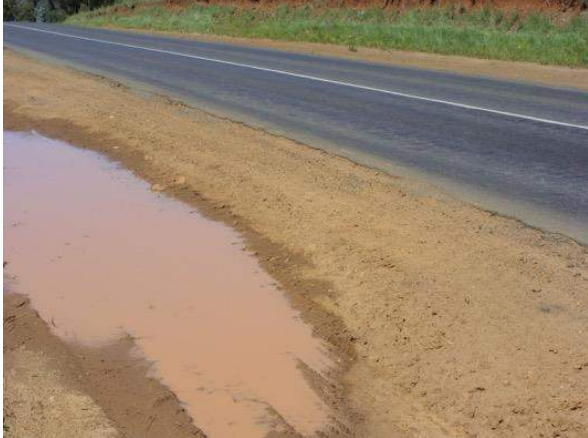
| Figure 18 Effectiveness of side drains | | | | | | | |
|---|---|---|---|---|---|---|---|
| | | <p style="text-align: center;">3</p> <table border="1" style="width: 100%; text-align: center;"> <tr> <td style="width: 20px;">1</td> <td style="width: 20px;">2</td> <td style="width: 20px;">3</td> <td style="width: 20px;">4</td> <td style="width: 20px;">5</td> </tr> </table> <p style="text-align: center;">Drains are incorrectly graded or have uneven surfaces that retain water for prolonged periods.</p> | 1 | 2 | 3 | 4 | 5 |

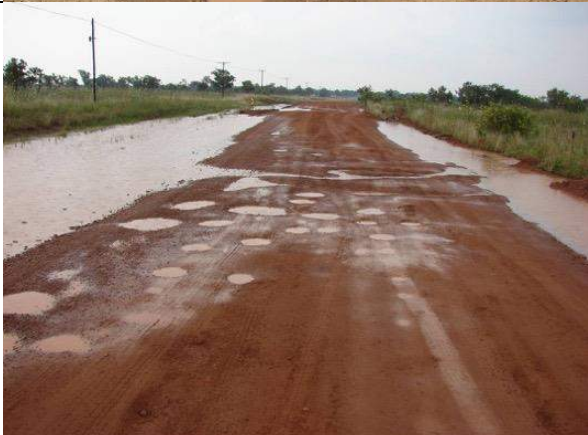
| Figure 18 Effectiveness of side drains | | | | | | | |
|---|---|---|---|---|---|---|---|
| | | <p style="text-align: center;">5</p> <table border="1" style="width: 100%; text-align: center;"> <tr> <td style="width: 20px;">1</td> <td style="width: 20px;">2</td> <td style="width: 20px;">3</td> <td style="width: 20px;">4</td> <td style="width: 20px;">5</td> </tr> </table> <p style="text-align: center;">No effective drains or else water is not removed from road side</p> | 1 | 2 | 3 | 4 | 5 |

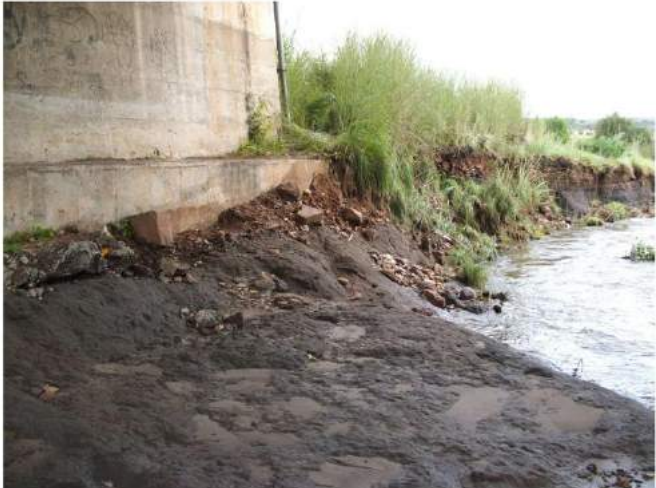
Figure 20 Damage to large drainage structures

| | <table border="1"> <tr> <td colspan="5" style="text-align: center;">1</td> </tr> <tr> <td style="text-align: center;">1</td> <td style="text-align: center;">2</td> <td style="text-align: center;">3</td> <td style="text-align: center;">4</td> <td style="text-align: center;">5</td> </tr> <tr> <td colspan="5" style="text-align: center;">Minor evidence of localised damage</td> </tr> </table> | 1 | | | | | 1 | 2 | 3 | 4 | 5 | Minor evidence of localised damage | | | | |
| | <table border="1"> <tr> <td colspan="5" style="text-align: center;">3</td> </tr> <tr> <td style="text-align: center;">1</td> <td style="text-align: center;">2</td> <td style="text-align: center;">3</td> <td style="text-align: center;">4</td> <td style="text-align: center;">5</td> </tr> <tr> <td colspan="5" style="text-align: center;">Obvious damage to the bridge or culvert structure, but which can be repaired</td> </tr> </table> | 3 | | | | | 1 | 2 | 3 | 4 | 5 | Obvious damage to the bridge or culvert structure, but which can be repaired | | | | |
| | <table border="1"> <tr> <td colspan="5" style="text-align: center;">5</td> </tr> <tr> <td style="text-align: center;">1</td> <td style="text-align: center;">2</td> <td style="text-align: center;">3</td> <td style="text-align: center;">4</td> <td style="text-align: center;">5</td> </tr> <tr> <td colspan="5" style="text-align: center;">Severe damage to the structure that requires reconstruction of the bridge</td> </tr> </table> | 5 | | | | | 1 | 2 | 3 | 4 | 5 | Severe damage to the structure that requires reconstruction of the bridge | | | | |

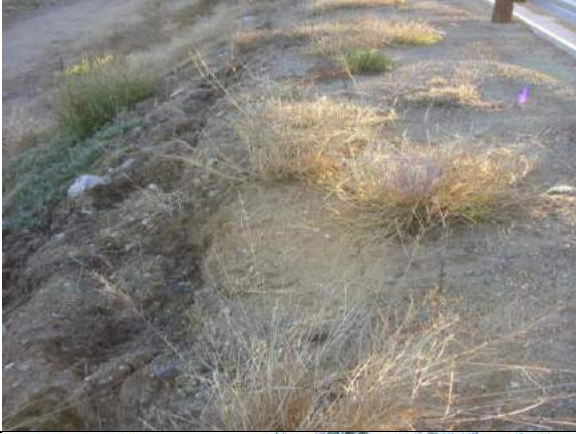
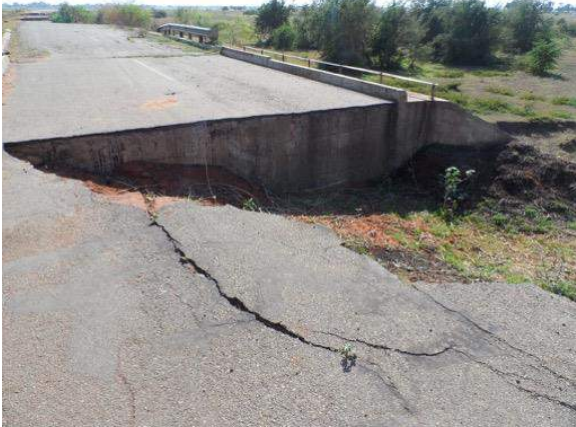
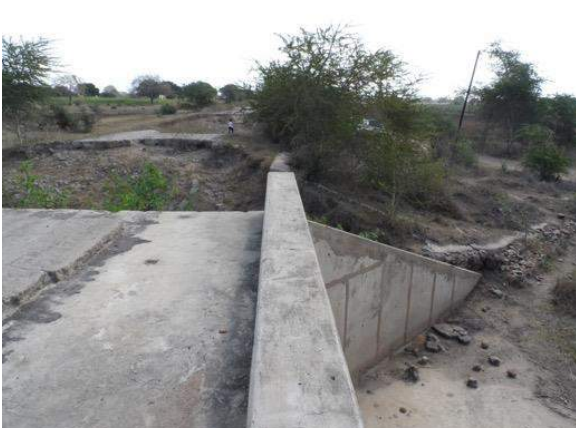
| Figure 21 Embankment damage | | | | | | |

| Figure 21 Embankment damage | | | | | | |
|---|--|--|---|---|---|---|
| | <p style="text-align: center;">1</p> <table border="1" style="width: 100%; text-align: center;"> <tr> <td>1</td> <td>2</td> <td>3</td> <td>4</td> <td>5</td> </tr> </table> <p style="text-align: center;">Minor evidence of water damage</p> | 1 | 2 | 3 | 4 | 5 |
| | | <p style="text-align: center;">3</p> <table border="1" style="width: 100%; text-align: center;"> <tr> <td>1</td> <td>2</td> <td>3</td> <td>4</td> <td>5</td> </tr> </table> <p style="text-align: center;">Loss of material from embankment. Can be repaired</p> | 1 | 2 | 3 | 4 |
| | | <p style="text-align: center;">5</p> <table border="1" style="width: 100%; text-align: center;"> <tr> <td>1</td> <td>2</td> <td>3</td> <td>4</td> <td>5</td> </tr> </table> <p style="text-align: center;">Severe loss of material - closure of road – needs reconstruction</p> | 1 | 2 | 3 | 4 |

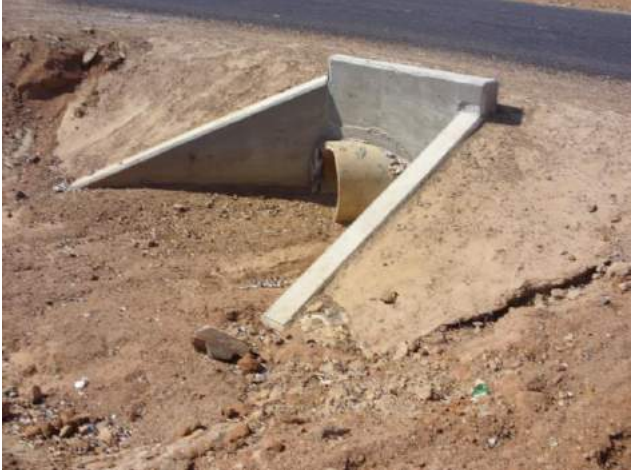
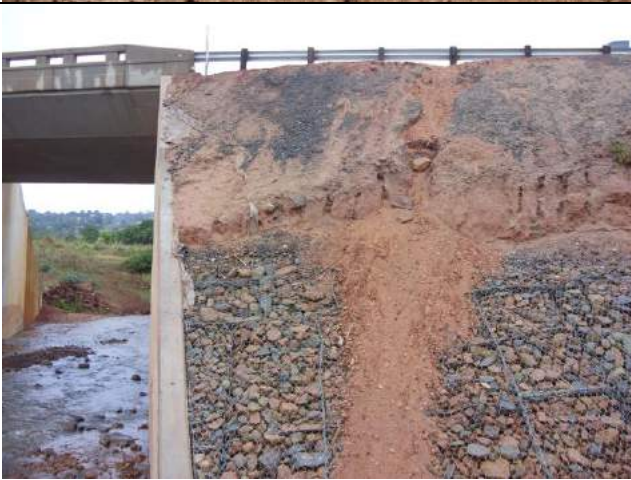
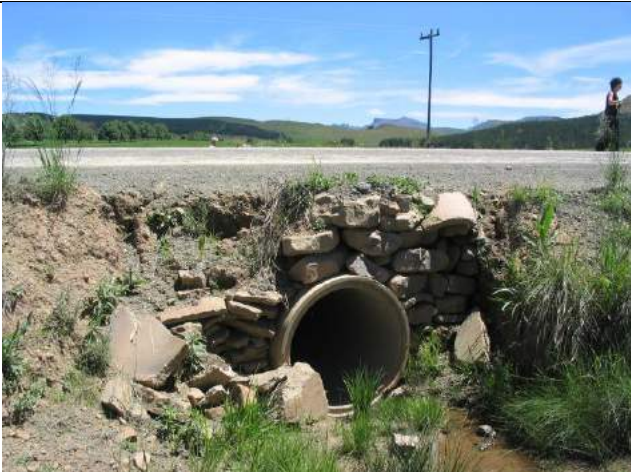
Figure 23 Damage to protection works

| | | 1 | <table border="1" style="width: 100%; text-align: center;"> <tr> <td style="width: 15%;">1</td> <td style="width: 15%;">2</td> <td style="width: 15%;">3</td> <td style="width: 15%;">4</td> <td style="width: 15%;">5</td> </tr> </table> | | | | | 1 | 2 | 3 | 4 | 5 | Minor evidence of water damage | | | | |
| | | 3 | <table border="1" style="width: 100%; text-align: center;"> <tr> <td style="width: 15%;">1</td> <td style="width: 15%;">2</td> <td style="width: 15%;">3</td> <td style="width: 15%;">4</td> <td style="width: 15%;">5</td> </tr> </table> | | | | | 1 | 2 | 3 | 4 | 5 | Damage to protection works requiring significant repairs | | | | |
| | | 5 | <table border="1" style="width: 100%; text-align: center;"> <tr> <td style="width: 15%;">1</td> <td style="width: 15%;">2</td> <td style="width: 15%;">3</td> <td style="width: 15%;">4</td> <td style="width: 15%;">5</td> </tr> </table> | | | | | 1 | 2 | 3 | 4 | 5 | Damage to protection works requiring reconstruction and/or replacement | | | | |

Damage to protection works (gabions, stone pitching, rip-rap, etc.) associated with drainage structures caused by high water levels can be expected to increase under more extreme events and these works should be assessed in terms of their capacity to resist future damage.

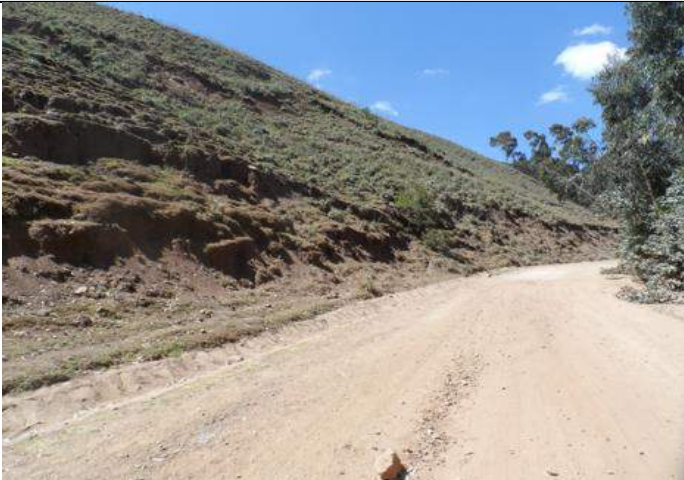
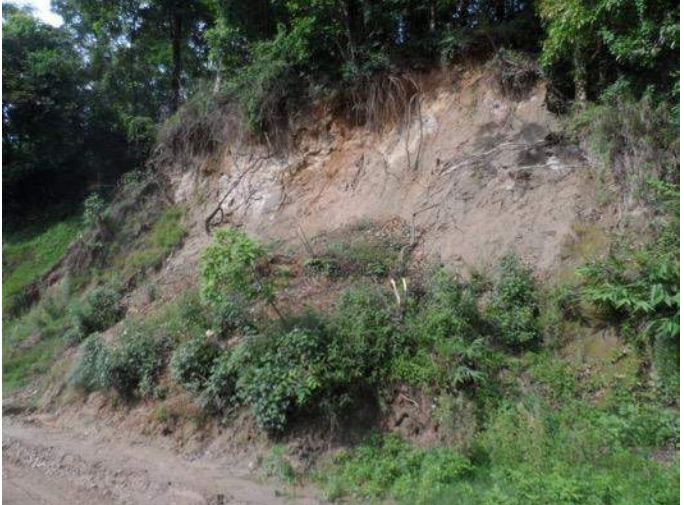
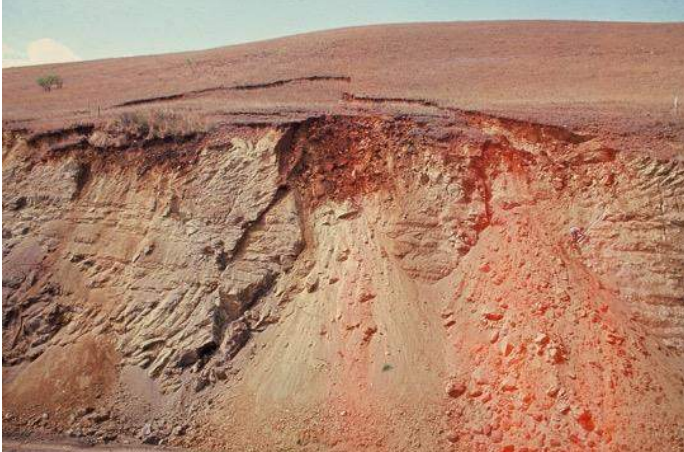
Figure 24 Stability of cut slopes

| | <table border="1"> <tr> <td colspan="5" style="text-align: center;">1</td> </tr> <tr> <td style="text-align: center;">1</td> <td style="text-align: center;">2</td> <td style="text-align: center;">3</td> <td style="text-align: center;">4</td> <td style="text-align: center;">5</td> </tr> <tr> <td colspan="5" style="text-align: center;">Minor evidence of surface instability – major failures unlikely</td> </tr> </table> | 1 | | | | | 1 | 2 | 3 | 4 | 5 | Minor evidence of surface instability – major failures unlikely | | | | |
| | <table border="1"> <tr> <td colspan="5" style="text-align: center;">3</td> </tr> <tr> <td style="text-align: center;">1</td> <td style="text-align: center;">2</td> <td style="text-align: center;">3</td> <td style="text-align: center;">4</td> <td style="text-align: center;">5</td> </tr> <tr> <td colspan="5" style="text-align: center;">Evidence of movement of material on slope – failure likely to cause short disruptions to traffic flow</td> </tr> </table> | 3 | | | | | 1 | 2 | 3 | 4 | 5 | Evidence of movement of material on slope – failure likely to cause short disruptions to traffic flow | | | | |
| | <table border="1"> <tr> <td colspan="5" style="text-align: center;">5</td> </tr> <tr> <td style="text-align: center;">1</td> <td style="text-align: center;">2</td> <td style="text-align: center;">3</td> <td style="text-align: center;">4</td> <td style="text-align: center;">5</td> </tr> <tr> <td colspan="5" style="text-align: center;">Major slope failure likely – long-term closure of roads caused by slope failure</td> </tr> </table> | 5 | | | | | 1 | 2 | 3 | 4 | 5 | Major slope failure likely – long-term closure of roads caused by slope failure | | | | |

During the assessment exercise, it is thus necessary to look at the overall stability of the area surrounding the cut slopes as well as any evidence of instability directly affecting the individual slopes. Figure 24 illustrates typical unstable terrain, in which any interference with the natural stability (e.g. by undercutting slopes during road excavations) could lead to large slope failures.

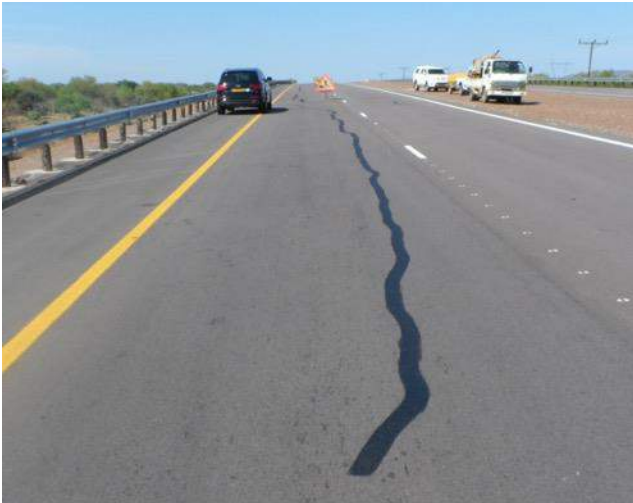
Figure 25 Cracking of embankment due to overstressing

The stability of embankments must be assessed. Unlike cuts, there is usually evidence of arcuate cracking on the surface of the embankment prior to failure and evidence of such cracking should be investigated. Many high embankments develop one or two longitudinal cracks which are indicative of tensile strains in the upper portion of the fill (Figure 25), but provided that they are timeously sealed, will not usually lead to failure.

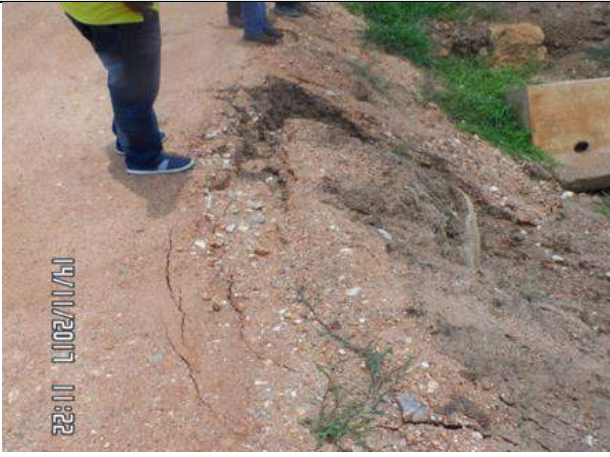
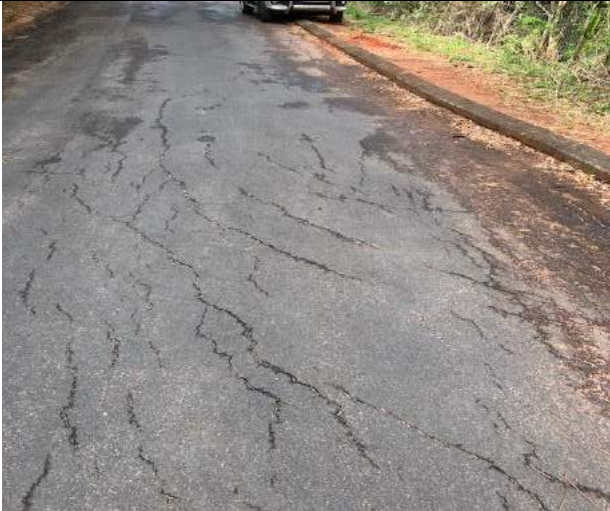
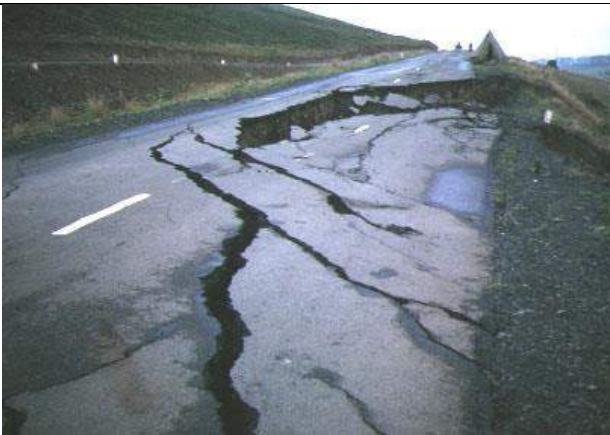
Figure 26 Stability of embankments

| | <table border="1"> <tr> <td colspan="5" style="text-align: center;">1</td> </tr> <tr> <td style="text-align: center;">1</td> <td style="text-align: center;">2</td> <td style="text-align: center;">3</td> <td style="text-align: center;">4</td> <td style="text-align: center;">5</td> </tr> <tr> <td colspan="5" style="text-align: center;">Minor evidence of surface instability</td> </tr> </table> | 1 | | | | | 1 | 2 | 3 | 4 | 5 | Minor evidence of surface instability | | | | |
| | <table border="1"> <tr> <td colspan="5" style="text-align: center;">3</td> </tr> <tr> <td style="text-align: center;">1</td> <td style="text-align: center;">2</td> <td style="text-align: center;">3</td> <td style="text-align: center;">4</td> <td style="text-align: center;">5</td> </tr> <tr> <td colspan="5" style="text-align: center;">Evidence of widespread or large arcuate cracks with minimal vertical displacement – short-term disruptions to traffic flow</td> </tr> </table> | 3 | | | | | 1 | 2 | 3 | 4 | 5 | Evidence of widespread or large arcuate cracks with minimal vertical displacement – short-term disruptions to traffic flow | | | | |
| | <table border="1"> <tr> <td colspan="5" style="text-align: center;">5</td> </tr> <tr> <td style="text-align: center;">1</td> <td style="text-align: center;">2</td> <td style="text-align: center;">3</td> <td style="text-align: center;">4</td> <td style="text-align: center;">5</td> </tr> <tr> <td colspan="5" style="text-align: center;">Evidence of or potential for large failure causing closure of road for extended period</td> </tr> </table> | 5 | | | | | 1 | 2 | 3 | 4 | 5 | Evidence of or potential for large failure causing closure of road for extended period | | | | |

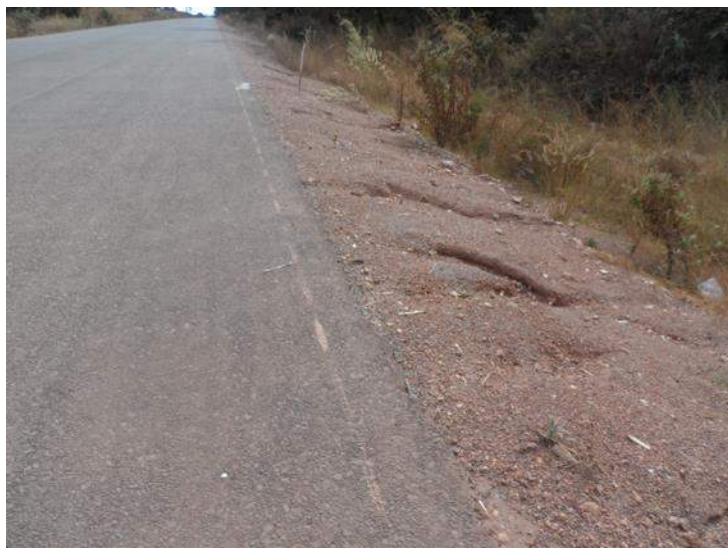
Figure 27 Poor finish of newly constructed road

The overall finish of the road should be visually assessed in terms of the impression that a good job was done during construction. Typically, poor finishing off and a product that does not look neat is indicative of the possibility that the construction quality was not ideal. Figure 27, for example illustrates a newly constructed road with a poorly finished and uneven shoulder.. A typical example of this on unpaved roads, is the presence of excessive oversize material, when the specification included a limit on the maximum size.

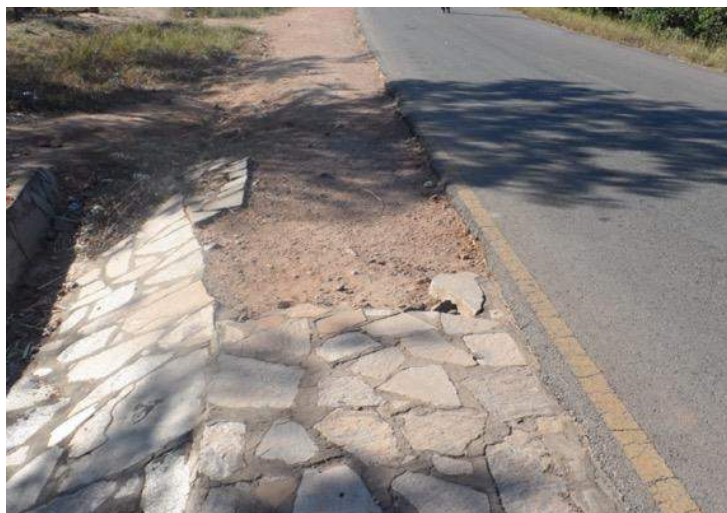
Figure 28 Poor finish of protection works resulting in failure – no “anchor” beams

All erosion protection measures should be assessed to ensure that they are intact, integral and do not allow water to enter behind or through them. This is normally a simple visual inspection (Figure 28), although the presence of “anchoring beams” may be difficult to observe in some areas.

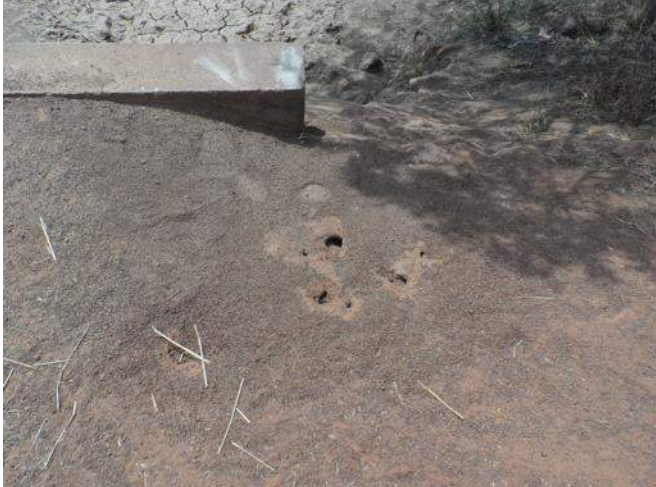
| Figure 30 Other issues | | | | | |

There are many other issues that may need taking note of and these will usually be identified as the assessment takes place. A typical example of one of these is the presence of ants in the road area. Figure 30 Shows ant “holes” that will allow water to penetrate into the embankment (there is usually an extensive network of tunnels beneath such an area) and these should be taken care of.

| Figure 30 Other issues | | | | | |
|---|---|---|---|---|---|
| | Ant nests allowing water access into embankment | | | | |

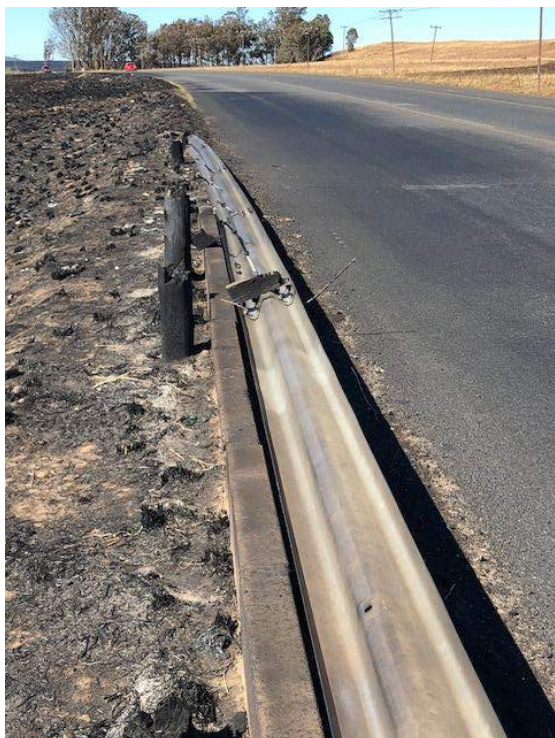
Figure 31 Damage to guardrail posts and bitumen surfacing caused by wildfire

Recently, the impact of wildfires combined with extremely windy conditions has been noted on guard rail supports (Figure 31). Burning of the wooden supports has resulted in collapse of the guard-rail. In addition, obvious damage to the bitumen seal (on the left side of the photograph) can be clearly noted in Figure 31. Such instances would be recorded under comments.

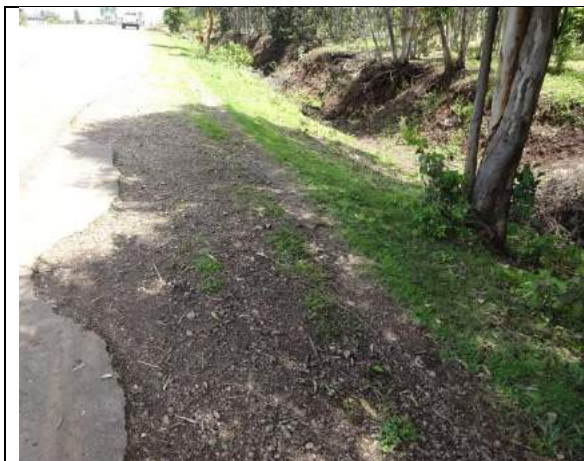
Assessment Item: Erodibility - Side drains, unlined

Distress: Severe erosion of side drains

Chainage: 300 m to 400 m

Degree: 4 Extent: 5

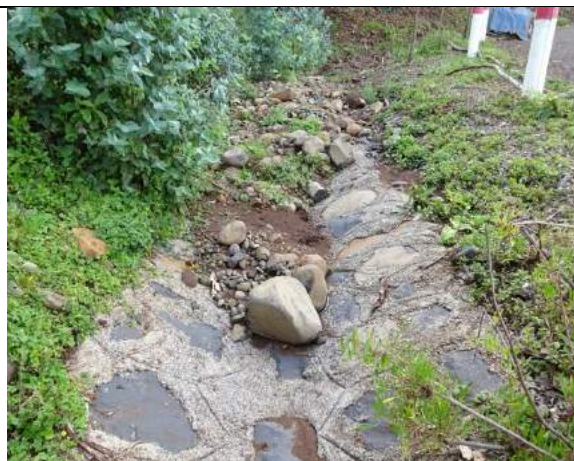
Assessment Item: Drainage (in reserve) – Side drains

Distress: Blockage of side drains by landslide debris

Chainage: 700 m to 800 m

Degree: 5 Extent: 3

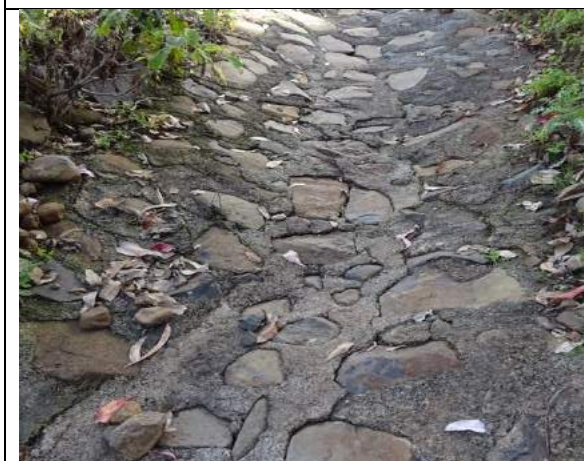
Assessment Item: Drainage (in reserve) – Side drain

Distress: Damage to erosion protection in side drain

Chainage: 1 600 m to 1 700 m

Degree: 2 Extent: 1

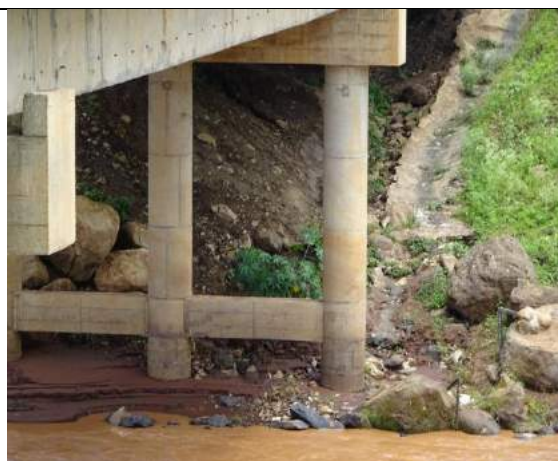
Assessment Item: Drainage (stream) - Erosion

Distress: Erosion of river bank and damage to protection works

Chainage: 700 m to 800 m

Degree: 5 Extent: 1

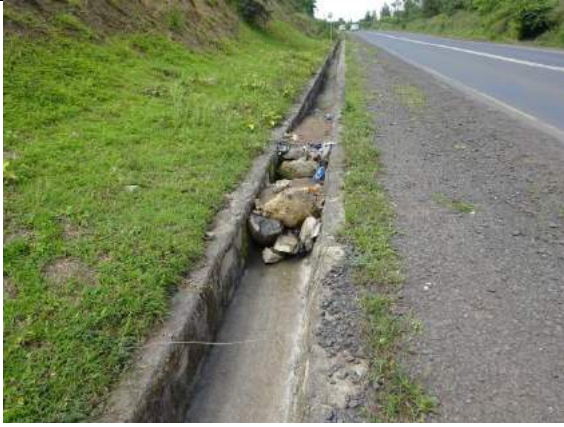
Assessment Item: Drainage (in reserve) – Side drains

Distress: Poor maintenance of lined side drain

Chainage: 700 m to 800 m

Degree: 5 Extent: 3

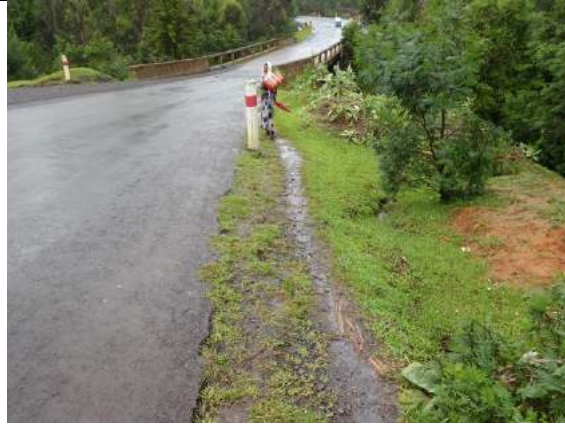
Assessment Item: Drainage (streams) – Erosion of approach fills

Distress: Poor control of water next to road leading to erosion of bridge approach fill

Chainage: 1 600 m to 1 700 m

Degree: 3 Extent: 1
