Climate Adaptation: Risk Management and Resilience Optimisation for Vulnerable Road Access in Africa

Visual Assessment Manual

ReCAP Project GEN2014C

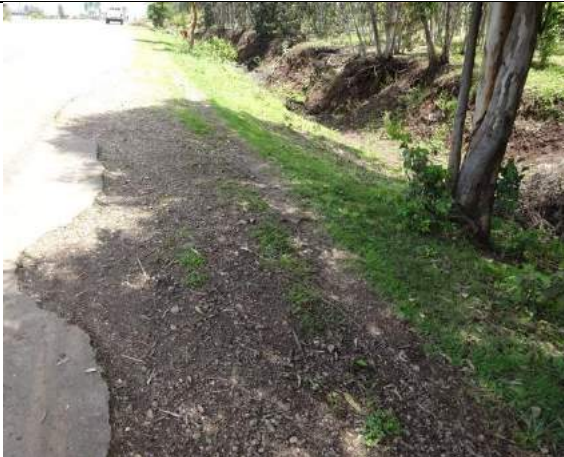
Assessment Item: Drainage (in reserve) - Shoulders

Distress: Poor shoulder maintenance
