Air Quality and Dust Monitoring
Monthly Report – **September** 2020
Buckinghamshire Council

A report prepared by Align JV and Fusion on behalf of HS2 Ltd.

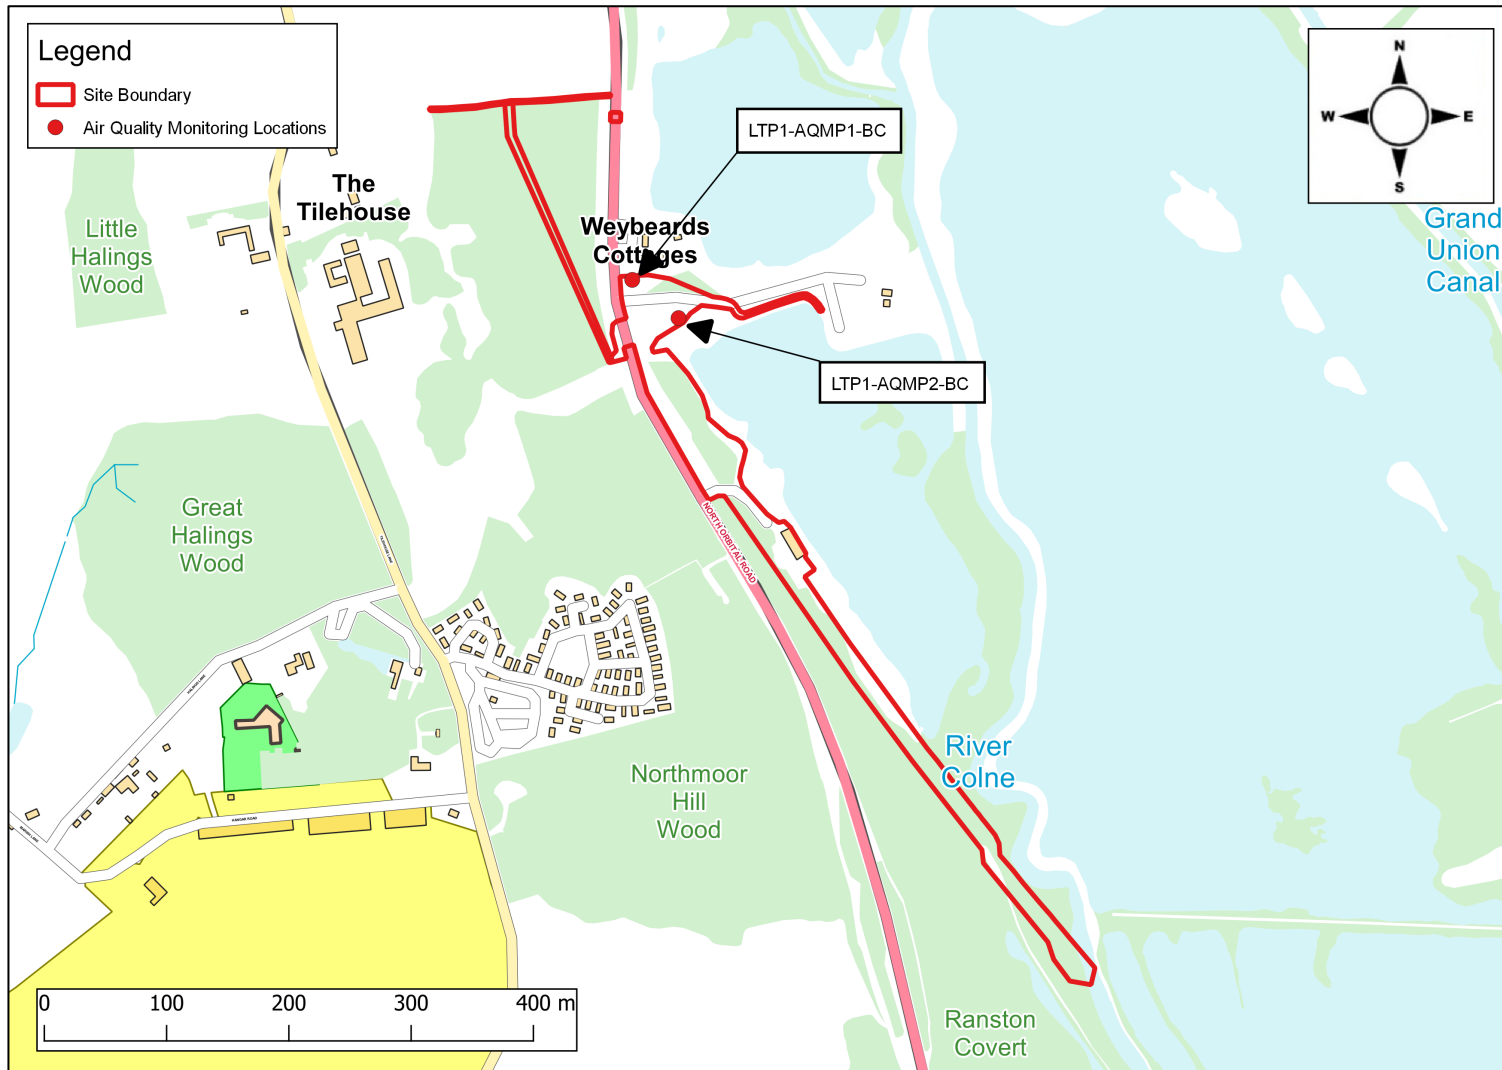
Figure 1: Worksite and Monitoring locations during September 2020 – CVV LTP1

- 1.1.2 Figures 1 to 4 in Appendix A presents the current worksites together with the dust monitoring locations for September 2020.
- 1.1.3 This summary should be read in conjunction with the overview monitoring report available from www.gov.uk/government/collections/monitoring-the-environmental-effects-of-hs2, which highlights: the applicable standards and guidance, as well as the air quality and dust monitoring methodologies to be implemented by nominated undertakers throughout construction.

- 1.1.4 The current phase of works that commenced within BC during January 2020 and is expected to be completed by the end of May 2021. The current worksites at Colne Valley Viaduct (CVV) LTP1, Chalfont St Peter Vent Shaft, Amersham Vent Shaft and Lower Bottom House Farm Lane. are presented in Appendix A, Figures 1 to 4. Activities for each worksite within September 2020 included:

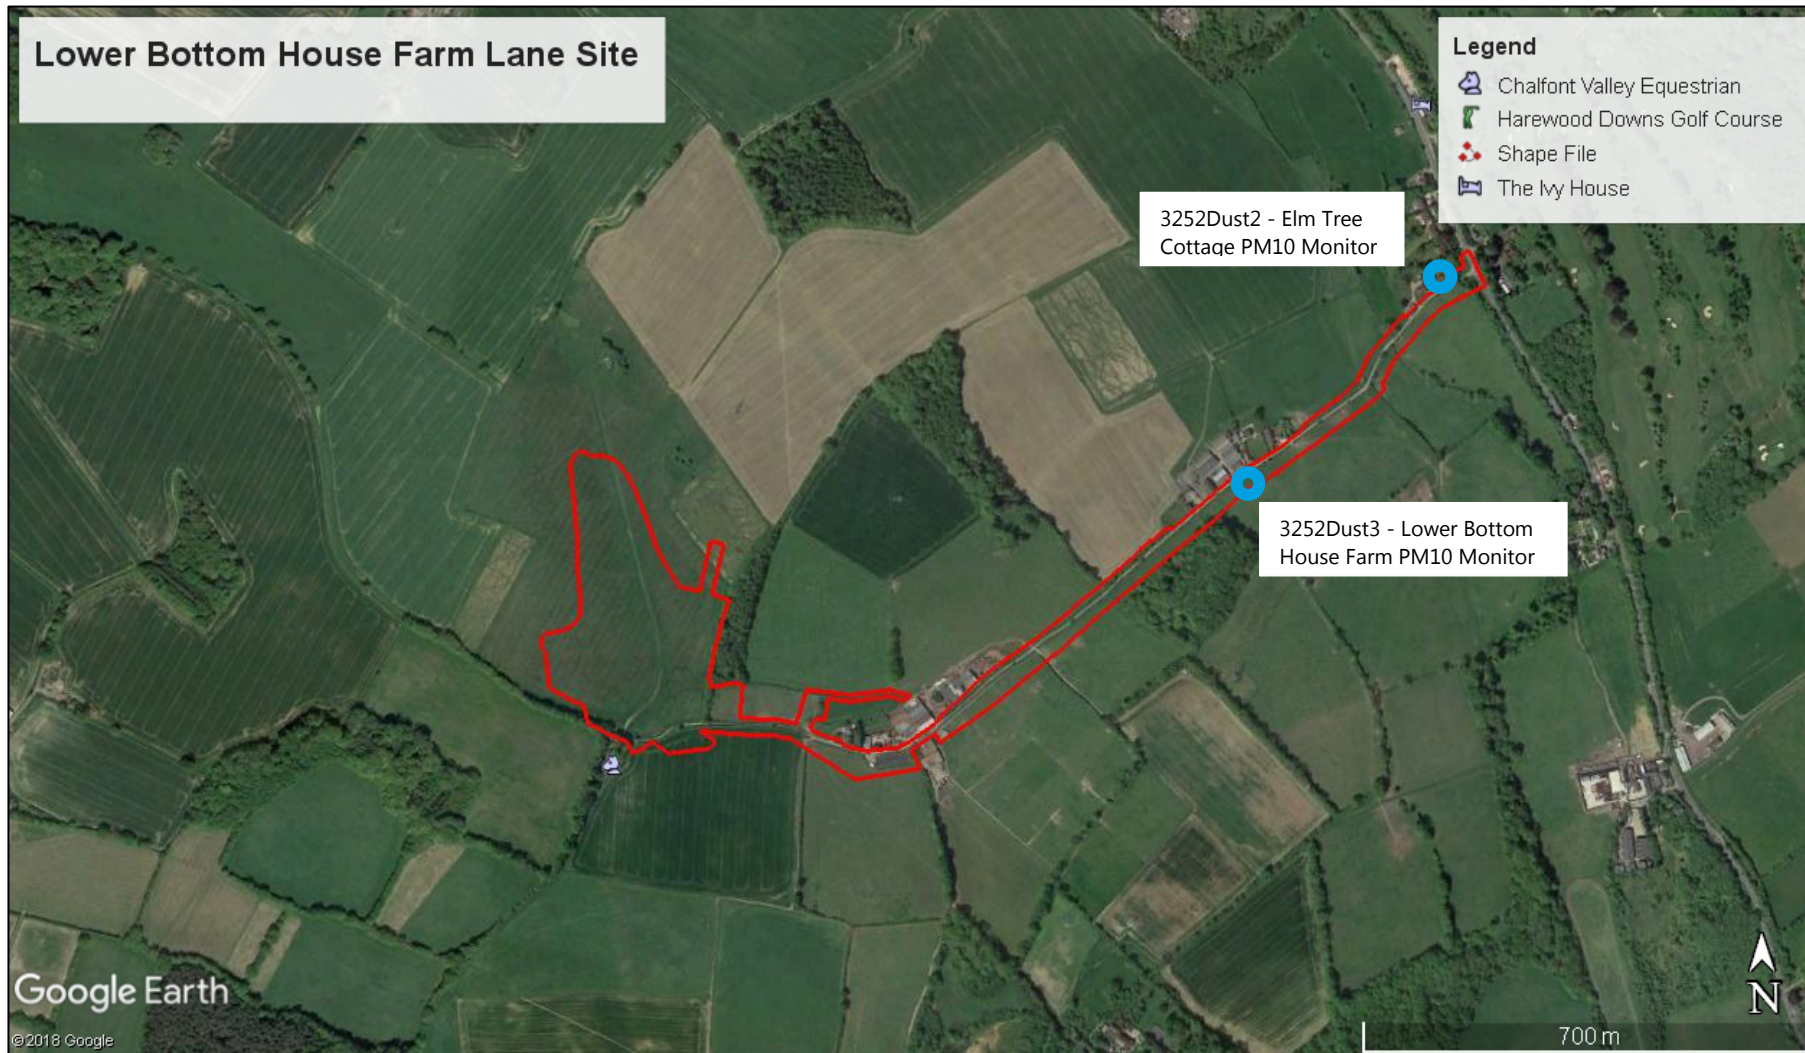
Figure 4: Worksites and Monitoring locations during September 2020 - Lower Bottom House Farm Lane

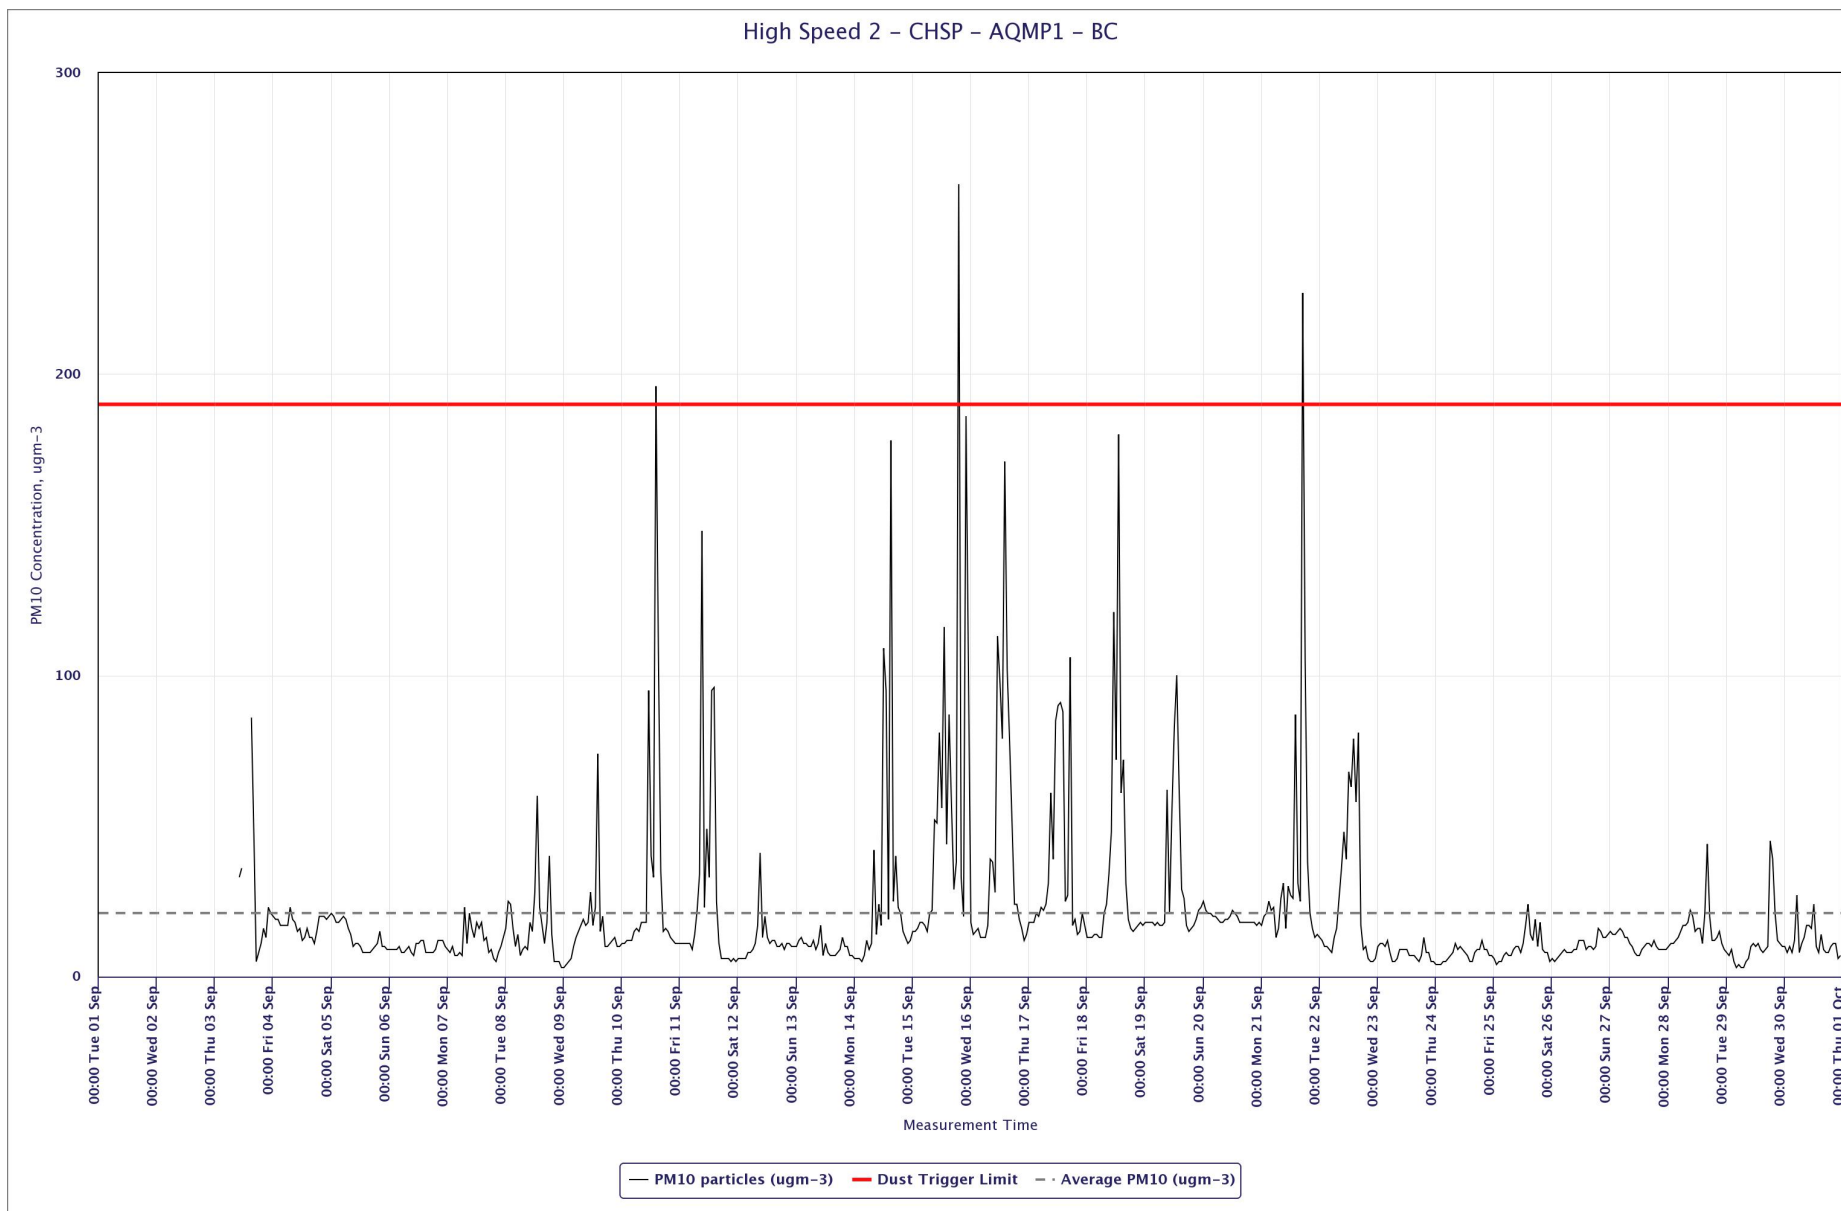
Figure 5: Continuous dust 1-hour mean indicative PM₁₀ concentration for CHSP-AQMP1-BC for September 2020

1.1.6 Dust monitoring locations and results are presented in Appendix B, Table 1, together with a line chart of monthly data from each dust monitor presented in Figures 5 to 12. All continuous dust monitoring is undertaken using indicative monitors. Despite being Environment Agency (MCERTS) certified, indicative monitors carry a higher level of uncertainty than reference monitors, and therefore cannot be strictly compared with Air Quality Standards for human health and the environment. The purpose of the monitoring undertaken is to ensure the effectiveness of the on-site mitigation.

Monitoring Site ID	Period of trigger alert & Concentration recorded	Investigation	Outcomes / Resolution / Remedial measures implemented
CHSP-AQMP1-BC	<u>10/09/2020</u> 14:01 - 15:00: 196.0 µg/m ³	On investigation, it was determined that the cause of the trigger alert was as a result of a waste contractors vehicle speeding on site, in close proximity to the monitor.	The waste contractor has been informed that if they are caught speeding again they will not be allowed back on site.
LTP1-AQMP2_BC	<u>11/09/2020</u> 05:01 - 06:00: 216.2 µg/m ³	No LTP1 site activities were taking place at the time of the trigger, site activities at LTP1 commence from 08:00. On investigation, it was noted that a few vehicles passed through the site at 06:00 to drive to the Affinity water site, which is only accessed via LTP1.	Not due to Align LTP1 site activities. No site activities take place before 08:00.
CHSP-AQMP1-BC	<u>15/09/2020</u> 19:01 - 20:00: 262.5 µg/m ³	This was caused by a vehicle speeding on site.	Algin's Environment Team will be issuing a toolbox talk to both contractors, Tarmac and JOD, covering dust. The site team have also been asked to dampen down the site haul roads.

CHSP-AQMP1-BC	<u>21/09/2020</u> 17:01 - 18:00: 227.0 µg/m ³	Main Align activity stopped at 1700hrs. The CCTV camera image, capture at 1758hrs, shows no activity on site. The haul road was utilised by an excavator (to the left of the attached image) and a delivery truck to leave site / park in standing area, near the time of the trigger alert and could be the possible cause.	The site team will be increasing the damping down of the haul road in case this was the cause.
LTP1-AQMP1-BC	<u>21/09/2020</u> 08:01 - 09:00: 798.1 µg/m ³	No works taking place in the vicinity of the monitor.	The trigger is not believed to be associated with the works. Monitor maintenance regimes continue to be implemented to avoid the occurrence of false triggers.

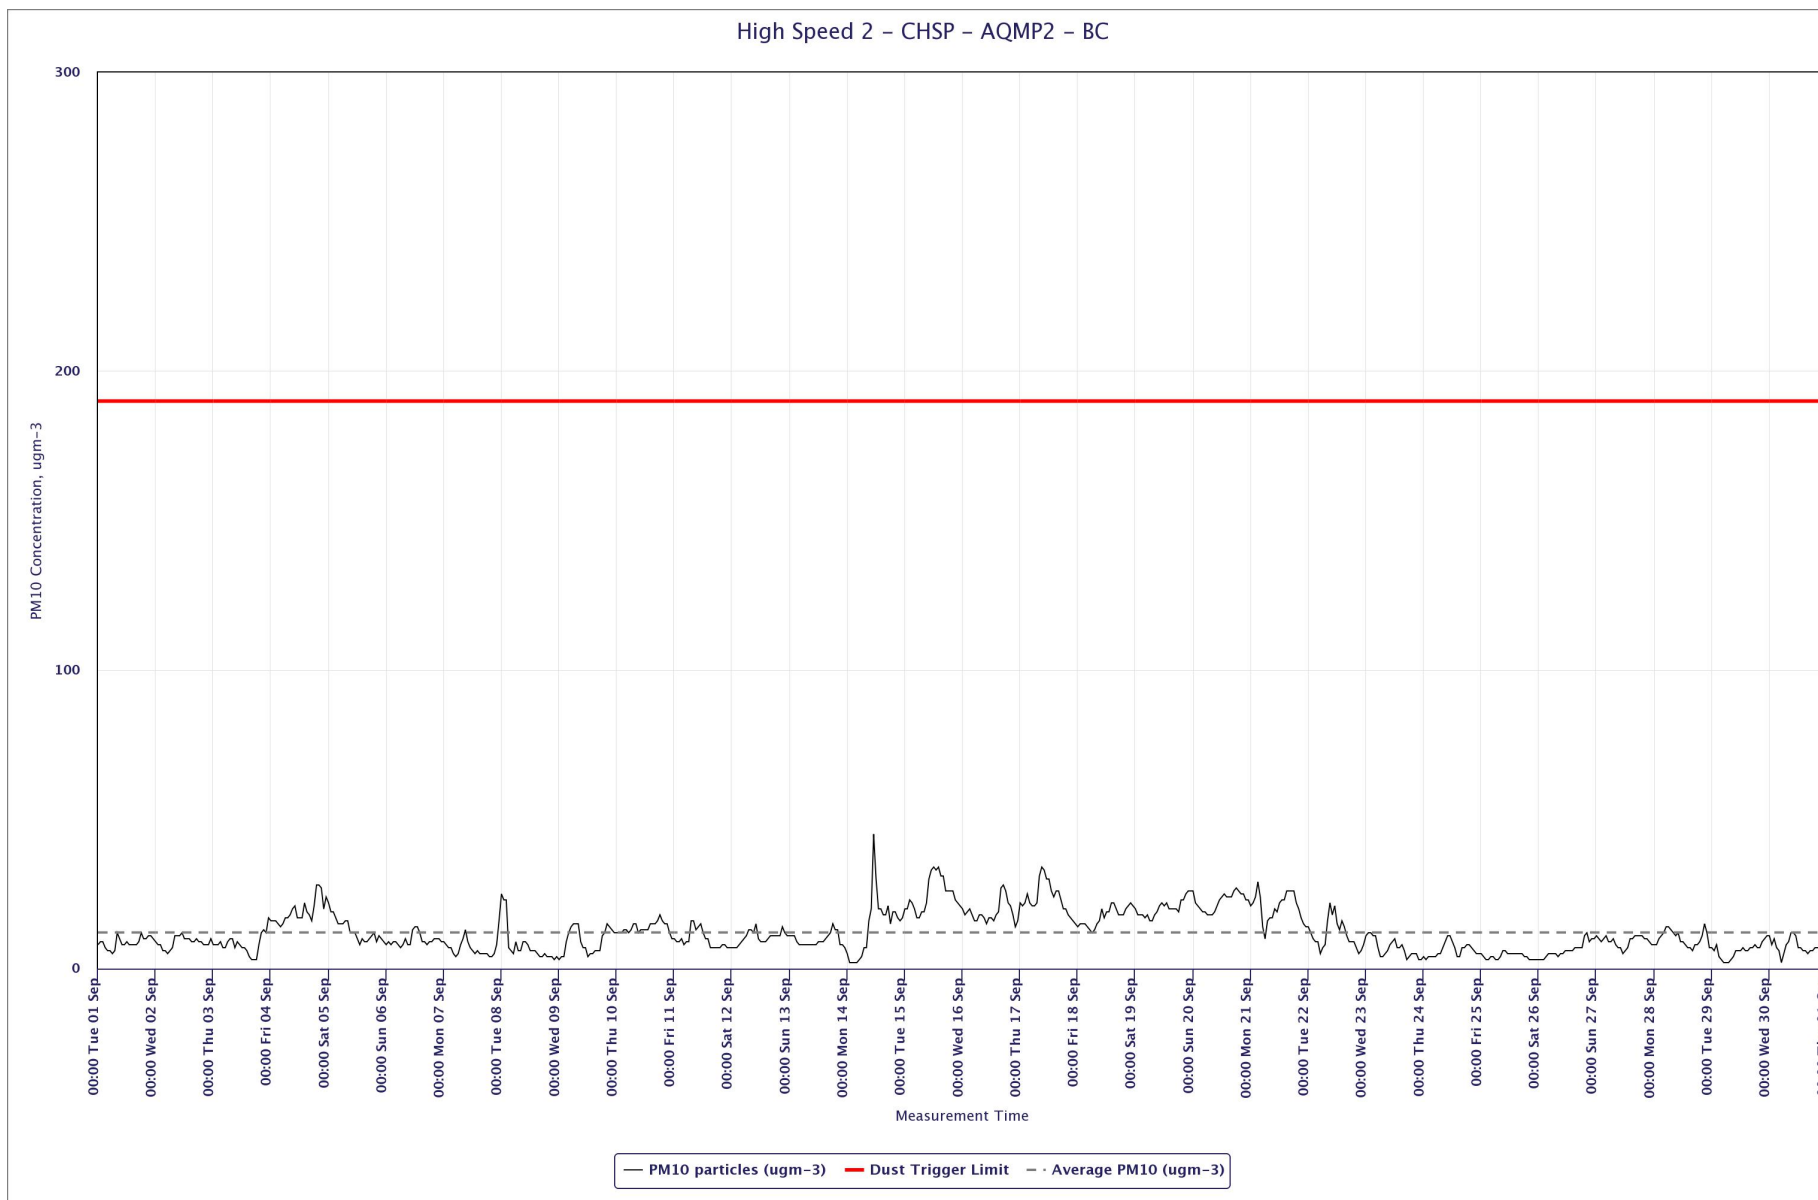
Figure 6: Continuous dust 1-hour mean indicative PM₁₀ concentration for CHSP-AQMP2-BC for September 2020

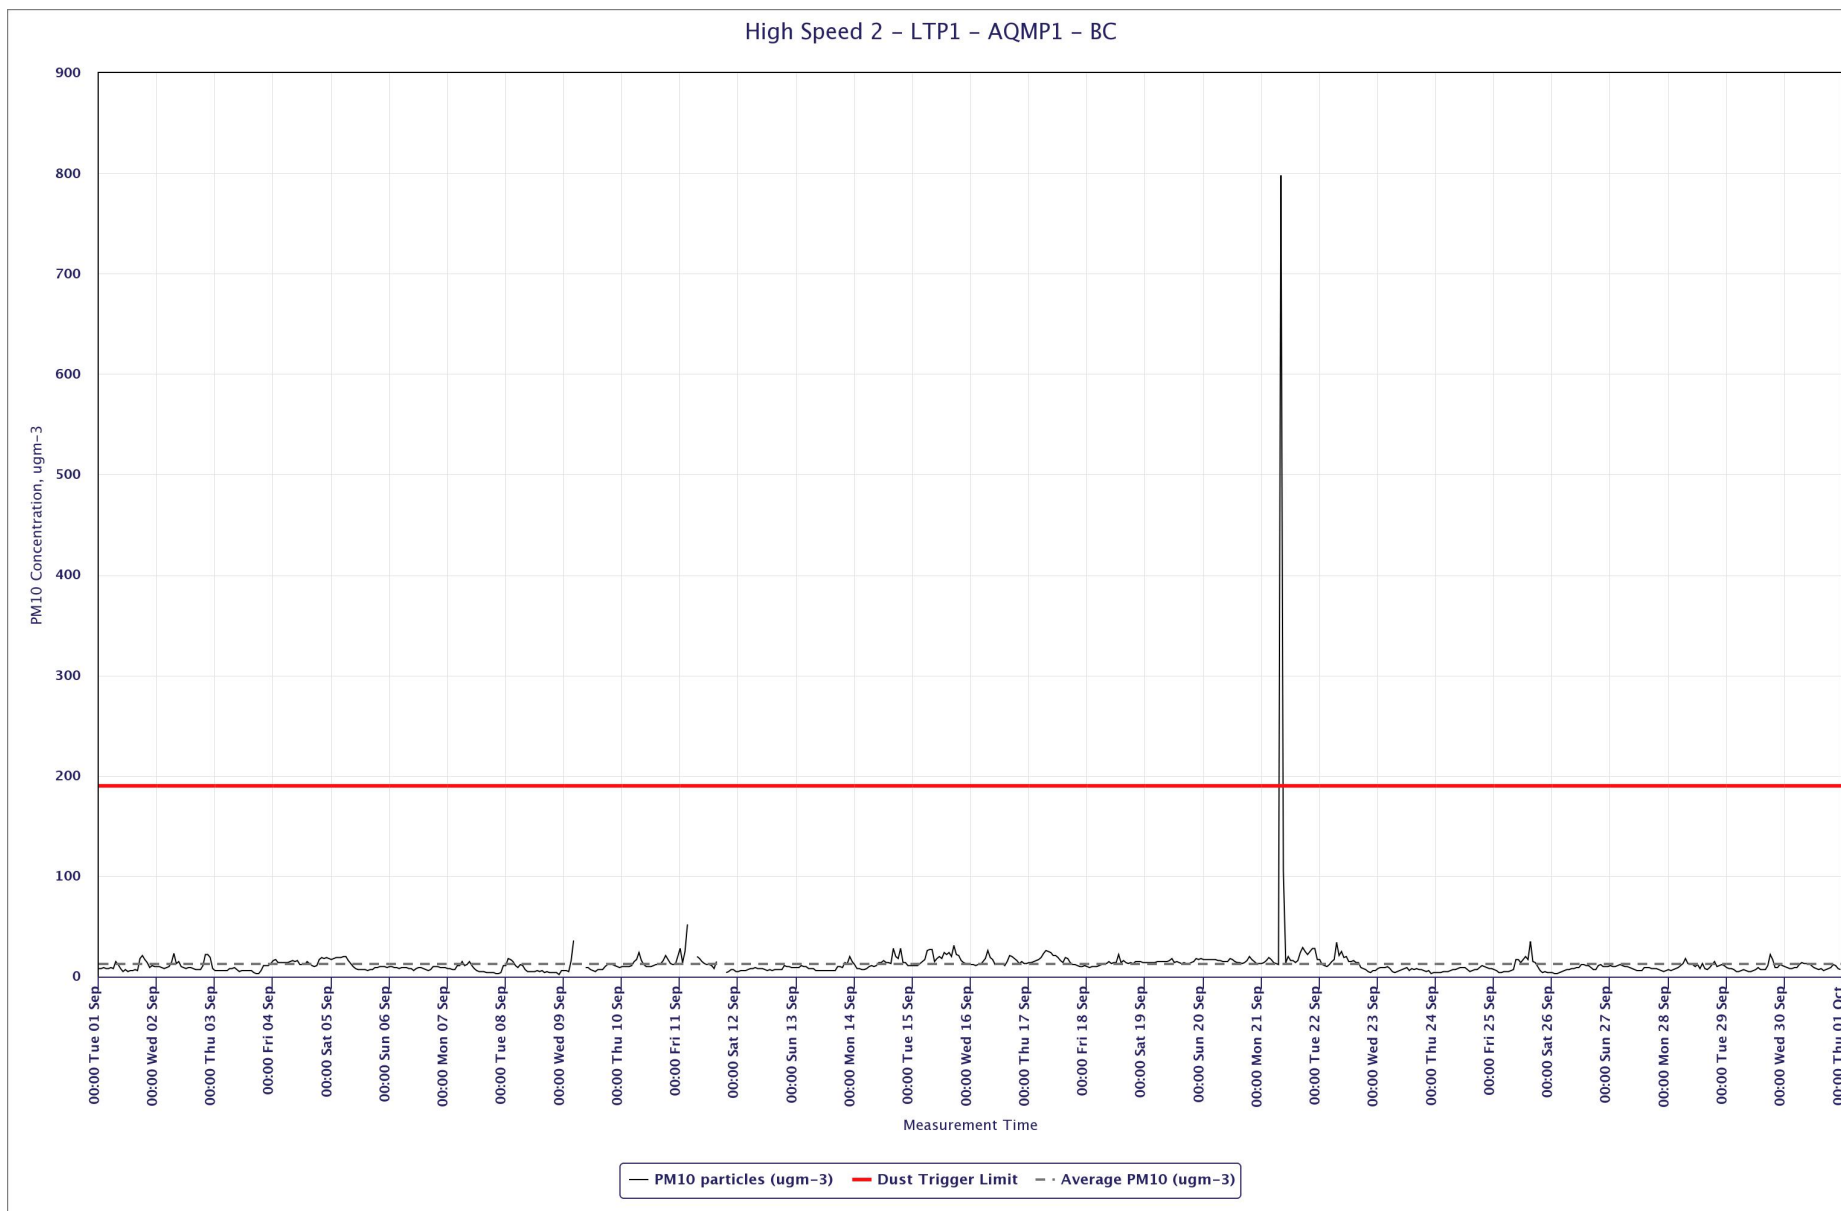
Figure 7: Continuous dust 1-hour mean indicative PM₁₀ concentration for LTP1-AQMP1-BC for September 2020

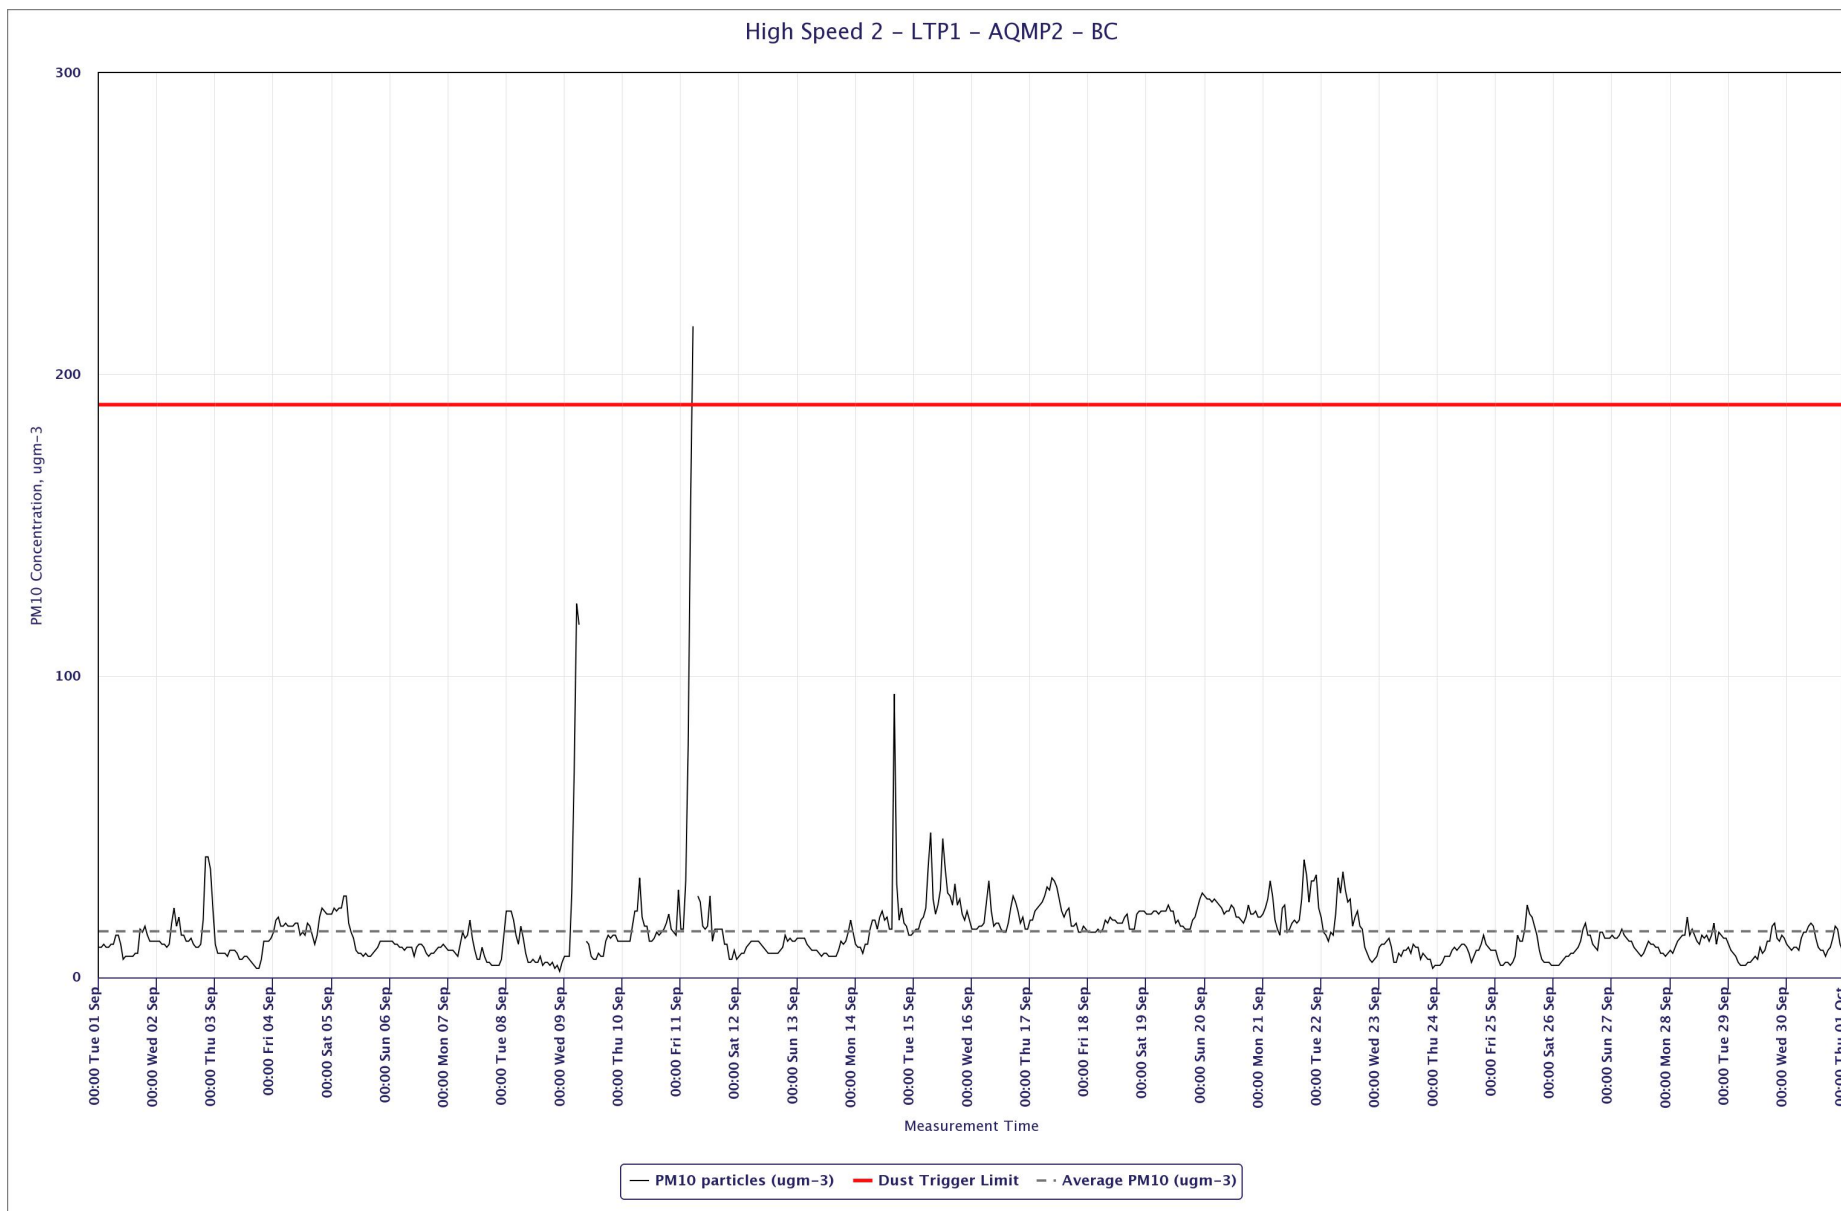
Figure 8: Continuous dust 1-hour mean indicative PM₁₀ concentration for LTP1-AQMP2-BC for September 2020

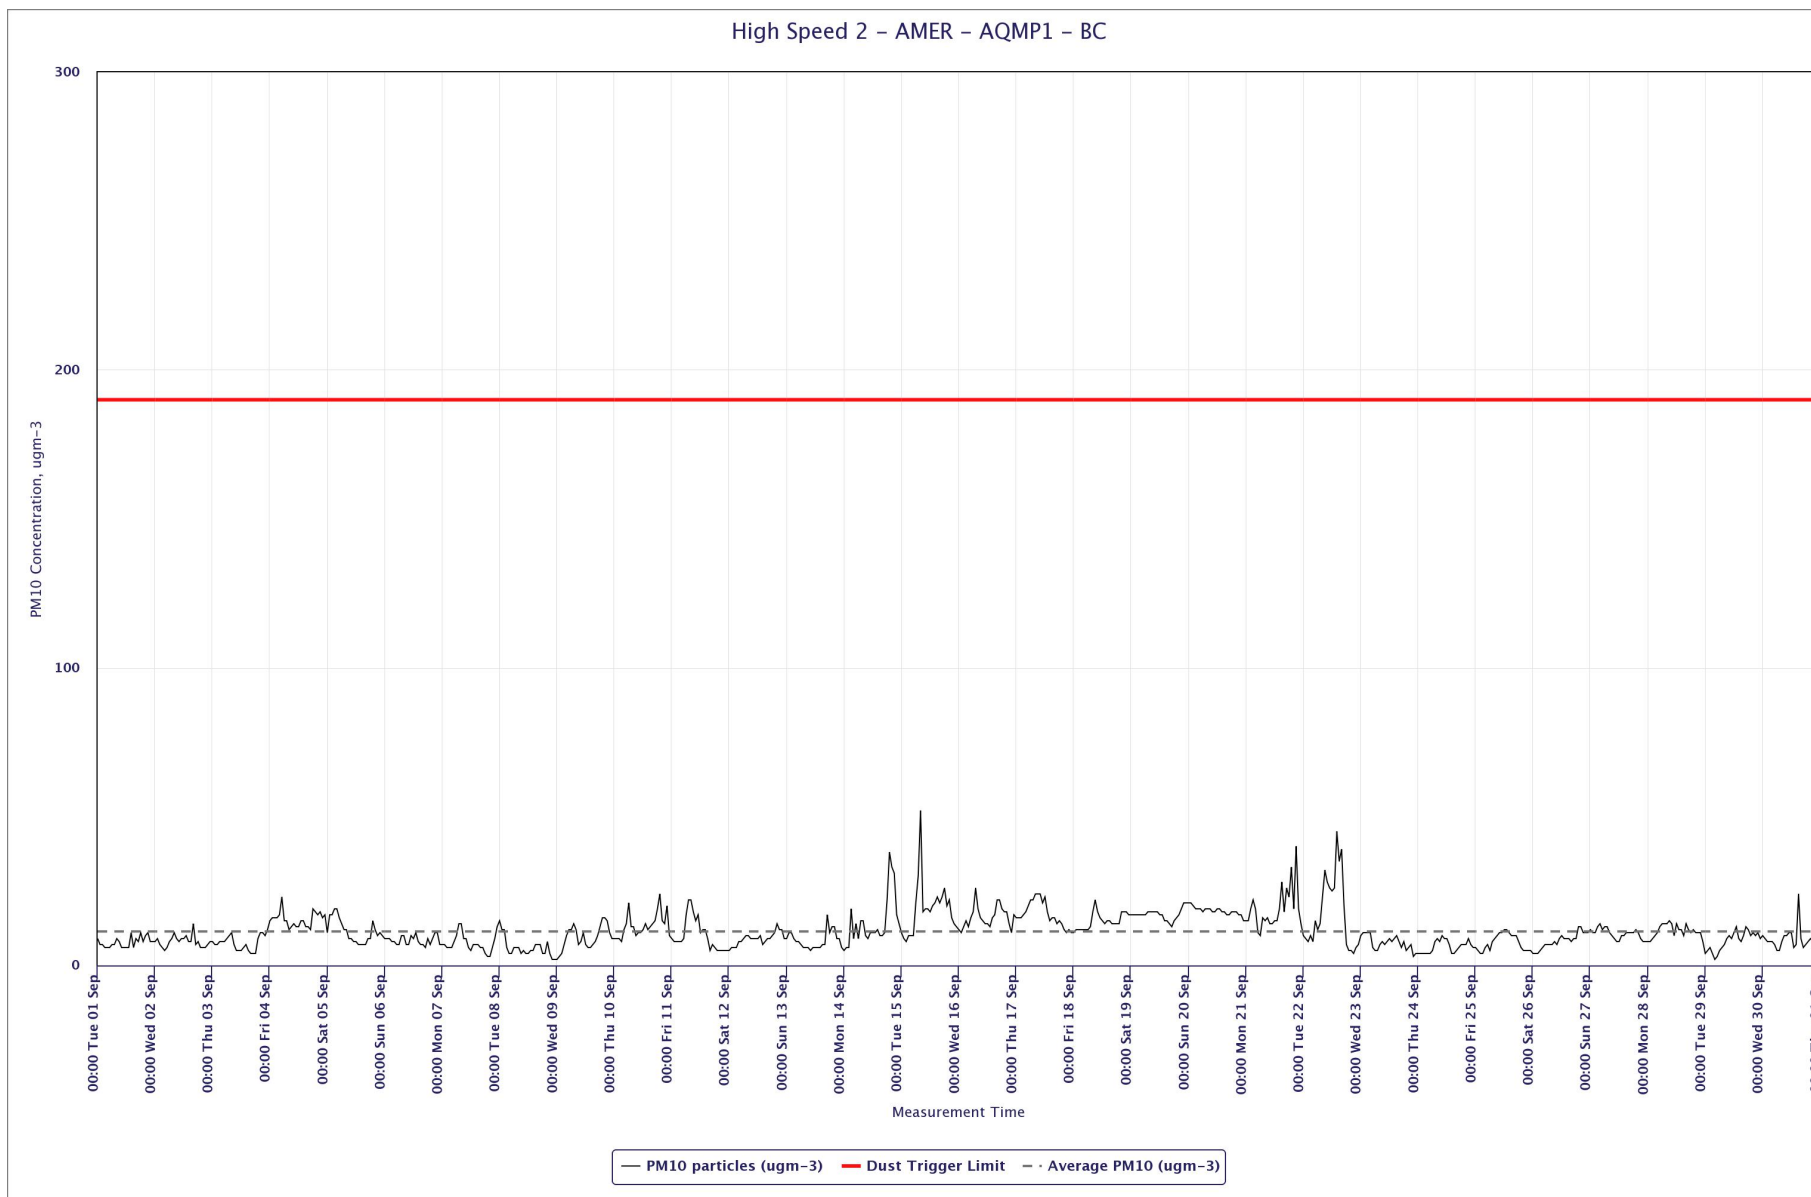
Figure 9: Continuous dust 1-hour mean indicative PM₁₀ concentration for AMER-AQMP1-BC for September 2020

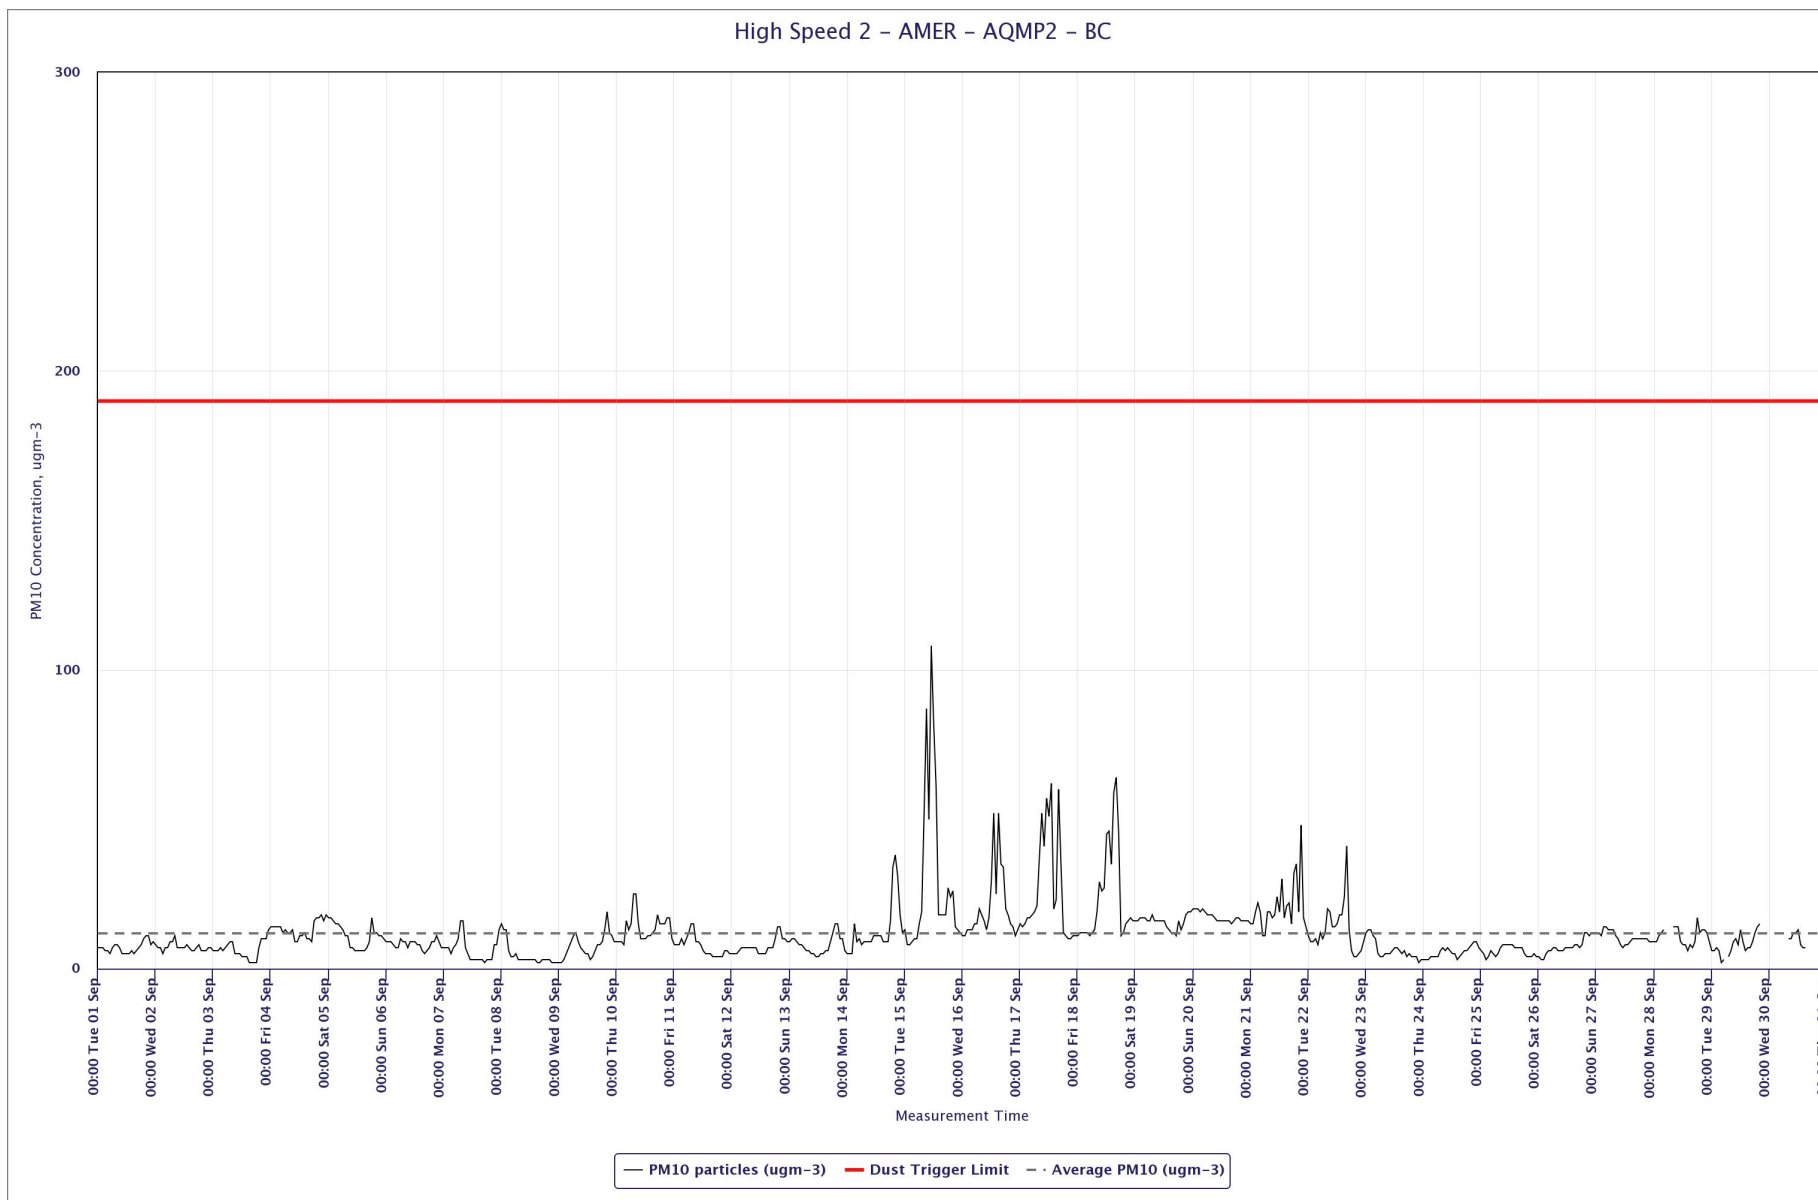
Figure109: Continuous dust 1-hour mean indicative PM₁₀ concentration for AMER-AQMP2-BC for September 2020

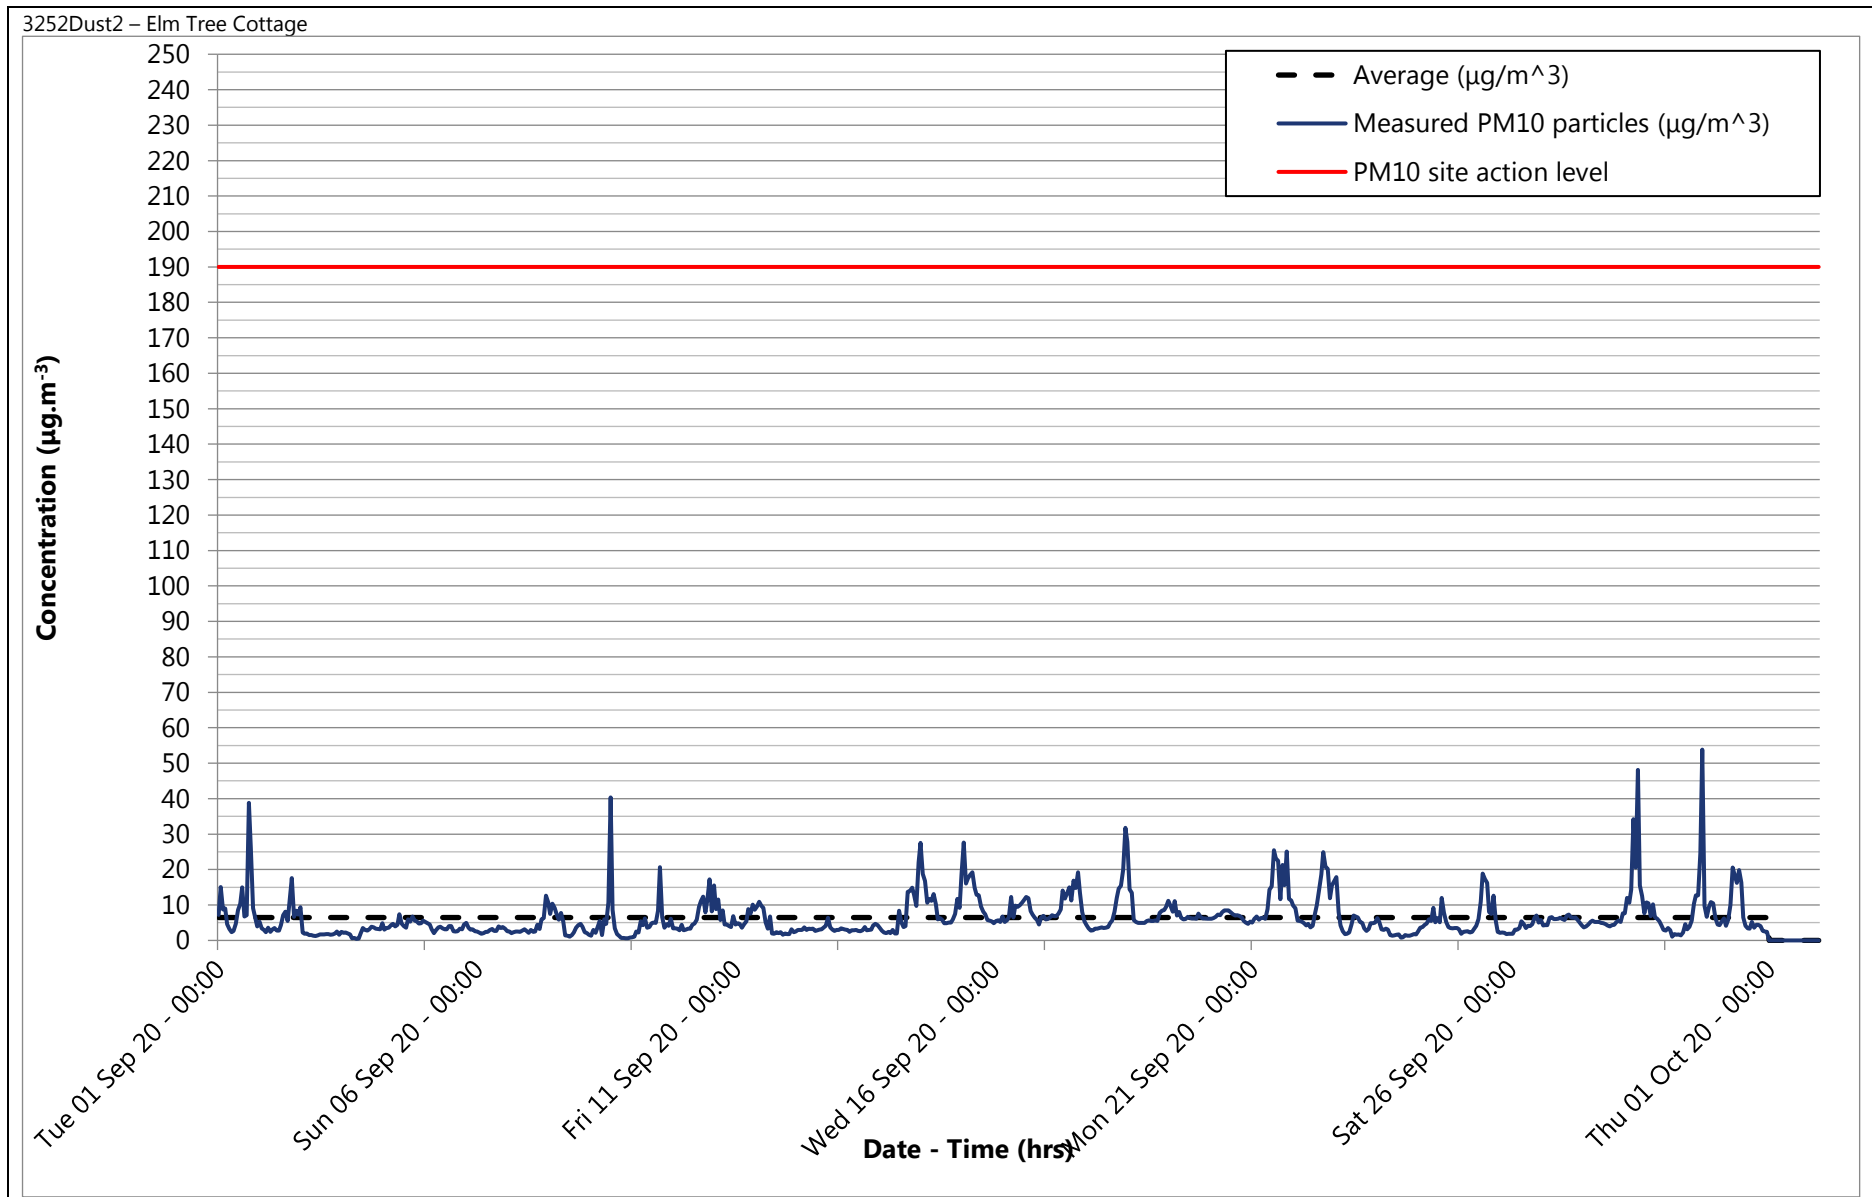
Figure 11: Construction dust 1-hour mean indicative PM₁₀ concentration for dust monitors

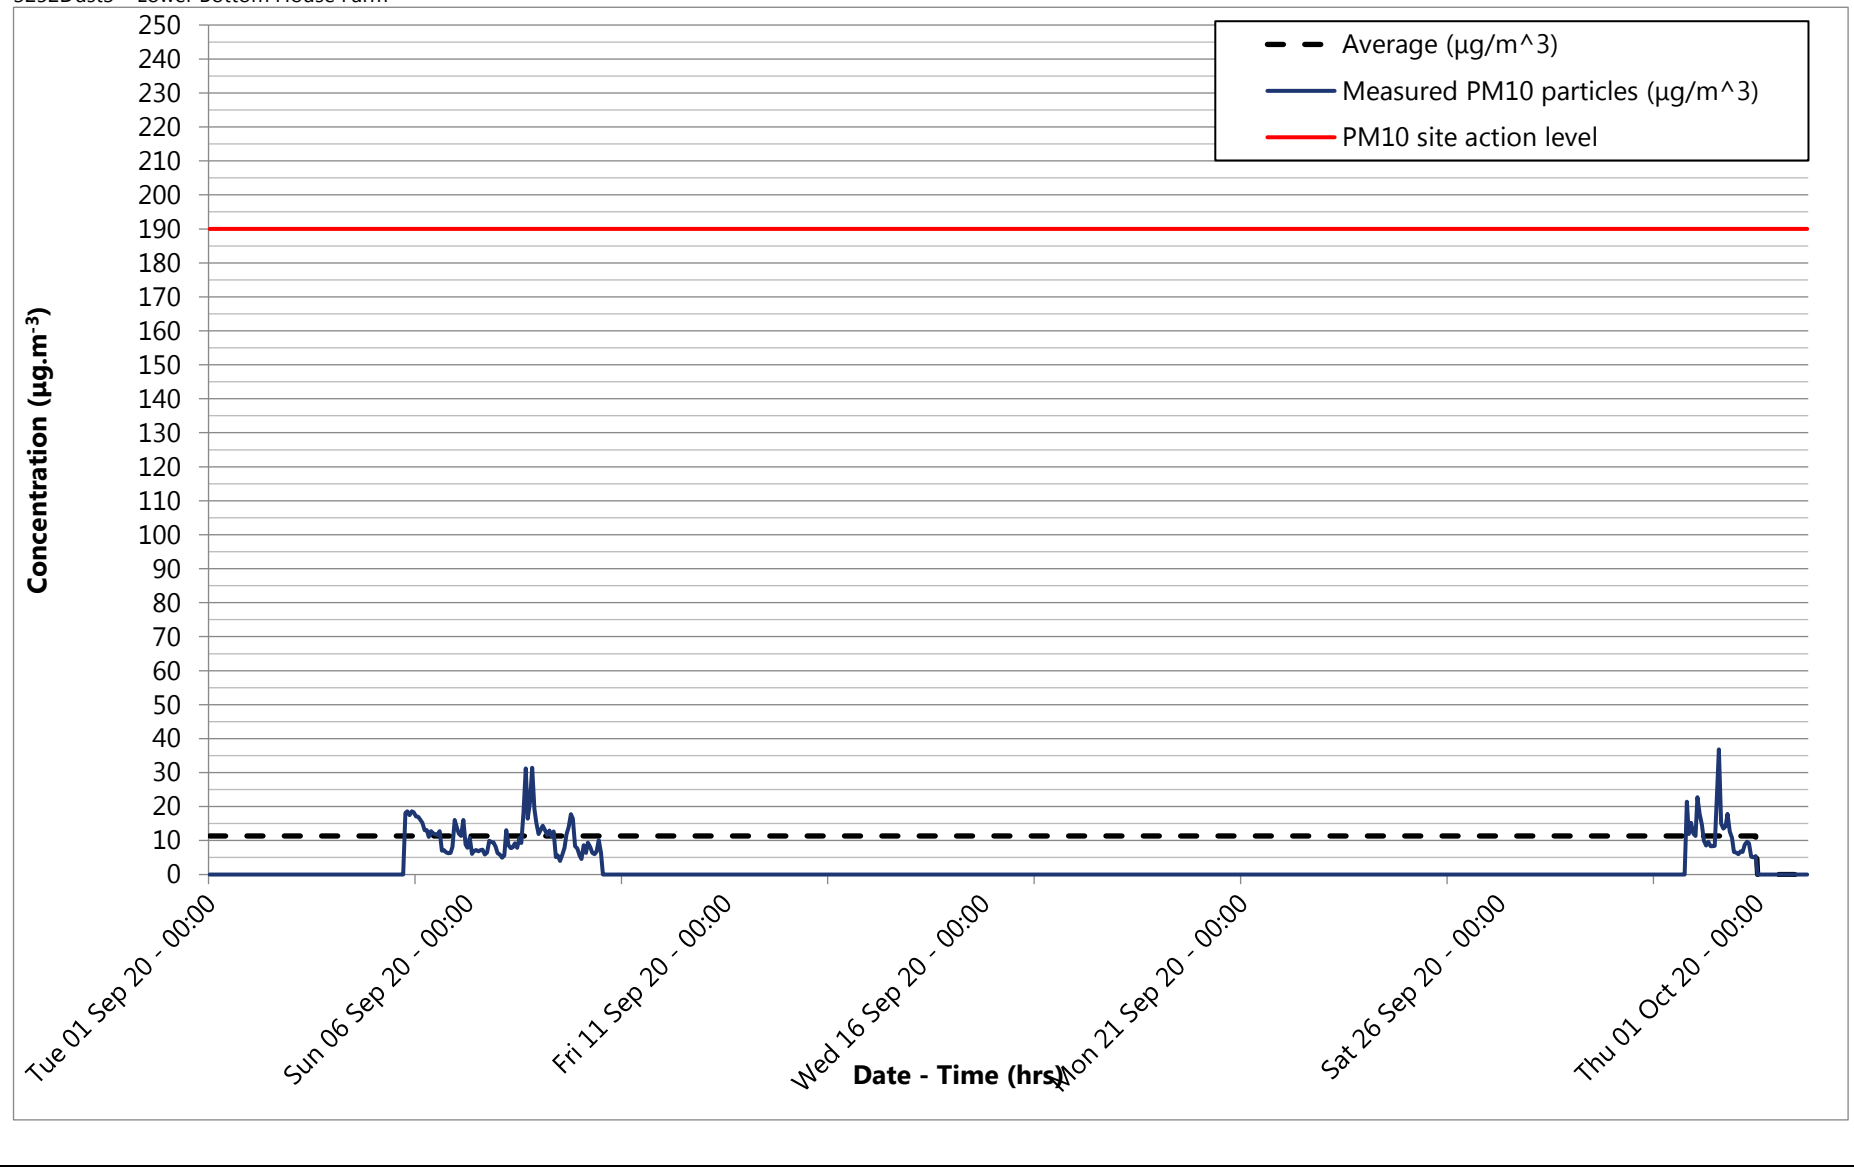
Figure 12: Construction dust 1-hour mean indicative PM10 concentration for dust monitors
3252Dust3 – Lower Bottom House Farm

3252Dust2	498390, 195434	On the boundary with Elm Tree Cottage, Bottom House Farm Lane	M	Yes	Yes	6.5	0.4	53.8	0	100
3252Dust3	498100, 195145	Lower Bottom House Farm, Bottom House Farm Lane	M	Yes	Yes	11.4	4.0	36.8	0	17
