## **Construction noise and vibration Monthly Report – November 2020**

### **London Borough of Camden**

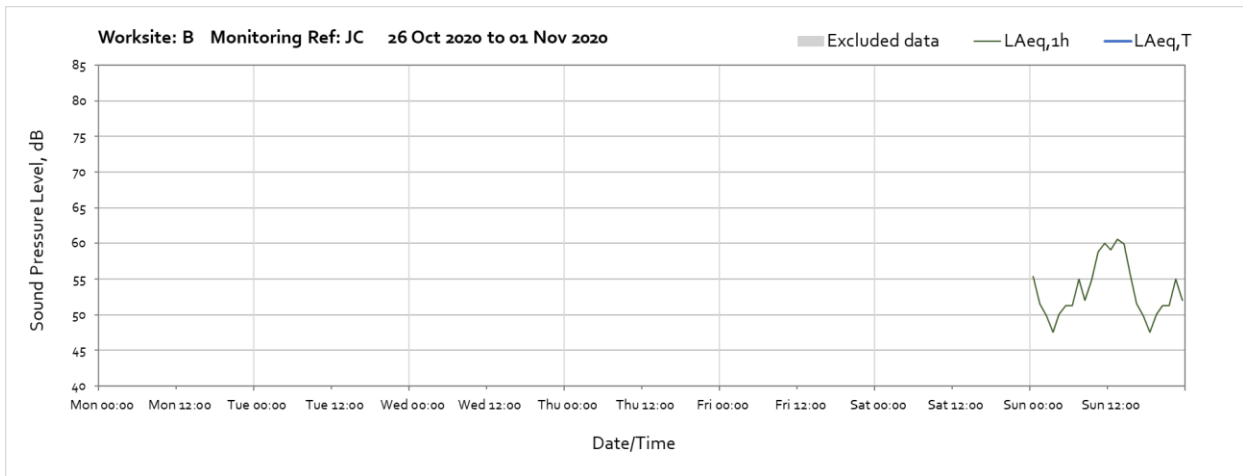
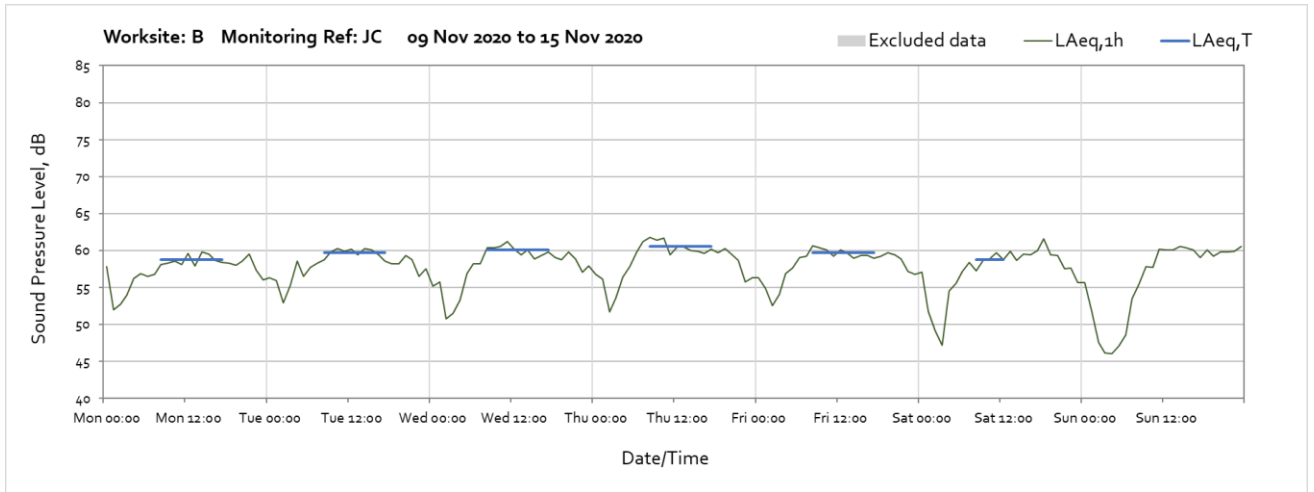
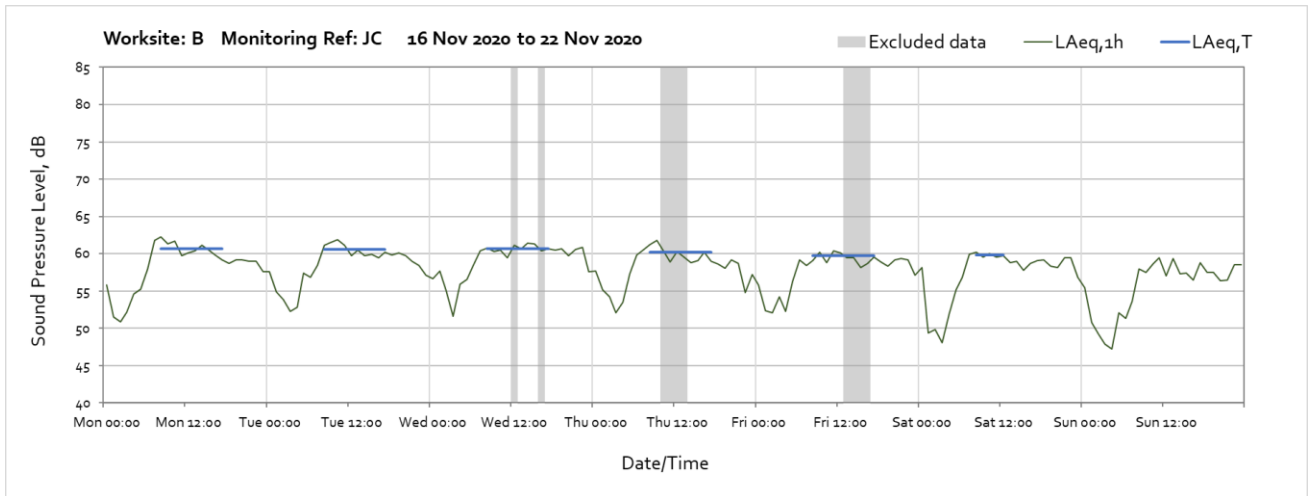
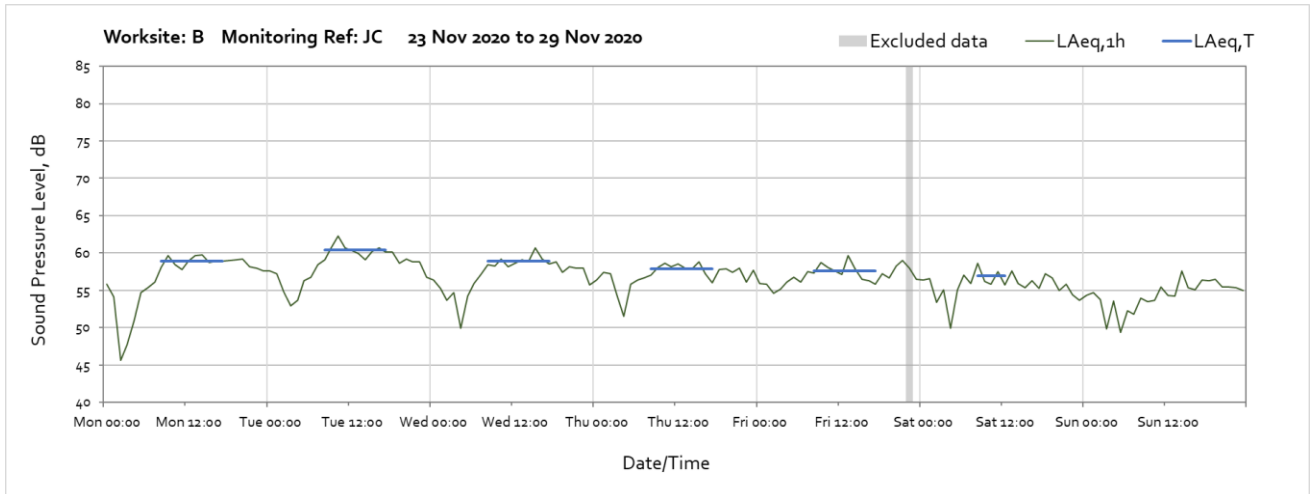
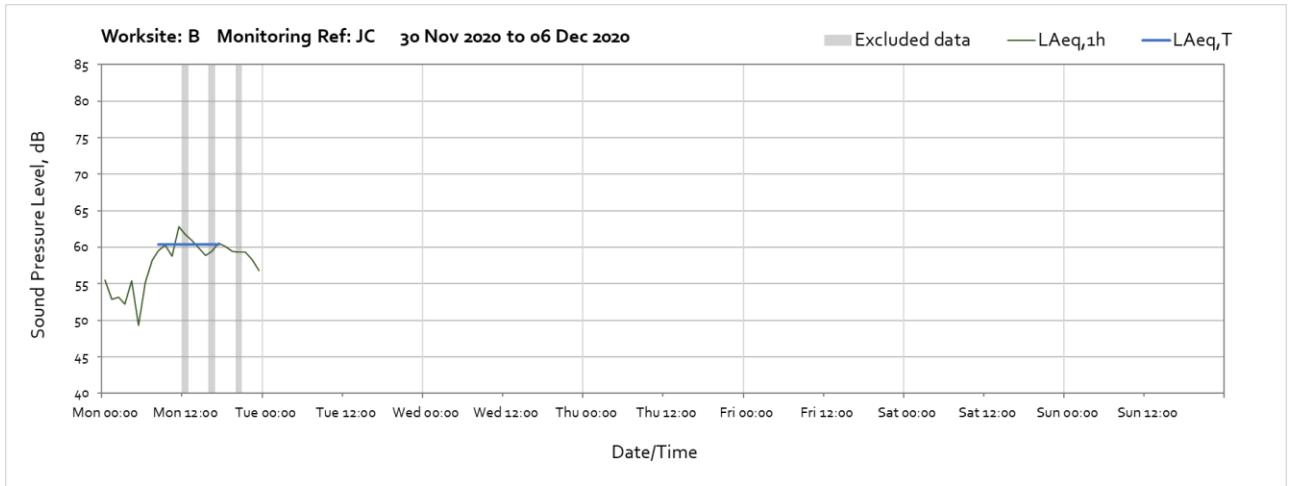
### Worksite: B – Monitoring Ref: JC

The following graphs show the hourly measured ambient noise level  $L_{Aeq,1h}$  and, where relevant, the averaged noise level  $L_{Aeq,T}$  values, where the time period T is as specified in Table 1 of HS2 Information Paper E23. Periods with adversely weather affected noise levels are greyed out and have been excluded from the calculation of the  $L_{Aeq,T}$  values in Table 3 of the main report.

2.1.6 Appendix C presents graphs of the noise and vibration monitoring data over the month for each of the measurement locations. Noise data presented consists of the hourly  $L_{Aeq}$  values and, where relevant, the  $L_{Aeq,T}$  values (where the time period T has been taken to be the averaging period as specified in Table 1 of HS2 Information Paper E23). Vibration data presented consist of hourly PPV values. The full data set for the monitoring equipment can be found at the following location: <https://data.gov.uk/dataset/24542ae7-dd44-444f-b259-871c4cc43b5e/environmental-monitoring-data>.

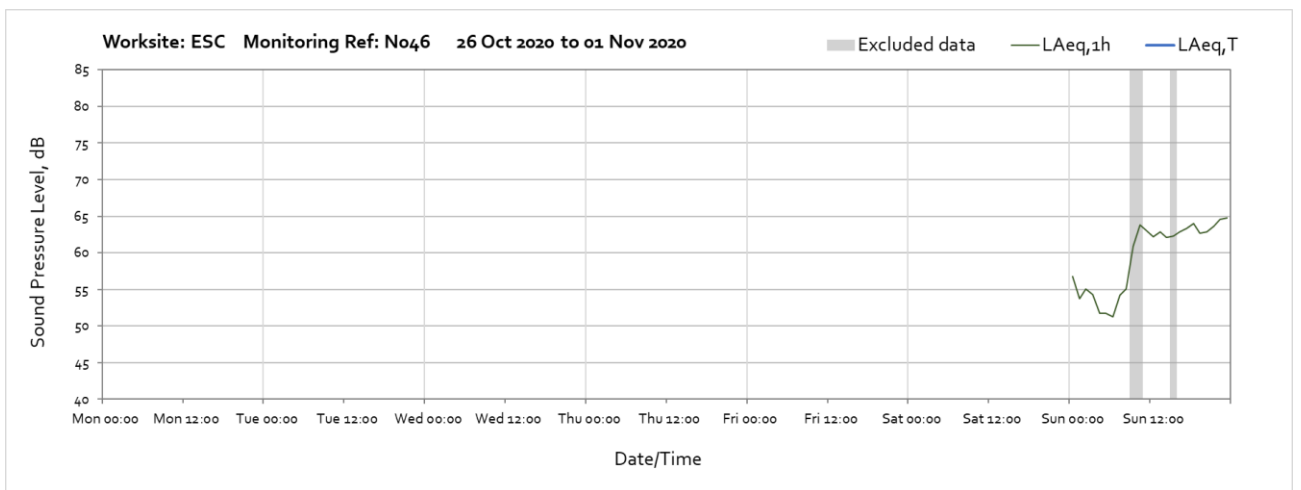
### Worksite: ESC – Monitoring Ref: N046

Note: Missing data from 00:00 on Monday 2<sup>nd</sup> November until the end of the month was due to an electrical fault with the lamppost which resulted in a loss of power at the noise monitor.

\*\* Data not measured within noted periods due to an electrical fault with the lamppost which resulted in a loss of power at the noise monitor.

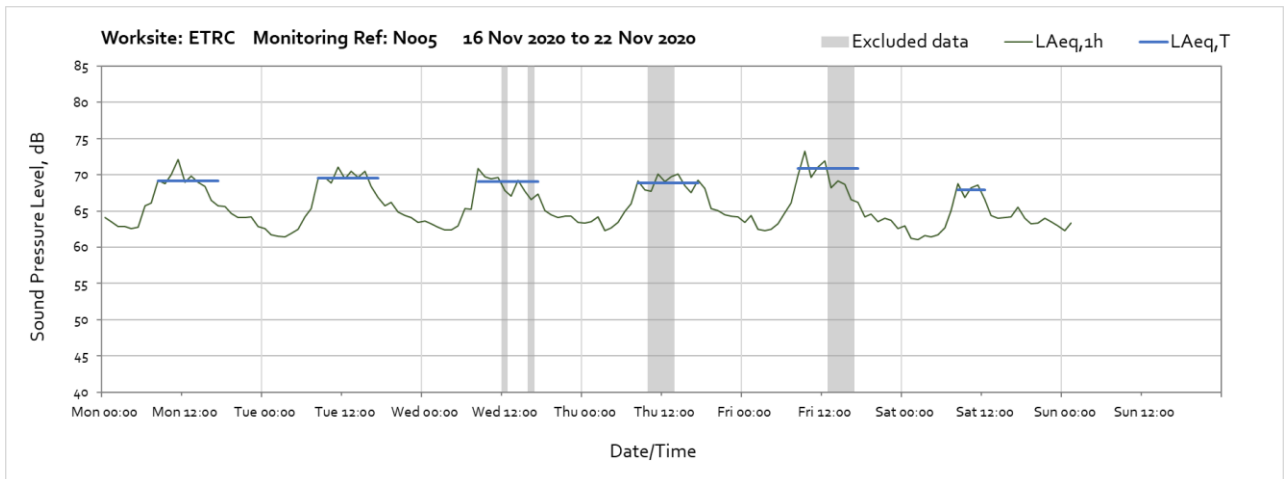
**Worksite: ETRC – Monitoring Ref: N005**

Note: Missing data from 01:00 on Sunday 22nd November until 12:00 on Monday 23rd November was due to a temporary loss of site power (including power to the monitoring station) which was subsequently restored.

Note: Missing data from 01:00 on Sunday 22<sup>nd</sup> November until 12:00 on Monday 23<sup>rd</sup> November was due to a temporary loss of site power (including power to the monitoring station) which was subsequently restored.

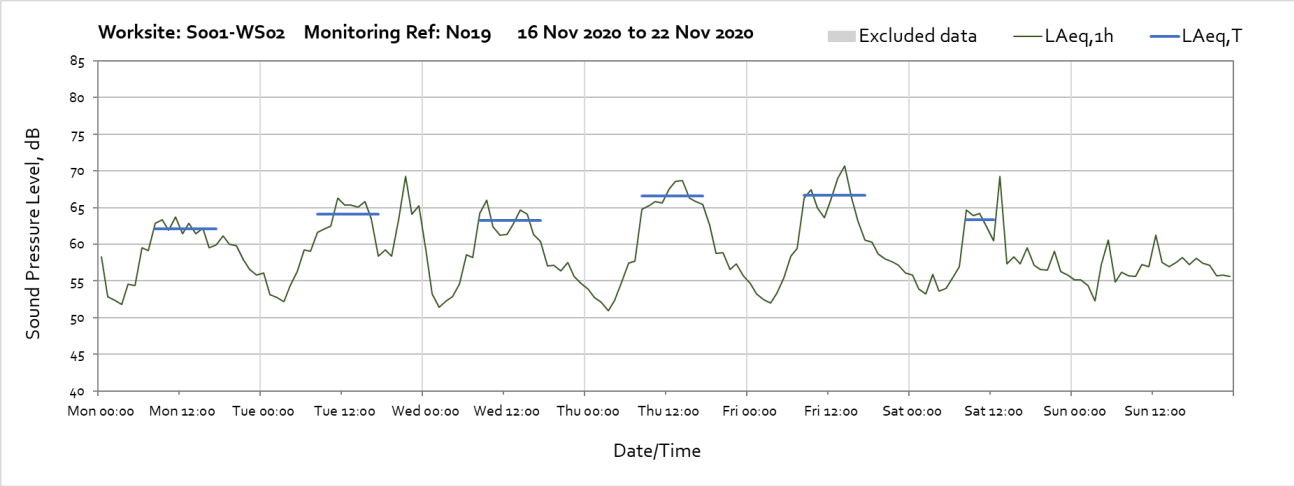
**Worksite: S001-WS02 – Monitoring Ref: N019**

Note: Missing data from the start of the month until 08:00 on Tuesday 12<sup>th</sup> November was due to the handover of monitoring stations between contractors.

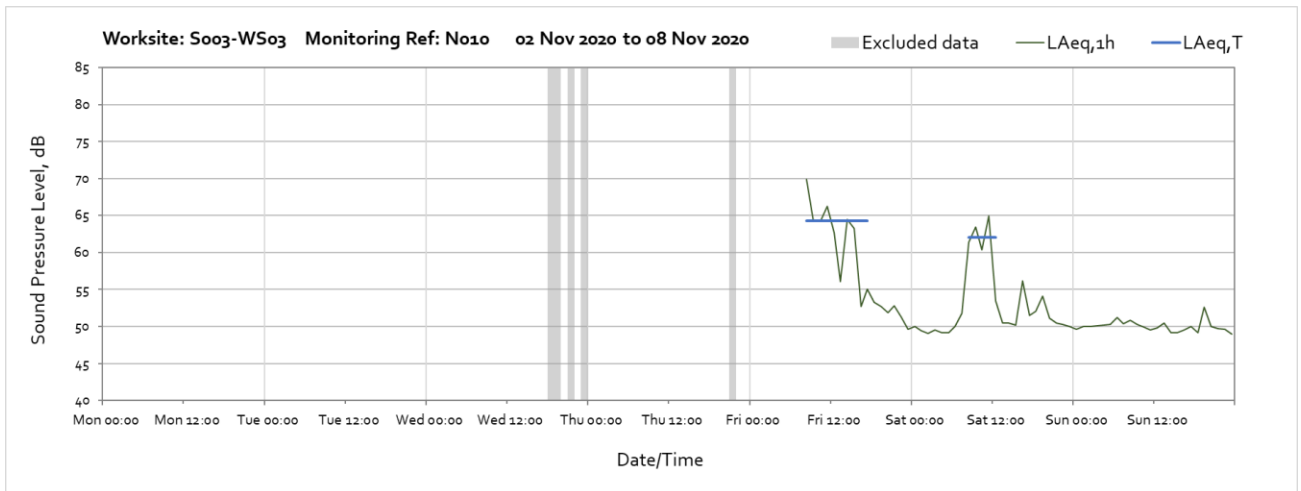
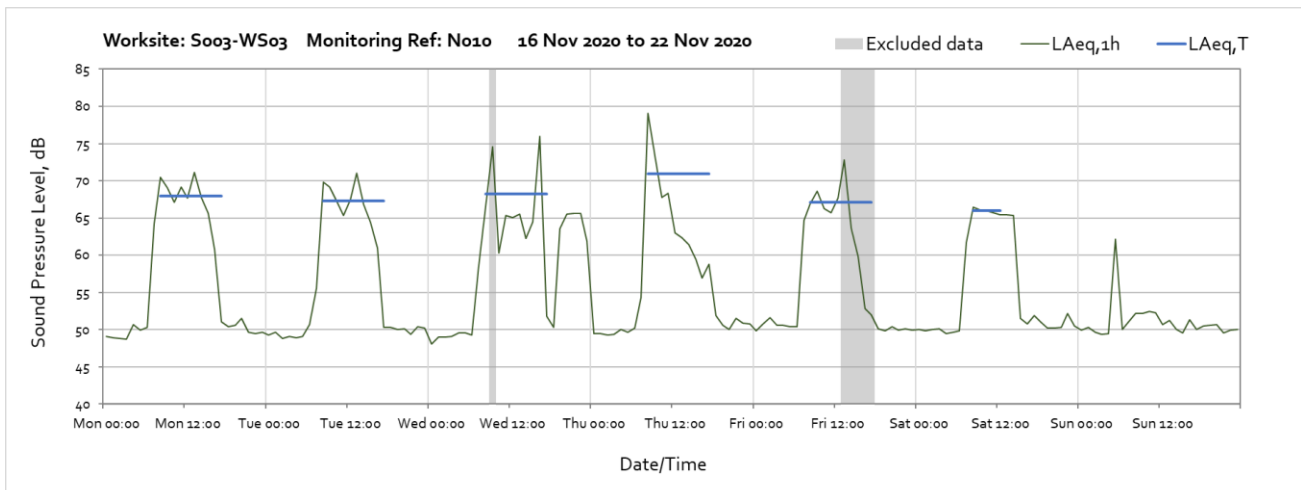
## Worksite: S003-WS03 – Monitoring Ref: N010

Note: Missing data from the start of the month until 08:00 on Friday 6<sup>th</sup> November was due to a fault with the monitoring station which resulted data not being recorded.

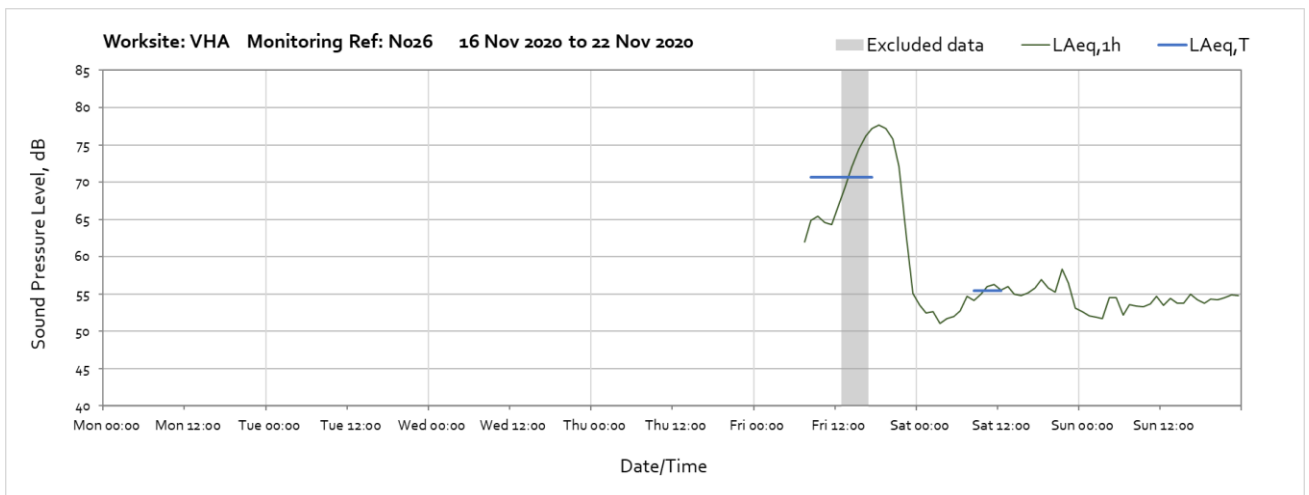
### Vehicle Holding Area (VHA) – Monitoring Ref: N026

Note: Missing data from the start of the month until 07:00 on Friday 20<sup>th</sup> November was due to the handover of monitoring stations between contractors.

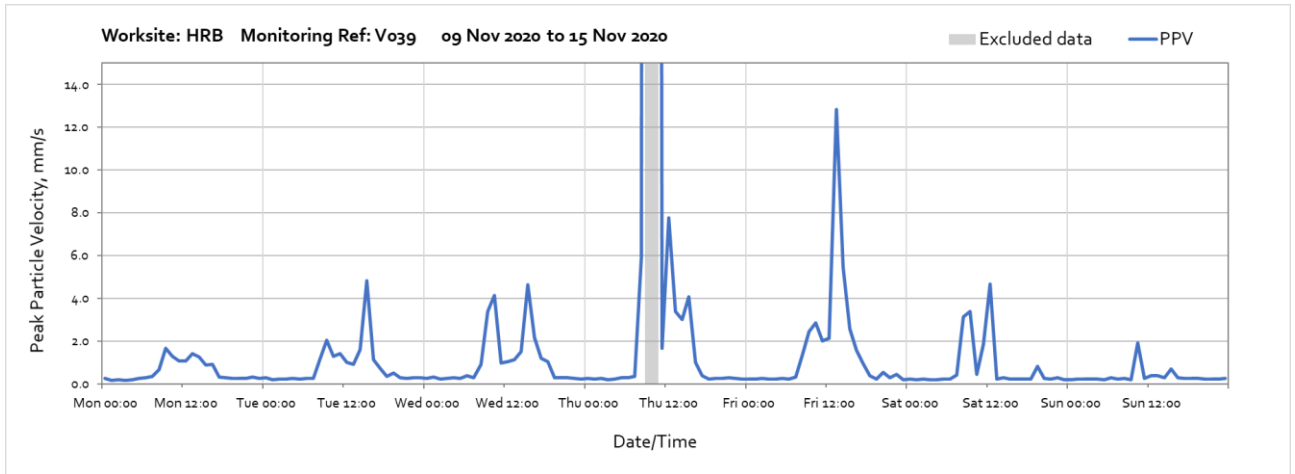
### Worksite: HRB – Monitoring Ref: V039

The following graphs show the hourly measured peak particle velocity PPV recorded during the monitoring period. The graphs show the resultant PPV due to vibration components on three orthogonal axis x, y and z. Where high values of PPV were caused by local interference with the vibration monitor, which are not representative of HS2 construction works, these values have been greyed out in the following charts and have been excluded to calculate values in Table 4 of the main report.

Note: High vibration levels measured between 09:00-11:00 on Thursday 12<sup>th</sup> November were due to local disturbance of the vibration monitor and are not representative of HS2 vibration levels.

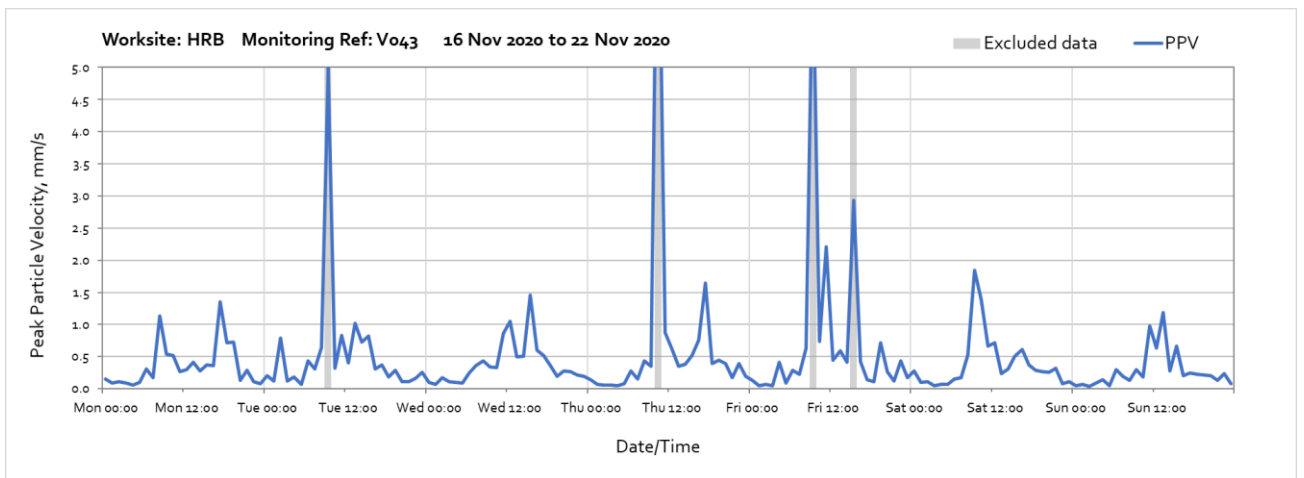
Note: High vibration levels measured throughout the week were due to the use of the neraby residential bin store and local interference of the monitor and are not representative of HS2 vibration levels.

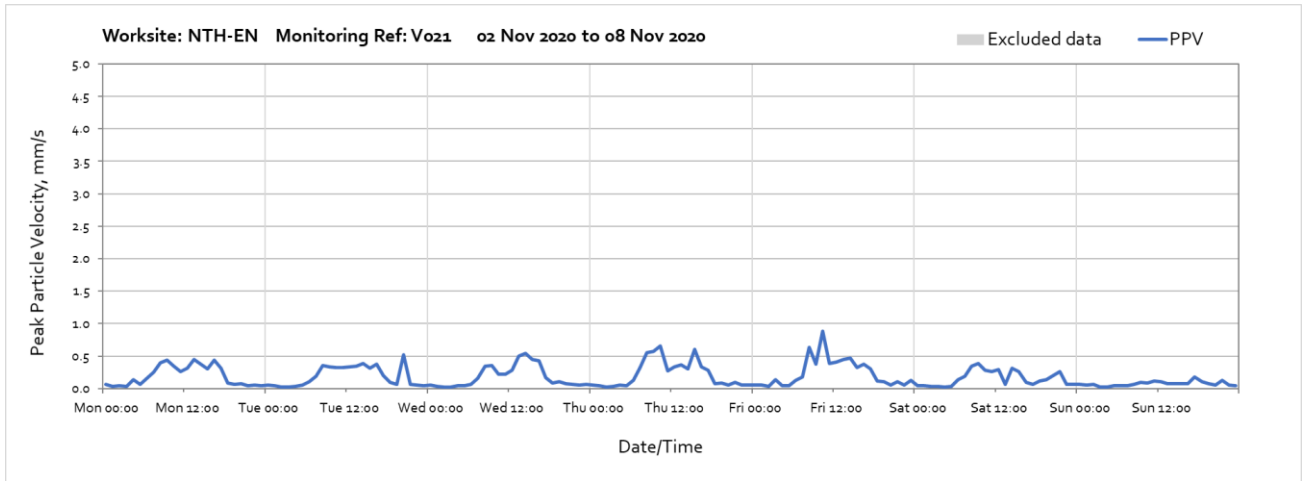
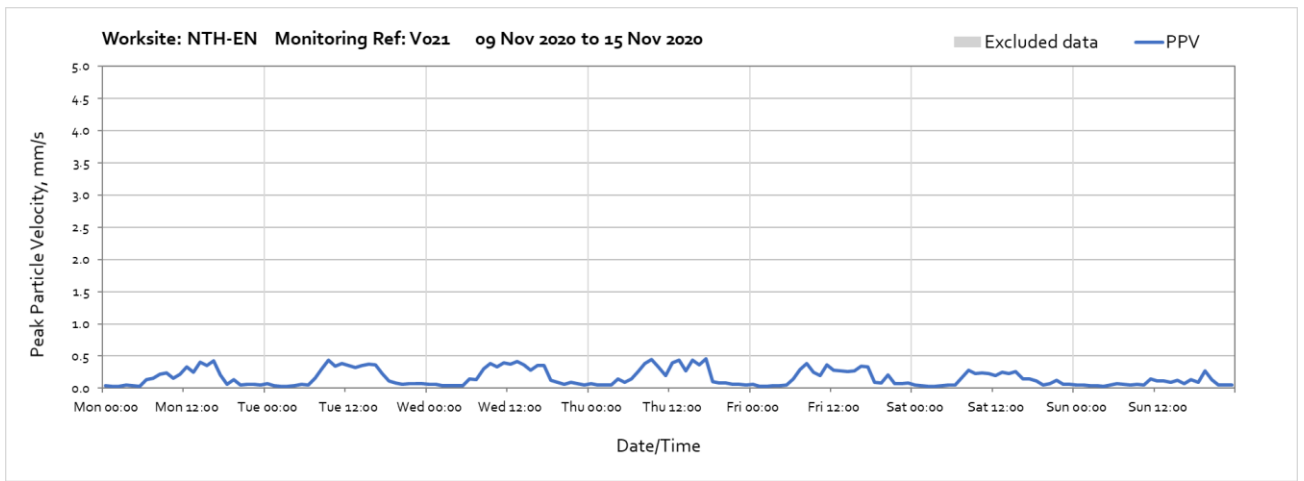
### Worksite: NTH-EN – Monitoring Ref: V021

Note: High vibration levels measured at 11:00 on Wednesday 18<sup>th</sup> November was due to local disturbance of the vibration monitor during setup and are not representative of HS2 vibration levels.
