# **Construction noise and vibration Monthly Report – November 2020**

**London Borough of Ealing**

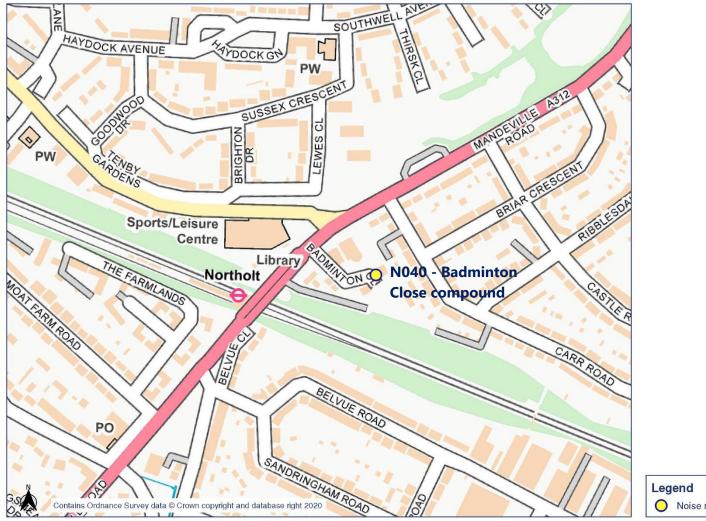
#### Noise and vibration monitoring plan - 1

O Noise monitor

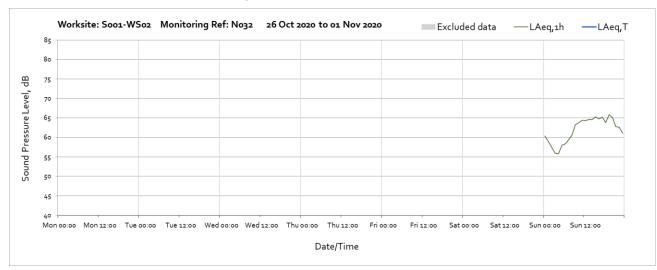
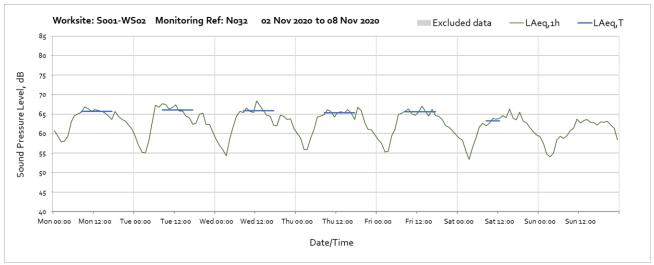
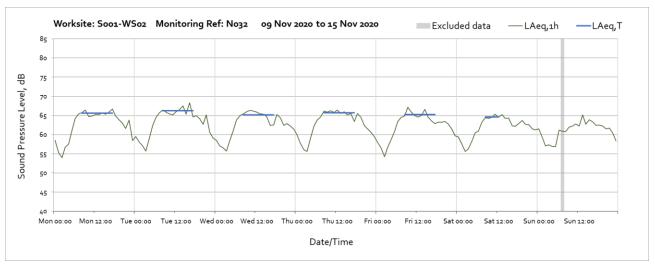
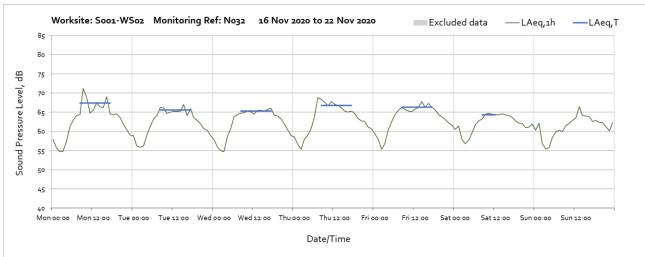
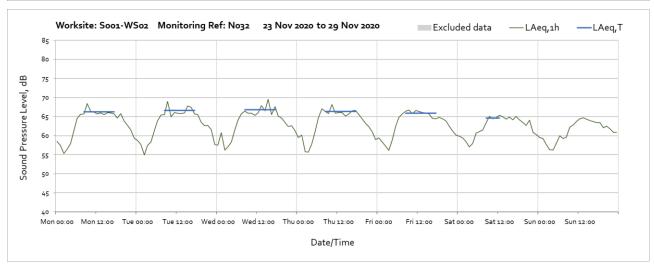
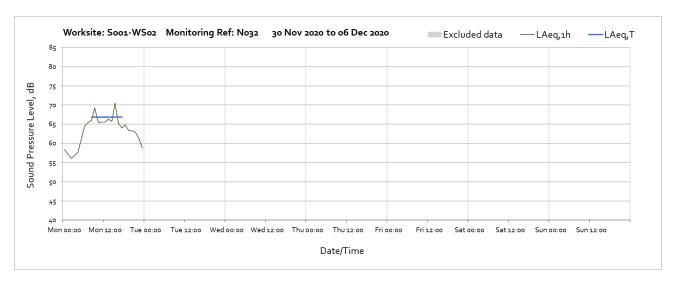
#### Worksite: S001-WS02 - Monitoring Ref: N032

The following graphs show the hourly measured ambient noise level  $L_{Aeq,1h}$  and, where relevant, the averaged noise level  $L_{Aeq,T}$  values, where the time period T is as specified in Table 1 of HS2 Information Paper E23. Periods with adversely weather affected noise levels are greyed out and have been excluded from the calculation of the  $L_{Aeq,T}$  values in Table 3 of the main report.

2.1.3 Appendix C presents graphs of the noise and vibration monitoring data over the month for each of the measurement locations. Noise data presented consists of the hourly L<sub>Aeq</sub> values and, where relevant, the L<sub>Aeq,T</sub> values (where the time period T has been taken to be the averaging period as specified in Table 1 of HS2 Information Paper E23). Vibration data presented consist of hourly PPV values. The full data set for the monitoring equipment can be found at the following location: <a href="https://data.gov.uk/dataset/24542ae7-dd44-444f-b259-871c4cc43b5e/environmental-monitoring-data">https://data.gov.uk/dataset/24542ae7-dd44-444f-b259-871c4cc43b5e/environmental-monitoring-data</a>.

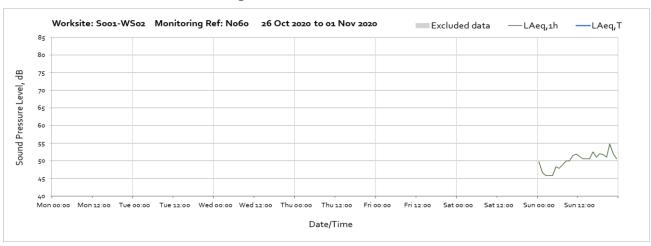
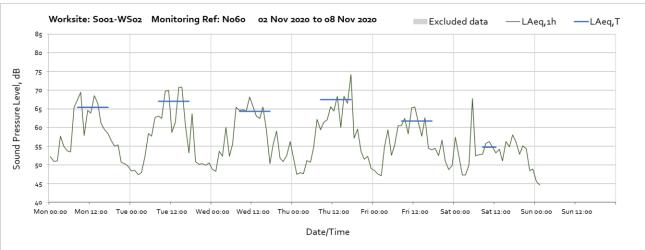
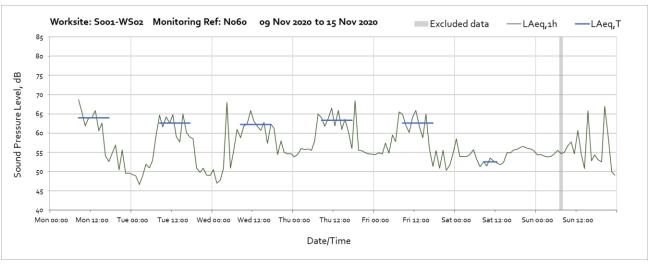
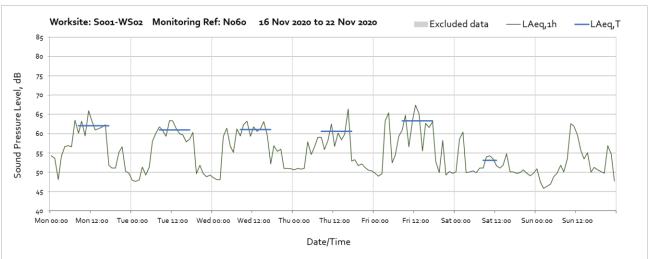
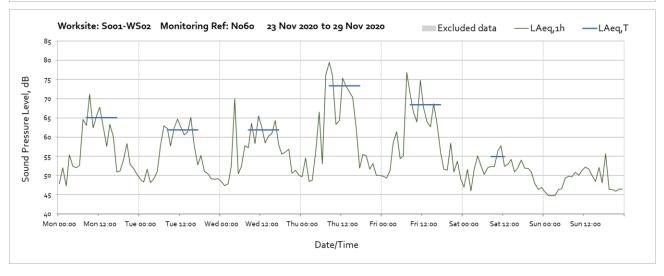
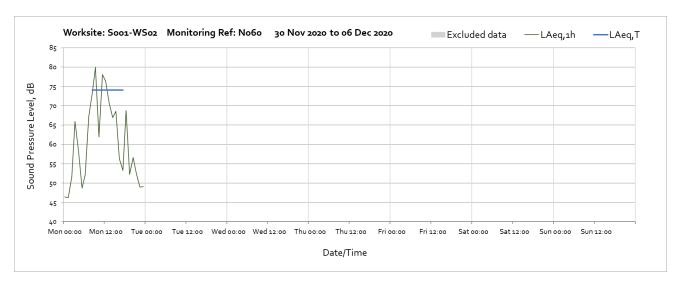
#### Worksite: S001-WS02 - Monitoring Ref: N060

Note: Missing data between 02:00 on Sunday 8<sup>th</sup> December and 07:00 on Monday 9<sup>th</sup> December was due depleted noise monitor internal battery.

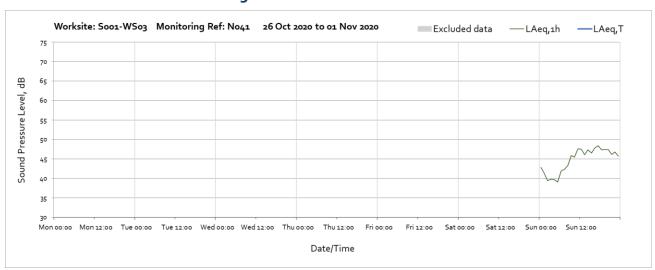
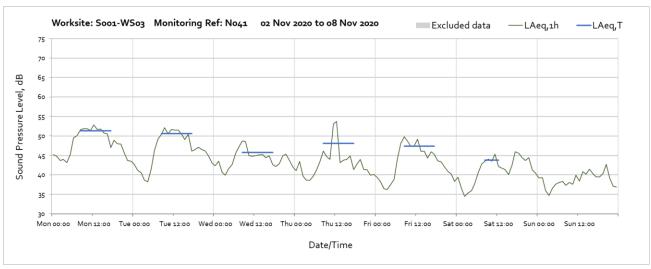
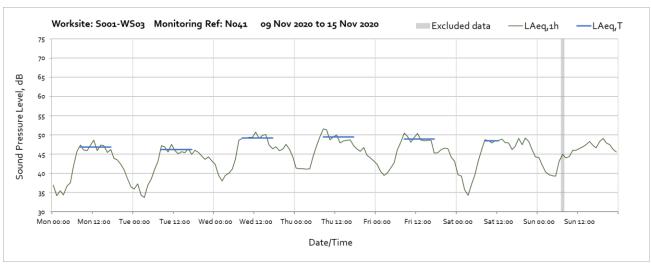
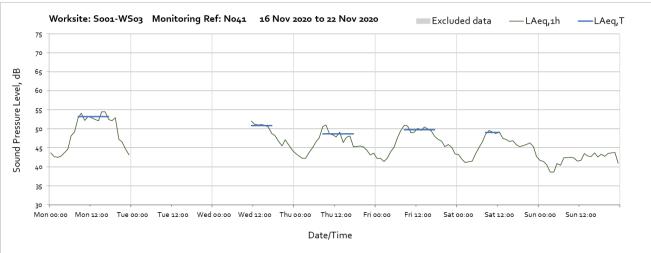
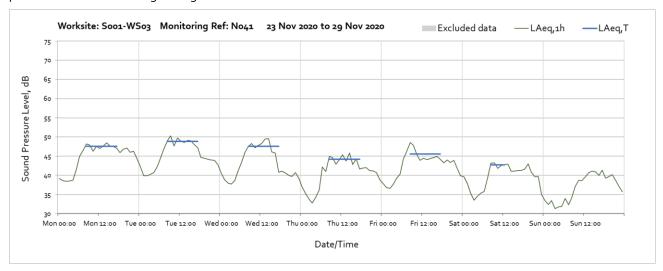
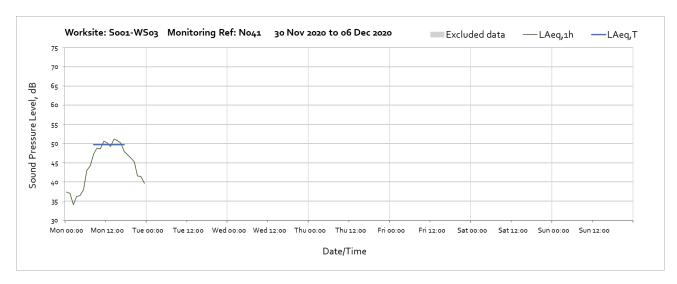
# Worksite: S001-WS03 - Monitoring Ref: N041

Note: Missing data from 00:00 on Tuesday 17<sup>th</sup> December until 11:00 on Wednesday 18<sup>th</sup> December was due to power disconnection during filming of "The Crown" in the area.

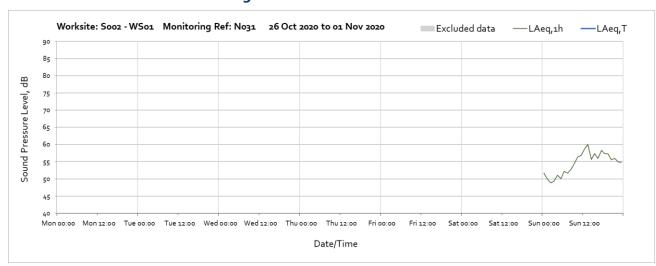
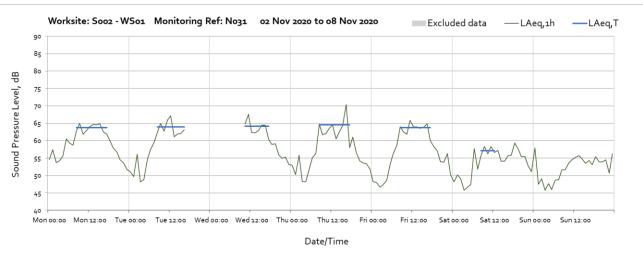
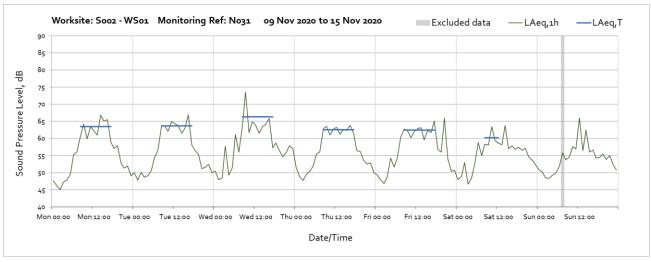
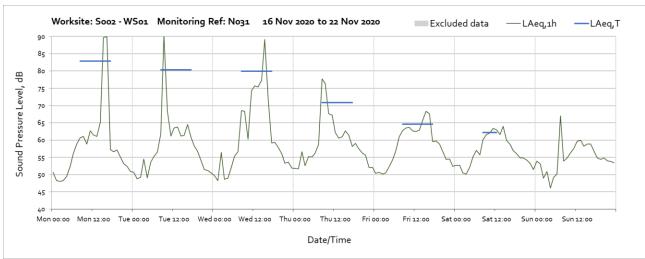
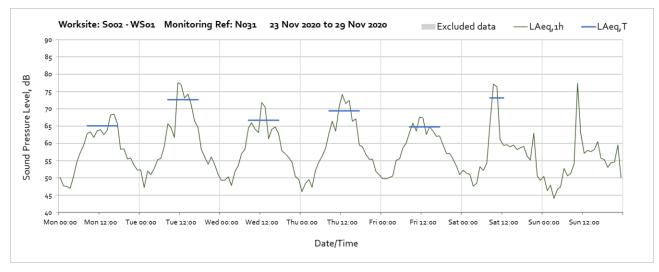
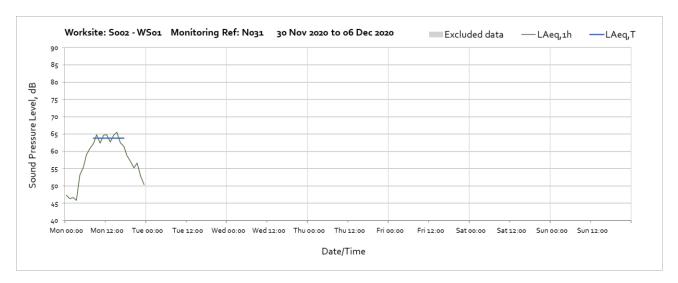
# Worksite: S002-WS01 - Monitoring Ref: N031

Note: Missing data due to loss of power at the monitoring station.

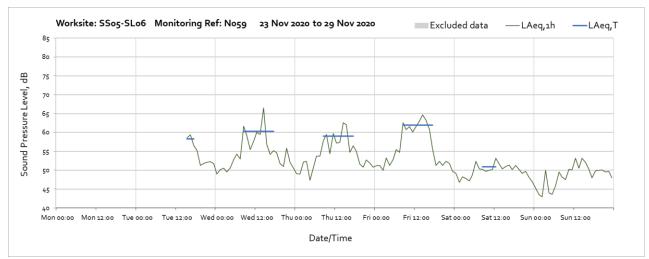
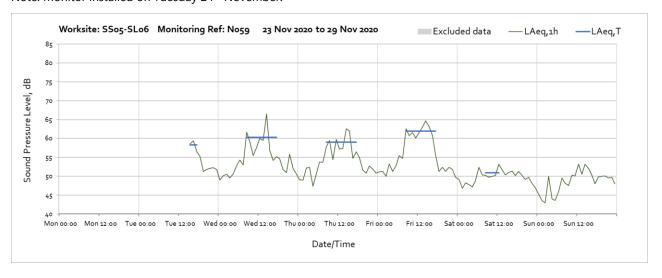
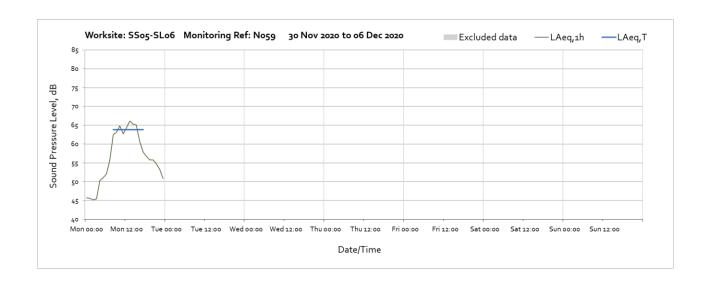
#### Worksite: SS05-SL-6 - Monitoring Ref: N059

Note: Monitor installed on Tuesday 24<sup>th</sup> November.

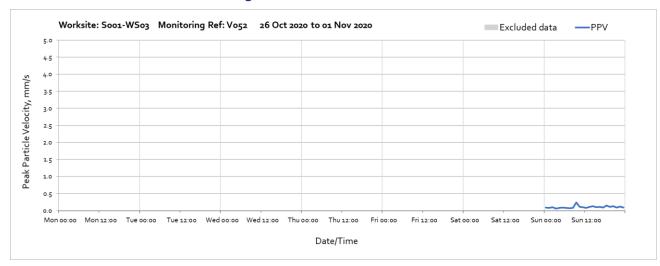
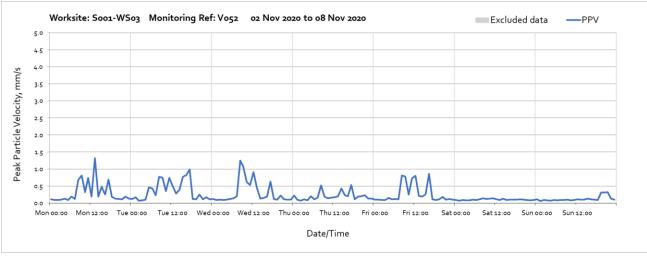
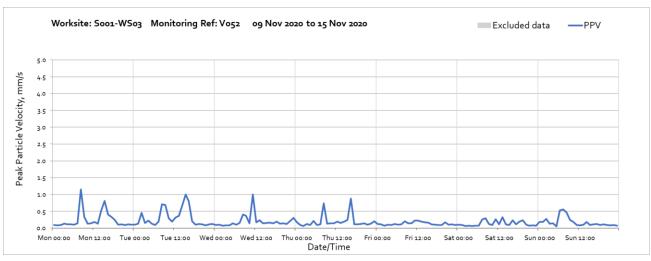
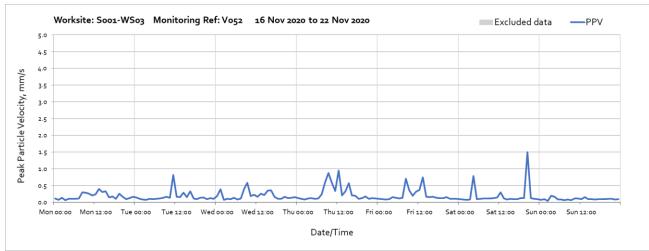
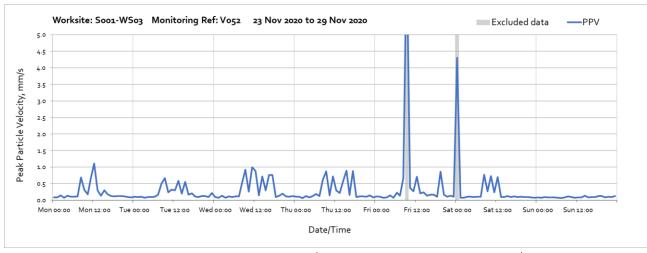
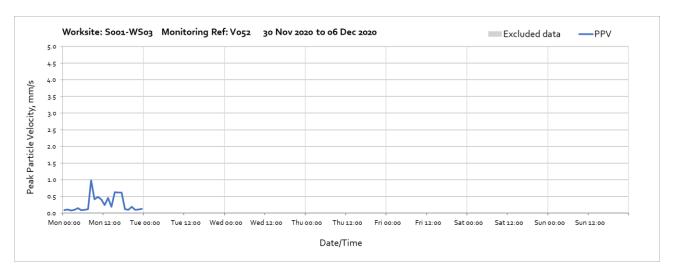
## Worksite: S001-WS03 - Monitoring Ref: V052

The following graphs show the hourly measured peak particle velocity PPV recorded during the monitoring period. The graphs show the resultant PPV due to vibration components on three orthogonal axis x, y and z. Where high values of PPV were caused by local interference with the vibration monitor, which are not representative of HS2 construction works, these values have been greyed out in the following charts and have been excluded to calculate values in Table 4 of the main report.

Note: High vibration levels measured at 09:00 on Friday 27<sup>th</sup> November and 00:00 on Saturday 28<sup>th</sup> November were due to local disturbance of the monitor and are not representative of HS2 construction vibration.

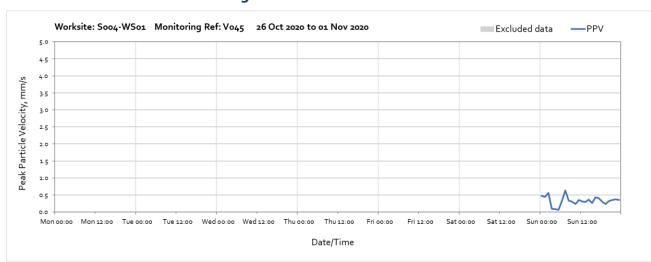
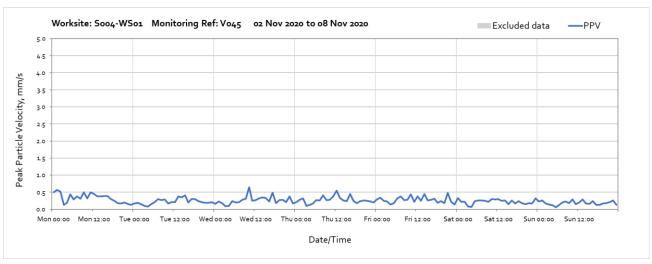
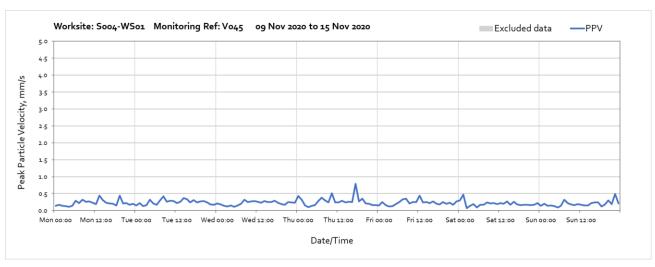
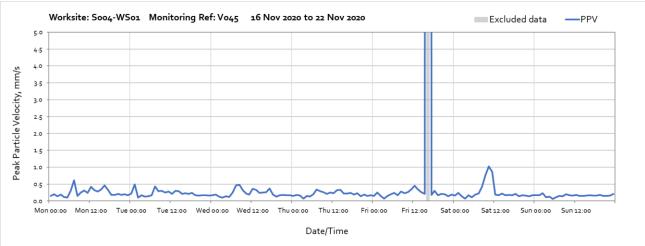
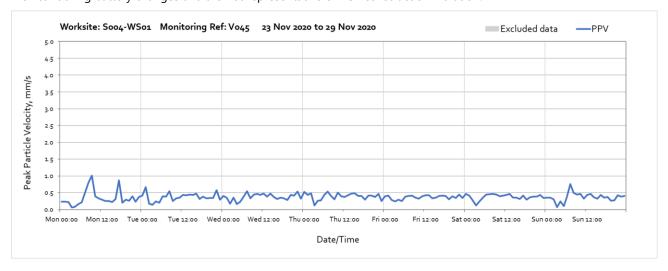
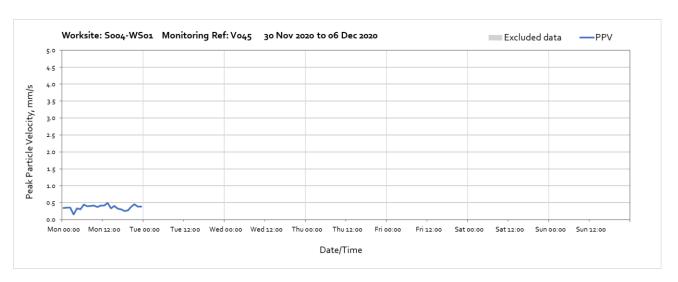
#### Worksite: S004-WS01 - Monitoring Ref: V045

Note: High vibration levels measured at 16:00 on Friday 20<sup>th</sup> November was due to local disturbance of the monitor during battery changes and are not representative of HS2 construction vibration.

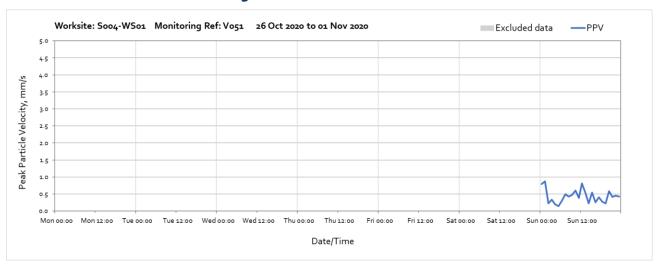
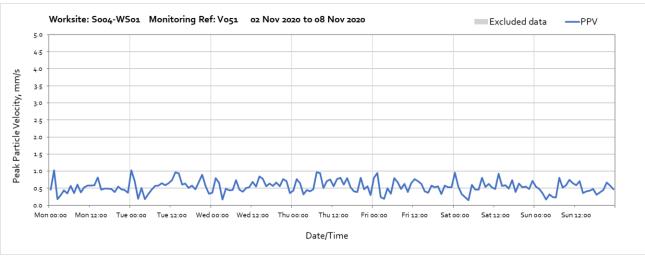
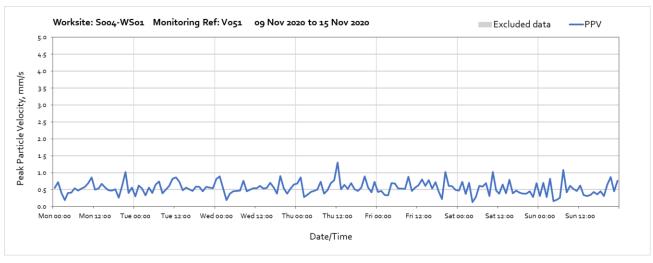
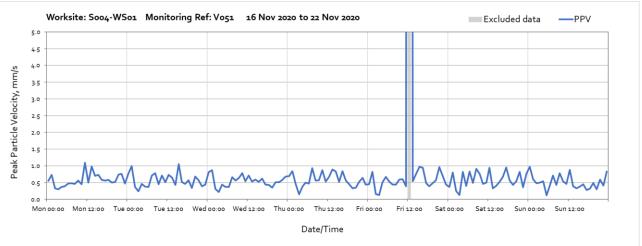
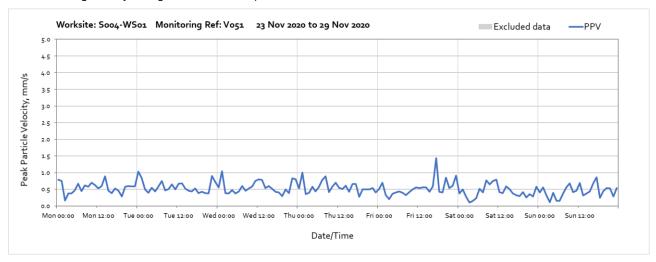
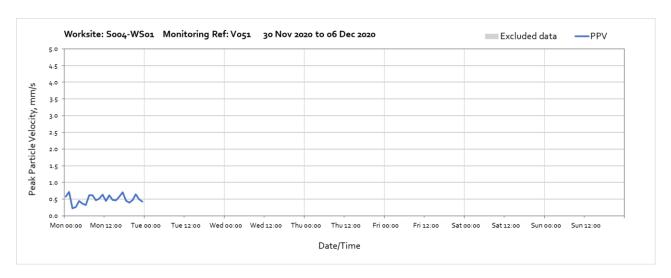
# Worksite: S004-WS01 - Monitoring Ref: V051

Note: High vibration levels measured at 12:00 on Friday 20<sup>th</sup> November was due to local disturbance of the monitor during battery changes and are not representative of HS2 construction vibration.

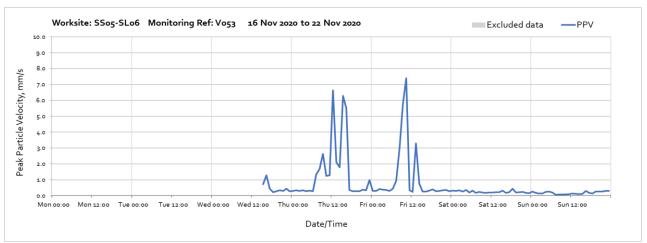
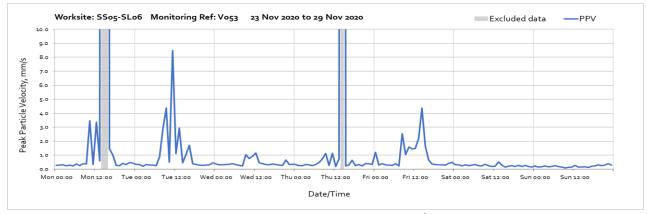
### Worksite: S004-WS01 – Monitoring Ref: V053

Note: Monitor installed on Wednesday 17<sup>th</sup> November.

Note: High vibration levels measured between 14:00 and 15:00 on Monday 23<sup>rd</sup> November and at 14:00 on Thursday 26<sup>th</sup> November was due to local disturbance of the monitor and are not representative of HS2 construction vibration.
