Construction noise and vibration Monthly Report – December 2020

London Borough of Camden

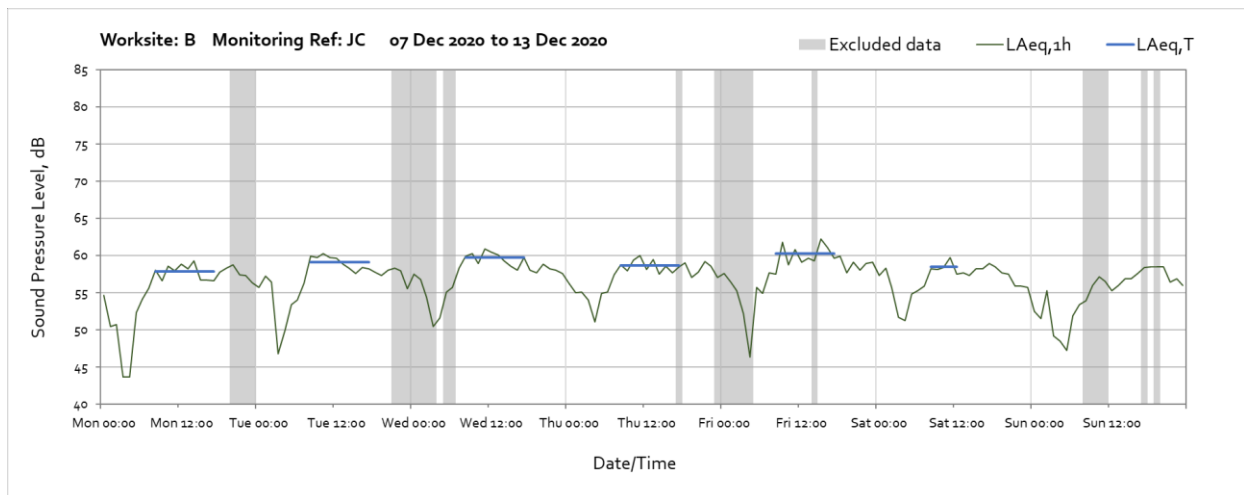
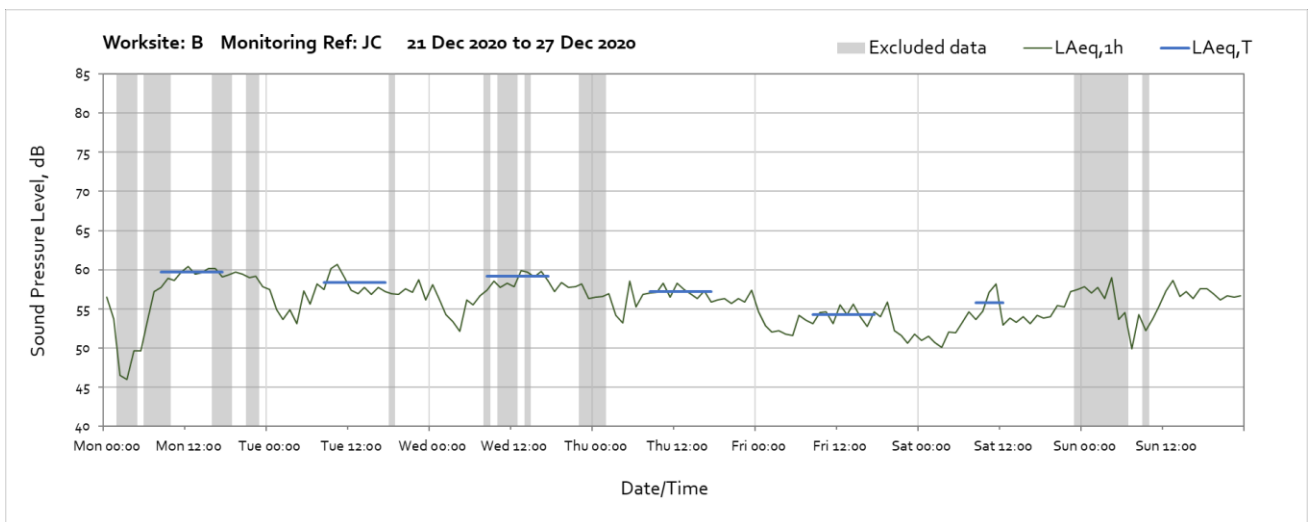
Worksite: B – Monitoring Ref: JC

The following graphs show the hourly measured ambient noise level $L_{Aeq,1h}$ and, where relevant, the averaged noise level $L_{Aeq,T}$ values, where the time period T is as specified in Table 1 of HS2 Information Paper E23. Periods with adversely weather affected noise levels are greyed out and have been excluded from the calculation of the $L_{Aeq,T}$ values in Table 3 of the main report.

2.1.5 Appendix C presents graphs of the noise and vibration monitoring data over the month for each of the measurement locations. Noise data presented consists of the hourly L_{Aeq} values and, where relevant, the $L_{Aeq,T}$ values (where the time period T has been taken to be the averaging period as specified in Table 1 of HS2 Information Paper E23). Vibration data presented consist of hourly PPV values. The full data set for the monitoring equipment can be found at the following location: <https://data.gov.uk/dataset/24542ae7-dd44-444f-b259-871c4cc43b5e/environmental-monitoring-data>.

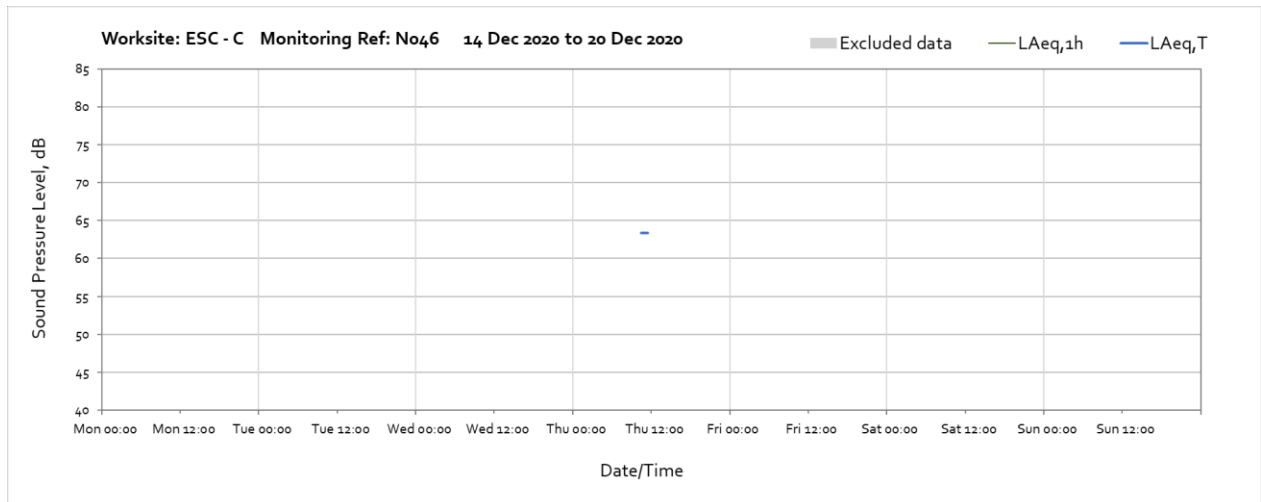
Worksite: ESC-C – Monitoring Ref: N046

Note: Missing data from the start of the month until 10:00 on Thursday 17th December and from 12:00 on Thursday 17th December until until 03:00 on Tuesday 22nd December was due to an electrical fault with the lamppost which resulted in a loss of power at the noise monitor.

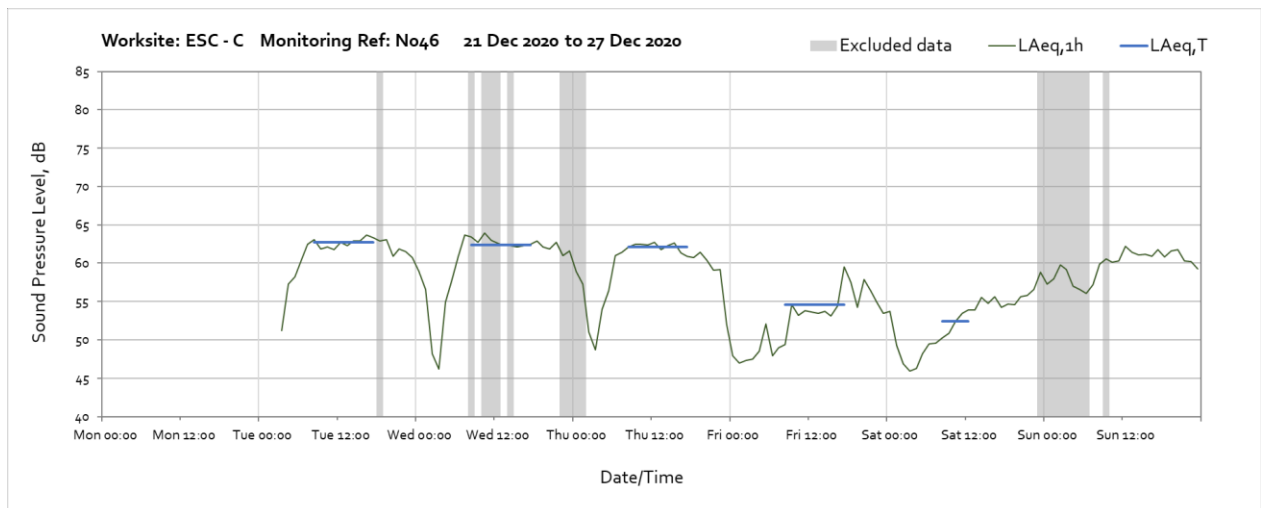
Note: Missing data from 12:00 on Thursday 17th December until until 03:00 on Tuesday 22nd December was due to an electrical fault with the lamppost which resulted in a loss of power at the noise monitor.

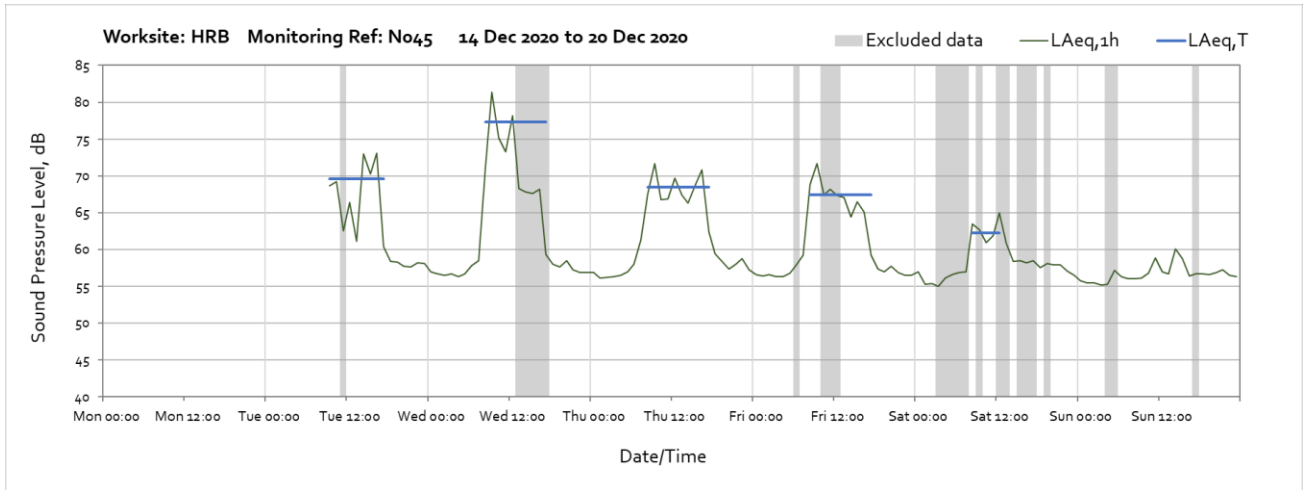
Worksite: HRB – Monitoring Ref: N045

Note: Missing data from 05:00 on Thursday 3rd December until 09:00 on Tuesday 15th December was due to loss of power to the monitor caused by the monitor being unplugged from the power supply. Environmental advisors have informed site teams to keep power connected. Alerts have been set up informing of power disconnect, which are sent to the Environmental Advisors who will take action and notify site teams to investigate loss of power.

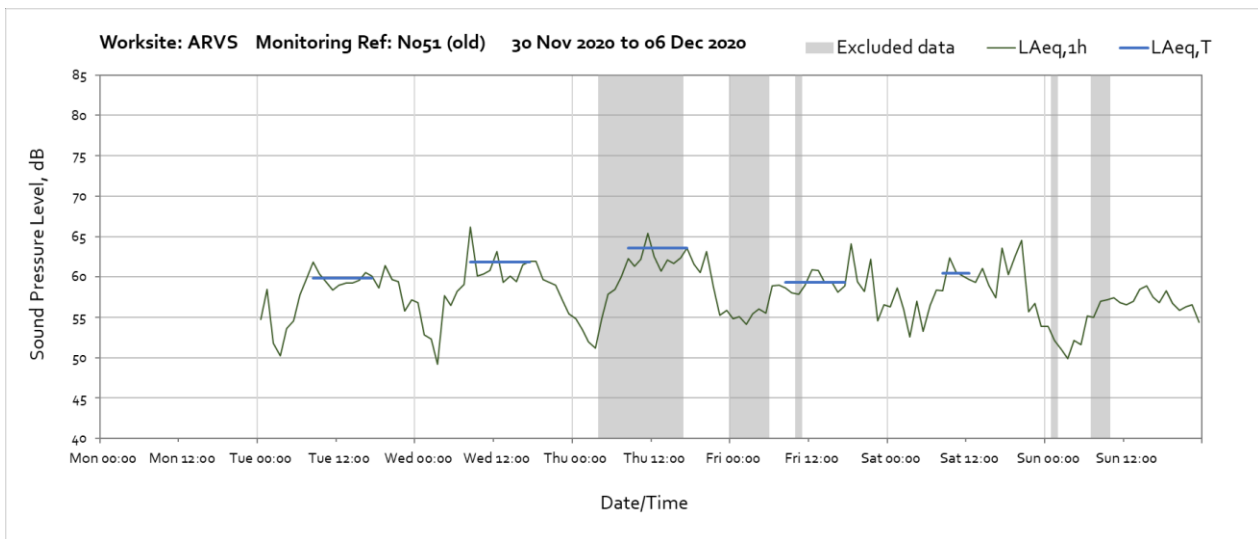
Adelaide Road Ventilation Shaft (ARVS) – Monitoring Ref: N051 (old)

Note: The monitor was relocated at 08:00 on Friday 11th December to a new position on a lamppost across the road.

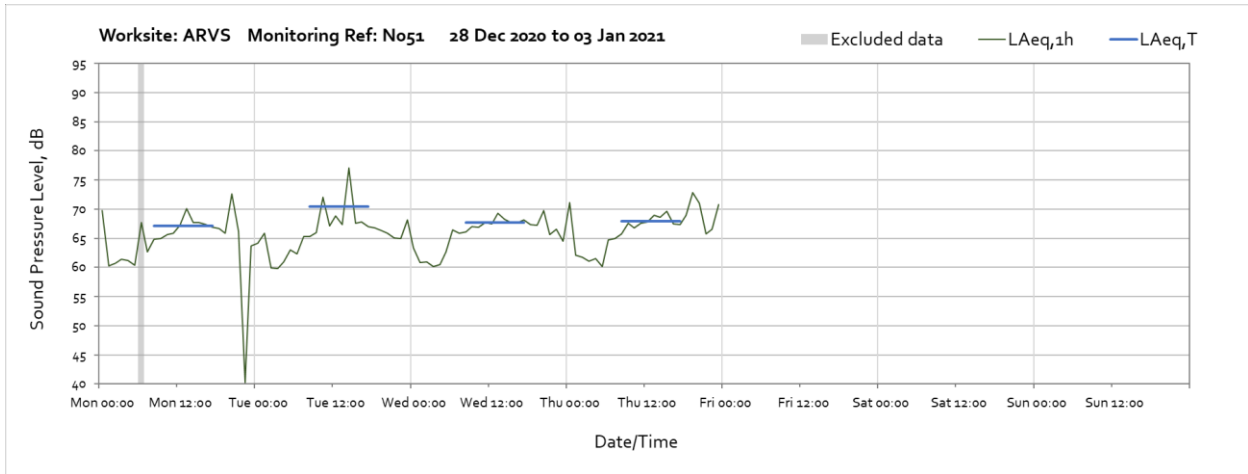
Adelaide Road Ventilation Shaft (ARVS) – Monitoring Ref: N051

Note: Monitoring at this position was started at 12:00 on Friday 11th December.

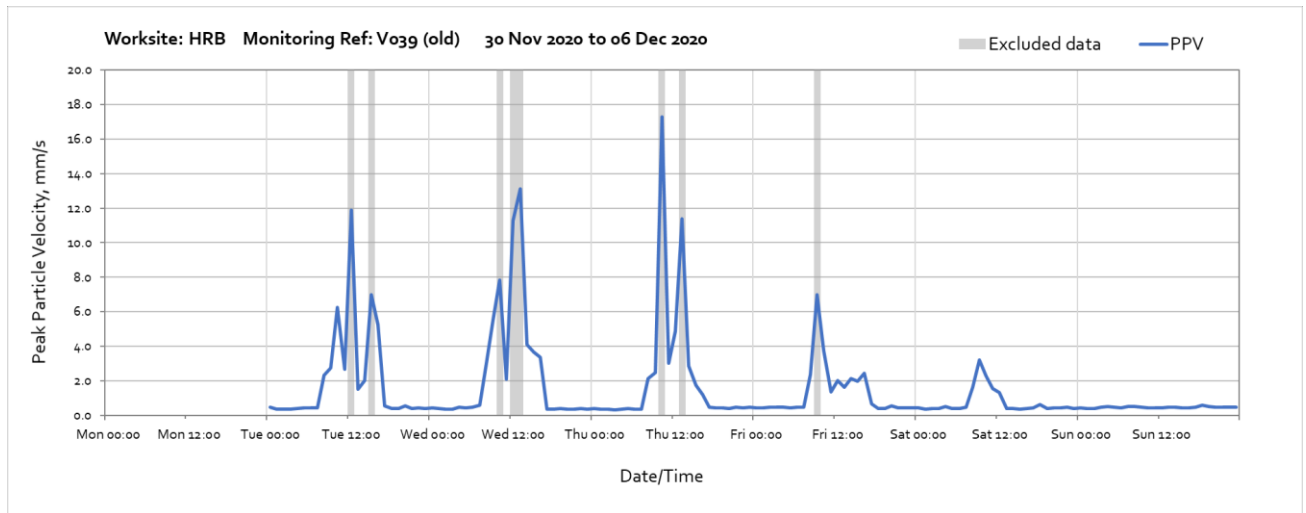
Worksite: HRB – Monitoring Ref: V039 (old)

The following graphs show the hourly measured peak particle velocity PPV recorded during the monitoring period. The graphs show the resultant PPV due to vibration components on three orthogonal axis x, y and z. Where high values of PPV were caused by local interference with the vibration monitor, which are not representative of HS2 construction works, these values have been greyed out in the following charts and have been excluded to calculate values in Table 4 of the main report.

Note: High vibration levels measured throughout the week were due to local disturbance of the vibration monitor and are not representative of HS2 vibration levels.

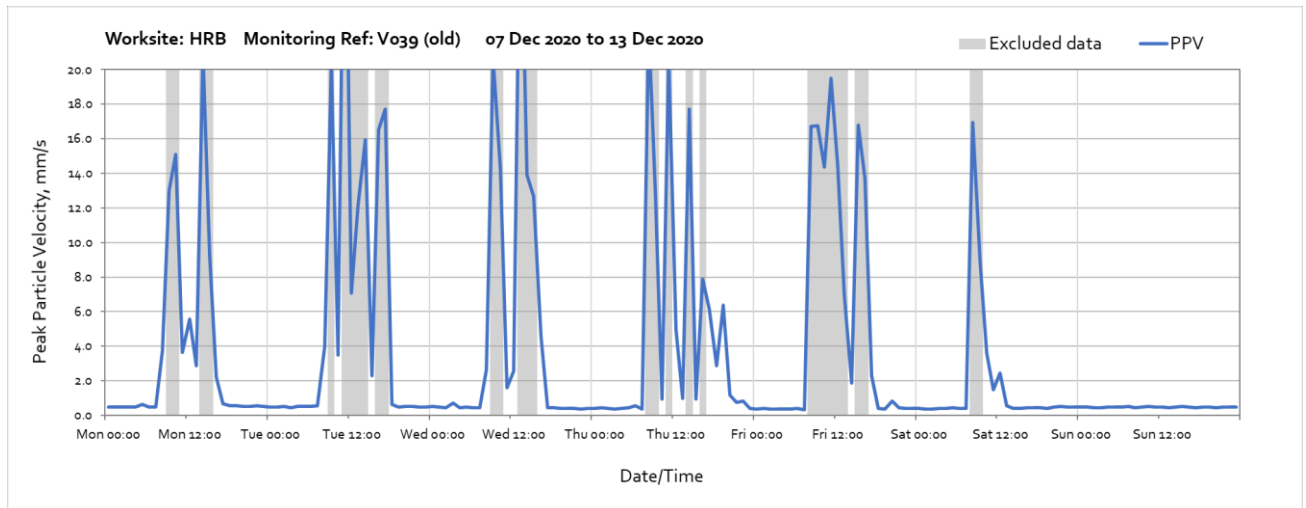
Note: High vibration levels measured throughout the week were due to local disturbance of the vibration monitor and are not representative of HS2 vibration levels.

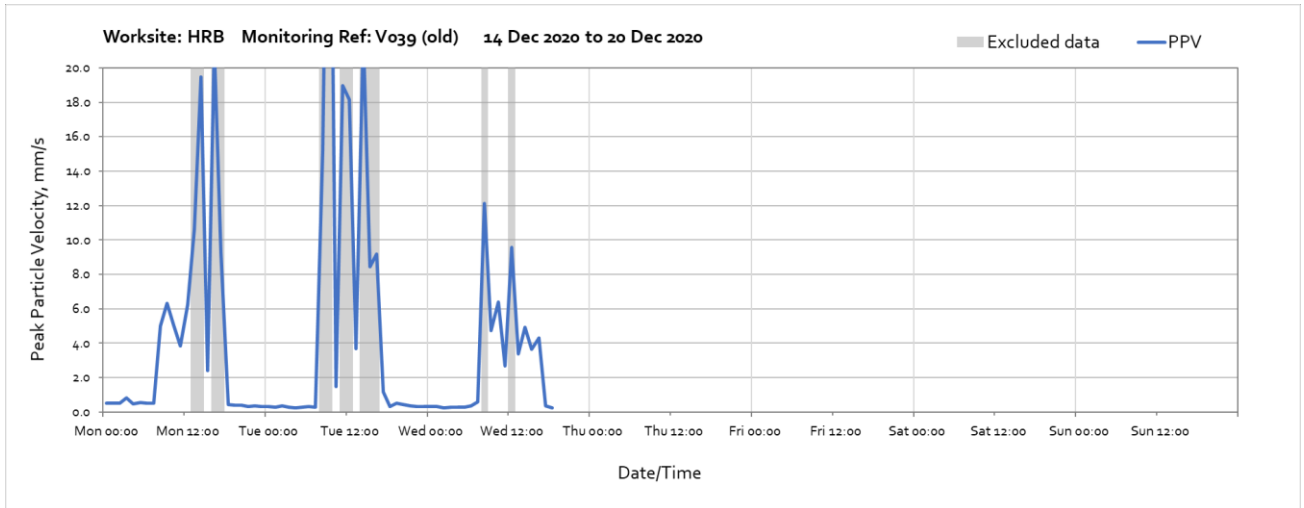
Note: High vibration levels measured throughout the week were due to local disturbance of the vibration monitor and are not representative of HS2 vibration levels. Missing data from 19:00 on Wednesday 16th until 16:00 on Friday 18th December was due to the handover of the monitoring station between contractors. The monitor was relocated on Friday 18th December to a new position more representative of residential receptors near the construction site.

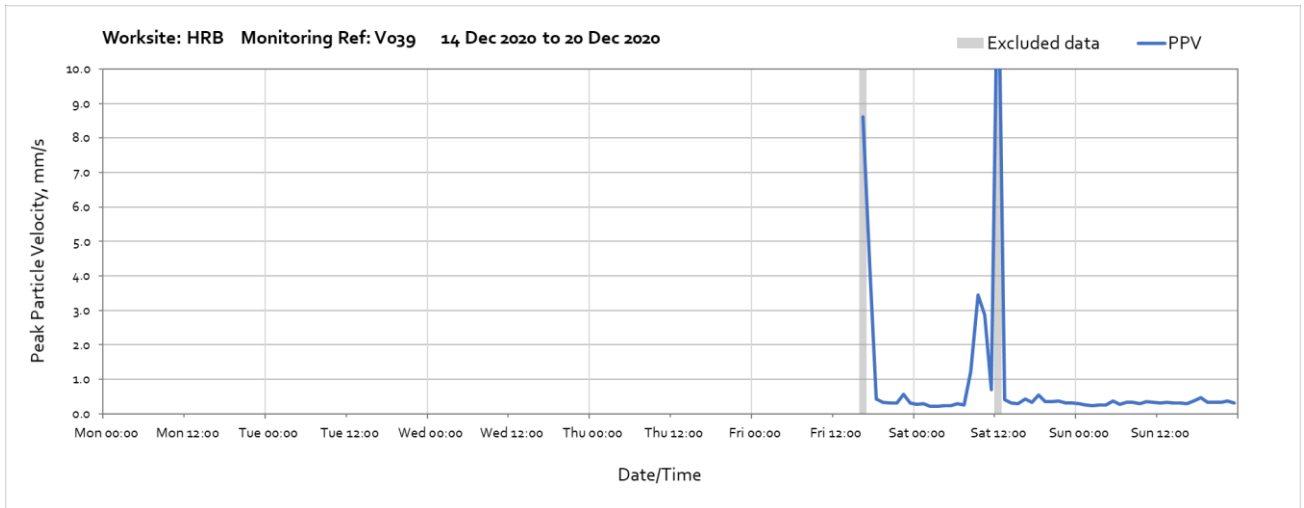
Worksite: HRB – Monitoring Ref: V039

Note: High vibration levels measured throughout the week were due to local disturbance of the vibration monitor and are not representative of HS2 vibration levels.

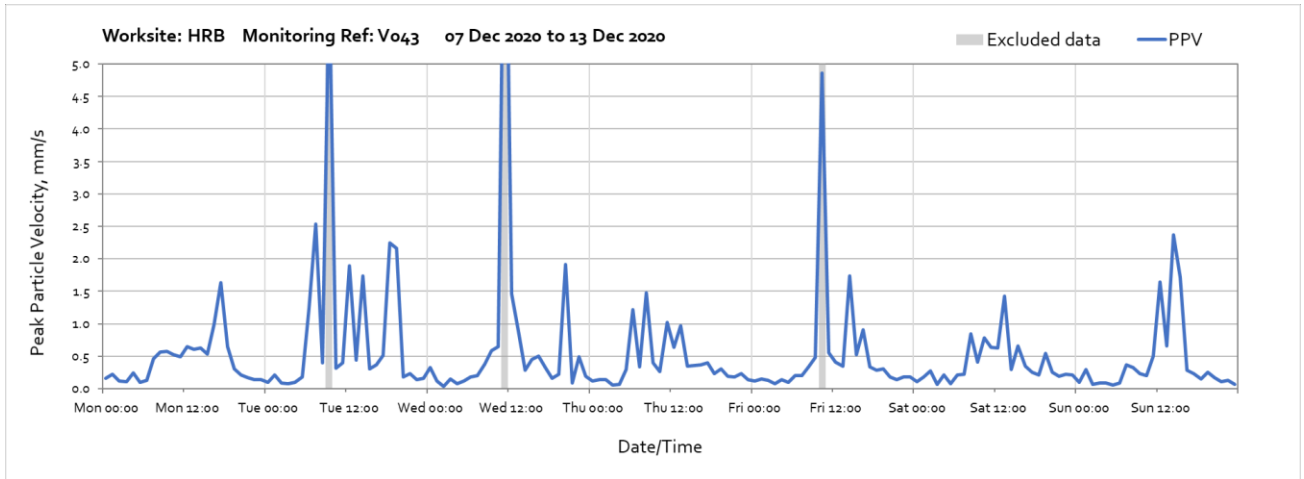
Note: High vibration levels measured throughout the week were due to the use of the neraby residential bin store and are not representative of HS2 vibration levels.

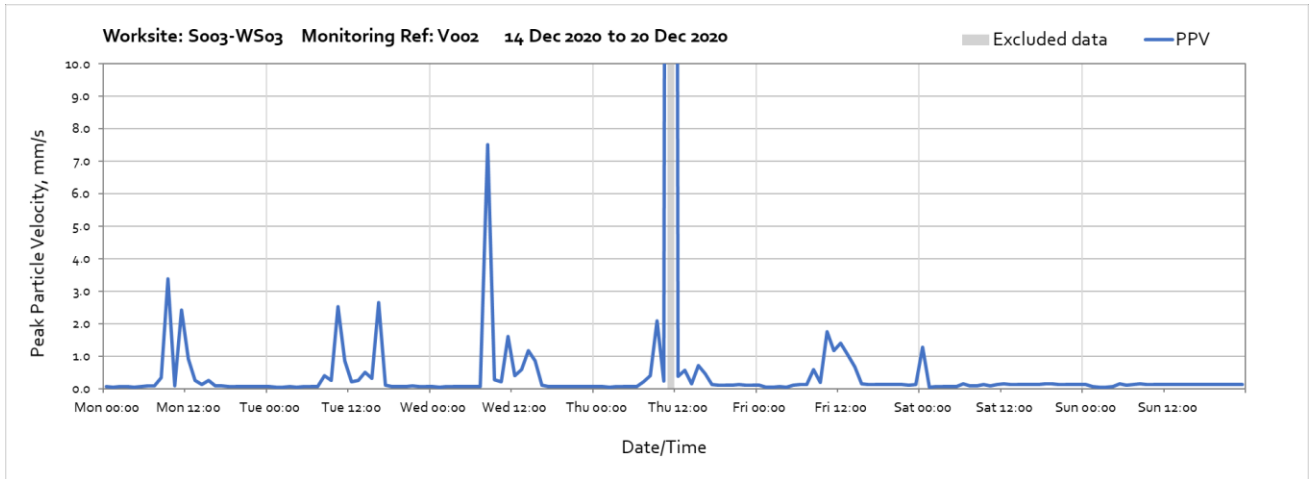
Worksite: S003-WS03 – Monitoring Ref: V002

Note: High vibration levels measured at 11:00 on Thursday 17th December were caused by local disturbance of the monitor due to the installation of a new boiler adjacent to the monitoring station and are not representative of HS2 construction works.
