## Toe structures management manual

Project: SC070056/R

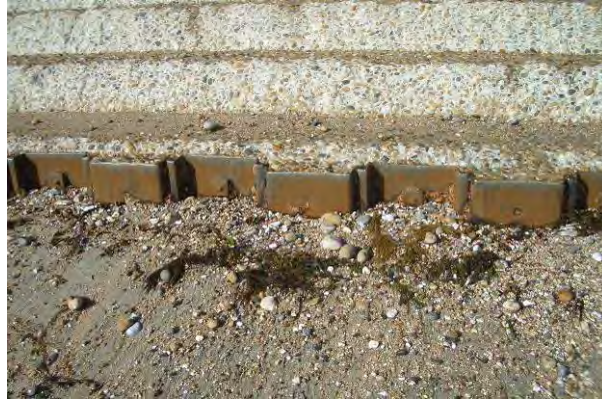
Steel sheet piling is a common means of securing a defence against the threat of undermining (Figure 2.1). This technique is commonly used to stabilise foundations and reduce loss of fill materials, thus prolonging the life of the overall defence.

**Figure 2.1 Underpinning of seawall toe with steel sheet piles (courtesy HR Wallingford)**

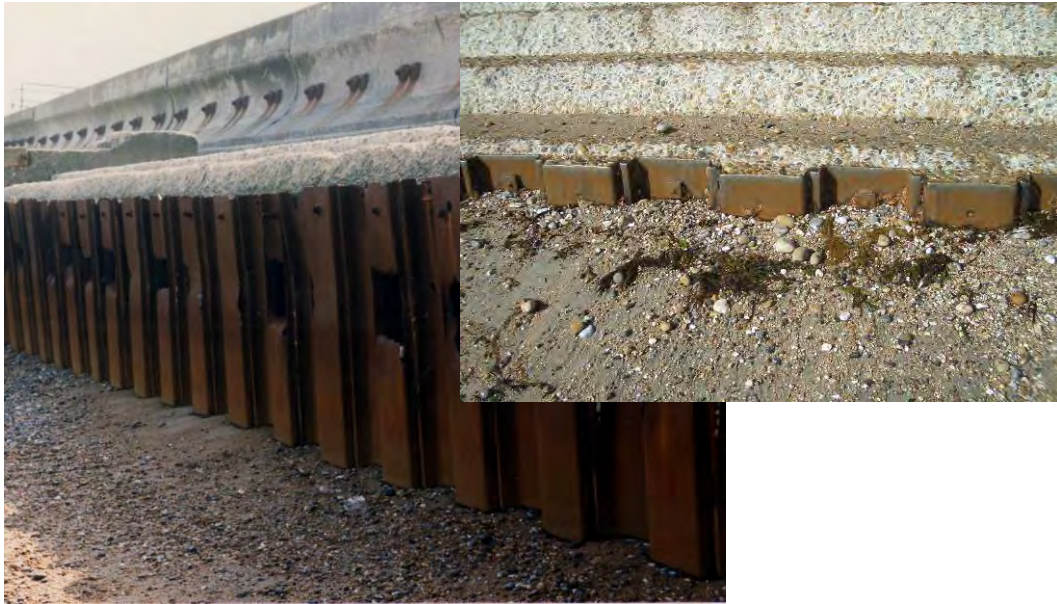
Figure 2.2 shows a further example of the use of sheet piling.

**Figure 2.2 Sheet pile underpinning**

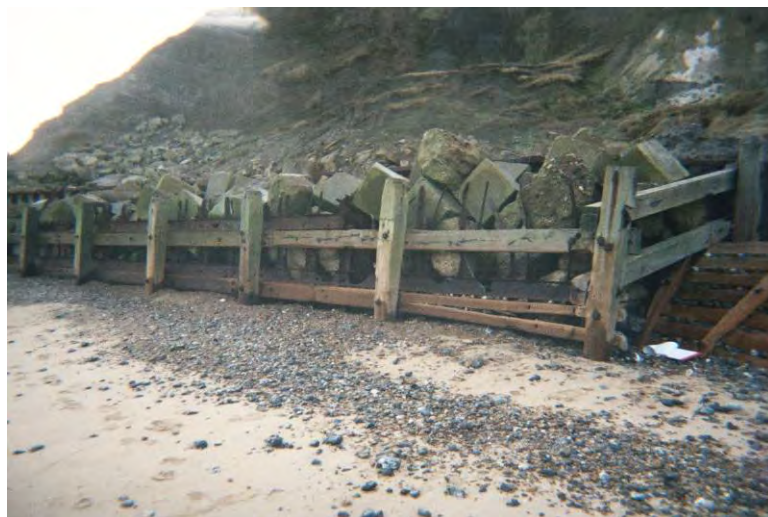
Cribwork is a low-cost form of coast protection comprising rock-filled cages formed by piling and fabricating timber lattices into a continuous structure (Figure 2.3). In essence, they are not dissimilar to gabions except that they are made out of timber or possibly reinforced concrete. Cribwork can protect the toe of defences by absorbing wave energy and preventing scour of beach material and undermining of the structure.

**Figure 2.3 Cribwork and concrete block fill, Norfolk (courtesy of North Norfolk District Council)**

Timber has been used in cribwork (see Figure 2.3). Timber planks were often used as pilings to seawalls before the introduction of steel piles.

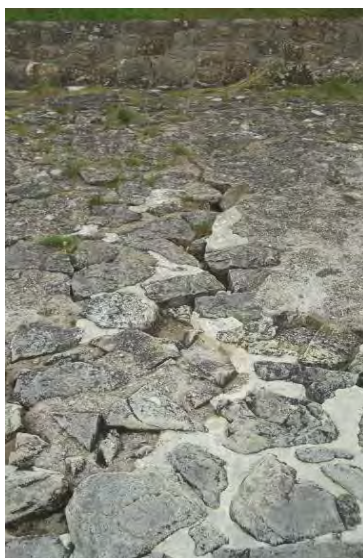
**Figure 2.4 Extensive crack in masonry toe (courtesy HR Wallingford)**

As soon as deterioration of the toe is identified, steps should be taken to repair the damage before it spreads. In this case, the use of replacement masonry is clearly an option as it offers durability and lack of visual intrusion. This is particularly important if the wall is a listed structure. However, before selecting the option, the cause of the problem (for example, whether it is the result of long-term beach lowering, a severe event or progressive attrition of the previous blockwork) should be determined to identify whether mere reinstatement of the blockwork is sufficient or whether additional measures (such as toe piling) are warranted. Care must be taken to ensure that any voids in the backfill are filled and that the replacement blocks are well founded.

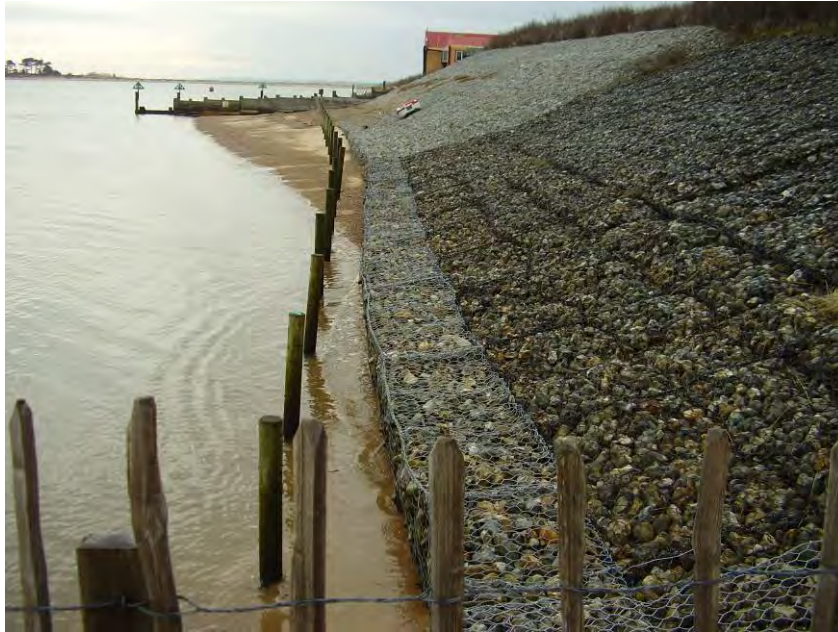
Gabions consist of steel mesh forming baskets that are filled with stones (Figure 2.5). They are available either as gabion boxes (and can be used as a flexible toe), or as mattresses (in which case they are used as a sloping apron where their flexibility allows them to accommodate beach lowering with time).

Figure 2.5 Gabion baskets of rock (courtesy HR Wallingford)

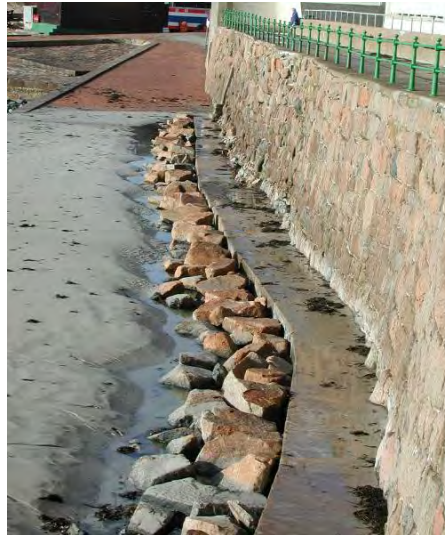
A modest amount of rock placed at the toe of a defence structure may serve to protect its toe from undermining, reduce the abrasion of its front face and even modify the hydraulic performance of the overall defence (Figures 2.6 and 2.7). The latter can result in changed overtopping or different loads on the defence. However, the introduction of the rock toe has at times **increased** overtopping, so it must be carefully considered in the design process. In addition, there are sometimes concerns about the impacts on aesthetics, access and public safety especially where such schemes are installed on beaches of high amenity and recreational usage.

**Figure 2.6 Rock infill of scour trough, Le Dicq, Jersey (courtesy HR Wallingford)**

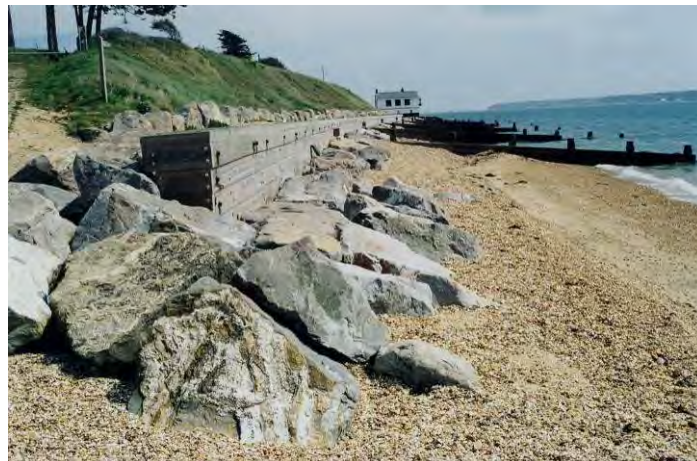
**Figure 2.7 Timber bulkhead with rock toe protection at Lepe, Hampshire**

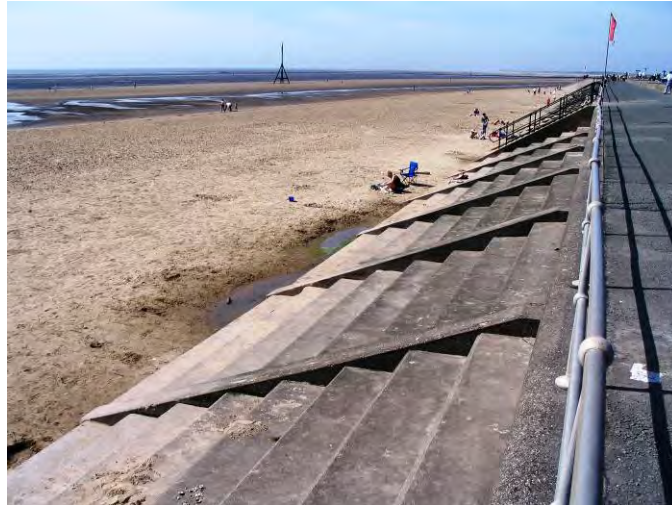
The construction of an apron or steps at the base of an existing structure (Figures 2.8 to 2.10) can prolong the life and add amenity value to the defence, albeit at the expense of losing an area of the beach. This can be achieved at much reduced cost compared with rebuilding the defence entirely. Such additions to a structure will extend it seaward. There is a perceived danger that such seaward extensions of a structure will interfere with longshore sediment transport and hence reduce sediment supply to downdrift beaches. However, this must be put in perspective given the very small extent of the structural intrusion compared with the width of the seaward extent of active sediment transport.

**Figure 2.9 Concrete stepped revetment, Crosby, UK (courtesy Sefton Council)**

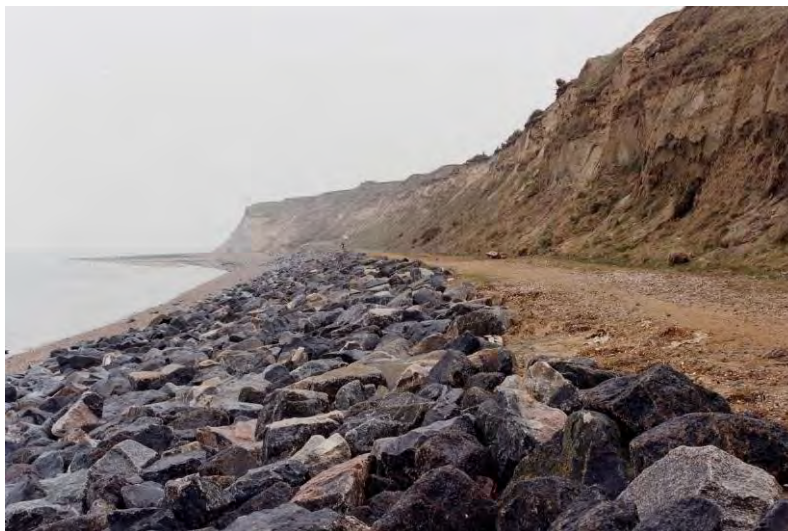
**Figure 2.10 Supplemental rock armour revetment (courtesy of HR Wallingford)**

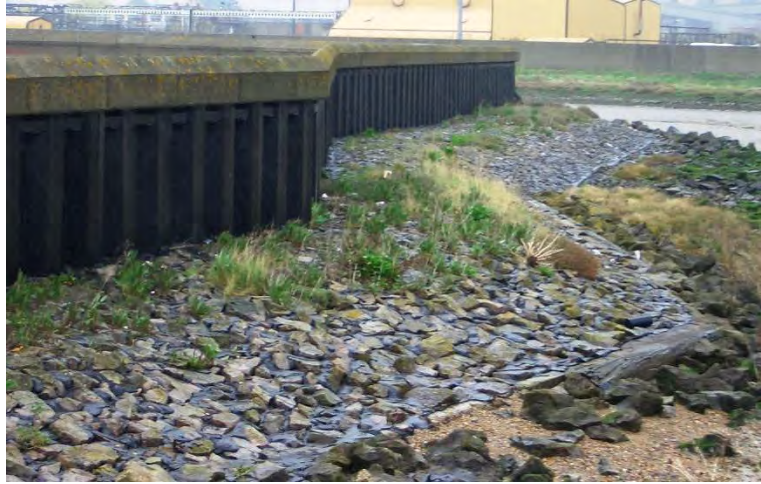
Partial grouting (Figure 2.13) is a reliable and well-established method to meet the requirements for a long-lasting scour protection including sufficient permeability to avoid excess water pressure below the armour layer. Partial grouting means filling the voids in the riprap or stone layer to 35–50 per cent with a special mortar, creating a bonded layer with high resistance and high permeability and sufficient flexibility. Cement-bonded grouting materials are recommended for partial grouting (Heibaum and Trentmann 2010), although the advantages and disadvantages of using asphalt as a binder is discussed in Section 2.3.4.

**Figure 2.13 Grouted stone toe apron, Thames Estuary (courtesy HR Wallingford)**

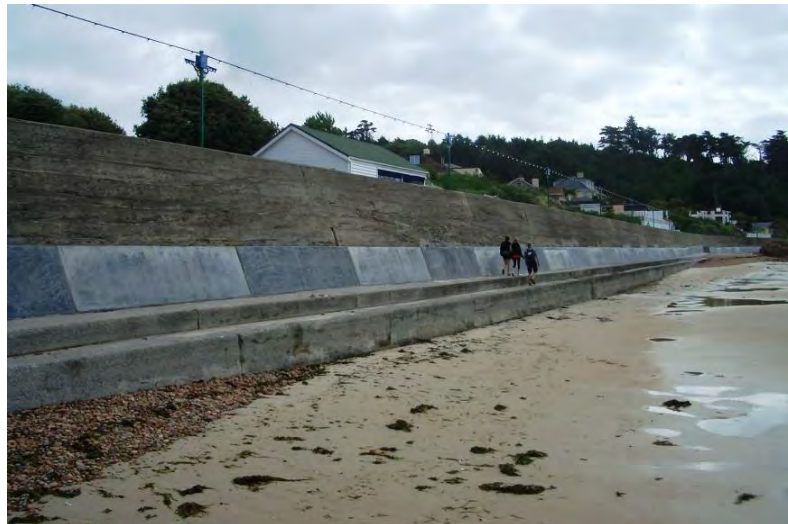
**Figure 2.14 Concrete toe beams (courtesy HR Wallingford)**

A significant feature of concrete for use in seawalls is that it can be formed to suitable shapes which may be both functional and decorative. The latter attribute is not usually so important in the case of the toe where it is less visible than the upper parts of the structure. Concrete will more commonly be used in toe protection works to provide weight and compressive strength. Figure 2.14 shows an example of the use of concrete toe beams and Appendix C contains a case study describing the use of concrete toe beams for foundation strengthening along the seawall between Dawlish and Teignmouth, South Devon, UK.

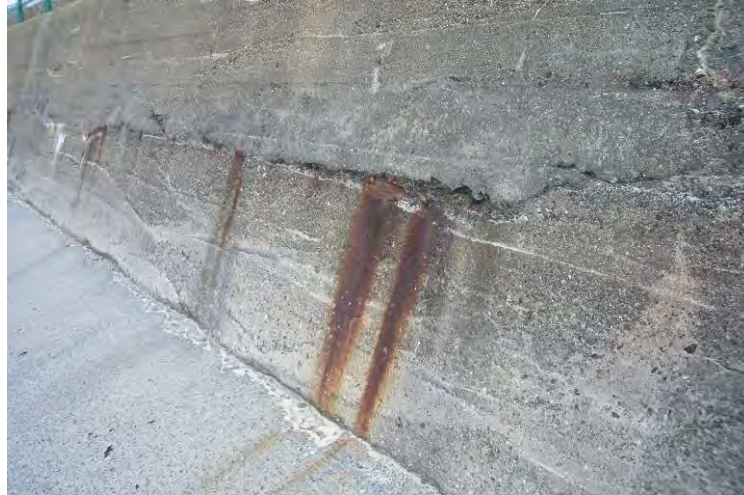
In the case of reinforced concrete, corrosion of steel reinforcement causes the bars to expand leading to fracture and bursting of the concrete (spalling) (Figure 2.15), possibly leading to failure. After spalling, the reinforcement is even more vulnerable to corrosion through direct exposure to air and water. This process is particularly significant in parts of the structure subject to wetting and drying, as illustrated in Zone 3 of Figure 2.11.

**Figure 2.15 Reinforcement rebar corrosion and spalling of concrete (courtesy of HR Wallingford)**

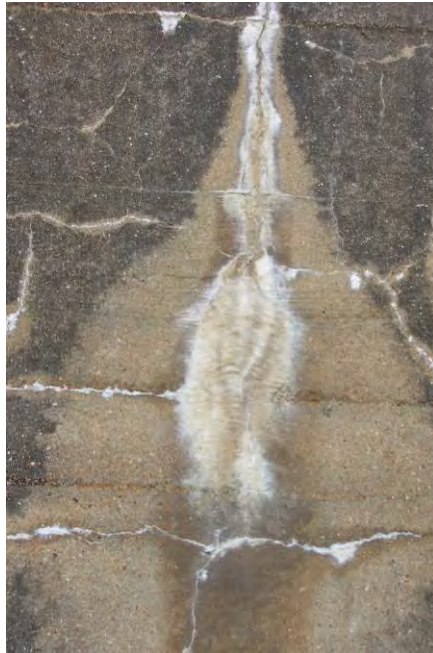
**Figure 2.16** Surface salt deposits and associated cracking from alkali–silica reaction in concrete (courtesy of HR Wallingford)

As time goes by and the concrete is subject to repeated cycles of wetting or submergence, chlorides from the seawater penetrate the concrete and reduce its alkalinity. The time for this penetration to seriously affect the steel depends on the thickness of cover and the permeability of the concrete (for example, penetration of 25–75 mm would typically take about ten years). The quality of the concrete is important as chlorides can penetrate very small cracks. Figure 2.16 shows an example of salt deposits with associated cracking, while Figure 2.17 shows the failure of a concrete toe beam on a Jersey beach.

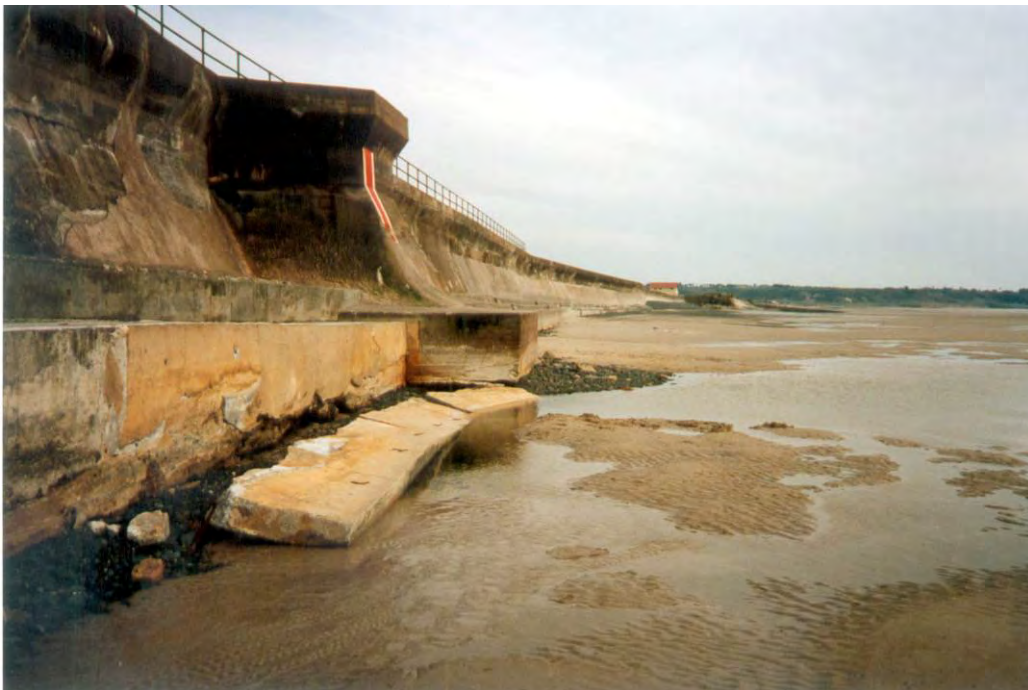
**Figure 2.17** Failure of a concrete toe beam at St Ouens Bay, Jersey (courtesy HR Wallingford)

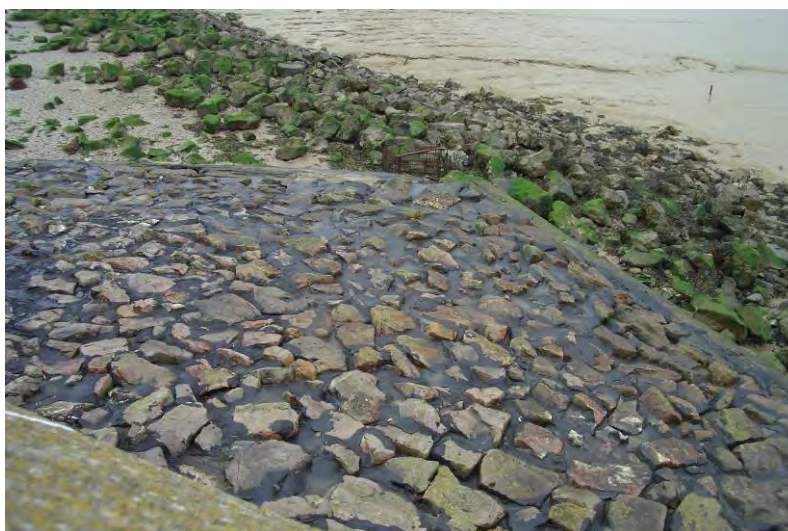
Figure 2.18 shows the use of asphalt to grout a stone revetment.

**Figure 2.18 Asphalt grouted stone revetment in the Thames Estuary (courtesy HR Wallingford)**

Concrete slopes and steps have been used frequently around the UK and new techniques have been developed, for example, using a sloping asphalt apron (see Figure 2.18) to both protect the original structure against undermining and abrasion, and to reduce wave overtopping.

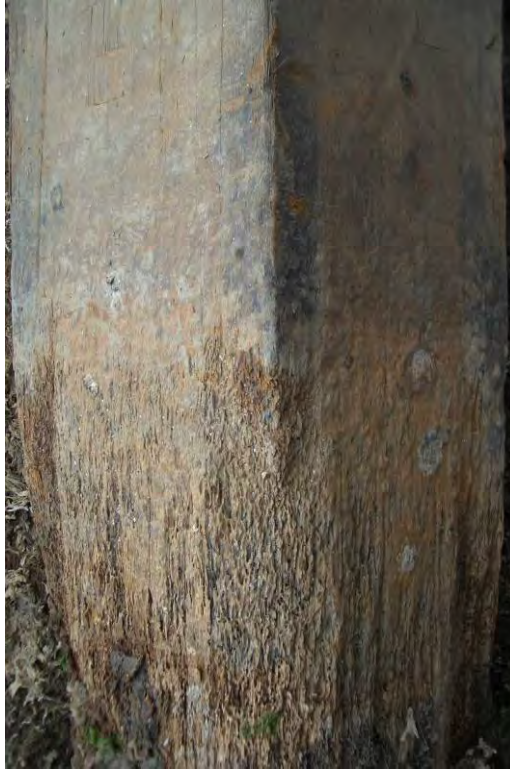
(Figures 2.19 and 2.20) and 'Teredo'. Gribble attacks the surface of exposed timber, mainly below mean tide, penetrating a few millimetres below the surface, whereas Teredo destroys the internal composition of the wood. Both gribble and Teredo are encouraged by clean warm water discharges and are less prevalent in more polluted environments. The more durable hardwoods used for marine construction tend to be resistant to biological attack and are thus able to provide a good service life in excess of 20 years or much longer in certain cases.

**Figure 2.19** Gribble attack on Timber pile at the sediment line (courtesy of HR Wallingford)

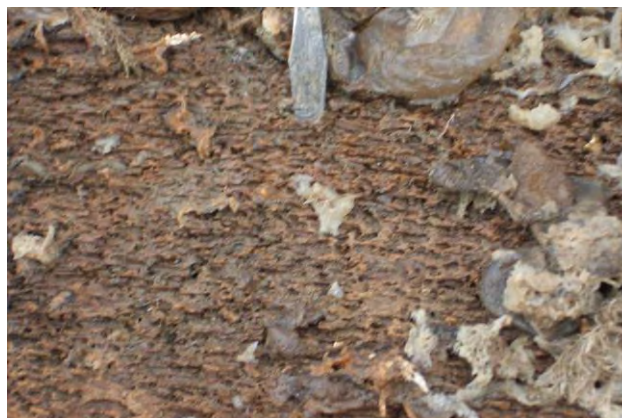
**Figure 2.20** Close up of gribble damage to timber (courtesy of HR Wallingford)

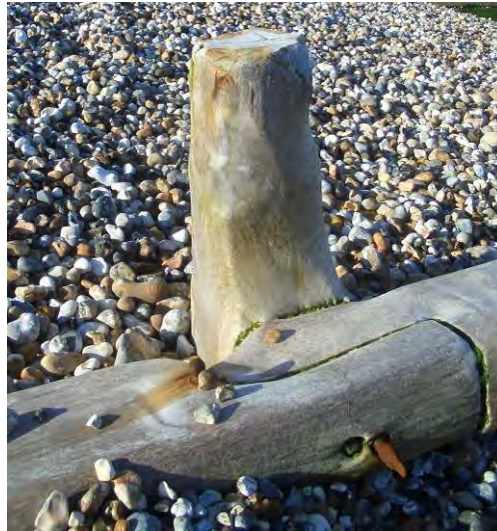
- **Abrasion.** Persistent abrasion by both sand and shingle has the effect of rounding off the corners and details of timber in the sea (Figure 2.21). As this effect tends to be concentrated close to the bed where sediments move more, the abrasion tends to be concentrated over a short length – a feature

**Figure 2.21 Rounding of groyne timbers by beach shingle (courtesy HR Wallingford)**

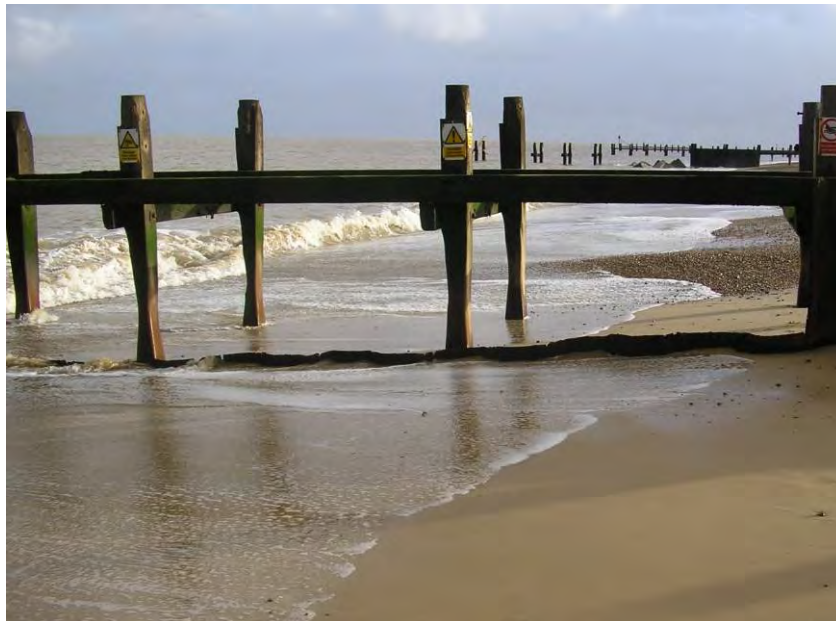
sometimes referred to as necking (Figure 2.22). Evidence of necking high above the bed can be indicative of a low beach (compared with normal or former times).

**Figure 2.22 Necking in derelict timber piles (courtesy ENBE)**

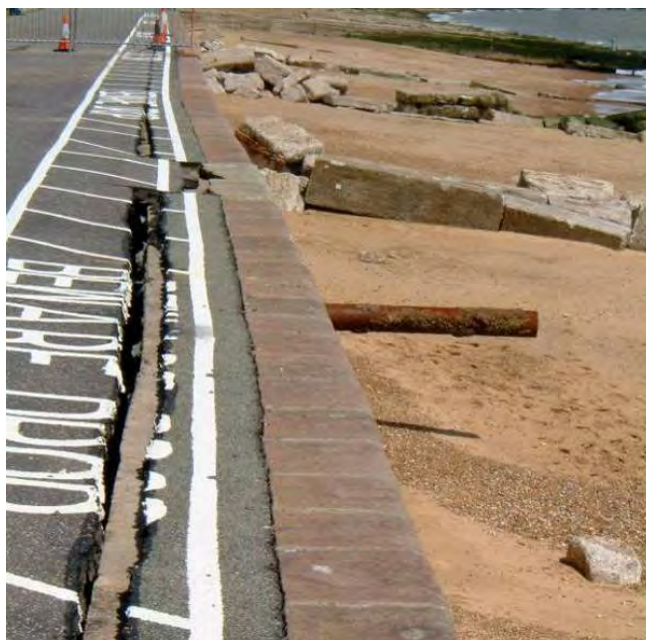
Figure 3.4 shows an example of a seawall in the process of overturning.

**Figure 3.4 A seawall in the process of overturning (courtesy of Black & Veatch)**

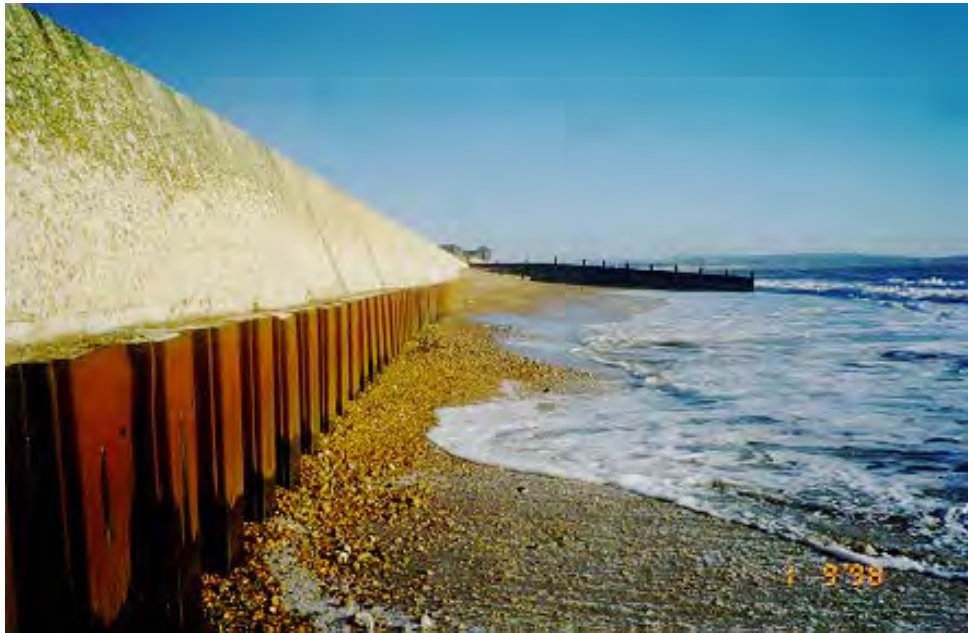
- Beach levels reached the crest of the wall at the time of construction and the wall was well protected, with shingle, limiting wave attack on the structure toe.
- Falling beach levels have exposed the structure toe piling (which extends 7 m below the pile tops) (Figure 3.5). Although the structure continues to resist overturning and sliding, increased water depths at the structure toe allow larger waves to attack the structure.

**Figure 3.5 Exposure of interlocking steel piled toe arising from beach lowering (courtesy A P Bradbury)**

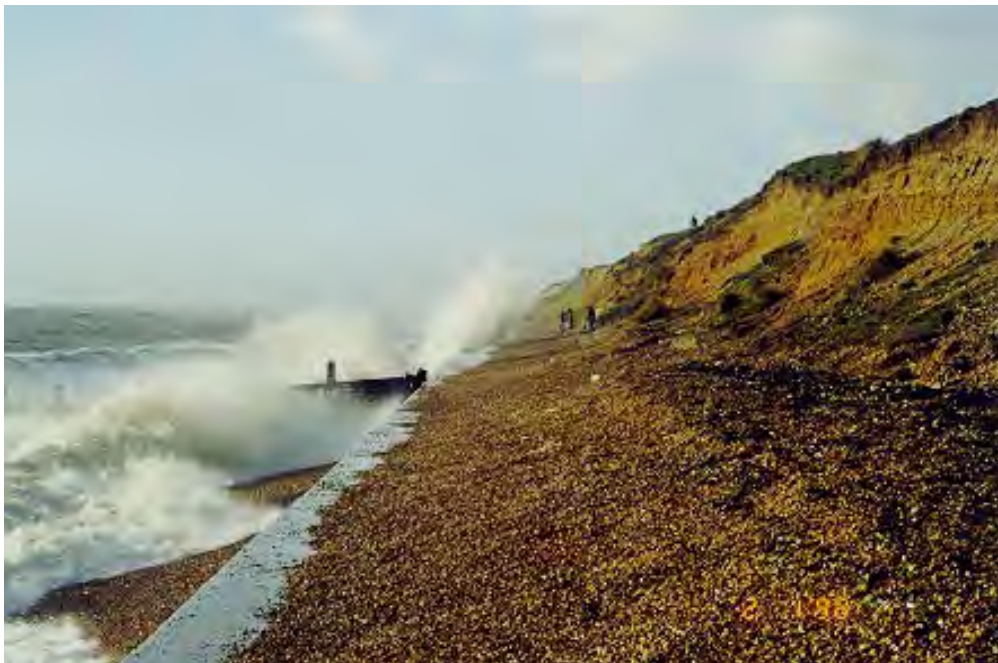
- Regular overtopping has occurred under even relatively benign conditions as a result of increasing water depths at the toe (Figure 3.6). Water percolation seawards of the seawall crest has caused a build-up of pressure to landwards of the seawall.

**Figure 3.6 Frequent overtopping causes build-up of pressure on landward side of seawall (courtesy A P Bradbury)**

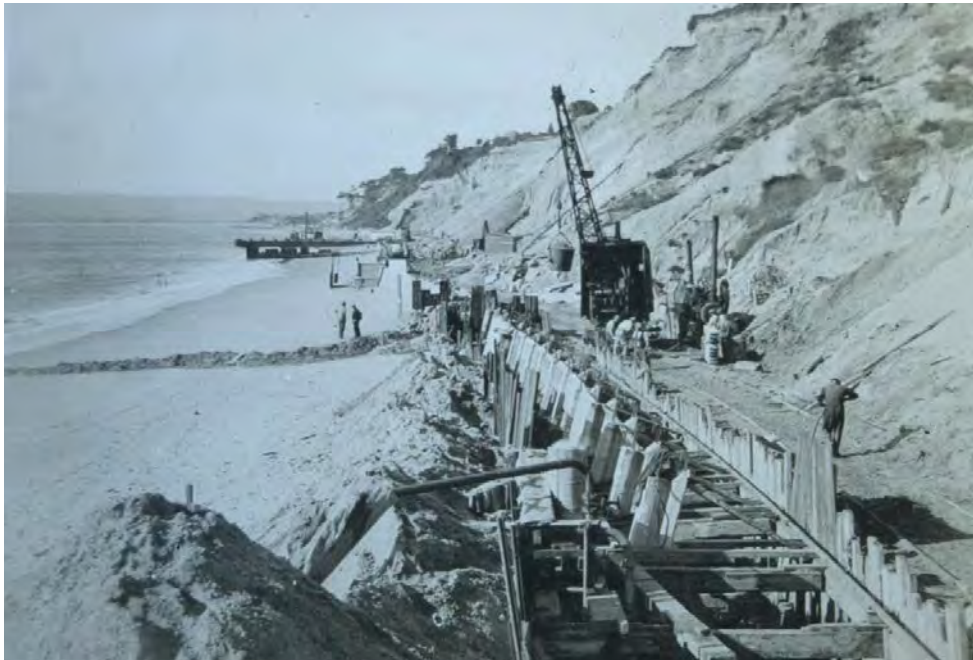
**Figure 3.8 Promenade wall under construction (courtesy Poole Borough Council)**

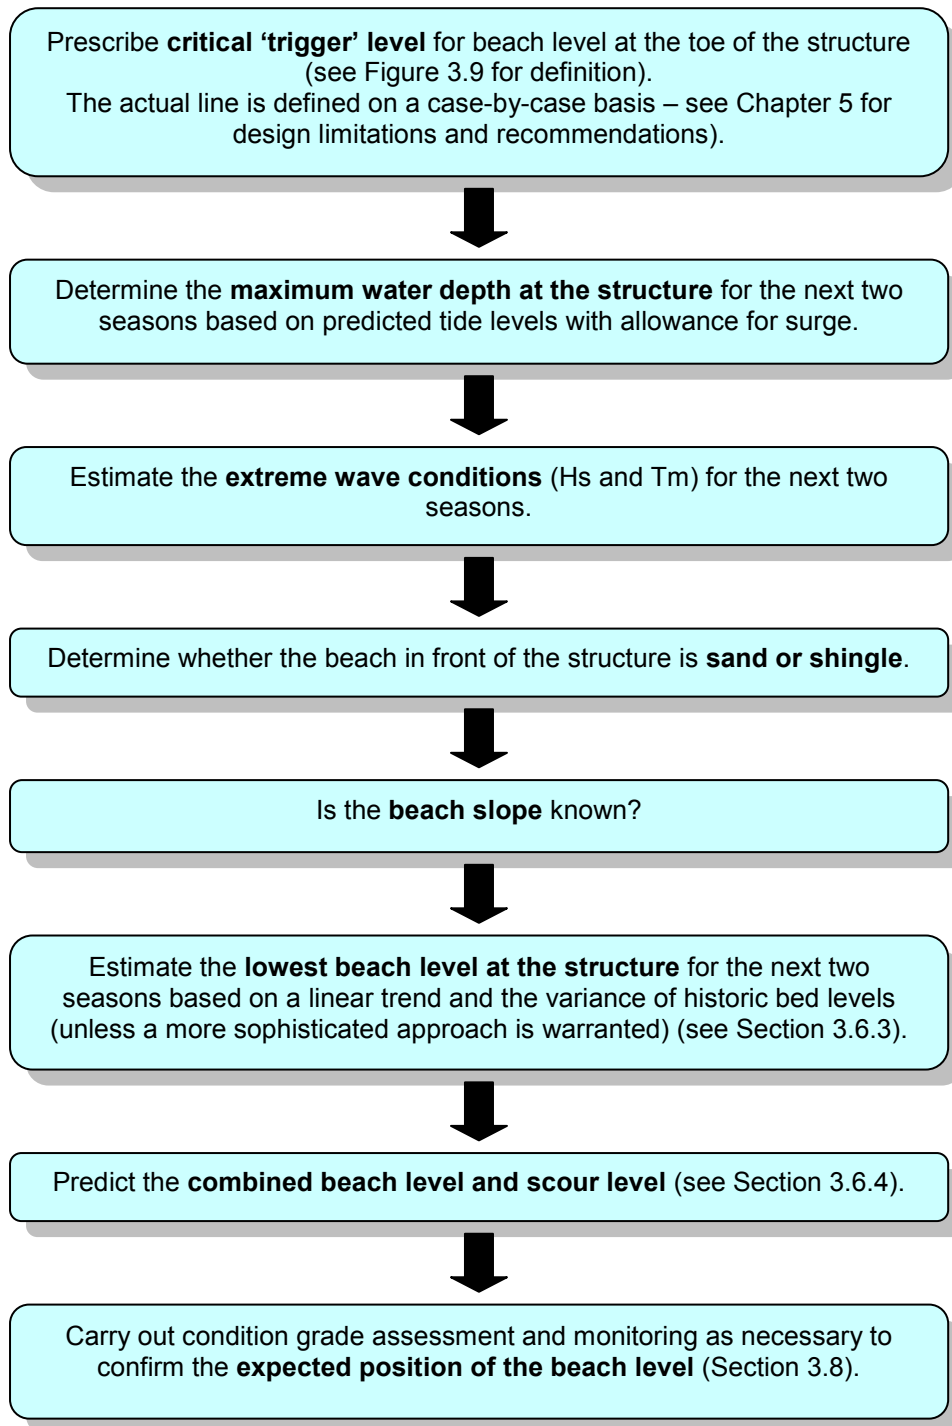
For each location being considered, the engineer needs to determine a trigger or 'alert' level for intervention (see Section 3.5). This will be based on key parameters related to structural performance, beach safety and so on. Once this level has been set, a simple assessment for any section of a structure can be determined (initially) on a seasonal (for example, summer and winter) six-monthly basis, possibly supplemented following storm events. The suggested approach is outlined using the eight steps shown in Figure 3.8.

**Figure 3.9 Information required to assess toe scour**

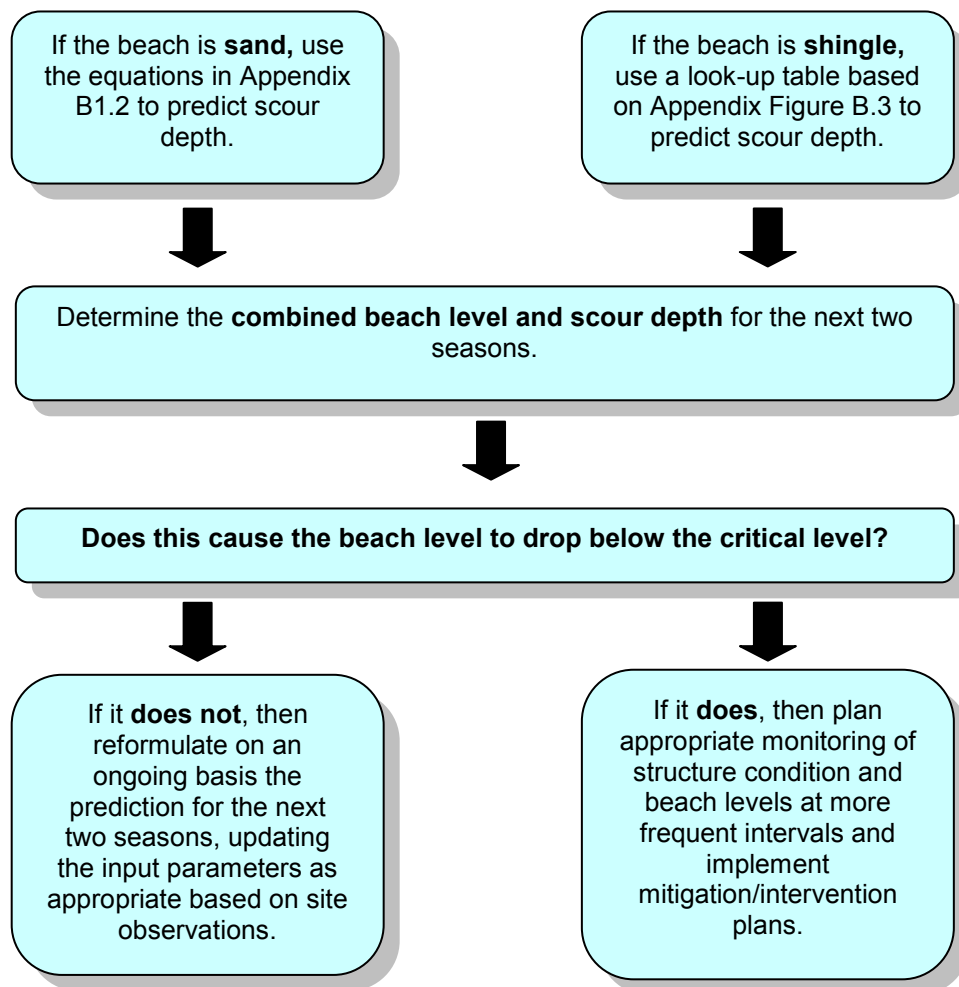
Once this information has been obtained, the decision process shown in Figure 3.10 is implemented.

**Figure 3.10 Assessment of toe scour decision process**

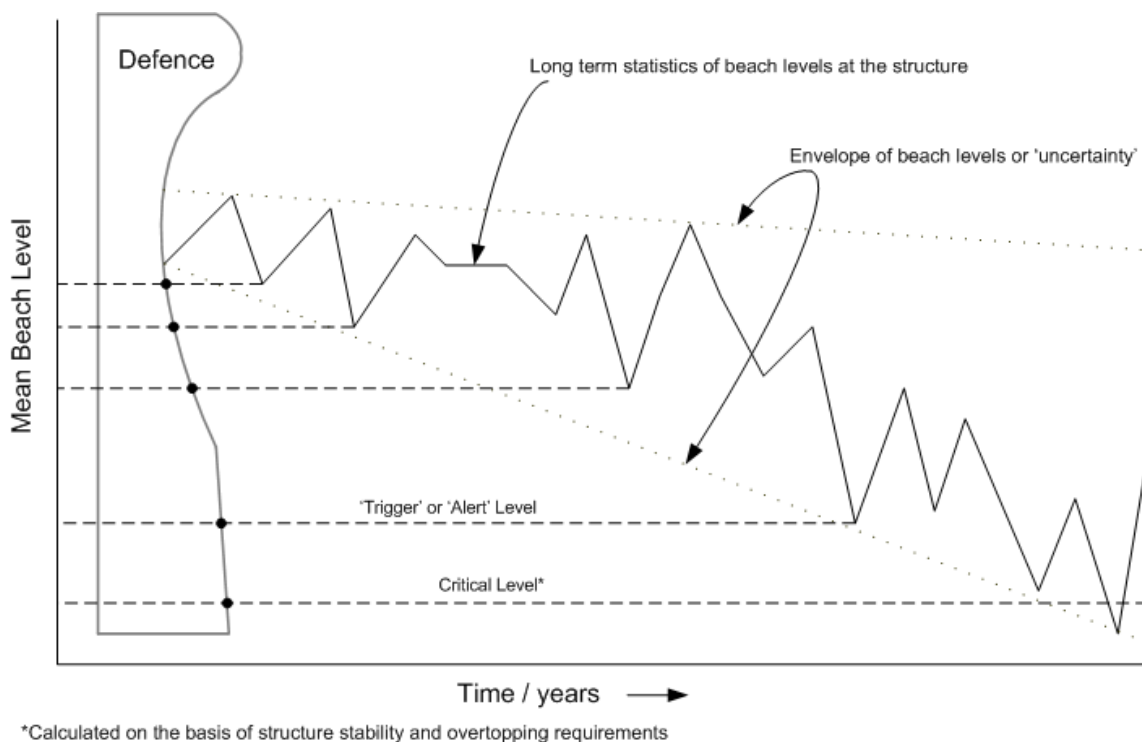
The examination of statistics on mean levels at the toe of a structure over a number of years, together with prediction methods and structure geometry information (level of the structure toe), provides sufficient information for the asset manager to determine the physical limits and timescale within which intervention options should be considered (that is, beach re-nourishment, remedial defence works, decommissioning and so on). This concept of the critical level is illustrated in Figure 3.11. The trigger for a more detailed asset inspection could therefore be the exceedance thresholds gained from results of the extrapolation of beach level data.

**Figure 3.11 Relationship between long-term statistics on beach levels at the structure, uncertainty, and 'trigger' and critical levels**

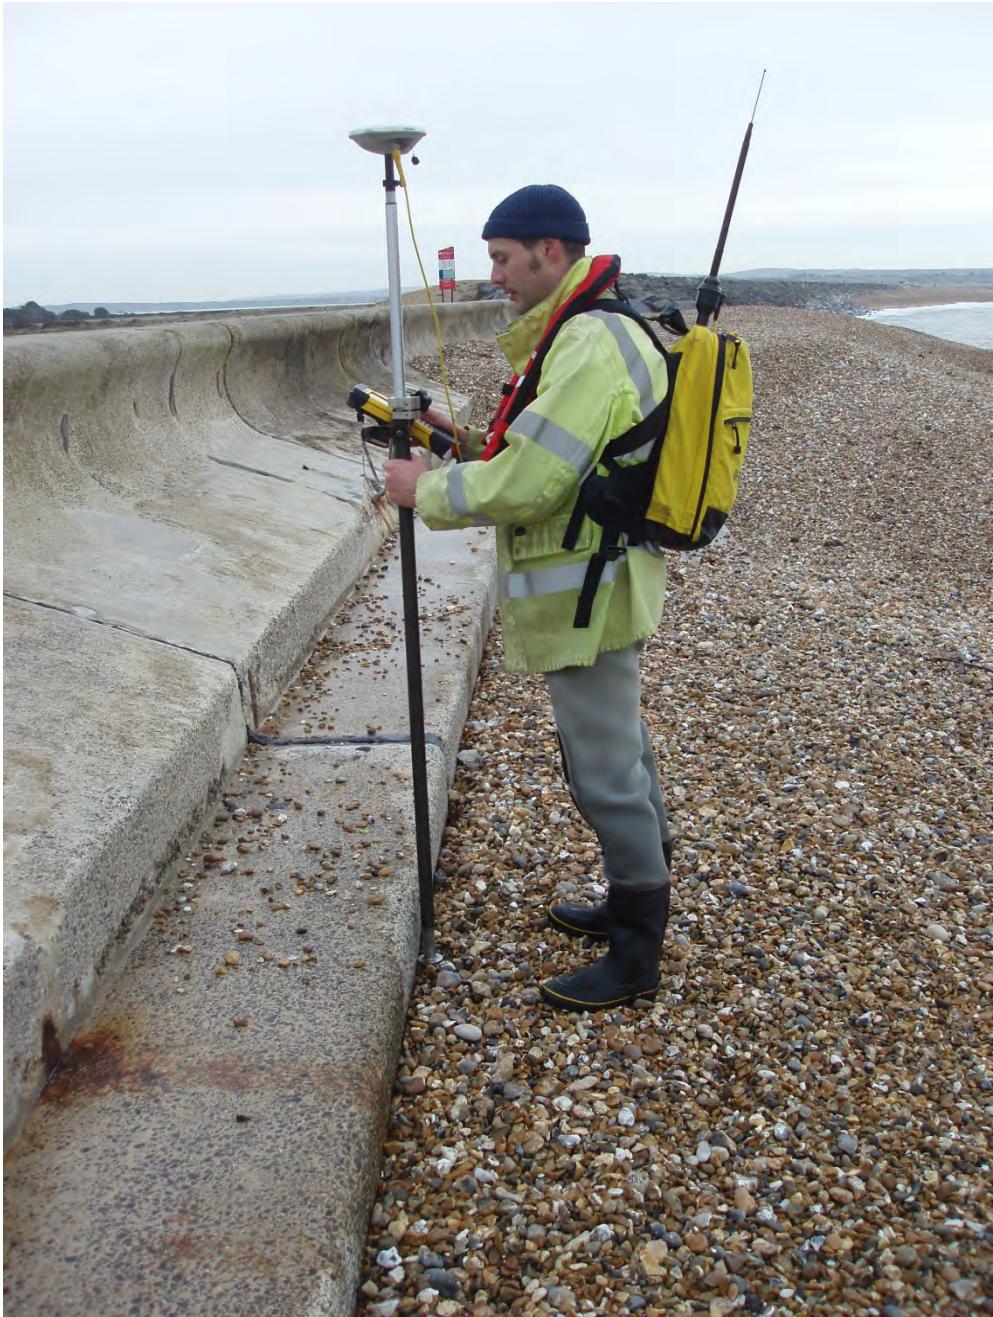
Baseline beach surveys should enable the beach plan-shape to be described adequately and be in context with existing control structures (for example, groynes). This will assist with the understanding of sediment transport patterns and the effect of sediment control structures on sediment transport rates (and therefore beach volume). Such surveys will also assist with the determination of the best places for subsequent monitoring locations, particularly if the orientation of the beach crest(s) varies significantly along the frontage. Contour and three-dimensional (3D) measurements can be achieved by a variety of methods and tools including terrain modelling using results from a real-time kinematic global positioning system (RTK GPS) (Figure 3.12), light detection and ranging (LiDAR), photogrammetry and bathymetric surveys.

**Figure 3.12 Beach survey using global positioning equipment (courtesy Channel Coastal Observatory)**

Shore parallel profiles are extremely valuable tools for monitoring beach structure interaction. Profiles are conducted by measuring elevations of the beach and structure intersection (see Figure 3.12). The example presented shows the spatial and temporal variability of the beach structure intersection level (Figure 3.21). Each elevation is measured at predefined locations along the seawall; in this instance these are defined using kinematic GPS and a data logger with a stakeout control file to ensure that each point is precisely relocated on each survey.

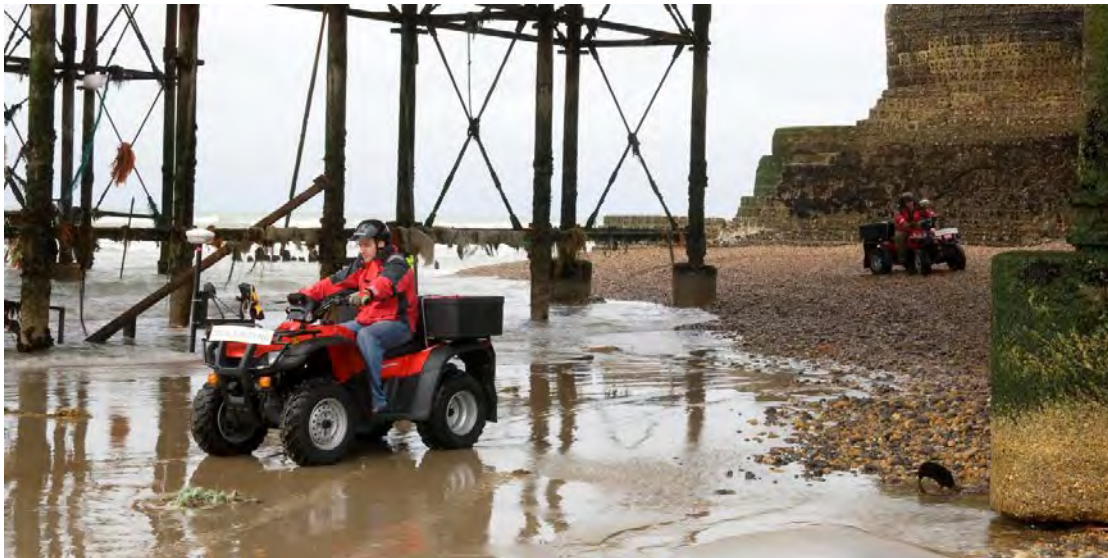
RTK GPS can now provide a vertical accuracy of  $\pm 30$  mm and plan accuracy to  $\pm 15$  mm. For rapid coverage, GPS can be mounted on suitable 'all terrain vehicles' (Figure 3.13). For further information the reader is referred to Section 5 of the *Beach Management Manual* (CIRIA 2010a).

**Figure 3.13 All terrain vehicle fitted with GPS equipment for coastal topographic surveying (courtesy of Worthing Borough Council)**

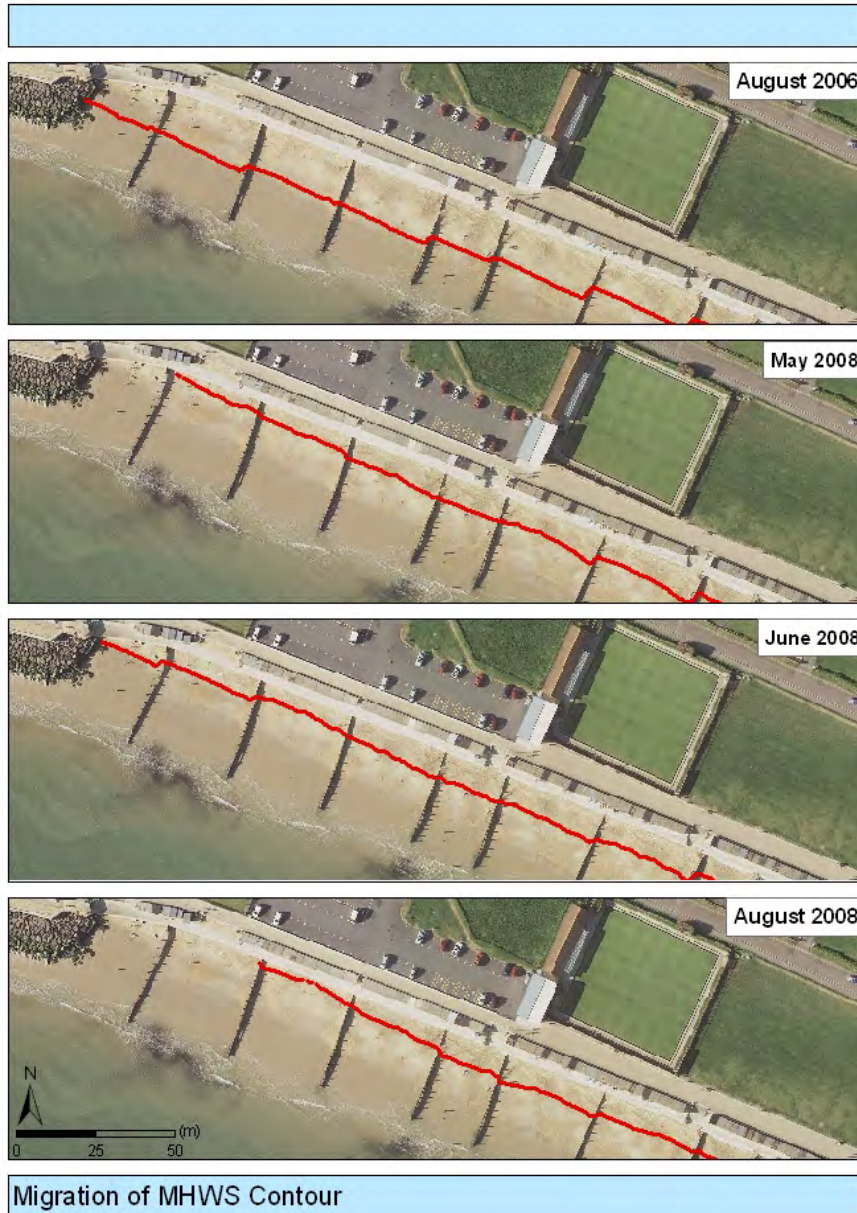
Migration of the mean high water spring (MHWS) beach contour can serve as a useful indicator that a structure toe is becoming under an increasing frequency of loading. Figure 3.15 illustrates the migration of the MHWS contour over a period of less than two years, yet shows a significant trend of migration towards the wall.

**Figure 3.15 Migration of MHWS contour towards seawall (courtesy Channel Coastal Observatory)**

The location of the MHWS contour suggests that 50 m of the structure frontage may be regularly under direct wave attack, in accordance with the tidal cycle. The survey frequency increased from April 2008, triggered by the rapid movement of the beach contours towards the wall (Figure 3.16). The pattern indicates that standing water will have occurred at the seawall at several stages during this period, over the upper part of the tidal cycle. Any wave activity during these periods will certainly have impacted on the wall. Parts of the wall will be offered some protection by the beach over most of the length monitored, but it is clear that the frequency of attack at the western end has

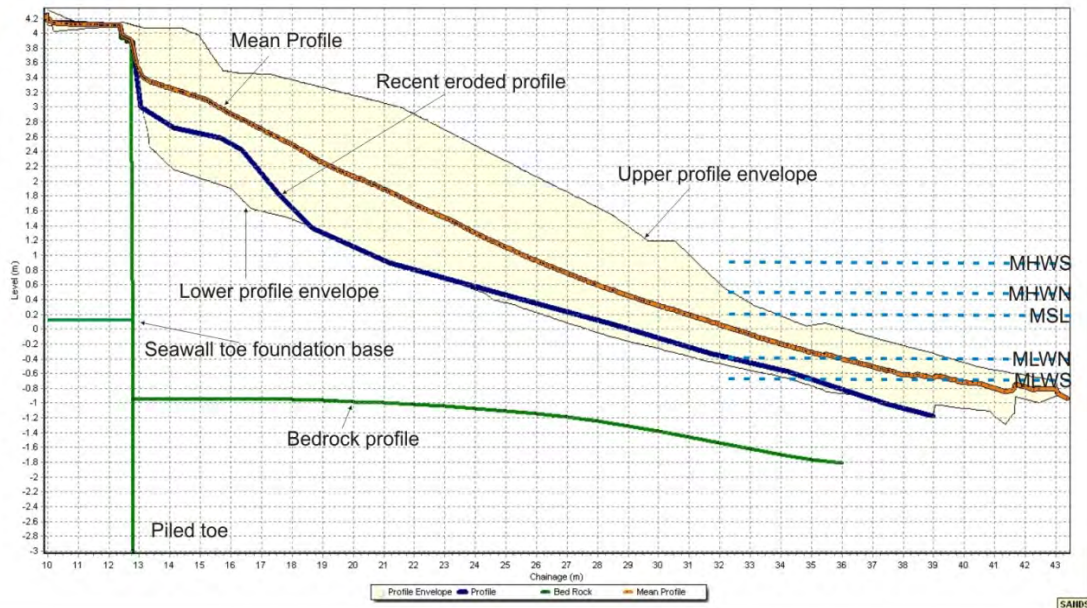
Regular beach profile surveys can be used to develop an indication of changes to protection of a structure toe. All of the key descriptors identified in Section 3.5.2 are shown on the simple plot presented in Figure 3.17. The long-term profile envelope indicates the lowest and highest points that the beach has reached over the course of the monitoring.

**Figure 3.17 Beach profile and structure descriptors used in structure toe analysis (courtesy AP Bradbury)**

The example shown represents changes over a 20-year monitoring period. These data can be used in combination with a trend analysis of beach cross-sectional area above a defined surface (master profile) (Figure 3.18). Where available, the master profile should be defined by the bedrock profile, thereby enabling absolute changes in beach volume to be determined; this profile cannot be defined at many sites and only relative changes can be measured. An at-a-glance assessment of the relative state of the beach to historical conditions is provided by comparing the most recent survey with the profile envelope and the mean profile.

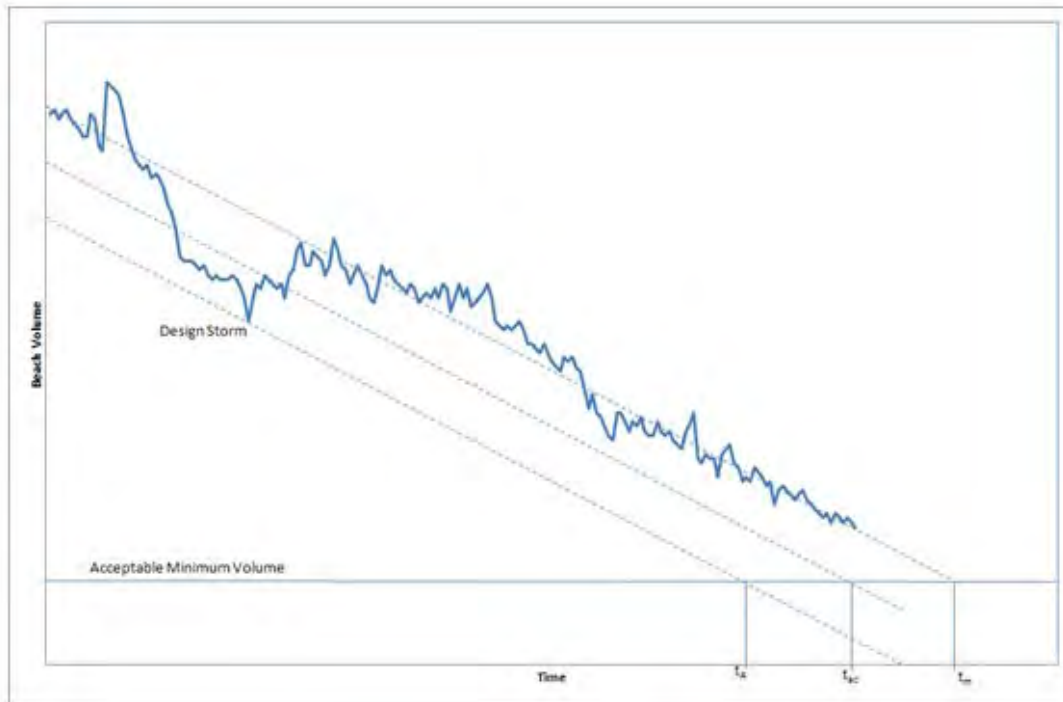
Figure 3.18 demonstrates a lengthy time series during which the general trend is of erosion, but with periods of recovery. A series of storm events of varying intensity punctuate the long-term profile trend and these are associated with defined combinations of wave and tidal conditions. Wave data can ideally be derived from a nearby wave buoy in shallow water (see Figure 3.20). Alternatively, hindcast modelled offshore data can be transformed to the nearshore zone. Several of these storm conditions are highlighted in Figure 3.20. Interestingly, the most severe hydrodynamic conditions are not always associated with the greatest damage or beach loss. A number of the notable dips in beach cross-section are associated with swell wave or bimodal wave conditions that would not generally be considered to be damaging events.

**Figure 3.18 Beach profile cross-sectional trend analysis**

A trend line is fitted through the data set, indicating the mean profile. The profile envelope is represented by lines parallel with the mean profile. The maximum departure from the line is associated with the design storm, which denotes the maximum departure from the envelope line. Application of a storm response line provides an indication of the anticipated maximum reduction in cross-section on a defined storm event. This is based on conventional topographic surveys and does not consider additional lowering that may take place during the storm but which is not detectable by conventional survey techniques. Additional allowance must be made for such changes (see Section 3.6.4). Using the critical cross-sections determined for each site (Section 3.5), a critical acceptable volume trigger can be added to the graph. Linear projection of the trend, envelope and storm damage lines can be used to estimate the potential timing for intervention.
