## Toe structures management manual

Project: SC070056/R

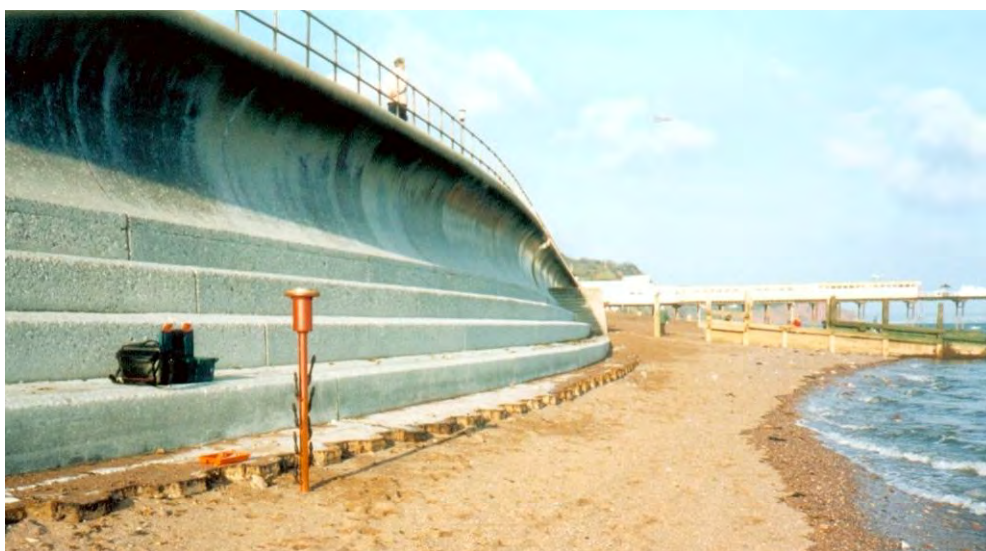
The deployment of scour monitoring systems that remain on-site, just in front of a toe structure operating at all water levels, for periods of weeks at a time may currently be the only realistic way of assessing the site specific variability of a beach surface with time. Figure 3.23 shows scour monitors deployed on a beach. Scour measurements can be conducted using, among other things, the following devices (Sutherland et al. 2007) installed at locations where the beach at the toe of the structure is exposed at low tide:

- HR Wallingford's 'Tell Tail' scour monitoring system (Figure 3.23) is based on a linear array of omni-directional motion sensors buried in the seabed adjacent to the structure. Identifying the elevation of the lowest active sensor places an upper limit on beach level. The system records the onset of scour, the depth of scour reached and the in-filling of scour holes following storm events. Tell-Tail scour monitors have been deployed in front of seawalls at Teignmouth (Whitehouse et al. 2000), at Southbourne (Pearce et al. 2006; HR Wallingford 2006a) and at Blackpool (Sutherland et al, 2006a).
- Linear array of electrical conductivity meters (Ridd 1992; Cassen et al. 2005), which rely on the fact that seawater has a high electrical conductivity, while dry sediment has a low conductivity and saturated

**Figure 3.23 Scour monitors in operation on a shingle beach to obtain data on within tide changes in bed levels (courtesy HR Wallingford)**

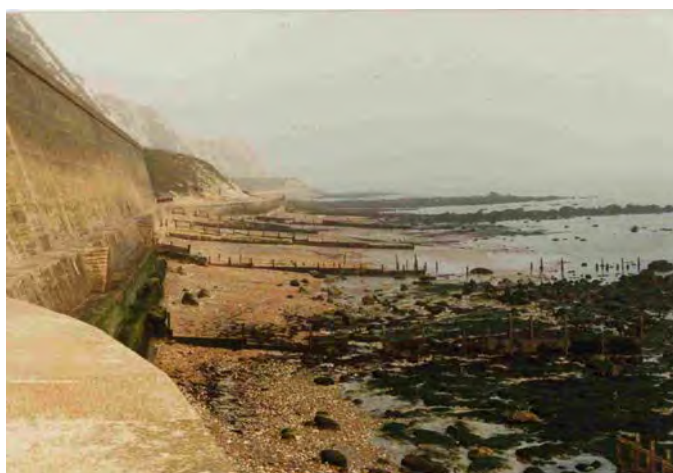
The performance of a beach depends largely on the volume of material present and the limits to its plan and profile changes. Where there is a net loss of sediment, beach recovery is an issue. Where there is clay beneath sand or shingle, then it is unlikely that a beach will recover naturally once the clay layer is exposed. Figure 3.26 shows an extreme example of beach depletion and foreshore down-cutting.

**Figure 3.26 An extreme example of beach depletion, foreshore erosion and down-cutting – note the level of the base of the access steps in relation to the level of the beach (courtesy HR Wallingford)**

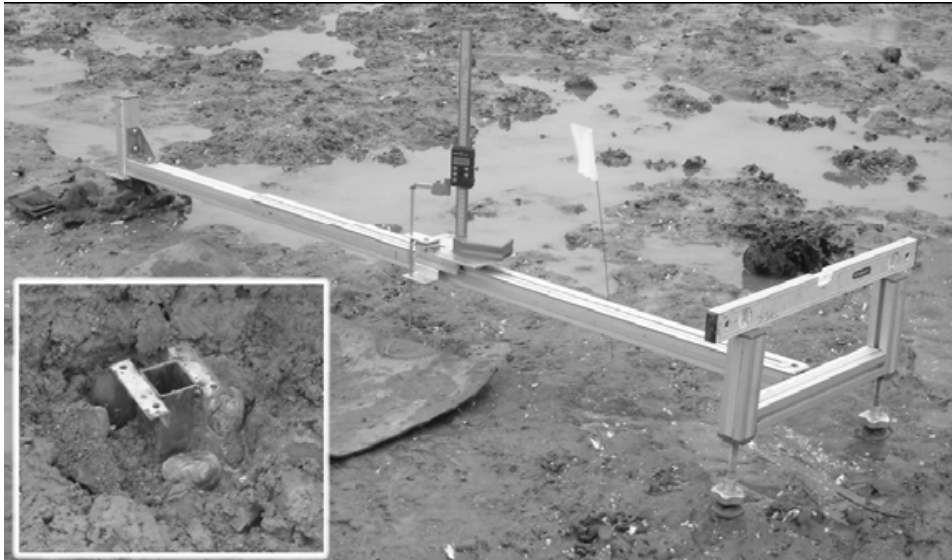
Various instruments and methods have been used in studies to assess down-cutting or down-wearing of shore platforms (see Sutherland et al. 2007). One such monitoring instrument is the traversing erosion beam (TEB) as shown in Figure 3.27.

**Figure 3.27 A traversing erosion beam instrument**

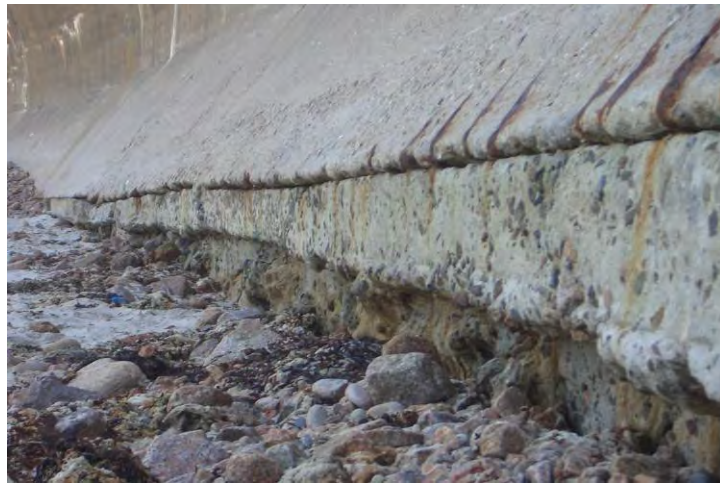
Once beach levels fall below the top level of a toe structure, it is exposed to the elements of wave attack and abrasion by mobile sediments. In the case of concrete and steel piles, this also means that chemical and biological processes may also ensue.

**Figure 3.28 Abraded concrete toe and onset of undermining (courtesy of HR Wallingford)**

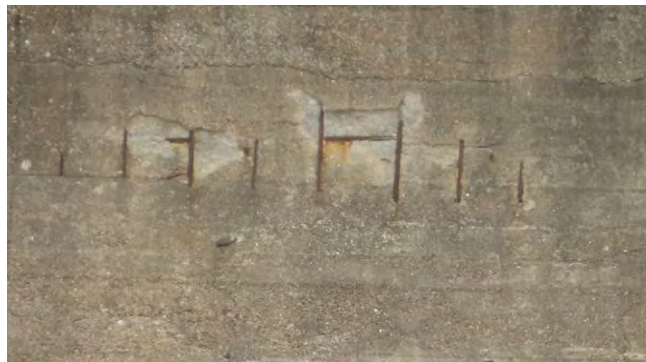
**Figure 3.29 Exposed reinforcing mesh due to steel oxidation and resultant cracking and flaking of concrete cover layer (courtesy HR Wallingford)**

Accelerated low water corrosion (ALWC) is a biological process of degradation that can lead to loss of section (width) of unprotected steel in the tidal zone. Chemical reactions in concrete caused by saline intrusion can contribute to crack expansion, spalling (surface flaking) and oxidation of internal steel rebars and reinforcing mesh. Abrasion of concrete by mobile sediments (Figures 3.28 and 3.29) can erode the structure and, if left un-remediated, can cause a serious loss of its mass leading to a reduction in function and performance and eventual failure (also see Section 4 on maintenance of concrete structures).

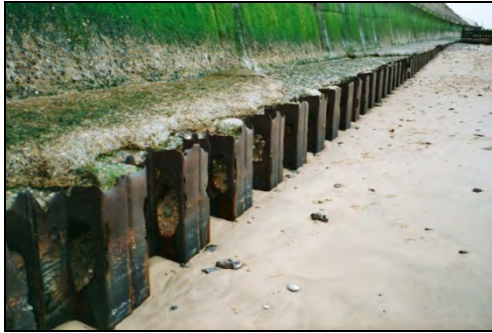
The current defence consists of a 2.74 m high reinforced concrete wall with a 1.43 m wide reinforced concrete apron and 4.3 m long piles as scour protection. The average crest height of the wall is 4.50 mAOD. Behind the 5.00 m wide promenade at the rear of the wall, the contorted glacial drift cliffs rise to a height of 23.6 mAOD. The defences were rebuilt in 1955. Observations are based on routine inspections.

The concrete wall has a condition grade of 2, tending to 3, and the steel piles have a condition grade of 3. The beach is in very poor condition lowering at a mean rate of 70 mm per year. The beach has been assigned a condition grade of 5. The sea breaks against the exposed steel piles at all high tides.

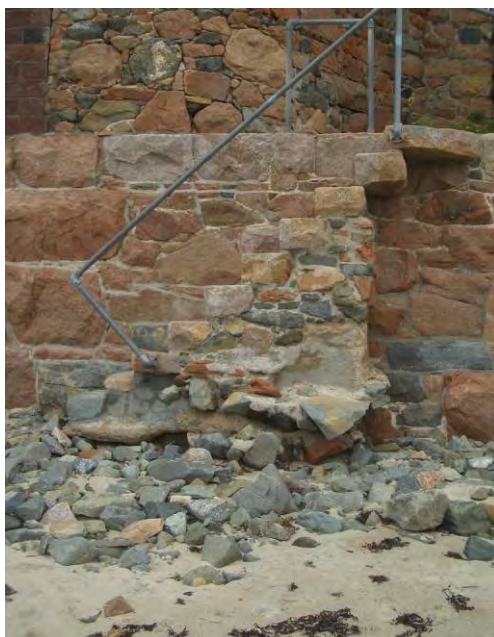
**Figure 3.30 Beach lowering at access steps (courtesy HR Wallingford)**

Problems with lowering beach levels may first become apparent from complaints about access – either pedestrian or vehicular or both (Figure 3.30). Beach levels falling dangerously below the lower extent of access steps or below the seaward end of slipways (performance features) can be a handy early warning to monitor the beach closely for what could be a relatively localised short-term issue or could be signs of a longer term and wider problem.

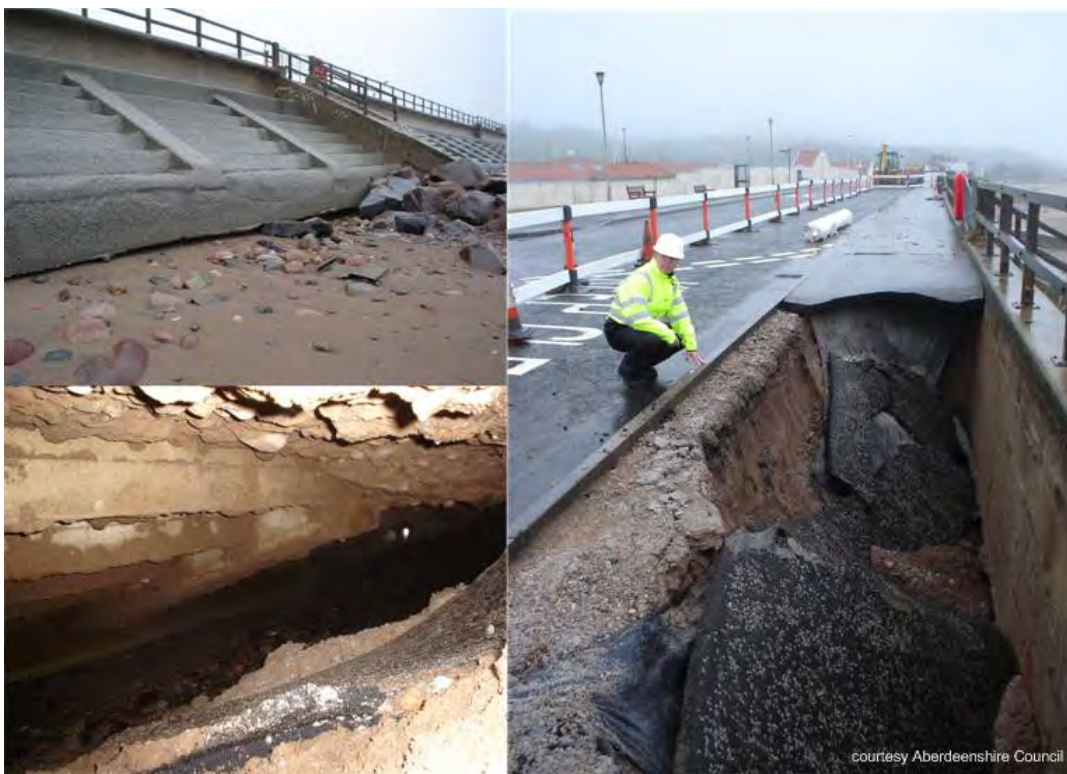
**Figure 3.32 Undermining and fill washout of stepped revetment and wave return wall**

Figure 3.31 illustrates this case where, over time, a stepped concrete revetment has been effectively undermined – the fill material removed by water entering beneath the toe of the structure leading to eventual collapse of the pavement behind (Figure 3.32). However there are no visible signs of deteriorating condition of the revetment or the seawall that may have contributed to this. This appears to be an extreme case but such failures are alarmingly common. It illustrates the importance of maintaining design beach levels. If this is not possible, there should be prudent consideration of structural remediation or adaptation of the defences.

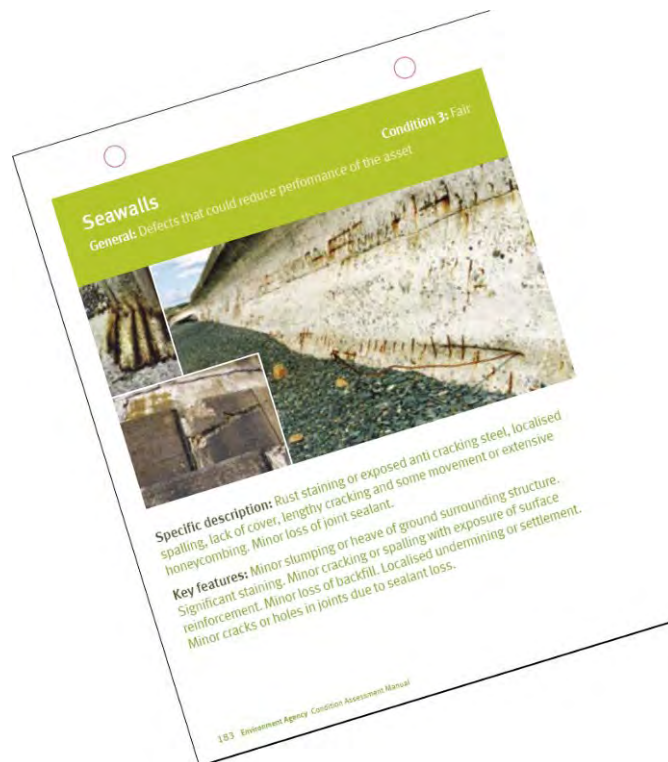
**Figure 3.33 An example of a page from the ‘Seawalls’ section of the Environment Agency’s *Condition Assessment Manual* (2006)**

For the purpose of visual inspection, however, toe structures can be inspected according to the relevant materials and structure inspection guidance (Figure 3.33) in the Environment Agency's *Condition Assessment Manual* (2006). The importance of maintaining good design and construction records, as a source for comparison, is emphasised.

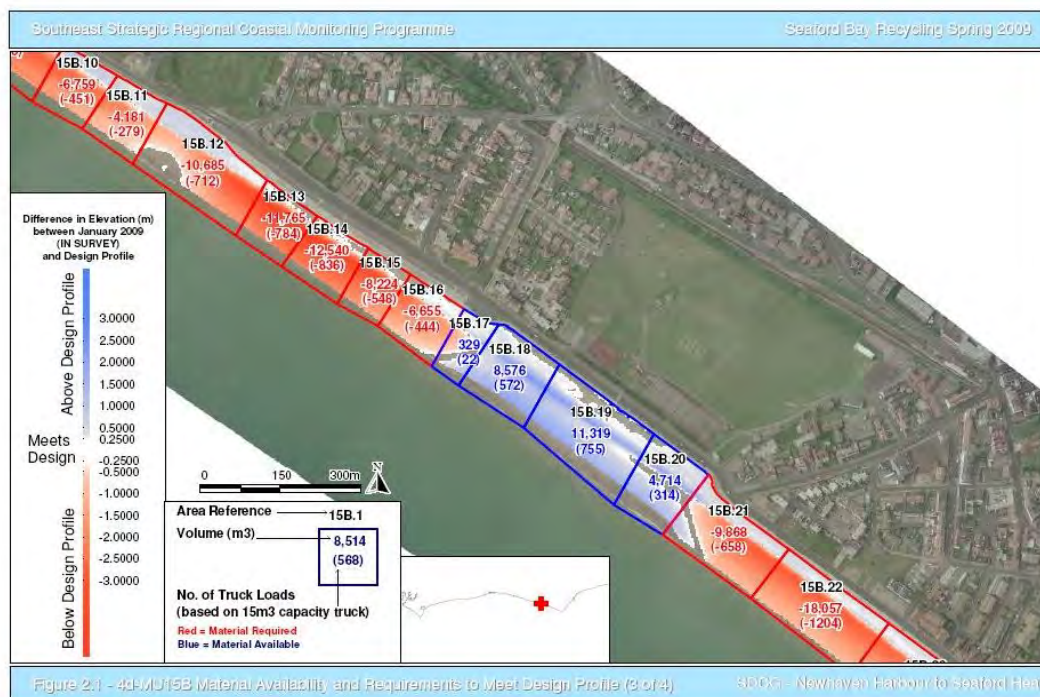
Figure 4.1 Application of monitoring data to identify beach zones beneath trigger levels (courtesy Worthing Borough Council)

The approach using regular detailed baseline topographic surveys allows generation of digital terrain models and calculation of beach volumes relative to trigger levels. The approach adopted in Figure 4.1 highlights the volume necessary to maintain the required design management levels at a site fronting a seawall. The approach locates and quantifies volumetric shortfalls within groyne compartments, identified by survey. Possible recycling sources are also shown within zones containing a surplus above the required management profile. The number of truck loads required in each groyne bay is highlighted, providing the basis for logistic planning of maintenance operations. The maintenance undertaken at this site is at a very large scale relative to most UK sites. Alternatively, material may be imported from offsite sources in order to achieve the required beach levels.

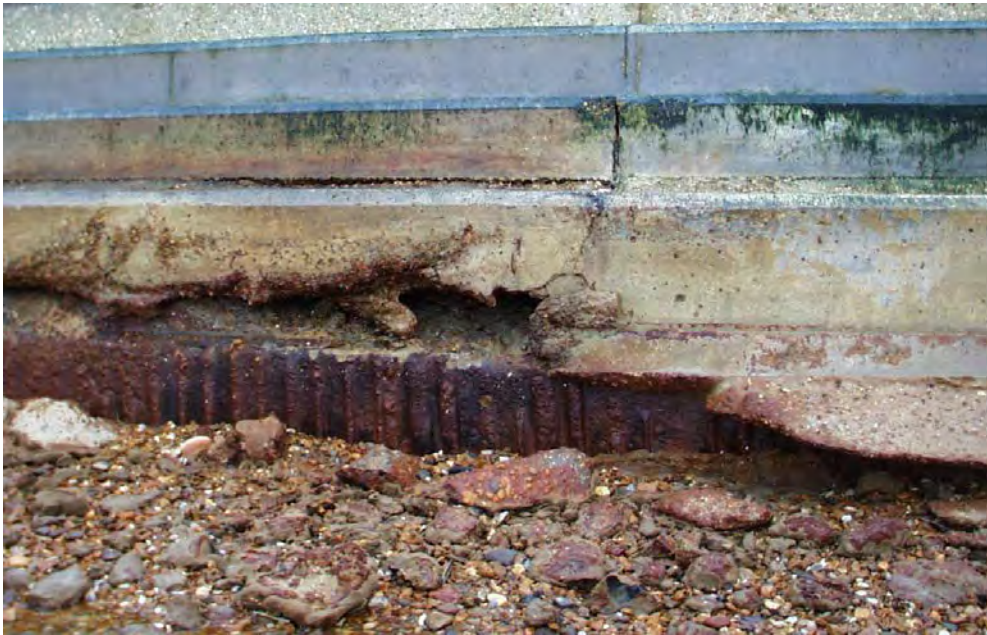
**Figure 4.2 Beach that has reached trigger level prior to repair and recharge (courtesy Poole Borough Council)**

On some occasions trigger levels are set on the basis of visual identification of key features on the structure toe. The example shown in Figure 4.2 has an intervention trigger when the interface between the bottom step and foundation shutter is exposed. This structure has not been designed to allow direct wave attack at this elevation on the toe.

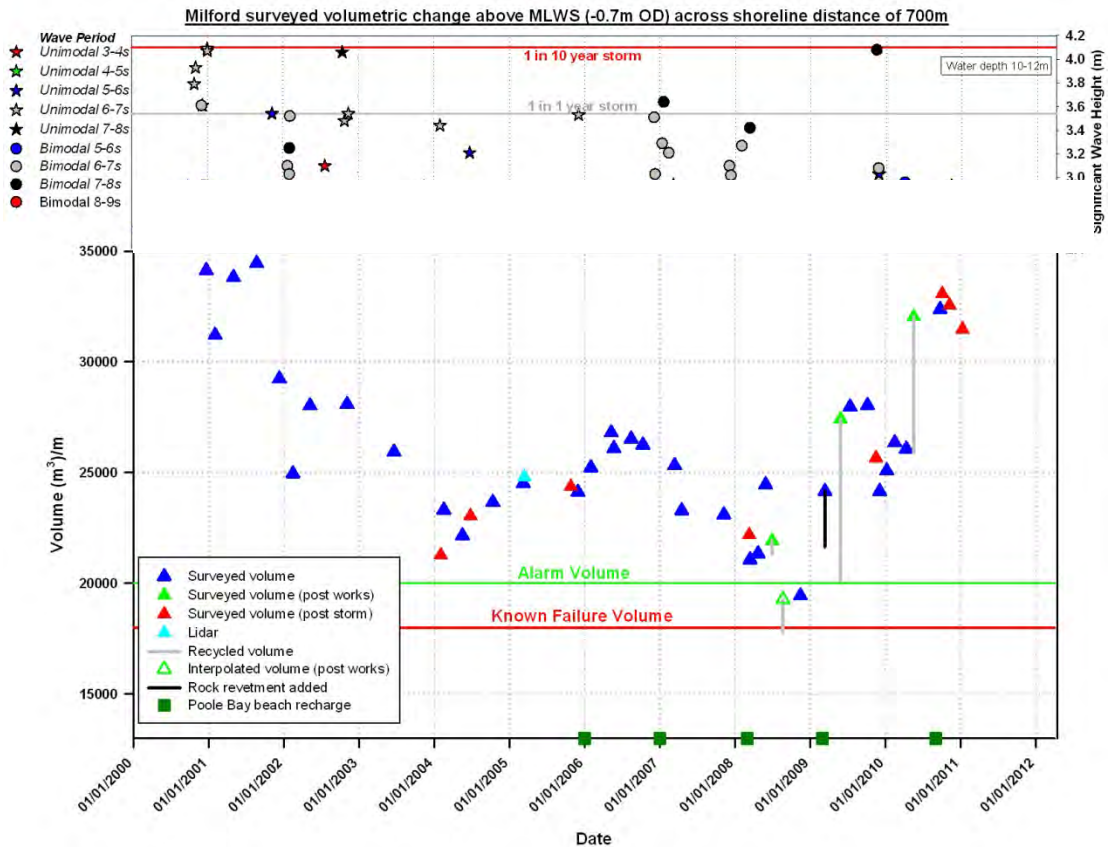
**Figure 4.3 Application of monitoring data to identify long term beach performance in context with structure toe triggers (courtesy Channel Coastal Observatory)**

Figure 4.3 provides a valuable summary assessment of toe scour management using beach recycling and small scale recharge. Trigger levels are shown. The experience of previous toe failure at this site has been built into the maintenance plot. The experiences and linkages between beach losses and storm events can be identified. A series of small recharge operations have been conducted to maintain the beach above trigger levels and there is a clear annual trend of loss which can be used to plan for the requirements of further intervention. The vertical grey lines indicate interim recharges, which are small in size (approximately 1,000–7,000 m<sup>3</sup> each).

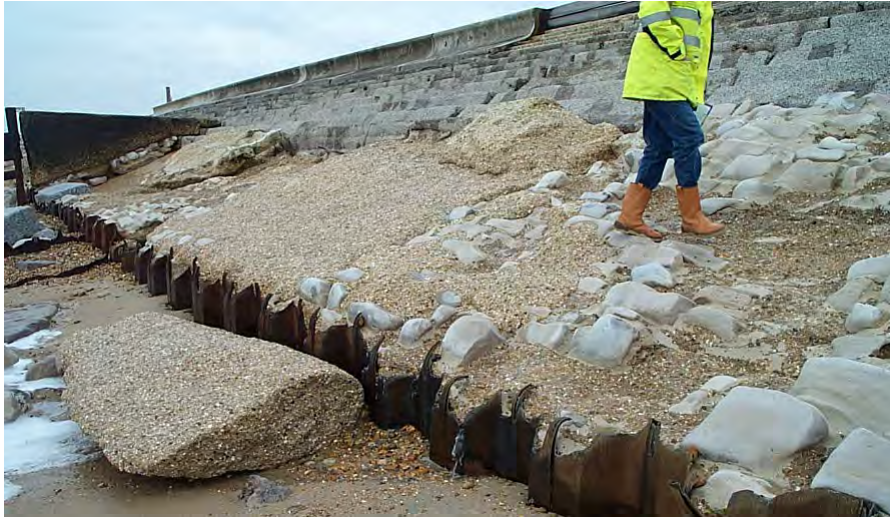
**Figure 4.4 Typical damage to tops of steel interlocking piles (courtesy AP Bradbury)**

in permanent works are likely to introduce a number of complications, including the difficulty of relocating the original piling records, and in practical terms, the fixity caused by walings, ties and so on. Although the removal and reuse of interlocking piles provides a theoretical solution, the state of the piles is often inadequate for reuse. Clutches are often extremely badly damaged, restricting the ability to interlock. In addition, the tops of the piles are often damaged by the ends being bent or burred under the combined action of waves and sediments (Figure 4.4). Reuse of piling for maintenance implies the replacement of piles, which in turn implies the sourcing of piles that will interlock with those left in place. These complications clearly limit the reuse of piling for maintenance purposes.

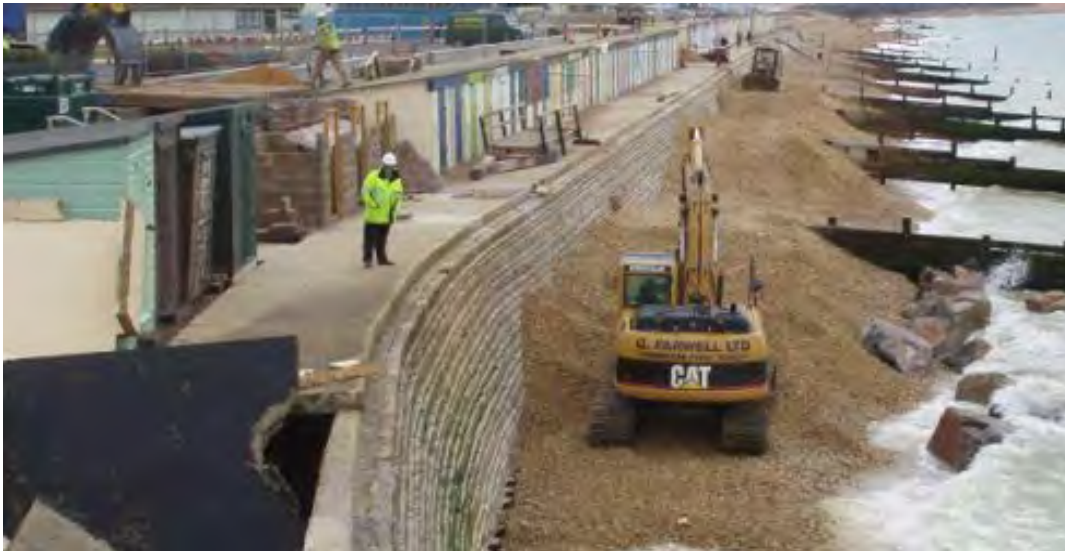
**Figure 4.5 Temporary access road constructed from local beach material (courtesy New Forest District Council)**

Access to the toe is a major problem at many sites and, where access is not possible at the crest of the structure, access via temporary haul roads may be required (Figure 4.5). In this instance, access is required over a number of closely spaced timber groynes. The simplest solution is often reshaping of beach material to form a temporary access way, although this approach is often fraught with the difficulties arising from inadequate beach volume and wave action which may regularly destroy the access.

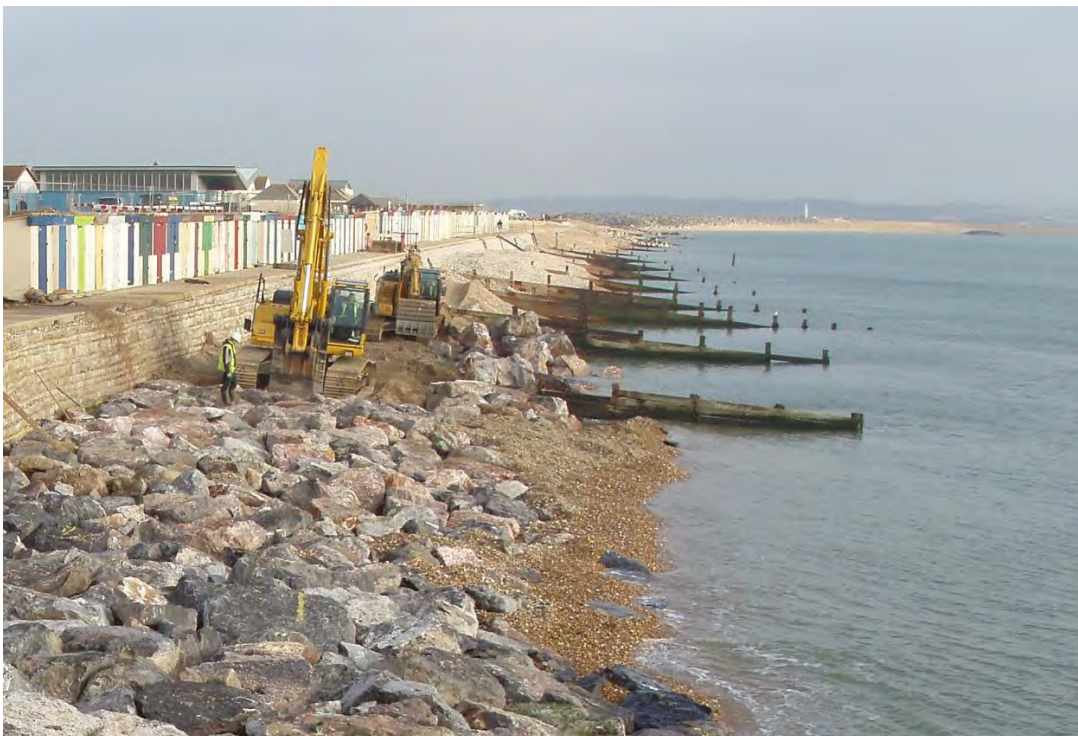
**Figure 4.6 Improvement of access by construction of rock toe with wide crest berm suitable for plant access (courtesy New Forest District Council)**

Maintenance activities may provide the opportunity to enhance access to a site. Addition of a rock toe (Figure 4.6) to support a vulnerable structure has provided the opportunity to improve access along the toe of the same structure as shown in Figure 4.5. The crest berm has been constructed to provide a suitable width to enable a tracked excavator to move safely along the top of the rock toe at all states of the tide. This approach is quite costly, since more rock is required for construction. In addition, the structure has considerable hydraulic benefits in reducing overtopping by the dissipative berm and reducing the volume of beach material required to recharge the site following completion of the toe maintenance works.

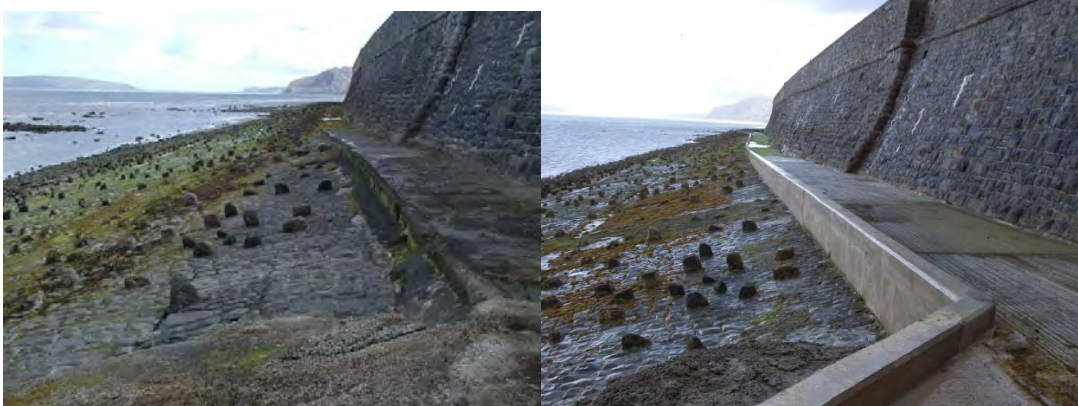
**Figure 4.7 Improvement of access by construction of concrete roadway suitable for plant access (courtesy Alan Williams)**

An example of improvement of an existing dilapidated access along the interface between a mid-19th century vertical wall and a toe revetment, at Llanfairfechan, North Wales, is shown in Figure 4.7. The later shot (to the right) shows how the access was upgraded for maintenance works that were carried out to the toe revetment.

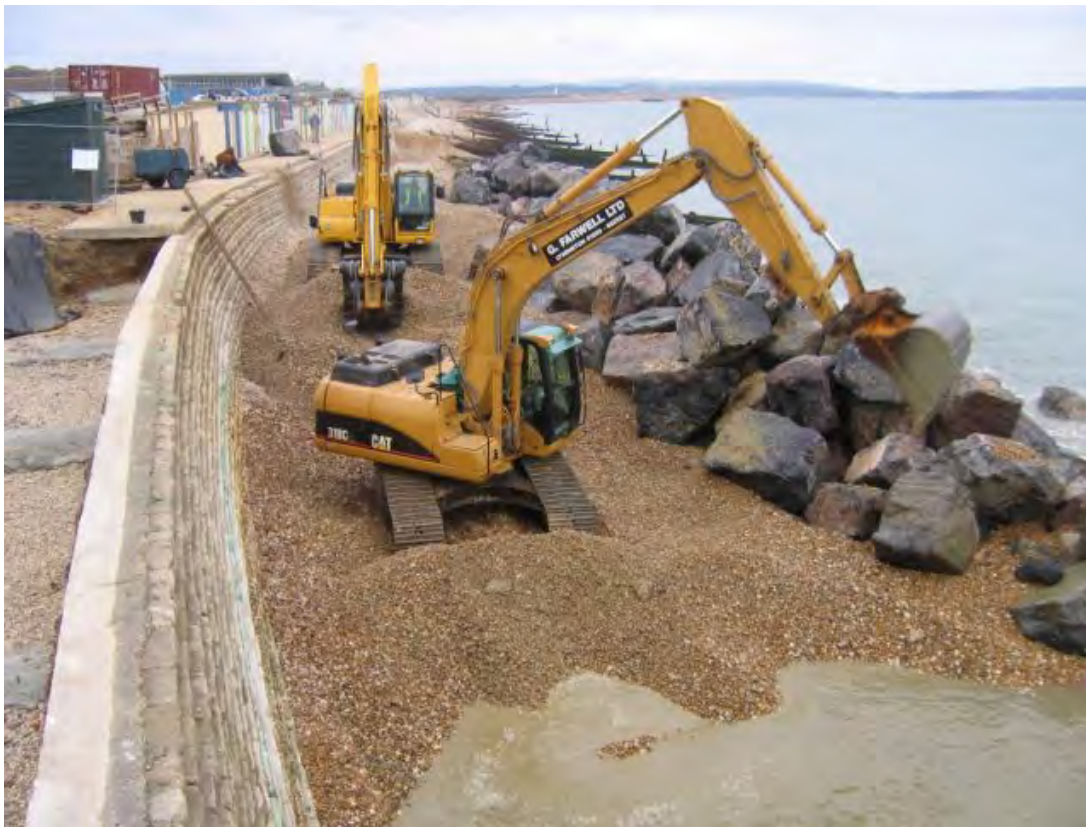
**Figure 4.8 Temporary rock bund to provide safe working area for plant during toe repairs (courtesy New Forest District Council)**

Maintenance works often need to be undertaken in difficult conditions. Working is often required at extreme low water and any small wave activity is likely to reduce the safety of operatives. Rock armour, which is eventually used to provide an additional toe, may be used to provide a temporary bund to achieve safe working adjacent to the wall (Figure 4.8).

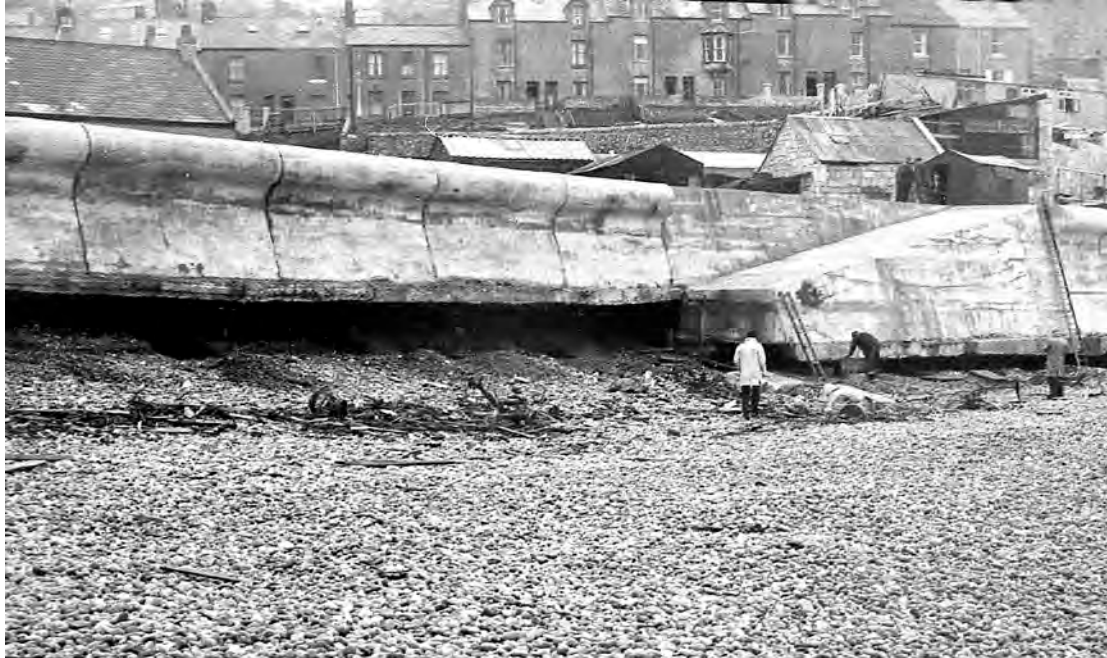
**Figure 4.9 Unsupported section of reinforced mass concrete seawall following major undermining (Chesil Cove 1962) © Stuart Morris**

concrete walls to remain unsupported over fairly long stretches, at least on a temporary basis (Figure 4.9). This occurs commonly where the structure foundations are perched within the tidal limits and where the original foundation construction has not closed onto bedrock. Support beneath the wall is required quickly to avoid cracking and failure under tension. This may often be conducted by underpinning the wall using mass concrete to provide a new foundation.

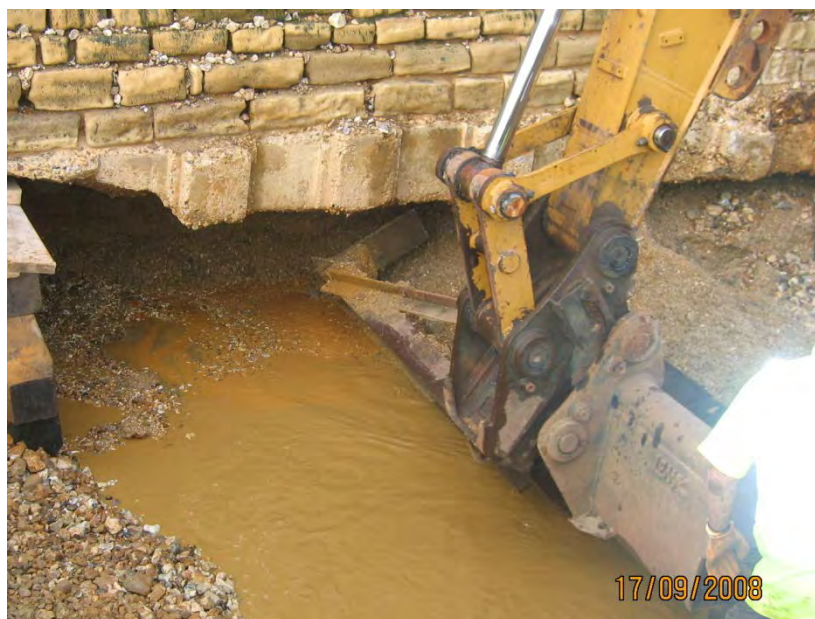
**Figure 4.10 Preparation of foundation excavation beneath wall for underpinning, using bespoke plant to ensure safe working beneath seawall (courtesy New Forest District Council)**

Maintenance operations which require underpinning are challenging and sometimes require the bespoke development of specialist tools to achieve safe working and to maximise the structural integrity of the repair. This often requires removal of failed or loose material from beneath the undermined wall. A modified excavator bucket is used to rake loose material from beneath the bridging wall while maintaining safety for operatives (Figure 4.10). Excavations should ideally close onto competent bedrock material, but this is not always possible due to the depth of beach sediments.

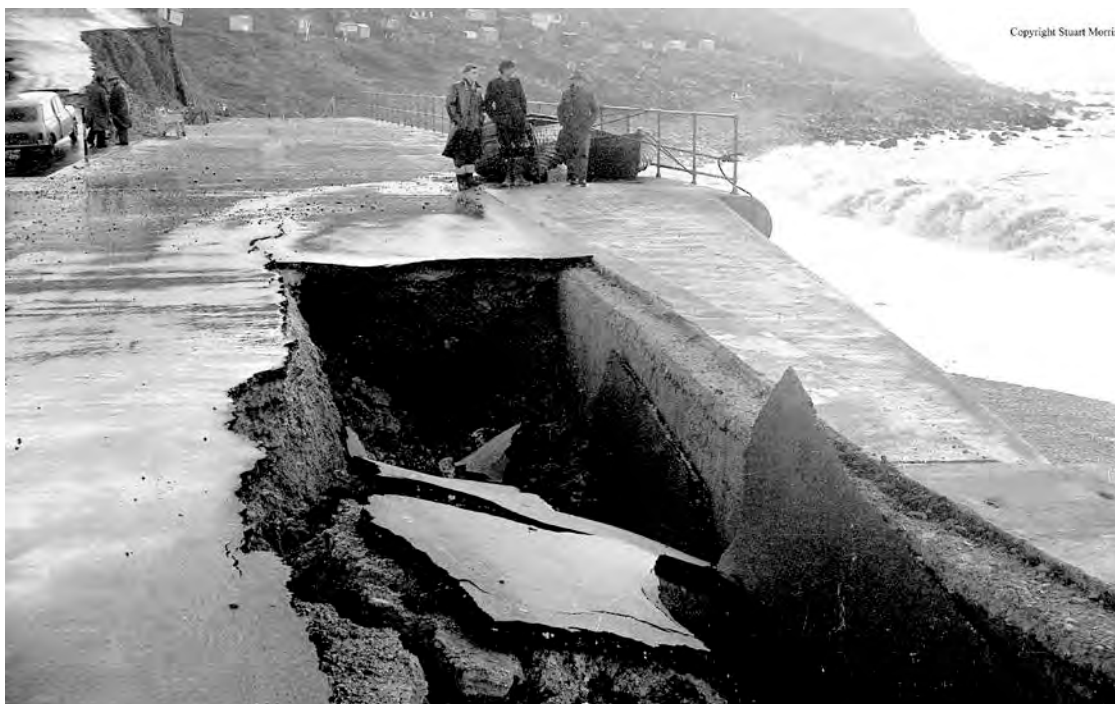
**Figure 4.12 Typical collapse of promenade decking following undermining of backfilled mass concrete wall and washout of fine core (Chesil Cove 1962) © Stuart Morris**

Promenade deck failures of the type shown in Figure 4.12 are fairly common and occur as a direct result of toe failure. Historical construction of mass concrete walls typically included a locally won backfilled material. This material is quite likely to have a significant fines content. Repairs of the backfill zone, following structure toe failure, should ideally be replaced with a coarse compacted granular fill that is free of fines. This will assist with drainage of water from the landward side of the structure and should prevent subsidence of the surface and formation of a void beneath decking, which may often be a cast concrete slab – although the example shown is a simple asphalt surface.

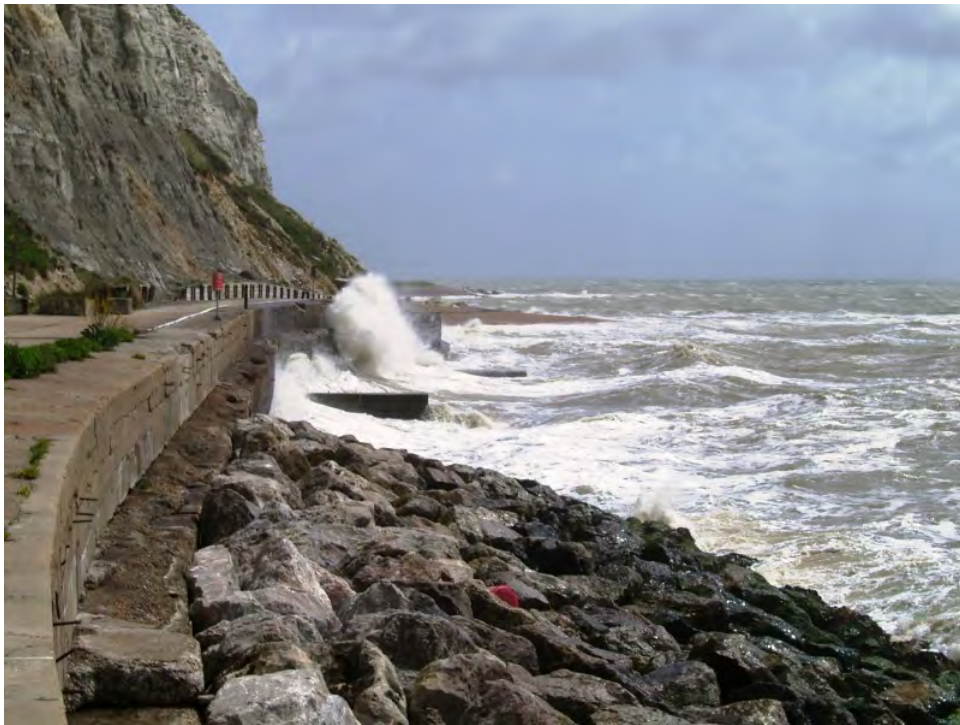
**Figure 4.13 Contrast between concrete toe and modified rock armour toe Folkestone Warren (courtesy Bryan Curtis)**

5. It is clear, however, that rock toe structures are far better at energy dissipation than vertical concrete structures (Figure 4.13).

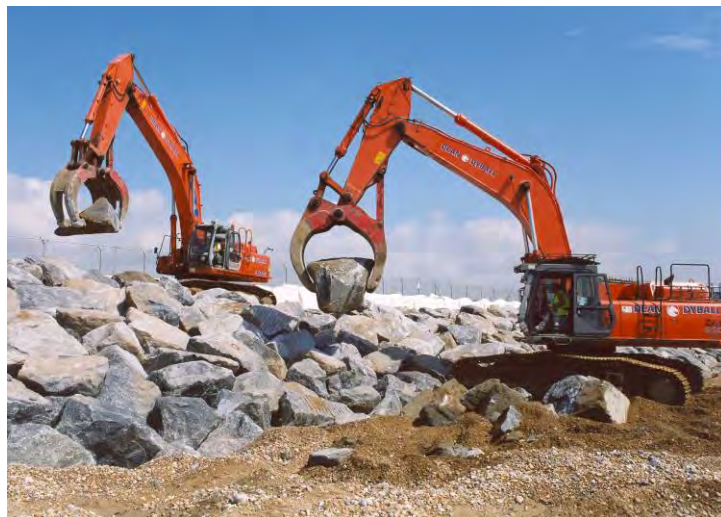
Provided access is possible, Repositioning or reprofiling of dislodged armourstone in a toe structure may be a relatively straightforward maintenance option for limited repairs (Figure 4.14).

**Figure 4.14 Manoeuvring armourstone blocks in a revetment (courtesy Dean and Dyball Ltd)**

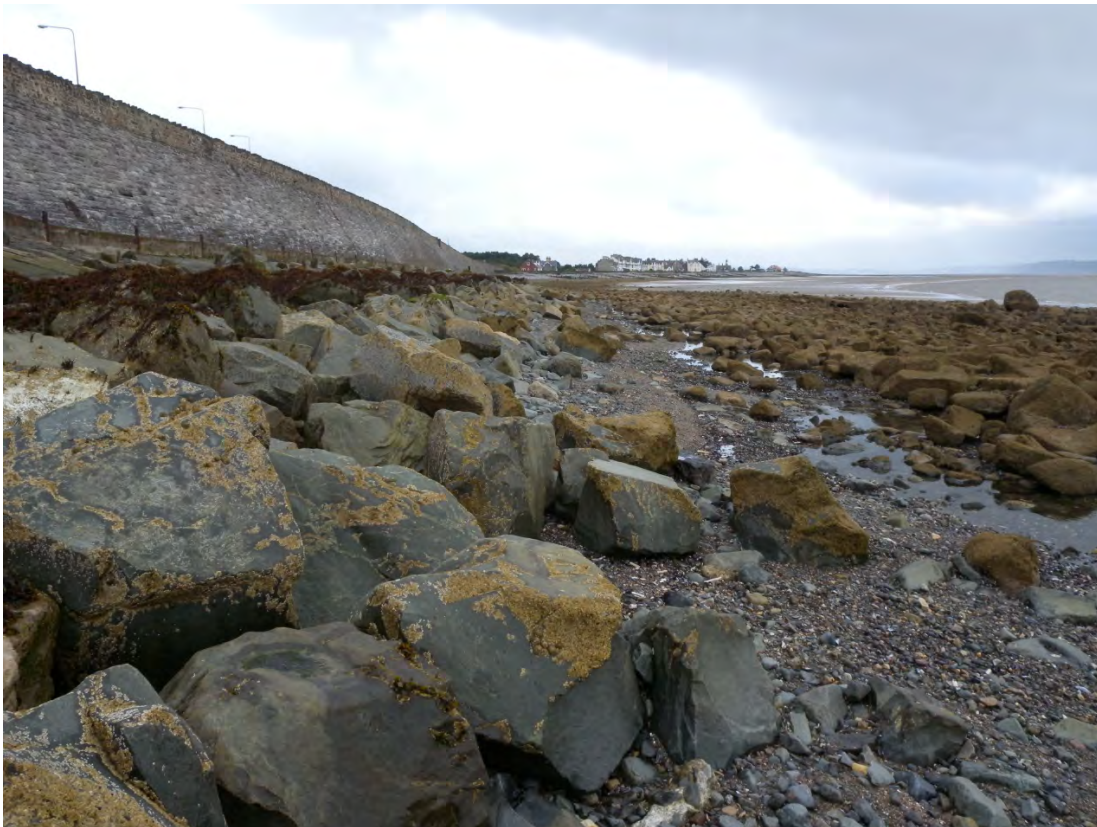
When rock armoured toes have been constructed as part of the defence (see Chapter 5), these may regularly suffer damage (Figure 4.15). A frequent problem arises as the rock toe settles, particularly when this is placed on soft bedrock material. Settlement may result in displacement and reduced interlock of some of the armour, which may require reconstruction to maintain structure integrity. The benefit of the rock armour at the toe is that it is self-healing at the point of bed settlement and will move with the bed. This has the advantage that the structure will not become undermined. The consequence of settlement though is that more material is generally needed to top up the profile. Allowance for settlement of a falling toe is often built in to the design of a rock toe.

**Figure 4.15** Armour displaced from a rock toe, Llanfairfechan, North Wales (courtesy Alan Williams)

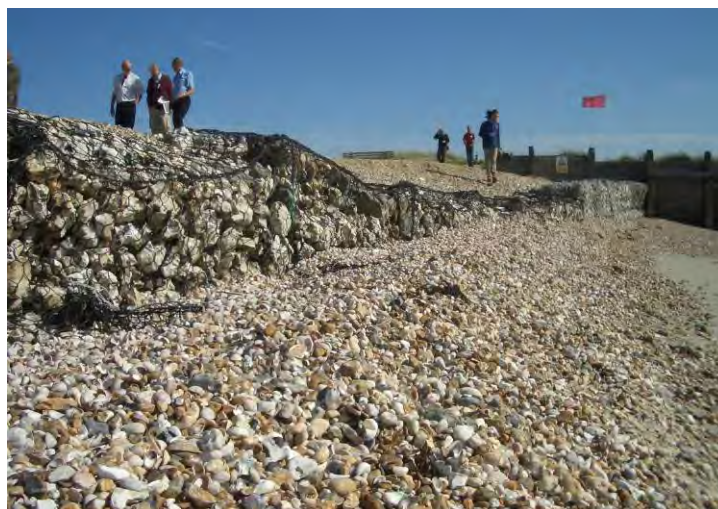
Gabions placed in even relatively mild coastal conditions usually require extensive maintenance and are not generally recognised as efficient toe structures. The contents can settle within the gabions or may escape altogether, with contortion of the mesh or breakage (Figure 4.16). Gabions that have simply 'settled', which remain intact and are relatively in shape may just require topping up with fill material. Sometimes 'leaked'

**Figure 4.16 Weathered gabions at East Head, Chichester Harbour, West Sussex (courtesy HR Wallingford)**

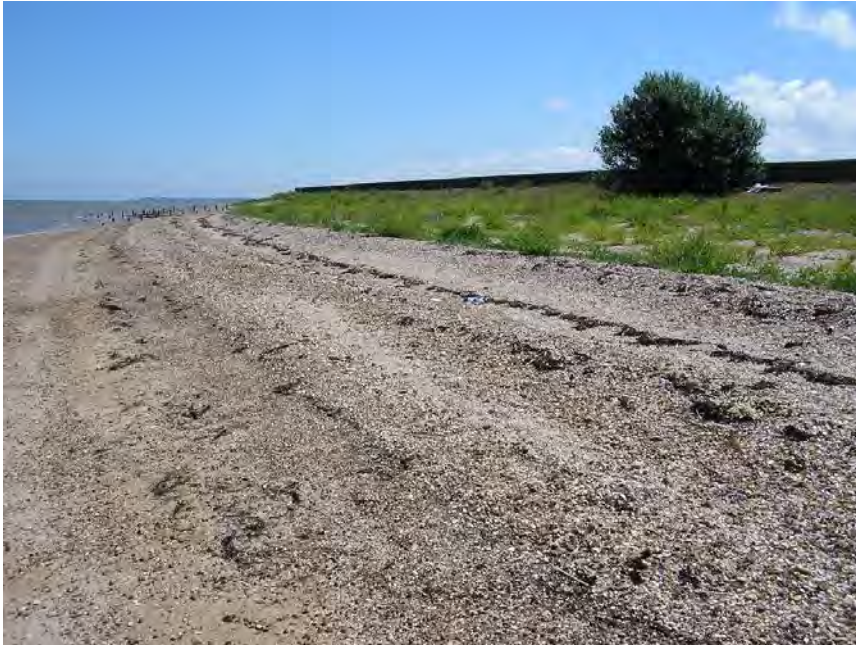
The regrouting or ‘pointing’ of joints in masonry structures is an important maintenance task. Missing joint filler allows water into the structure. If the gap penetrates through to the sublayer, then washout of fill material can ensue. The resultant voids in the sublayer can affect the response to hydrodynamic forcing on the structure, which can quickly weaken from repeated pressure changes. Loose blocks can simply be lifted or sucked out of the structure under wave or surge action and lead to further, potentially rapid, deterioration or even structural failure. Vegetation, once established in joints, can aggravate the percolation of water into the fabric of the structure (Figure 4.17) and the general weathering of the blocks.

**Figure 4.17 Vegetation growth on a revetment (courtesy ENBE)**

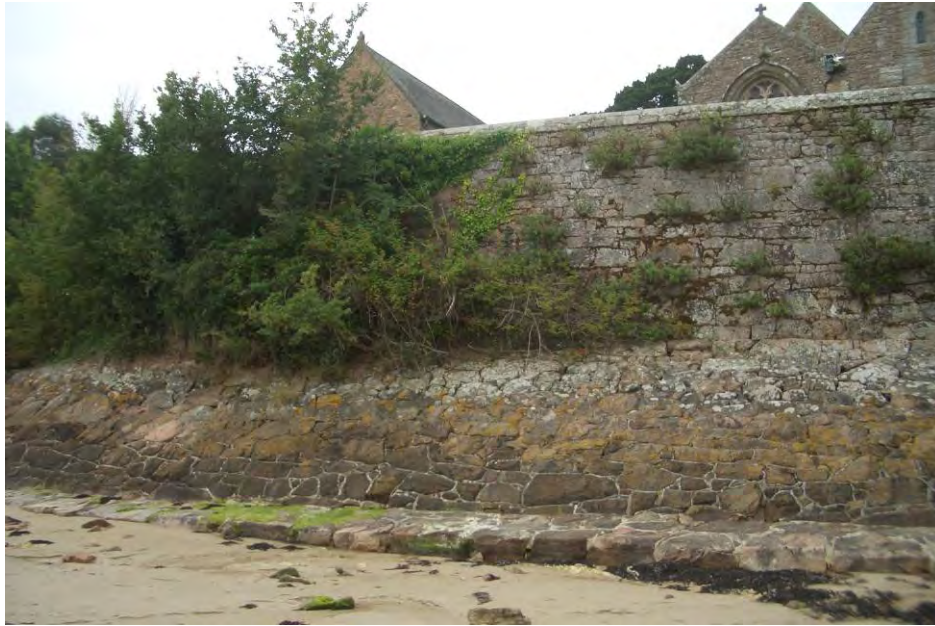
If allowed to grow, vegetation such as bushes and trees can cause deformation and movement in the structure – forcing blocks apart or out of the section (Figure 4.18). Hence vegetation should not be allowed to take root in such structures and should be cleared as necessary. Problems associated with vegetation are more likely to prevail in the higher parts of the wall structure rather than at the toe.

**Figure 4.17** Vegetation colonising joints in a masonry coastal defence  
(courtesy HR Wallingford)

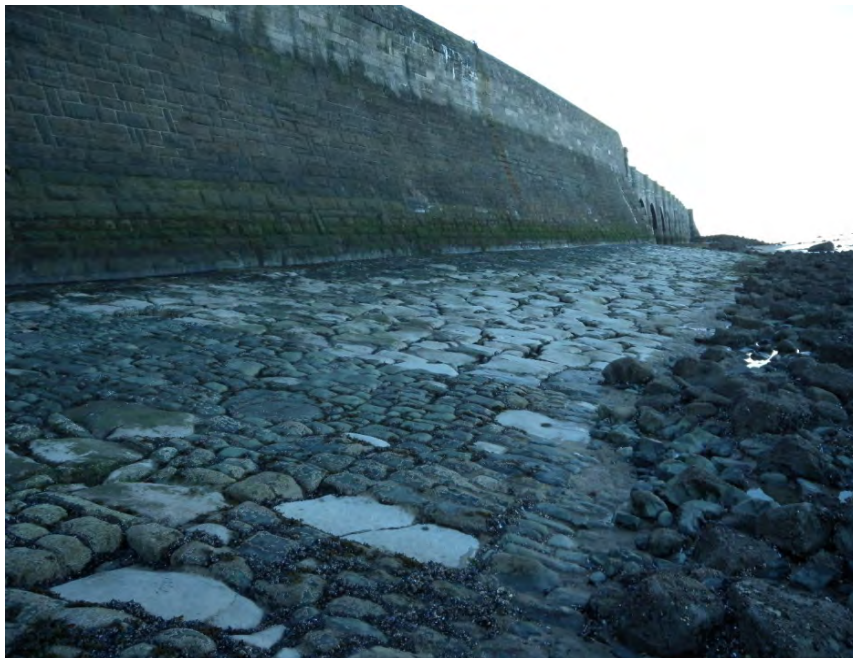
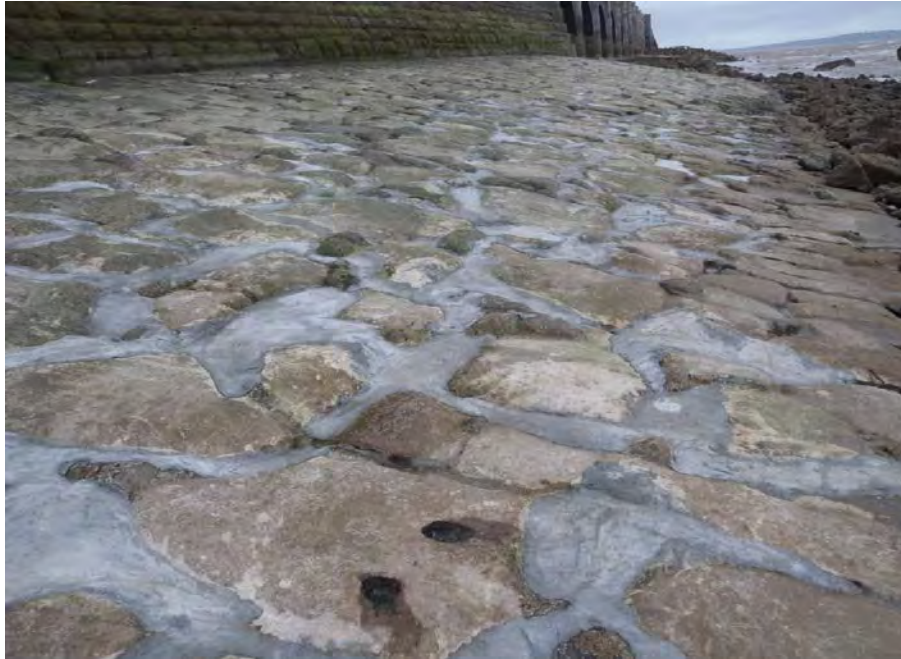
Figure 4.19 shows a masonry toe before and after repointing. A durable grout should be used for pointing to ensure effectiveness and regular inspections made to identify any damage or weaknesses, and to record general deterioration in joint grouting over time.

**Figure 4.19 Prior to and following maintenance of grouted masonry toe (courtesy Alan Williams)**

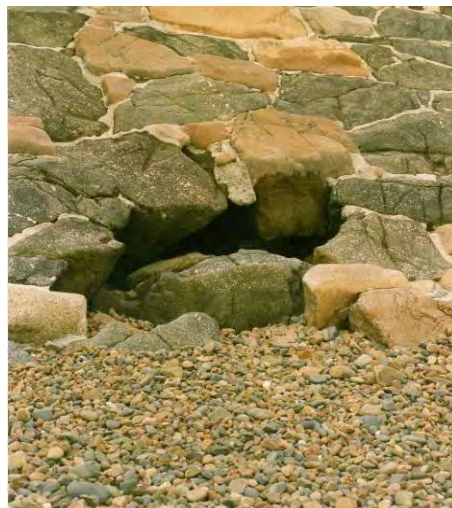
Dislodged masonry blocks at the structure toe may act as a catalyst to rapid toe failure. Under severe storm conditions, failure of the whole defence could quickly ensue. Figure 4.20 illustrates such a situation, which if left unaddressed could cause rapid development of damage to the revetment, together with possible collapse. Major damage arising from this initially small problem would result in significantly greater costs of repair than replacing the single displaced block. Maintenance has to be undertaken soon after damage occurred, if progressive damage is to be avoided. This, in turn, implies regular inspection of defences (and inspection after storms) so that damage can be quickly observed and acted on.

**Figure 4.20 Dislodged masonry blocks from revetment toe (courtesy HR Wallingford)**

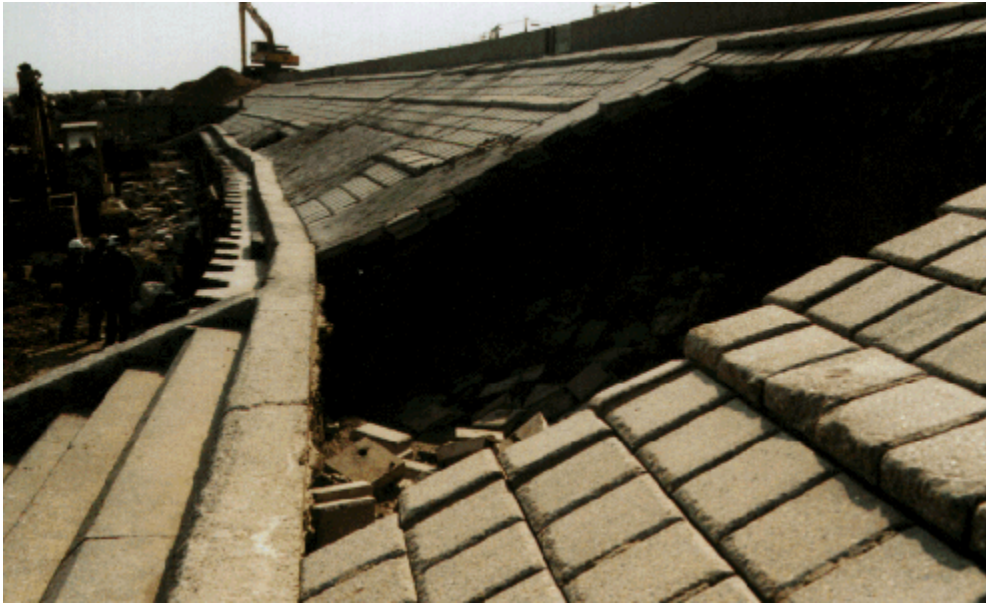
Collapsed, dislodged or missing blocks from toe revetments can quickly lead to more major problems, with washout of fill material and further structural instability and eventual failure (Figure 4.21).

**Figure 4.21 Washout and collapse of block revetment following block removal (courtesy Canterbury City Council)**

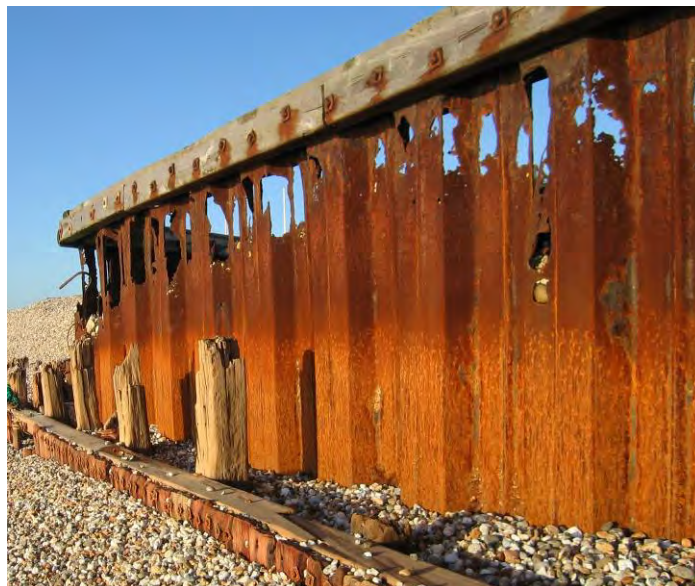
Sheet piles need replacement or repair where they have deteriorated over time either through rusting, abrasion and erosion of section, or through accelerated low water corrosion (ALWC). More generally, failure is manifested by holes in the piling rather than failure of the pile as a structure (Figure 4.22). In the more extreme cases, the thinning sections can become razor sharp. Remedial action should be taken immediately where corroded exposed piles pose a hazard to people or animals.

**Figure 4.22 Deteriorated sheet piles**

While the extreme damage shown in Figure 4.22 is generally unsuitable for repair by welding on steel plates, welding may provide a suitable repair method at locations where the damage is localised and small holes or thinning of the piles has occurred.
