## Toe structures management manual

Project: SC070056/R

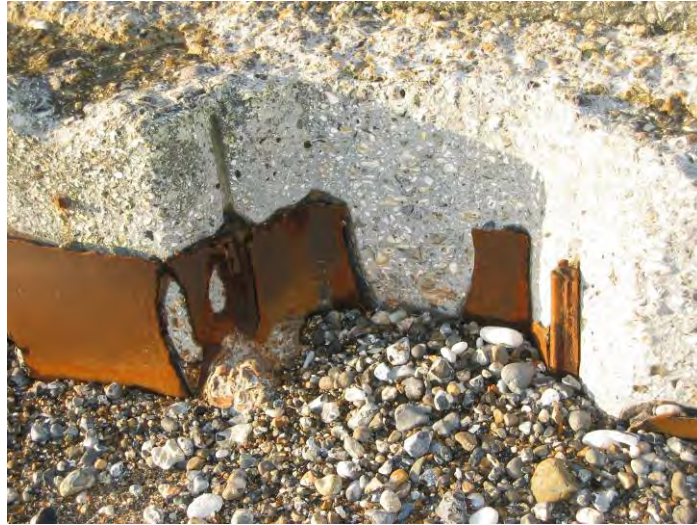
Damage to the tops of piles on toe structures is very common, especially when they are subject to rapid abrasion in a sediment-charged environment. Where the piles simply form a shutter to the mass concrete behind, this may not be a particularly serious issue (Figure 4.23).

**Figure 4.23 Complete loss of section of sheet piles in an area exposed to sediment movement**

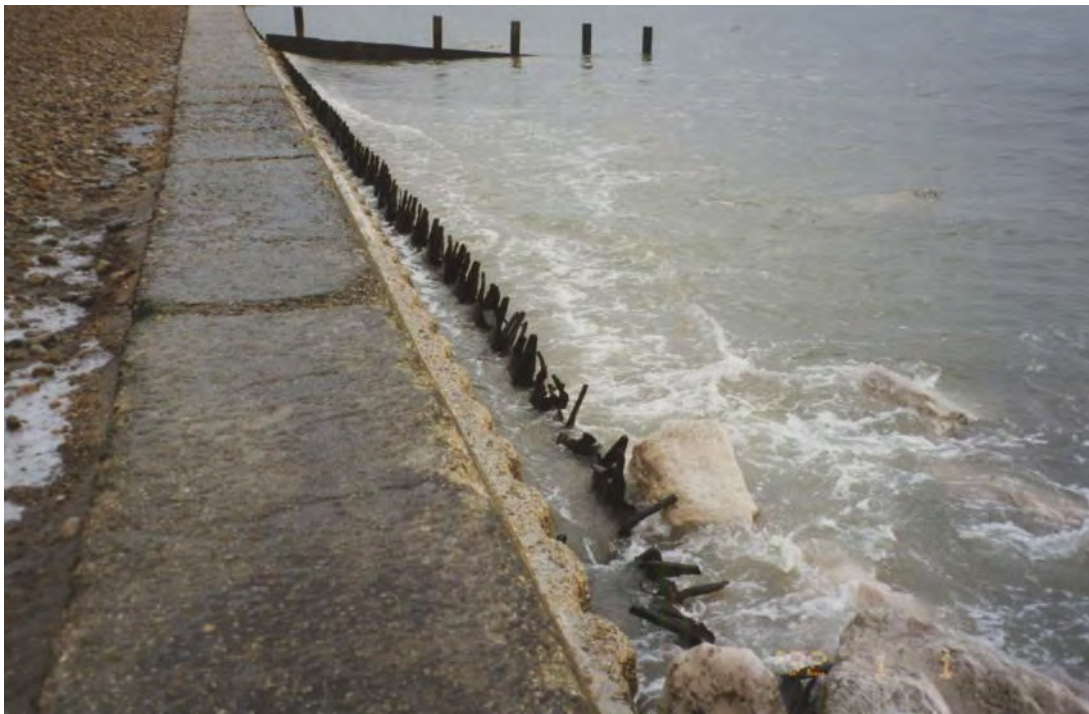
Where damage is noted to the pile tops, reference should be made to the original design to determine the role of the piling in the structure. In those instances where the pile is simply forming a shutter, without a structural role, the piles can be maintained by burning or cutting the tops to remove sharp edges or by covering with rock armour. This is generally a safety measure (Figure 4.24).

**Figure 4.24 Damaged interlocking steel piles requiring maintenance to make site safe (courtesy A P Bradbury)**

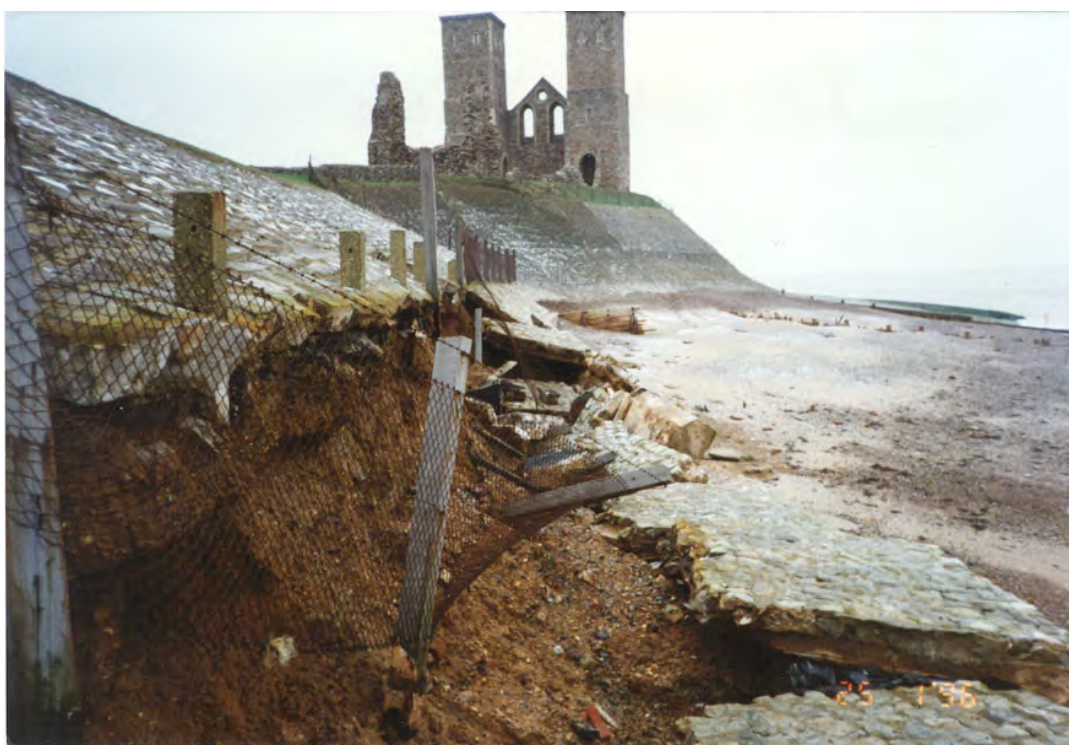
In the case of geotechnical failure (undermining), the principal consideration is the long-term beach lowering (or perhaps an initial inadequacy of the defence). Transient loadings such as those due to storm action may be secondary, except in so far as they lead to short-term beach lowering and possibly an increase in hydrostatic head across the defence structure. Figure 5.1 shows an example of toe failure.

**Figure 5.1 Toe failure example**

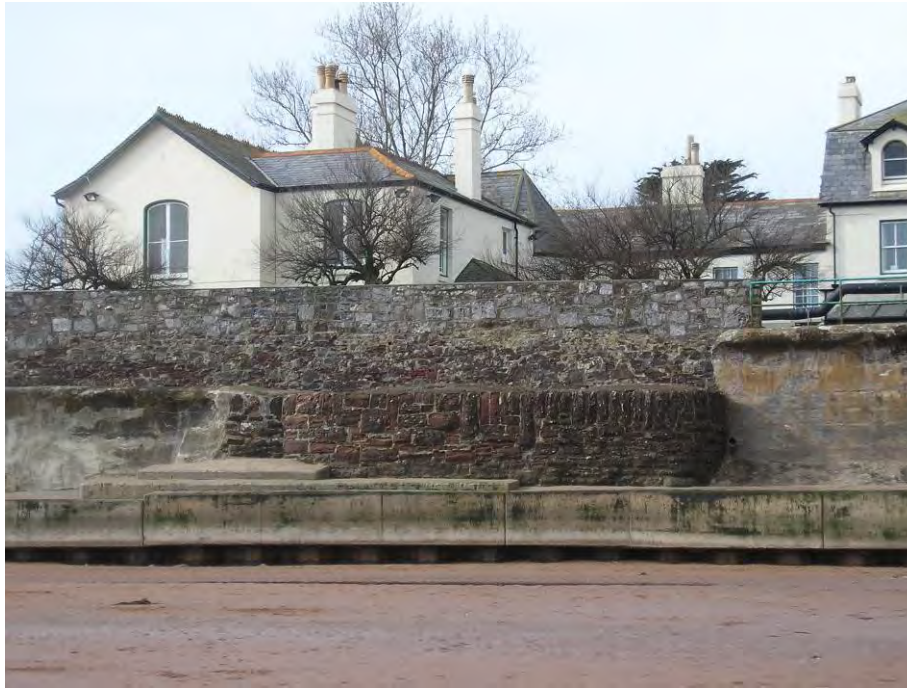
Figure 5.2 shows the seawall at Goodrington Sands, Paignton. Numerous additions to the wall since original 19th century construction can be seen, the last being the concrete/pile toe added by Torbay Council in 2007.

**Figure 5.2 Goodrington Sands Seawall, Paignton (courtesy of ENBE)**

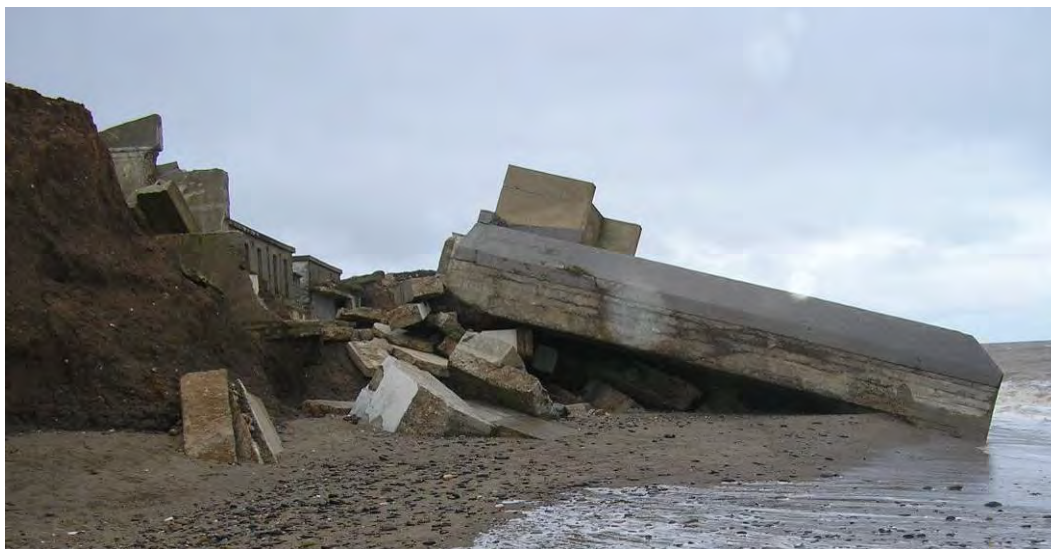
The term ‘undermining’ is not consistently defined in technical or non-technical literature. Perhaps this is because other modes of failures are likely to have occurred before a structure becomes truly undermined; see also USACE (2012). The case study from Corton, Lowestoft, in Appendix C describes a case of true undermining of a piled wall (also Figure 5.3). For discussion purposes here, and generally in these guidelines, ‘undermining’ is simply taken to mean the condition at which the beach is below the bottom of the main defence structure such that further beach lowering would lead to erosion beneath the structure.

**Figure 5.3 Undermining of wartime coastal structures at Kilnsey, Holderness (courtesy of ENBE)**

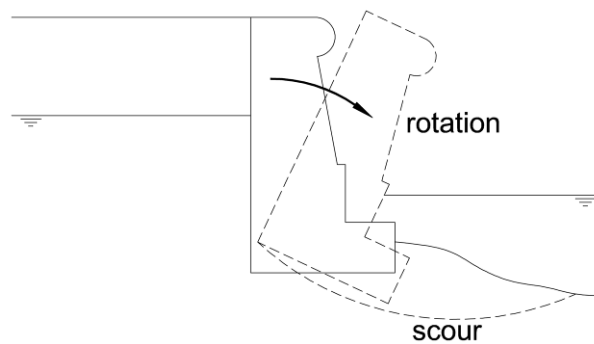
Sliding failure is confined essentially to monolithic type structures (Figure 5.7) while overturning failures are associated mainly with vertical or near vertical monolithic or piled defence structures (Figures 5.8 and 5.9). See also the case study from Lowestoft South Beach in Appendix C.

**Figure 5.8 Overturning failure of gravity wall**

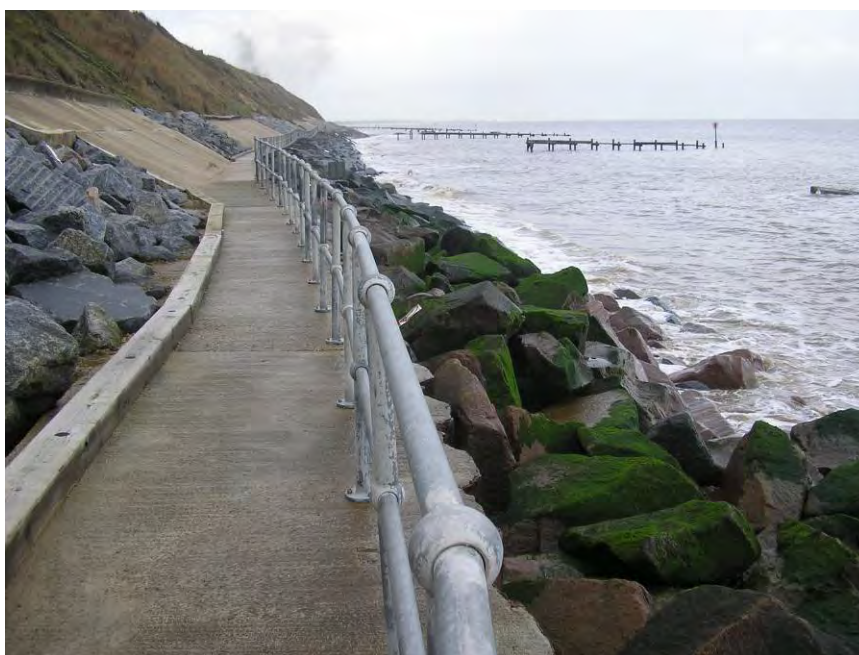
**Figure 5.13 Example of rock used to provide passive support**

It is wise to design for a longer service life than the immediate urgencies might suggest (for example, 10 years rather than 2 years), as the very act of providing some relief can have the effect of changing priorities. An example is provided in Figure 5.13.

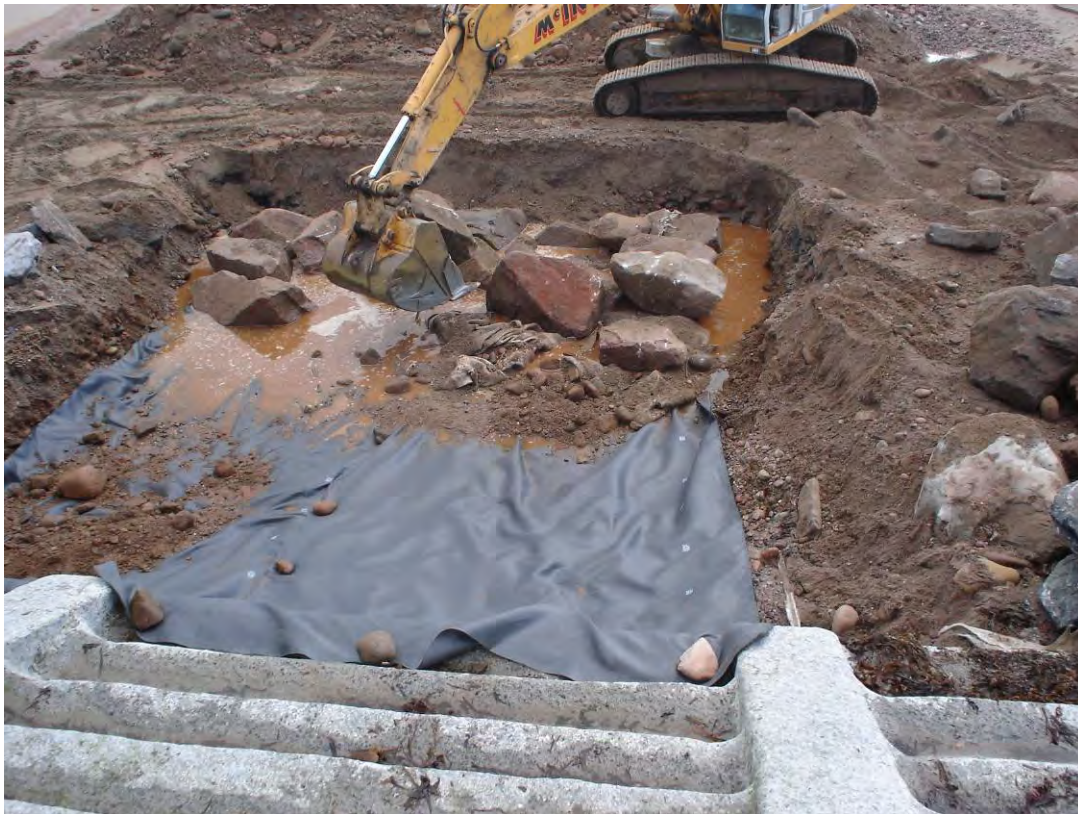
**Figure 5.17 Geotextile being incorporated as part of a toe structure**

Loss of bed material through the voids in rock layers can lead to a lowering of the bed beneath the rocks with consequent lowering of the rock itself until it becomes embedded – an effect akin to that of liquefaction. Unless an allowance is made for this, as for example in the case of a falling toe, it should be prevented. It can also be the case that rock armour will entrain beach sand, but under storm conditions, this will usually be washed out and sediment loss through the armour from the bed will ensue unless prevented. Erosion of bed material through a rock layer can be avoided by installing granular filters or suitably designed geotextile of appropriate specification (Figure 5.17).

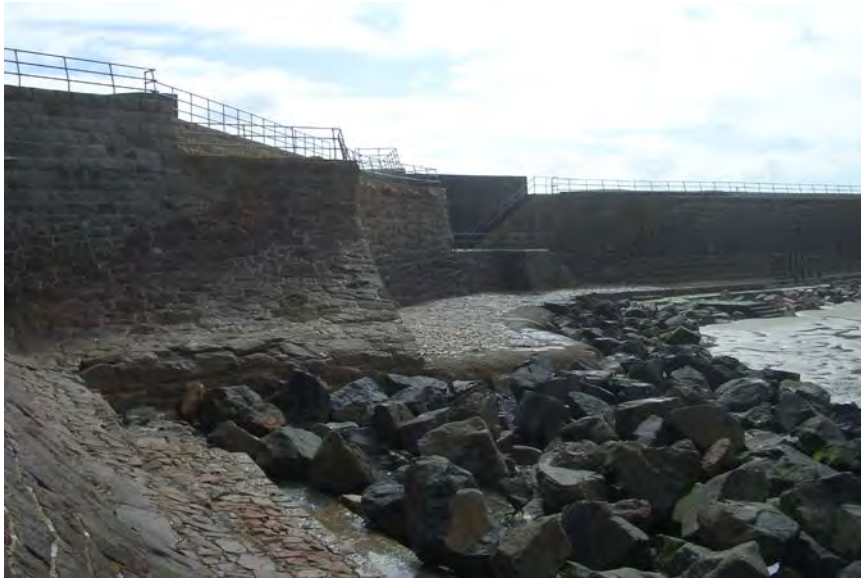
**Figure 5.18 Example of rock apron (courtesy Jersey States Government)**

Figure 5.18 shows an example of a rock apron:

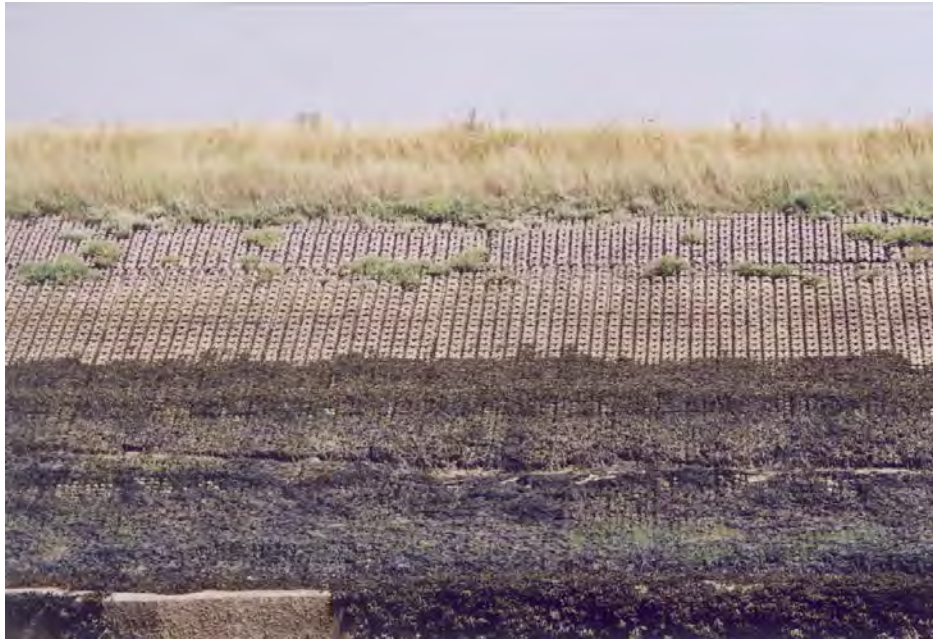
**Figure 5.19 Example of a flexible armoured revetment**

These systems consist of concrete blocks joined together with cables, or attached to a geotextile sheet, to form closely spaced pattern of armour (Figure 5.19).

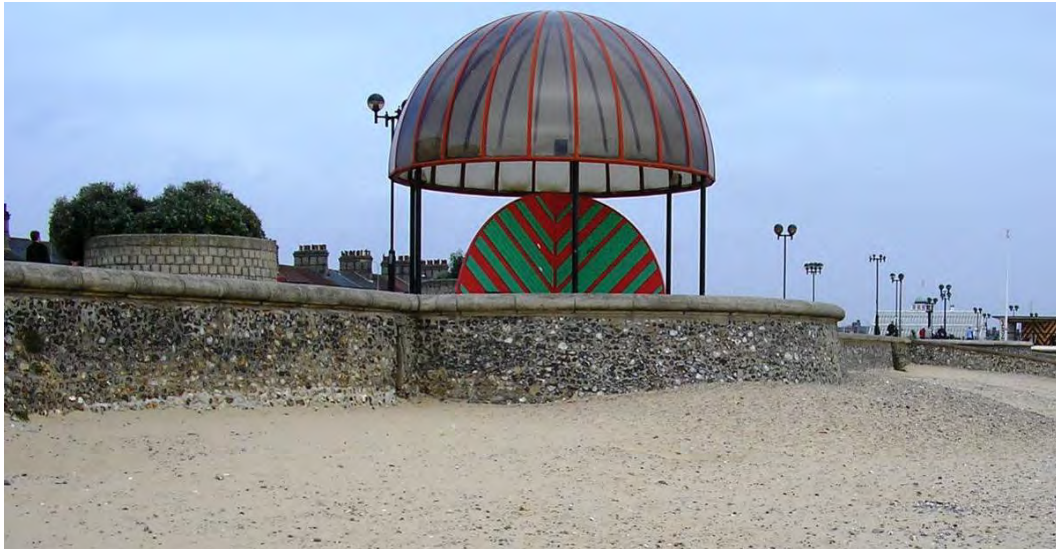
**Figure 5.21 Heritage interest – the flint-faced seawall at Lowestoft South Beach**

Heritage and visual impact considerations may include the appearance of a toe structure when it becomes exposed. The relevant planning authority should be able to advise on such issues during the appraisal stage of a project and on the suitability of design alternatives during the outline design stage (Figure 5.21).

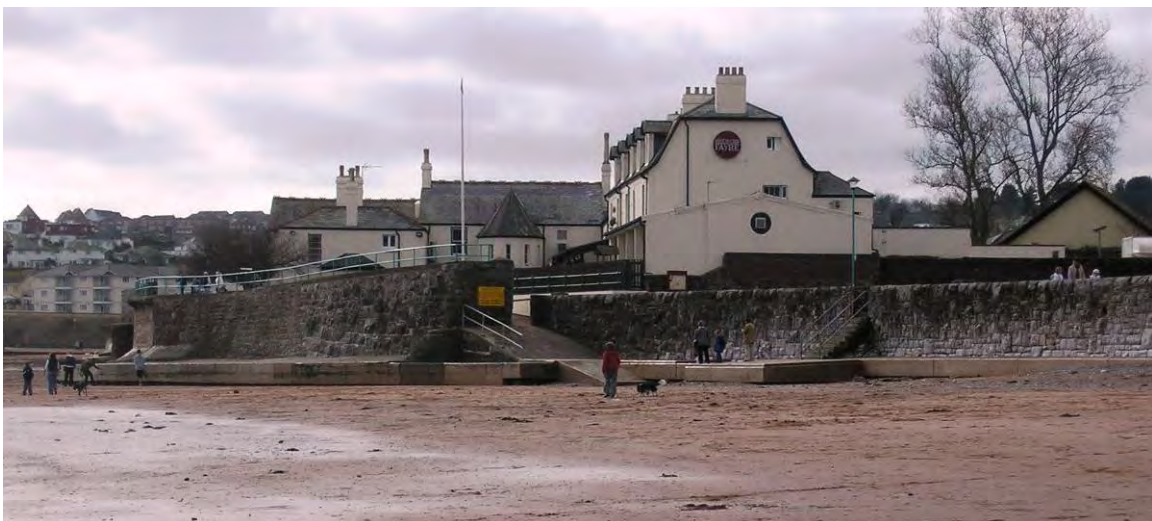
**Figure 5.22 Toe apron proves walking platform – Paignton, Devon (courtesy of ENBE)**

Large exposed aprons or other obtrusive toe structures have a negative impact on amenity by eliminating part of the otherwise available beach area. In some cases, though, the installation of steps or an apron can improve amenity. If the apron is too high above average beach levels, however, then there may be demands for hand rails which are very liable to storm damage and corrosion. The issue is very site- and project-specific (Figure 5.22).

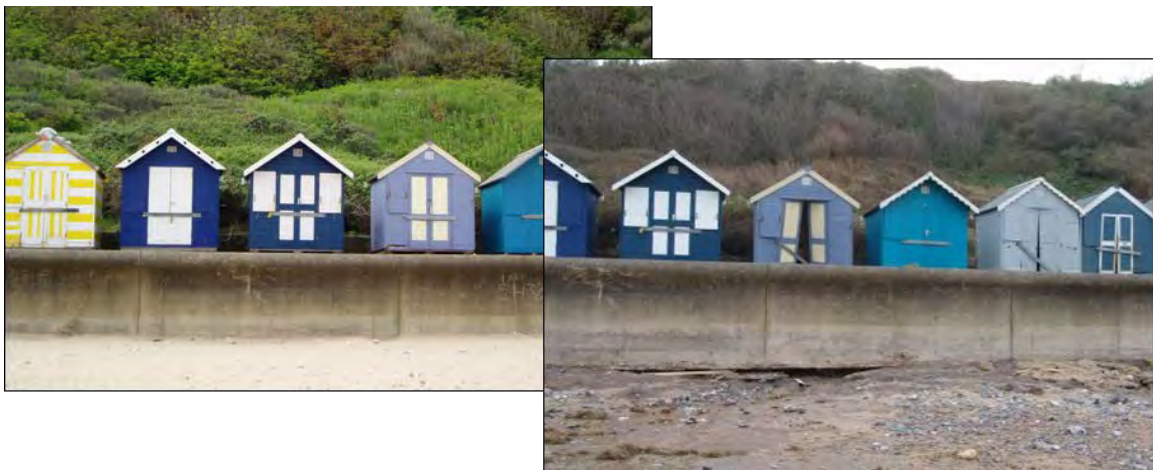
**Figure A.3 Storm event sediment scour (right) and post event recovery (left)  
(courtesy of Peter Frew, NNDC)**

Processes such as the drawing down of beach material from the top of a beach during a storm and the gradual recovery of the beach level after the peak of the storm lead to bathymetries in front of coastal defence structures (and in natural undefended beaches) that vary in space and time. This phenomenon leads to beach variability. Figure A.3 illustrates this phenomenon where a storm event removed sediment locally to a level below the toe of the defence (right image); the subsequent image (on the left) which was taken after a calm period of weather over several months shows sediment levels have recovered considerably once more (without active intervention).

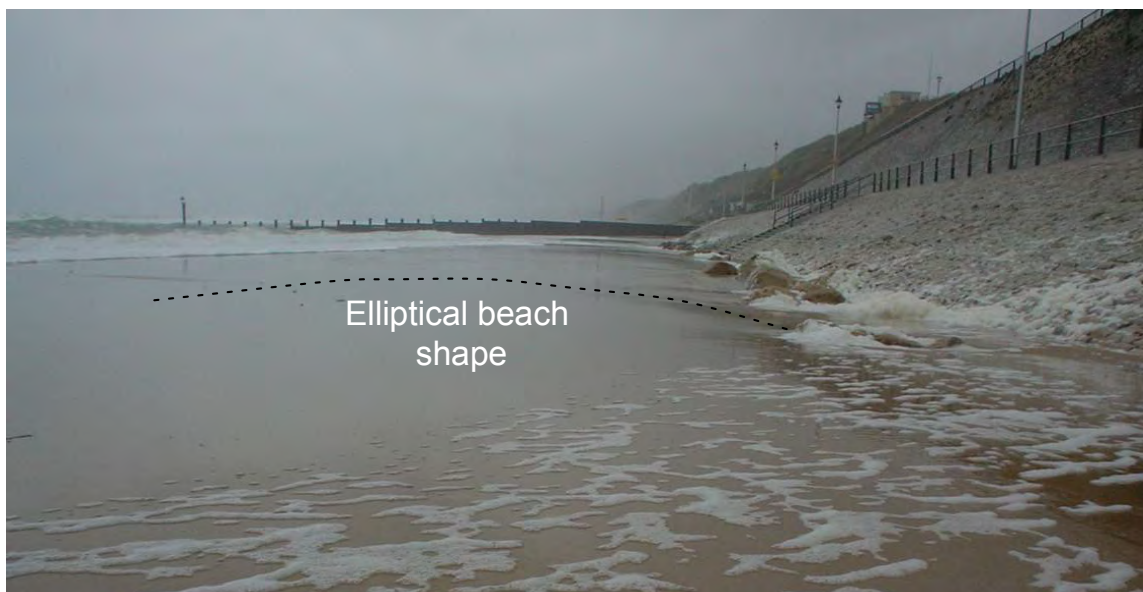
**Figure A.5 Local toe scour at Southbourne on 11 January 2006 (courtesy of Andrew Pearce)**

Southbourne is shown in Figure A.5 towards the end of a storm in 2006, when the beach had been drawn down and a scour trough had formed at the toe of the seawall exposing rock previously placed at the toe.

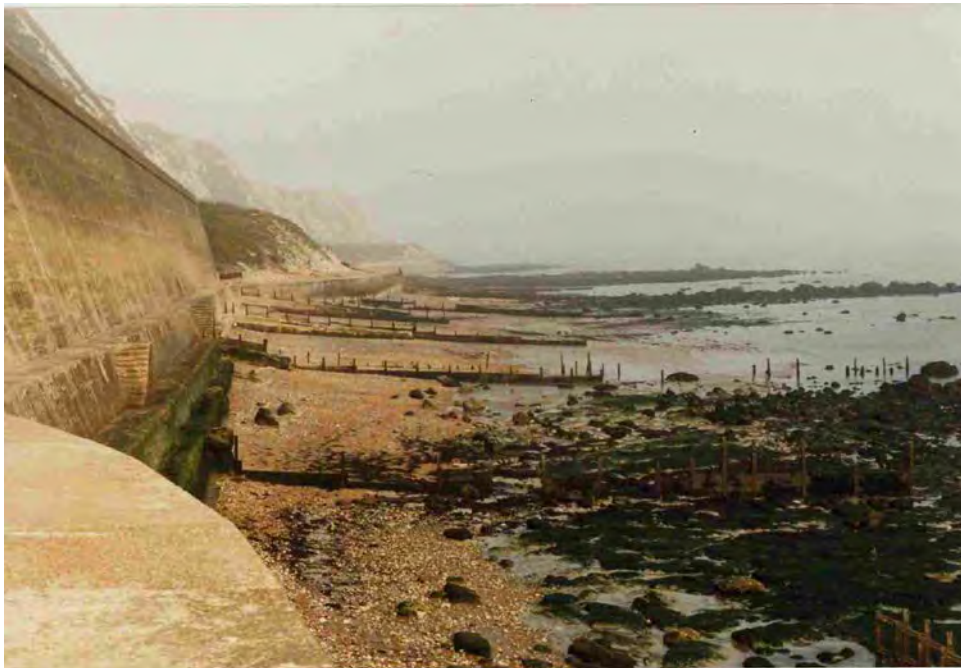
**Figure A.7 Beach and shore platform lowering, Shakespeare Cliff, Thanet**

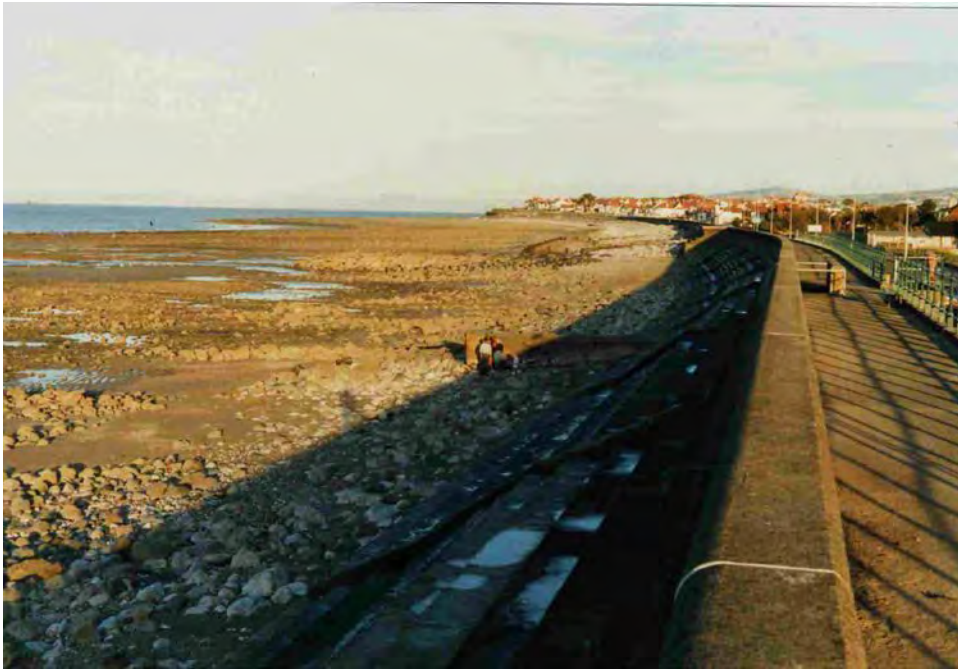
**Figure A.8 Removal of beach sediments from shore platform, Penrhyn Bay**

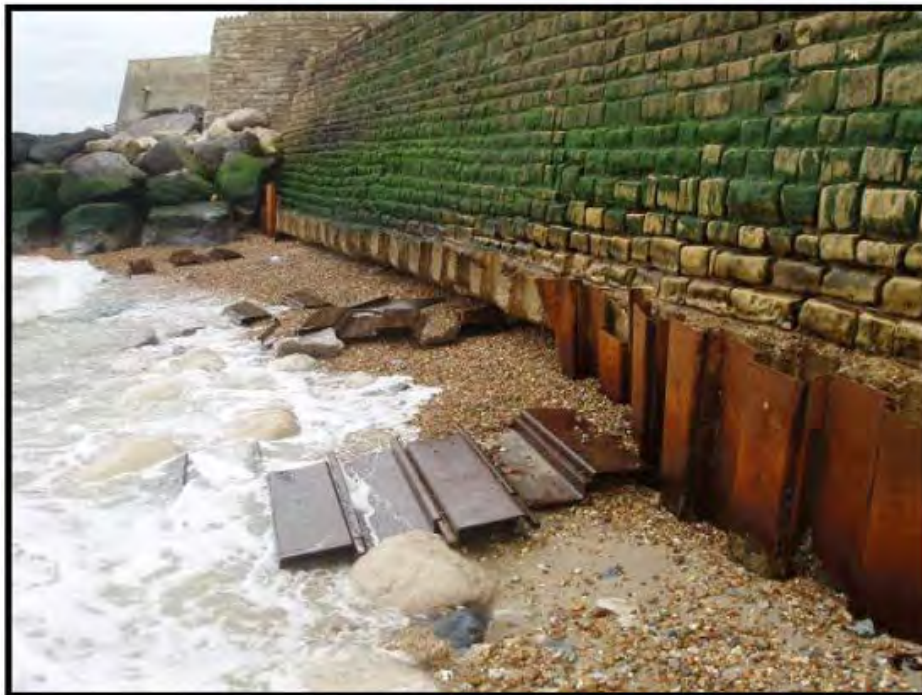
The removal of sediment may lead to the exposure and potential failure of the structure's toe, as shown in Figure A.9, which shows exposed sheet piling, some of which has been removed from the toe as a result of erosion and is lying on the beach.

**Figure A.9 Example of structural damage to a seawall at Milford-on-Sea (courtesy Andrew Bradbury, New Forest District Council)**

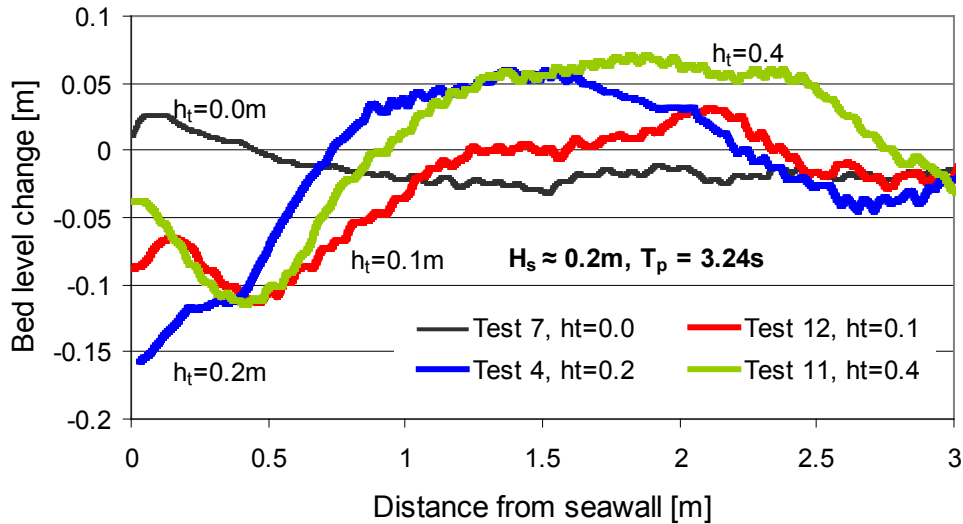
The pattern of scour under random waves reflects the kinematics of the waves that generate it. Bed level changes (final minus initial elevation) at the end of four laboratory experiments (after 3,000 waves) conducted with random waves, fine sand and a vertical seawall are provided in Figure A.13 (data from Sutherland et al. 2007). The wavelength in these tests was such that the scour plotted in Figure A.13 is over a distance of half of a wavelength (at a water depth of 0.4 m) to almost one wave length (at a depth of 0.1 m) – to compare with Figure A.11 – and the scour type in the model was a mixture of bedload and suspended load type. This also covers a distance of  $k_p x$  to a value of 3 (at a water depth of 0.4 m) to 5.9 (at a depth of 0.1 m), which means that it covers the most intense part of the variation in wave orbital velocity plotted in Figure A.12.

In Figure A.13 negative values represent scour while positive values represent accretion. These four tests had the same initial bed profile (a 1:30 slope), the same wave period ( $T_p = 3.24s$ ) and the same offshore incident wave height ( $H_s \approx 0.2m$ ), but different initial water depths at the toe of the seawall ( $h_t = 0.0, 0.1, 0.2$  and  $0.4m$  respectively). These tests show the controlling influence of water depth. A comparison has been drawn between these four tests as they resulted in very different breaking wave conditions at the wall and hence different bed profiles. Thus the scour profiles shown in Figure A.13 are for random, breaking waves in sand on a sloping beach.

**Figure A.13** Variation in final scour depth with water level for a vertical wall measured in laboratory experiments with a sand bed (from Sutherland et al. 2007)

During Test 7 ( $h_t = 0.0$  m), the waves broke offshore and the wave energy was largely dissipated before the waves reached the wall in the swash zone. As a result there was a slight accretion at the wall but a general lowering throughout the rest of the profile. The vertical seawall was situated within the surf zone during Test 12 ( $h_t = 0.1$  m) and some breaking occurred onto it, although most of the larger waves had already broken by the time they reached the seawall. The resulting scour profile includes a small dip at the toe of the seawall caused by turbulence and a deeper scour hole at about 0.5 m from the structure toe.

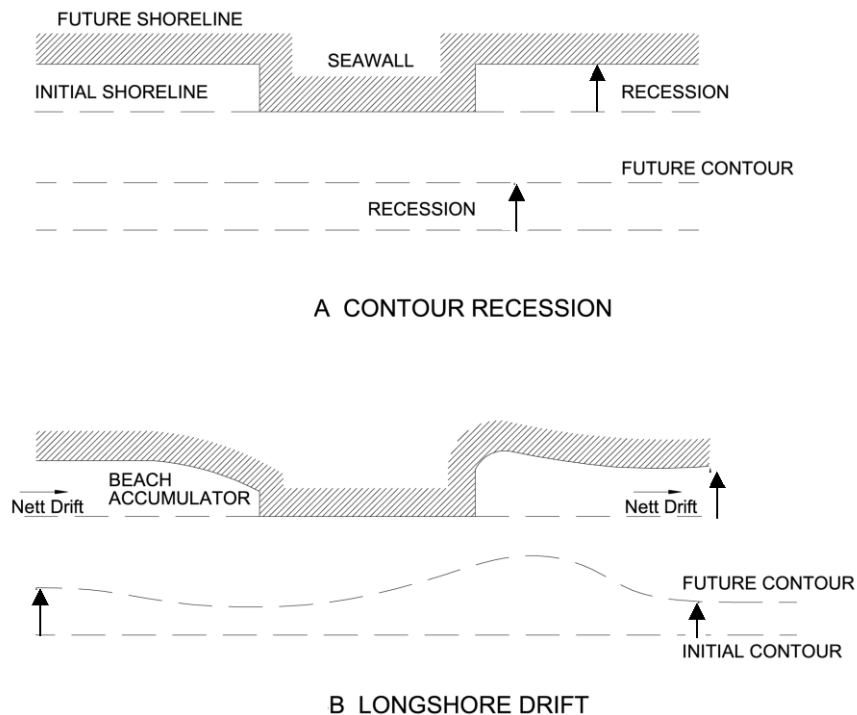
Where for example a seawall is built to protect an eroding shoreline, as sketched in Figure A.16, it will not directly prevent erosion of the adjacent sections of that coastline. In this hypothetical situation, it is assumed that there is no longshore sediment transport and that the material eroded from the coastline and the shore platform is so

**Figure A.16** Conceptual sketches of the effect of a seawall on coastal erosion

The simple example sketched in Figure A.16 for a short length of seawall may not apply for situations, such as at Blackpool or Bournemouth, where seawalls stretch along many kilometres of coastline. A further complication arises when different types of seawall are present along a stretch of coastline, since the lowering of the beach in front of one section of an energy-dissipating seawall may be altered by the effects of adjacent, more reflective structures.

Conversely, the interruption of longshore drift by the seawall results in greater downdrift erosion problems, at least locally, than would have occurred otherwise (for example the situation at the end of the seawall shown in Figure A.18 – Zanzibar). This localised erosion problem will be often reflected in the beach/shore/platform levels just downdrift of the wall, and the ground level contours in front of the wall can be expected to be lower at its downdrift end than at its updrift end (see Figure A.16B).

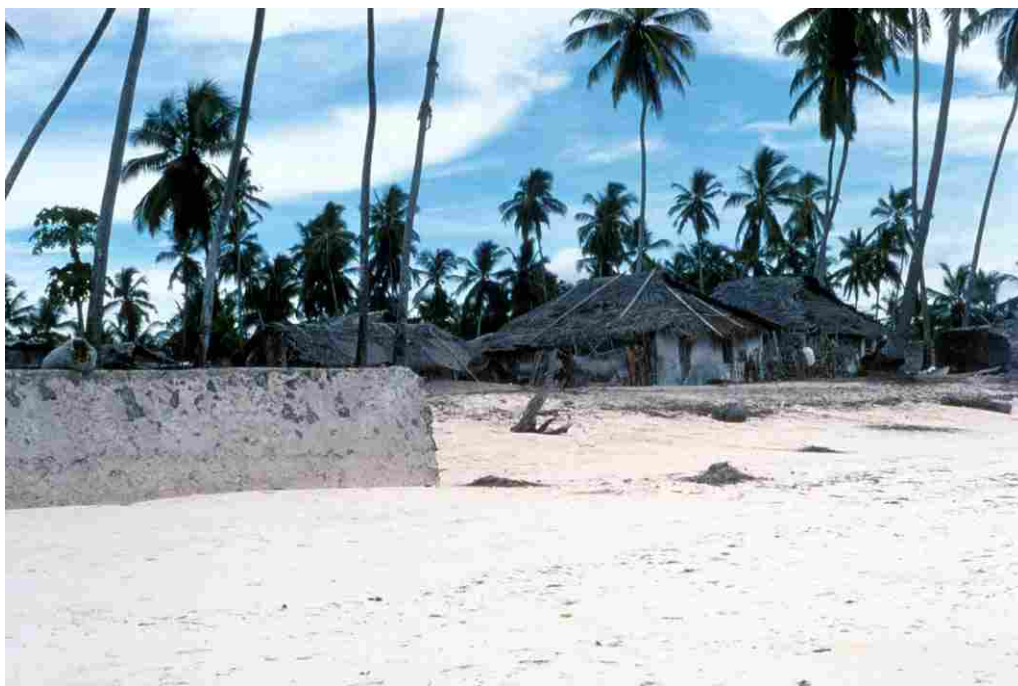
**Figure A.18 Erosion at downdrift end of seawall, Zanzibar**

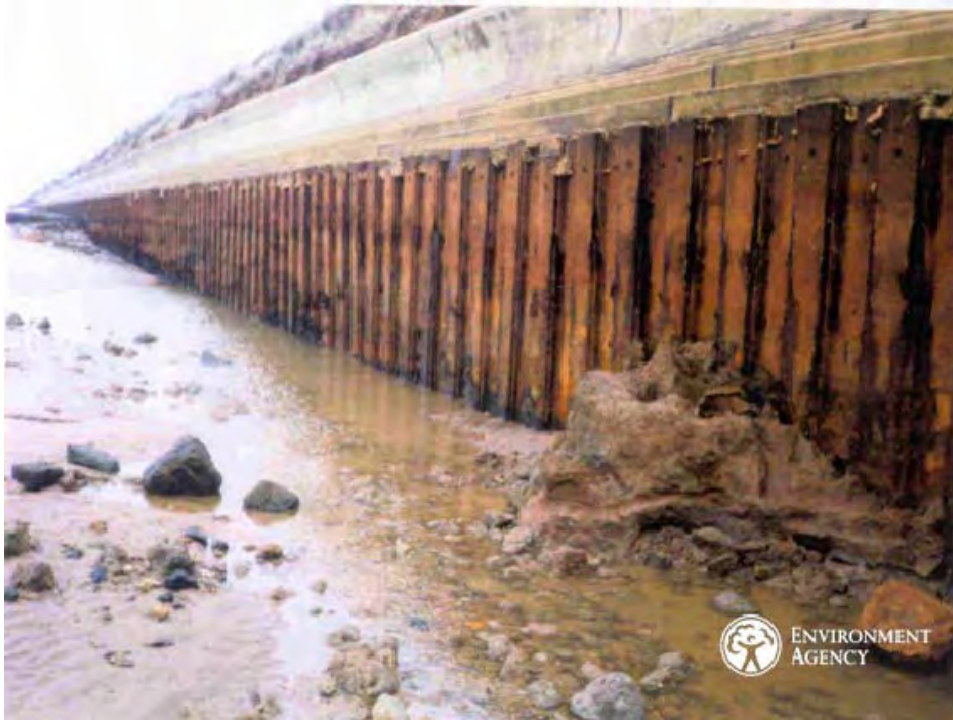
A shore platform and coastal defence is similar to a shore platform and cliff system. Indeed many shore platform and defence systems used to be shore platform and cliff systems. Defences may have been added when cliff recession threatened valuable assets and while these defences can halt the erosion of the subaerial cliff, they do not stop the erosion of the foreshore, as illustrated in Figure A.19.

**Figure A.19 Erosion of a cohesive shore platform at the toe of a seawall**

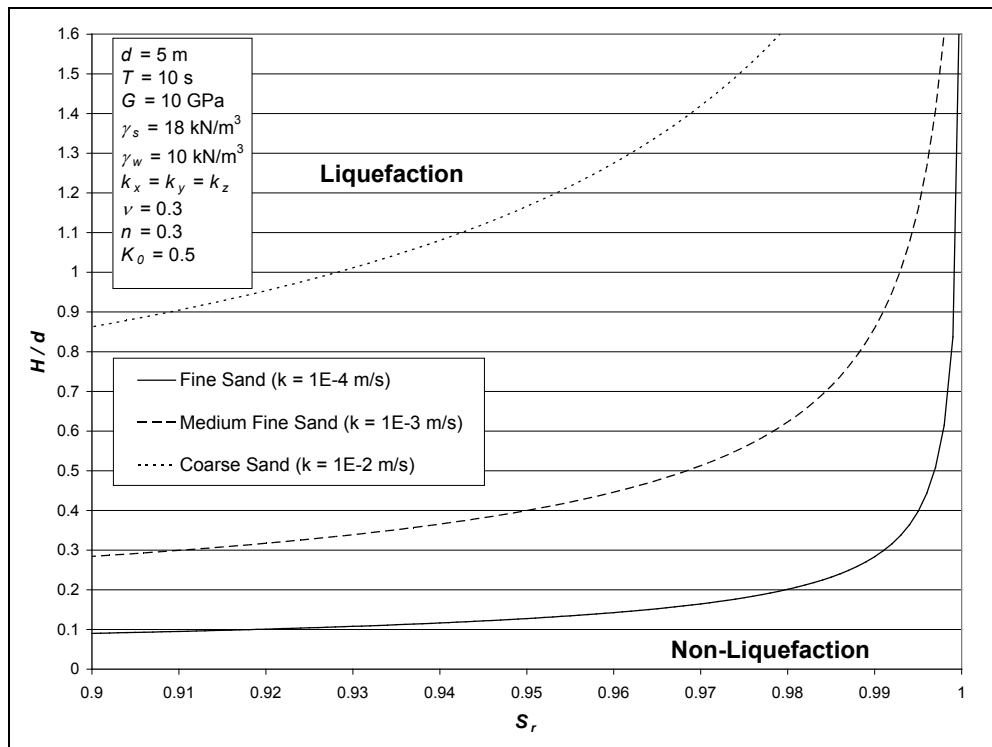
**Figure B.5** Wave-induced liquefaction potential around a marine structure founded on a saturated/unsaturated seabed subjected to various standing wave loadings with a water depth of 5 m (Sutherland et al. 2007)

The effects of wave height ( $H$ ) and degree of saturation of the seabed ( $S_r$ ) on the occurrence of liquefaction to a fine sand bed in a water depth of 5 m is shown in Figure B.5 for a typical storm wave period of 8 s. The degree of saturation of the seabed ranges between 0.9 and 1.0. Esrig and Kirby (1977) reported that the in situ values of the degree of saturation  $S_r$  for marine sediment normally lie in the range 90–100 per cent. Mory et al. (2007) observed from their field data that the  $S_r$  value of sand bed on the Atlantic coast of France ranged from 94 per cent to 100 per cent for the top 0.5 m of the sand bed.

The wave height,  $H$ , presented in the figures is the wave height of the combined incident and reflected waves. Liquefaction occurs in the seabed when both wave condition and seabed condition fall into the area above the line. For instance, the medium fine sand bed, with  $S_r$  value of 0.98, starts to liquefy under the wave condition with wave height greater than  $1.3d$  ( $d = 2$  m, see Figure B.5).

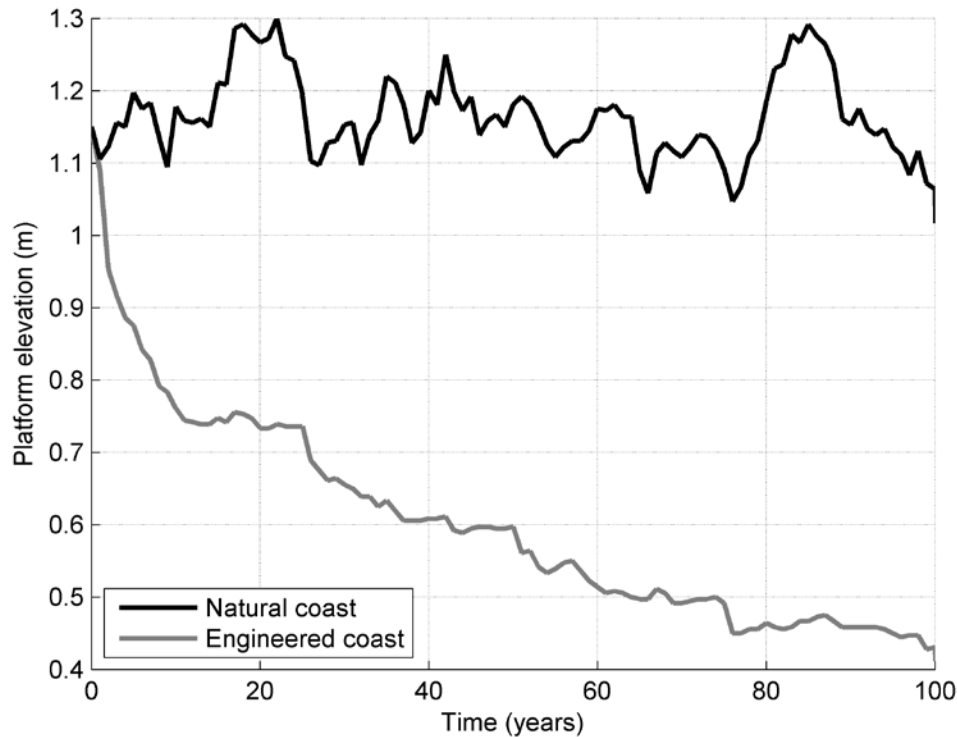
**Figure B.10 Downcutting of shore platform predicted by SCAPE model (Walkden and Rossington 2009)**

An example application of SCAPE to the platform elevation change in front of a coastal structure is shown in Figure B.10. This figure demonstrates that (at least for this specific application, which is for a cliffed coast) continued erosion of the cliff leads to the release of sediment onto the foreshore which maintains the platform elevation above 1 m (line labelled

'Natural coast'). Where the scenario of a seawall is introduced (line labelled 'Engineered coast') the platform is predicted to undergo a progressive reduction in elevation, in this case by 0.7 m over a period of 100 years. The average rate of 0.007 m/year is in the same ballpark as the observed rates in Table B.1. The model results were averaged between 10 m and 20m from the cliff toe or seawall toe, and not at the toe itself.

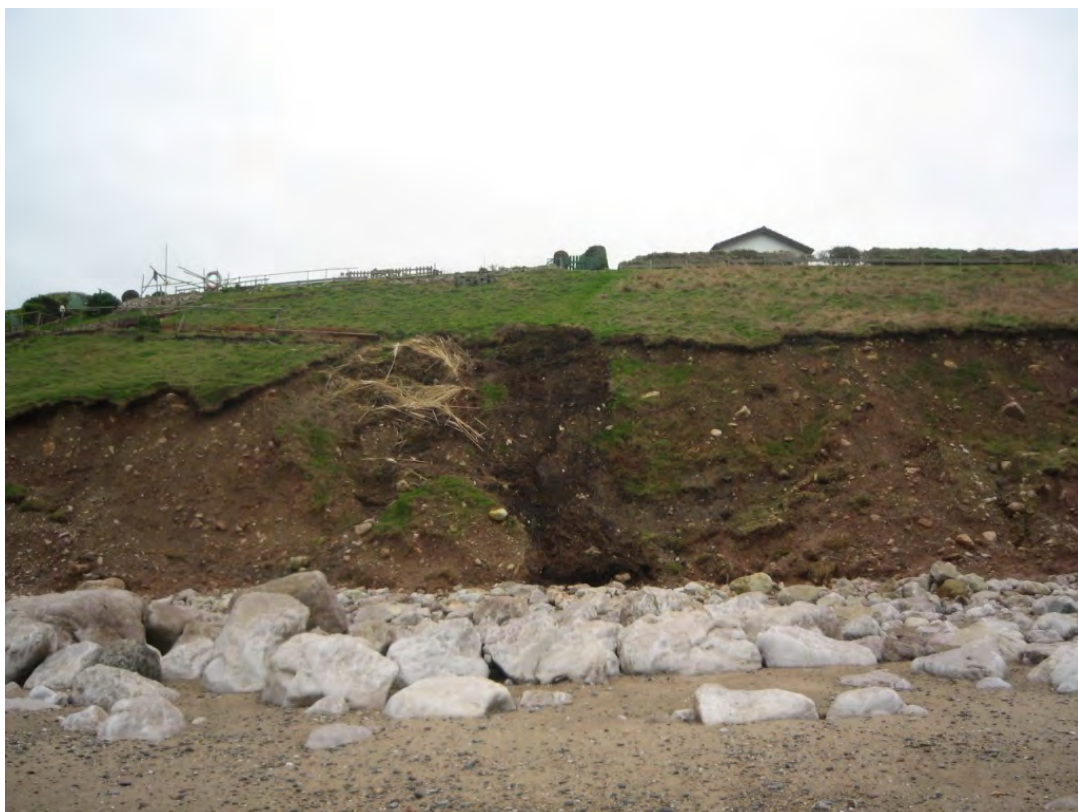
### **Figure C1.3 Coast protection measures constructed as a condition of the development**

condition for building these later properties, the developer was required by the (then) local authority, Aberconwy Borough Council, to provide coast protection. These measures entailed regrading the cliff and constructing a revetment. According to local observers, the revetment was formed by pushing the indigenous boulders from lower down the foreshore up to the toe of the cliff (Figure C1.3). Larger boulders were set at the bottom of the mound, with smaller boulders at the top.

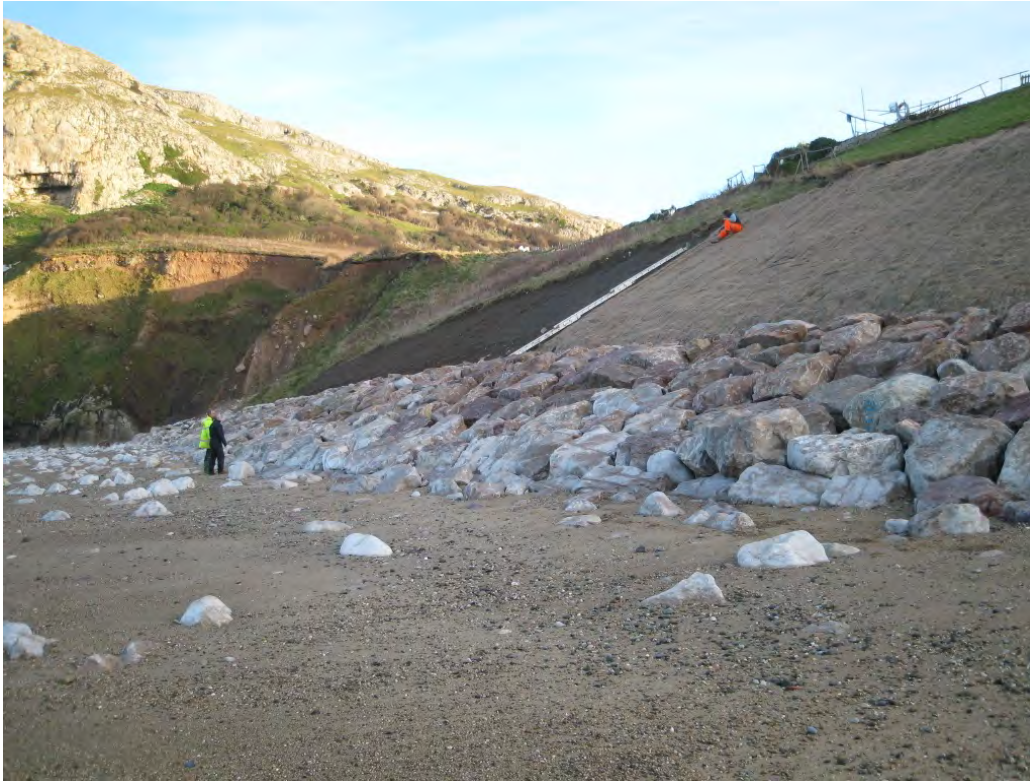
**Figure C1.6**                      **Regraded cliff face**

The capital works scheme was procured through competitive tender. Further to the reuse of the local rounded boulders, rock was obtained from local quarries. This limestone had been used elsewhere where it was known to be performing well after 30 years' service. Given its position at the foot of the cliff, access to site needed careful consideration. To facilitate access, a temporary haul road was created from the paddling pool (see Figure C1.2), the latter area also being allocated for the contractor's compound. Figure C1.6 shows the regraded cliff face.

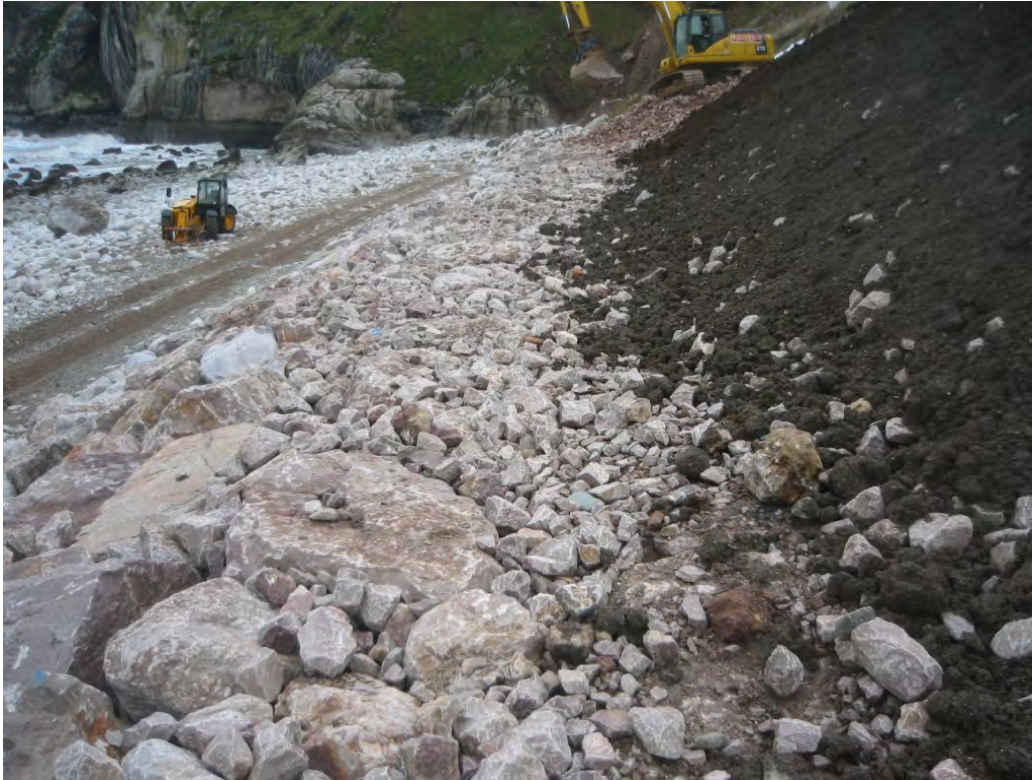
**Figure C1.7**                      **Construction in progress**

The construction works were at a high elevation in the beach profile but still required shift working in line with the tidal window and weather conditions (see Figure C1.7).

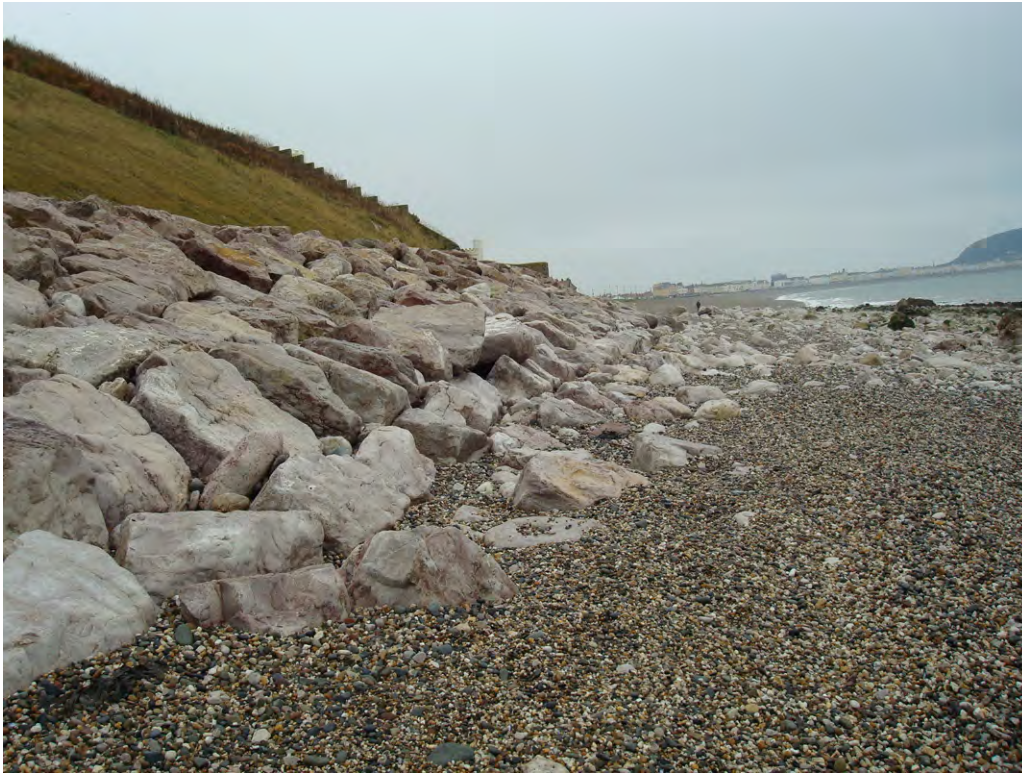
**Figure C1.8**

The completed scheme is shown in Figures C1.8 and C1.9. Beach surveys and an inspection of the site are carried out twice a year; there is an annual report. No problems have been encountered with the toe of the revetment. Public perception of the scheme is good.

**The completed scheme**

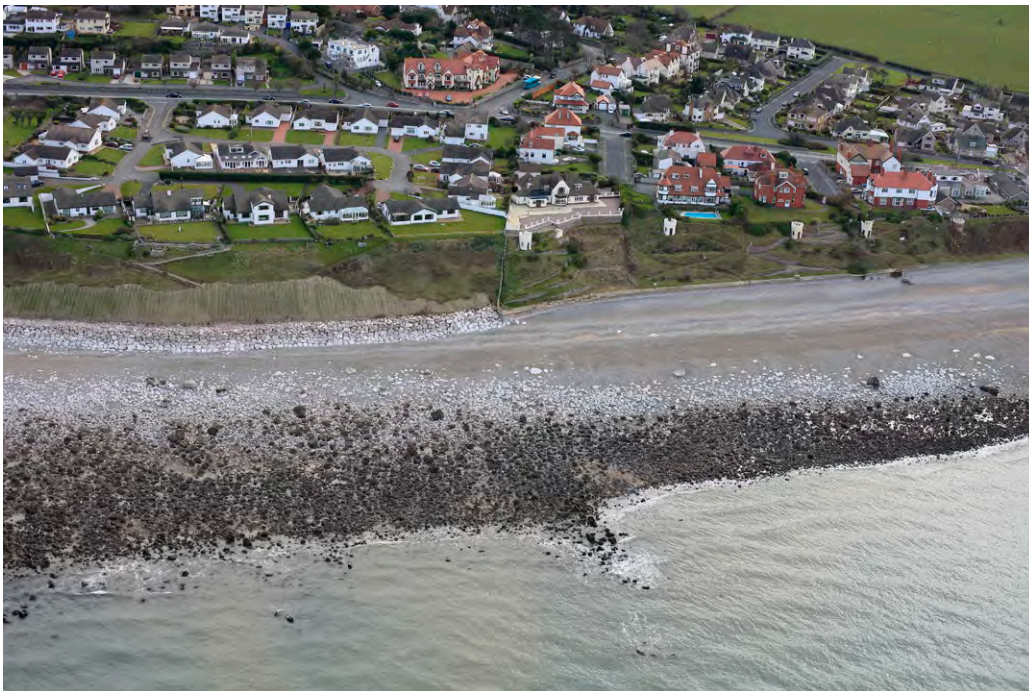
**Figure C1.9**

**Aerial view of the project (note Craigsidde vertical wall to the west of the revetment)**
